| Project | Proposed Alterations & Extension to Roman Lodge Tydd St. Mary Spalding Lincolnshire PE13 5SB | Date | August '09' |

| <b>Title</b><br>Proposed Barn Roof Plan | |

# APPLICATION FOR APPROVAL OF DETAILS RESERVED BY CONDITION

Roman Lodge, Mill Lane, Tydd St.  
Mary, Spalding PE13 5SB

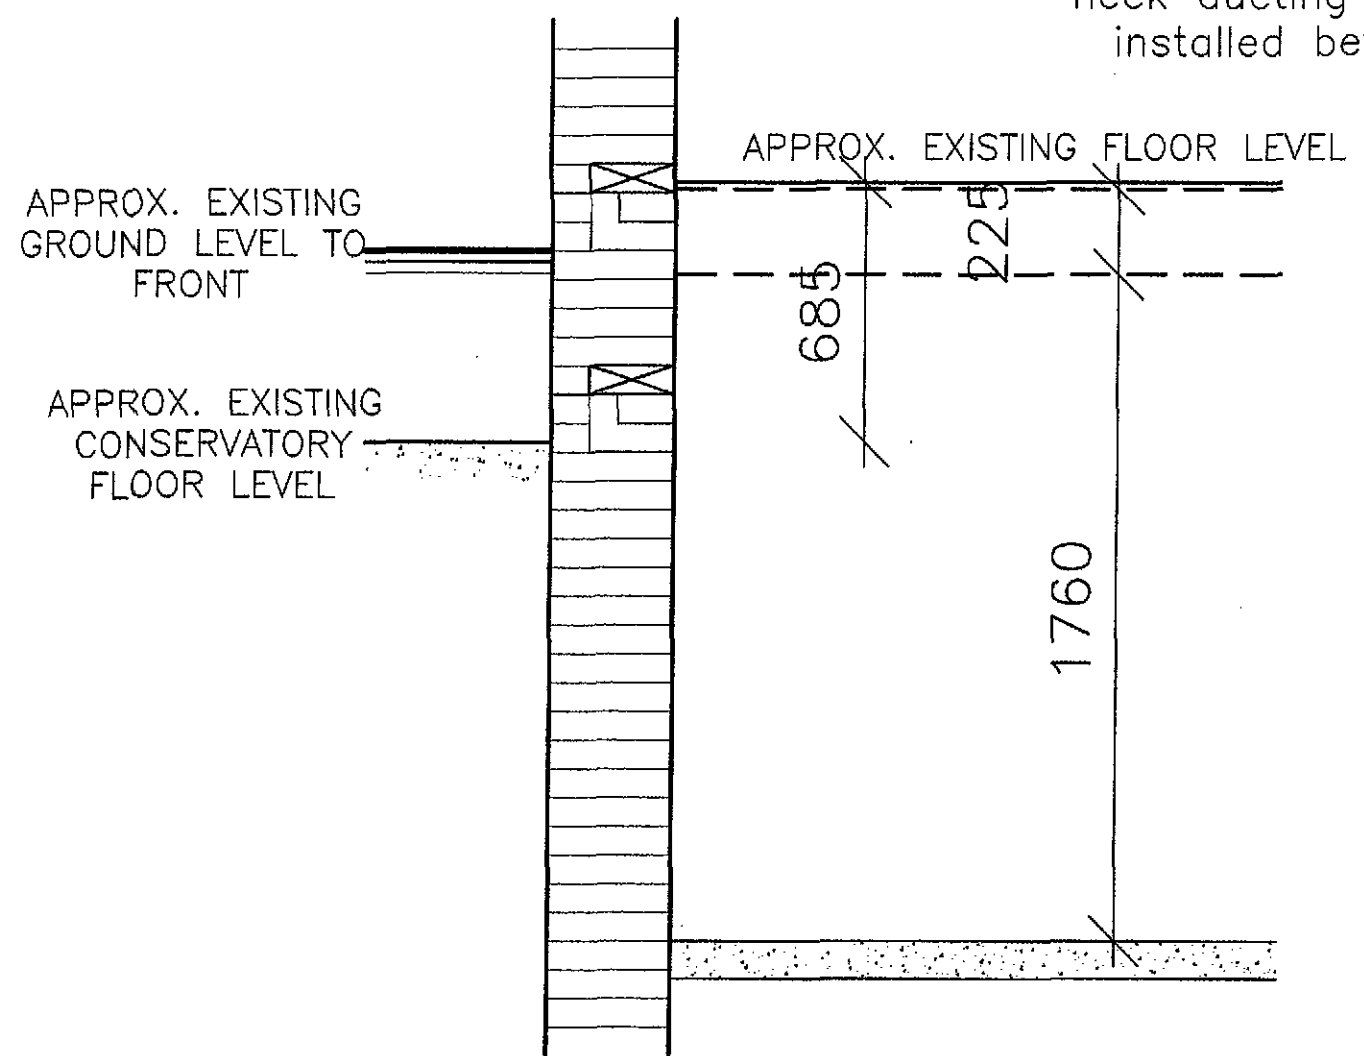
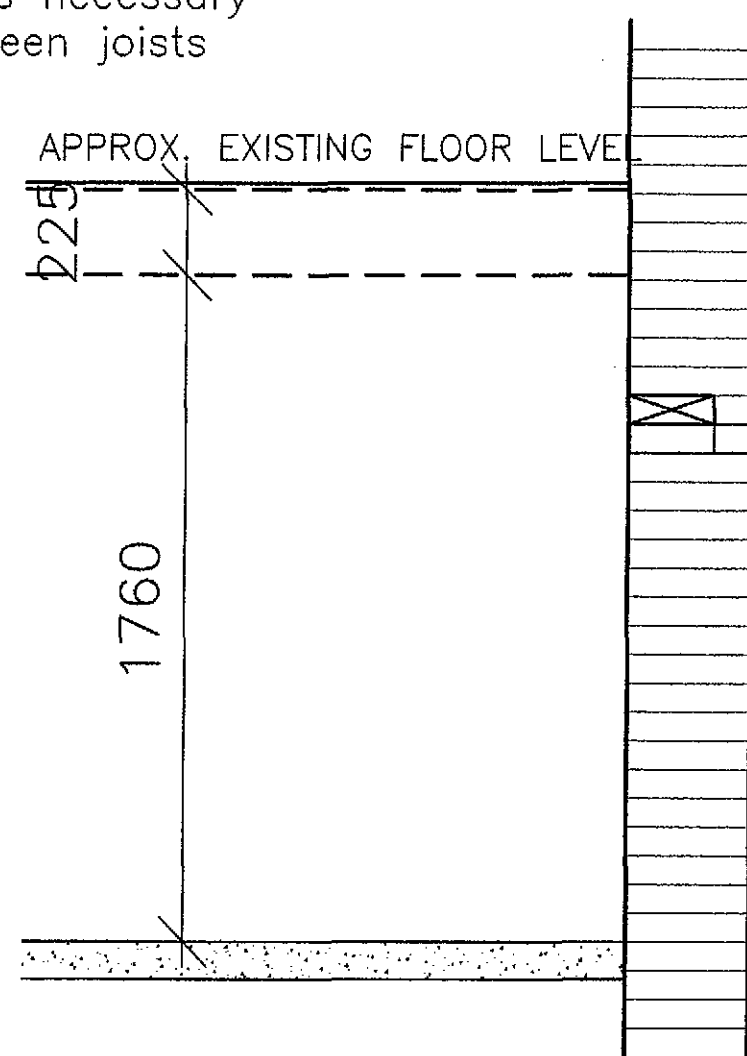
# **BASEMENT VENTILATORS** SCALE 1:20

Cast iron air bricks with swan neck ducting as necessary installed between joists

NOTE: Proximity to proposed boiler flues to be checked in accordance with Approved Document Part J

Front / North East Elevation  
& Proposed Air Bricks through  
Conservatory wall

South West Elevation

A French drain has been constructed along the NE elevation of the barn which should significantly reduce the amount of moisture passing through the solid wall. As a secondary measure to this we also propose to ventilate the void behind the dry lining as explained in Condition 9 iv) above. A section through the barn has been provided on dwg. no. B2043-16A.

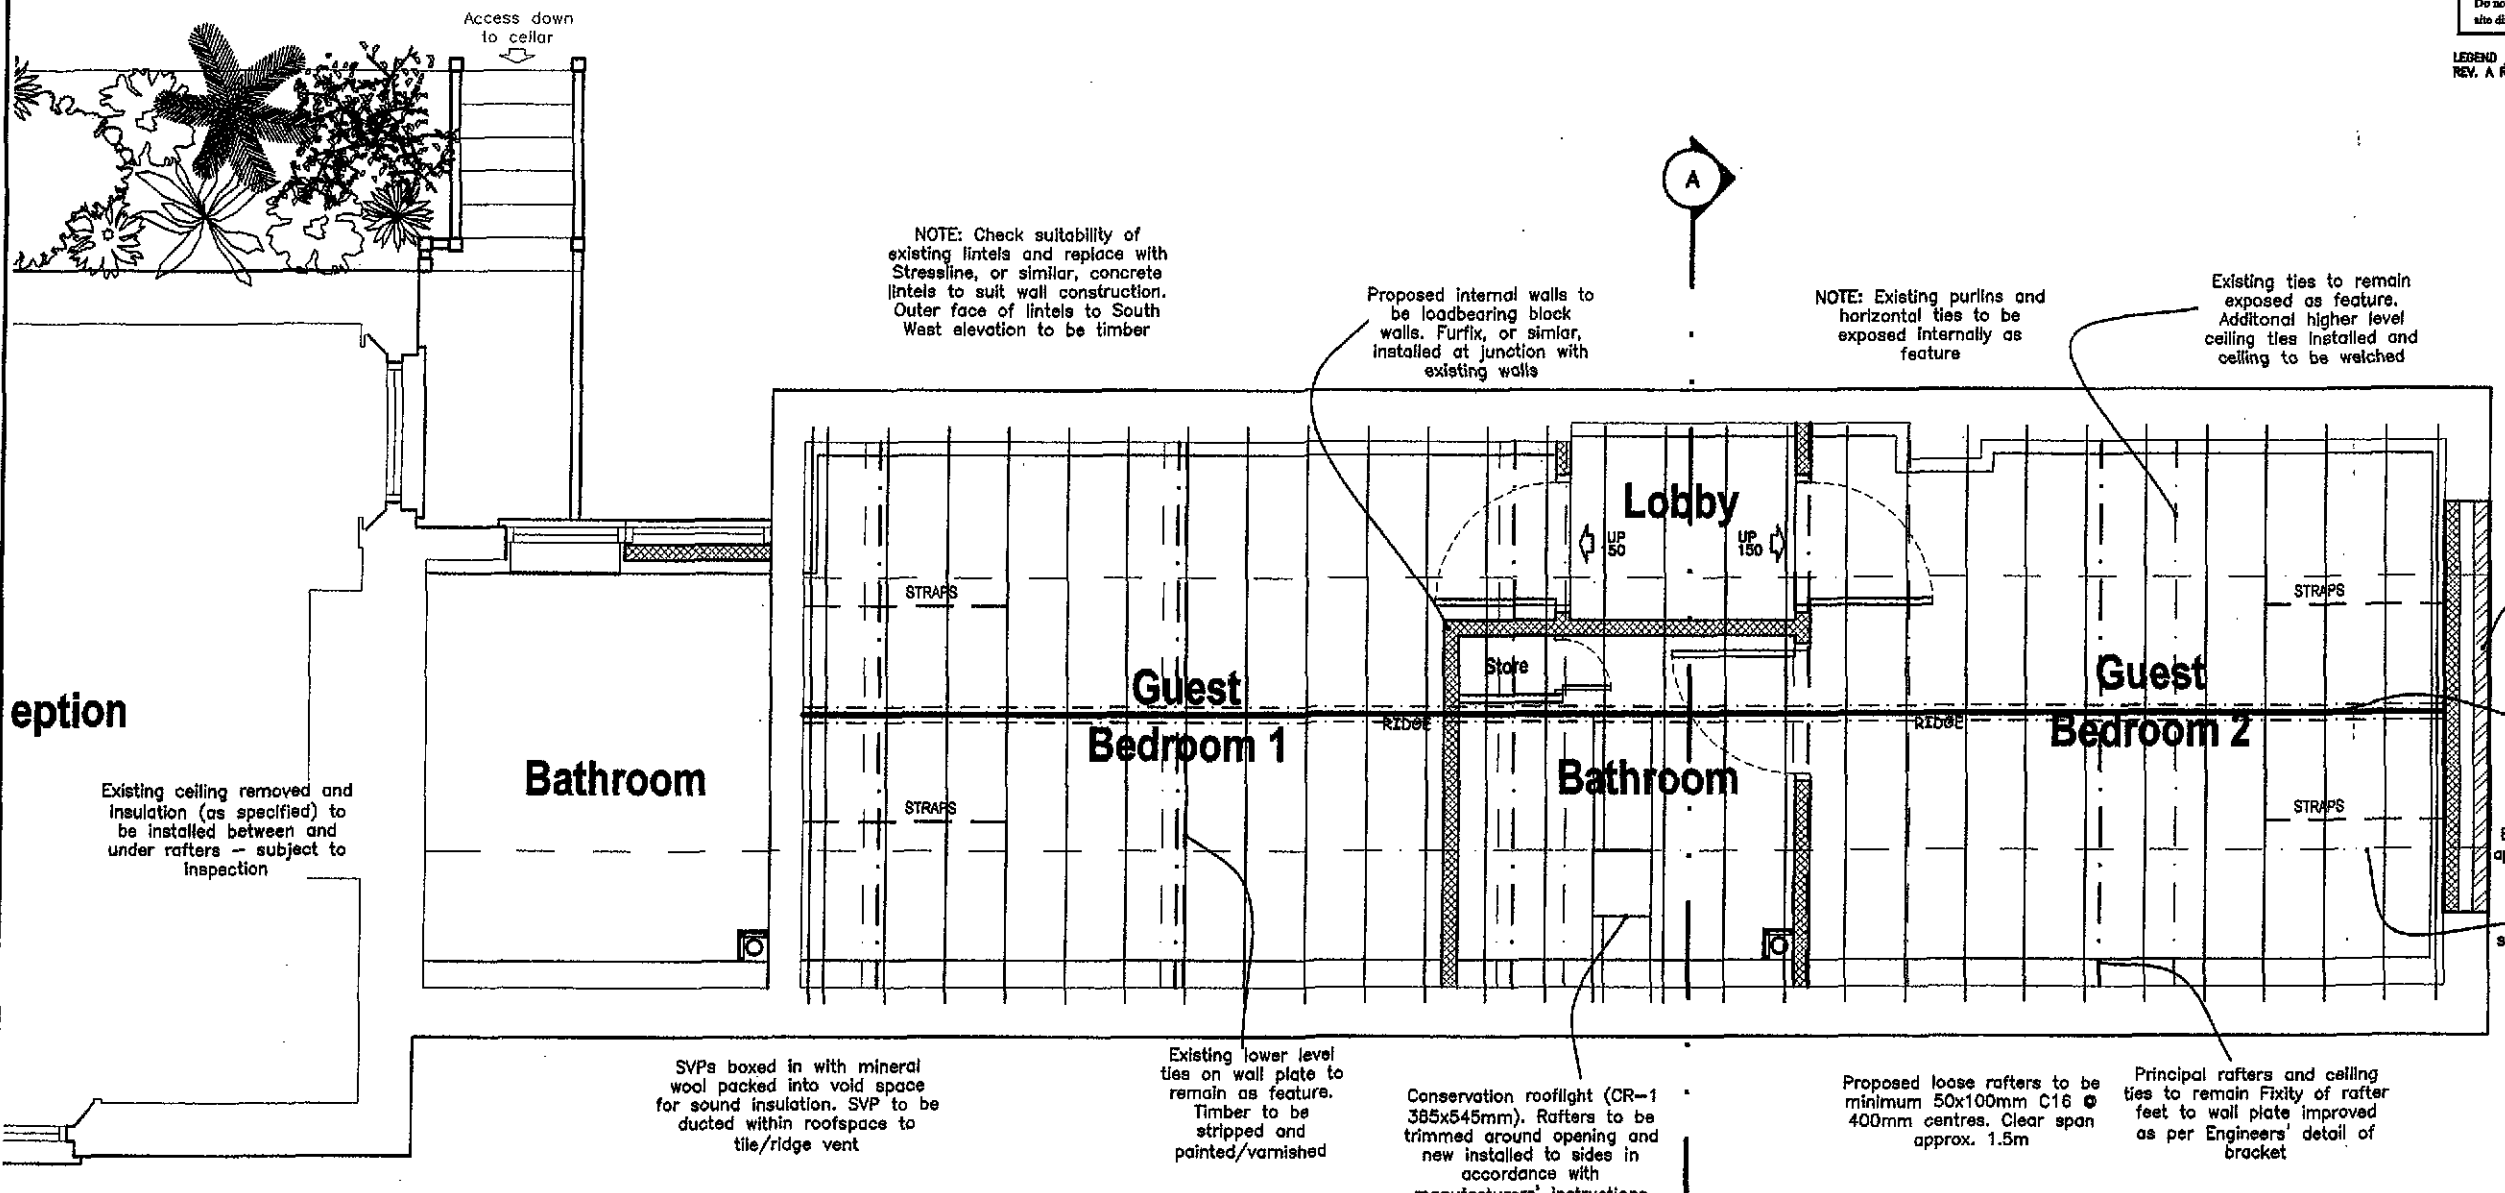
**ROOF PLAN**

Strengthening of existing roof members as per Engineers' drawings ref: 0377-01B

- been retained. These timbers are to be treated. The proposed solution is detailed and explained in the separate Structural Engineers' Drawing No. 0377-01.
- iv. Repairs to the cellar chimney breasts are covered in the separate Structural Engineers' Report which is to be forwarded in due course
  - v. Details of the proposed internal doors are provided on dwg no. B2043-35 & 36

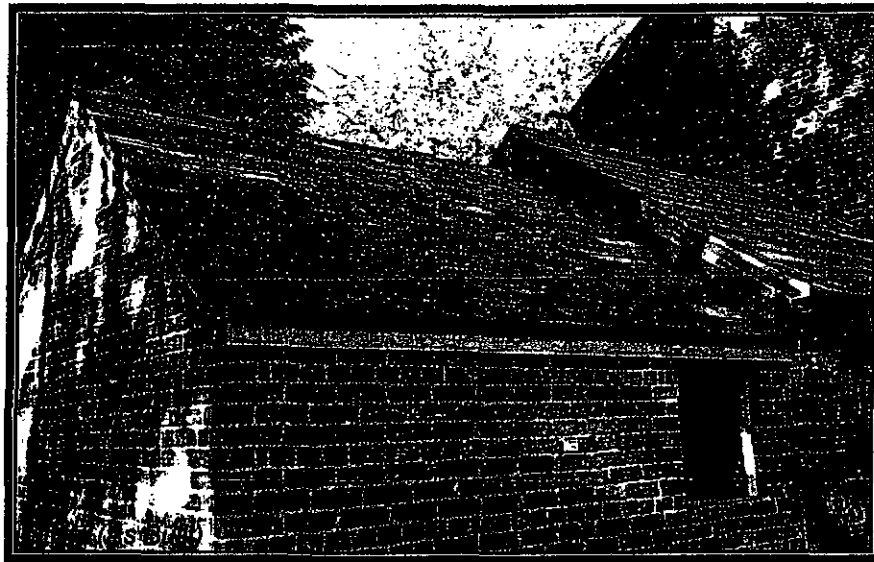
Slates for the new Utility roof have been agreed on site with the Conservation Officer.

The barn will be roofed with pantiles that have been set aside following removal. Tiles that require replacement will be done so in a tile of matching colour, profile and size. A sample of which will be provided for agreement on site prior to installation. Any new tiles will be installed on the West side of the roof.

- i. Eaves details for both new/replacement roofs will be simple timber fascias to match the depth and profile of the existing fixed to the face of the bricks as shown on dwg. no. B2043-16A and as shown on the photograph above.
- ii. Verge details for the proposed Utility match the existing Kitchen gable with two courses oversailing and proposed slates bedded on mortar as shown on the photograph above. The Utility structure has been constructed on site and the Conservation Officer has approved the work carried out so far. At her request the verge detail has been amended to match the adjacent gable.
- iii. Taskers' metal contractor has provided a sketch of the proposed railings as shown below:

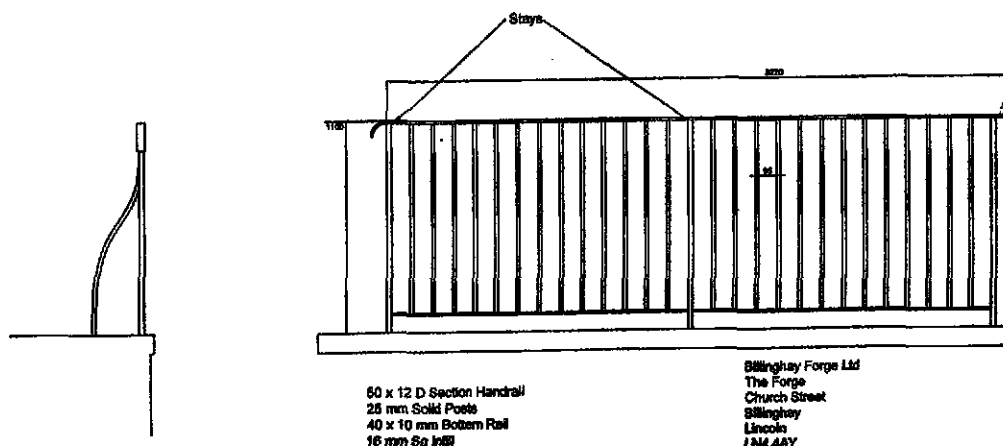
- *Proposed metal railings*

The railings will be painted black with simple plate and bolt fixings into the masonry. In order to provide a sound base for the railings to fix into, we propose to remove the top five courses (which are loose) of brickwork and re-build them in 215mm brickwork. The brickwork will not protrude above the ground level.

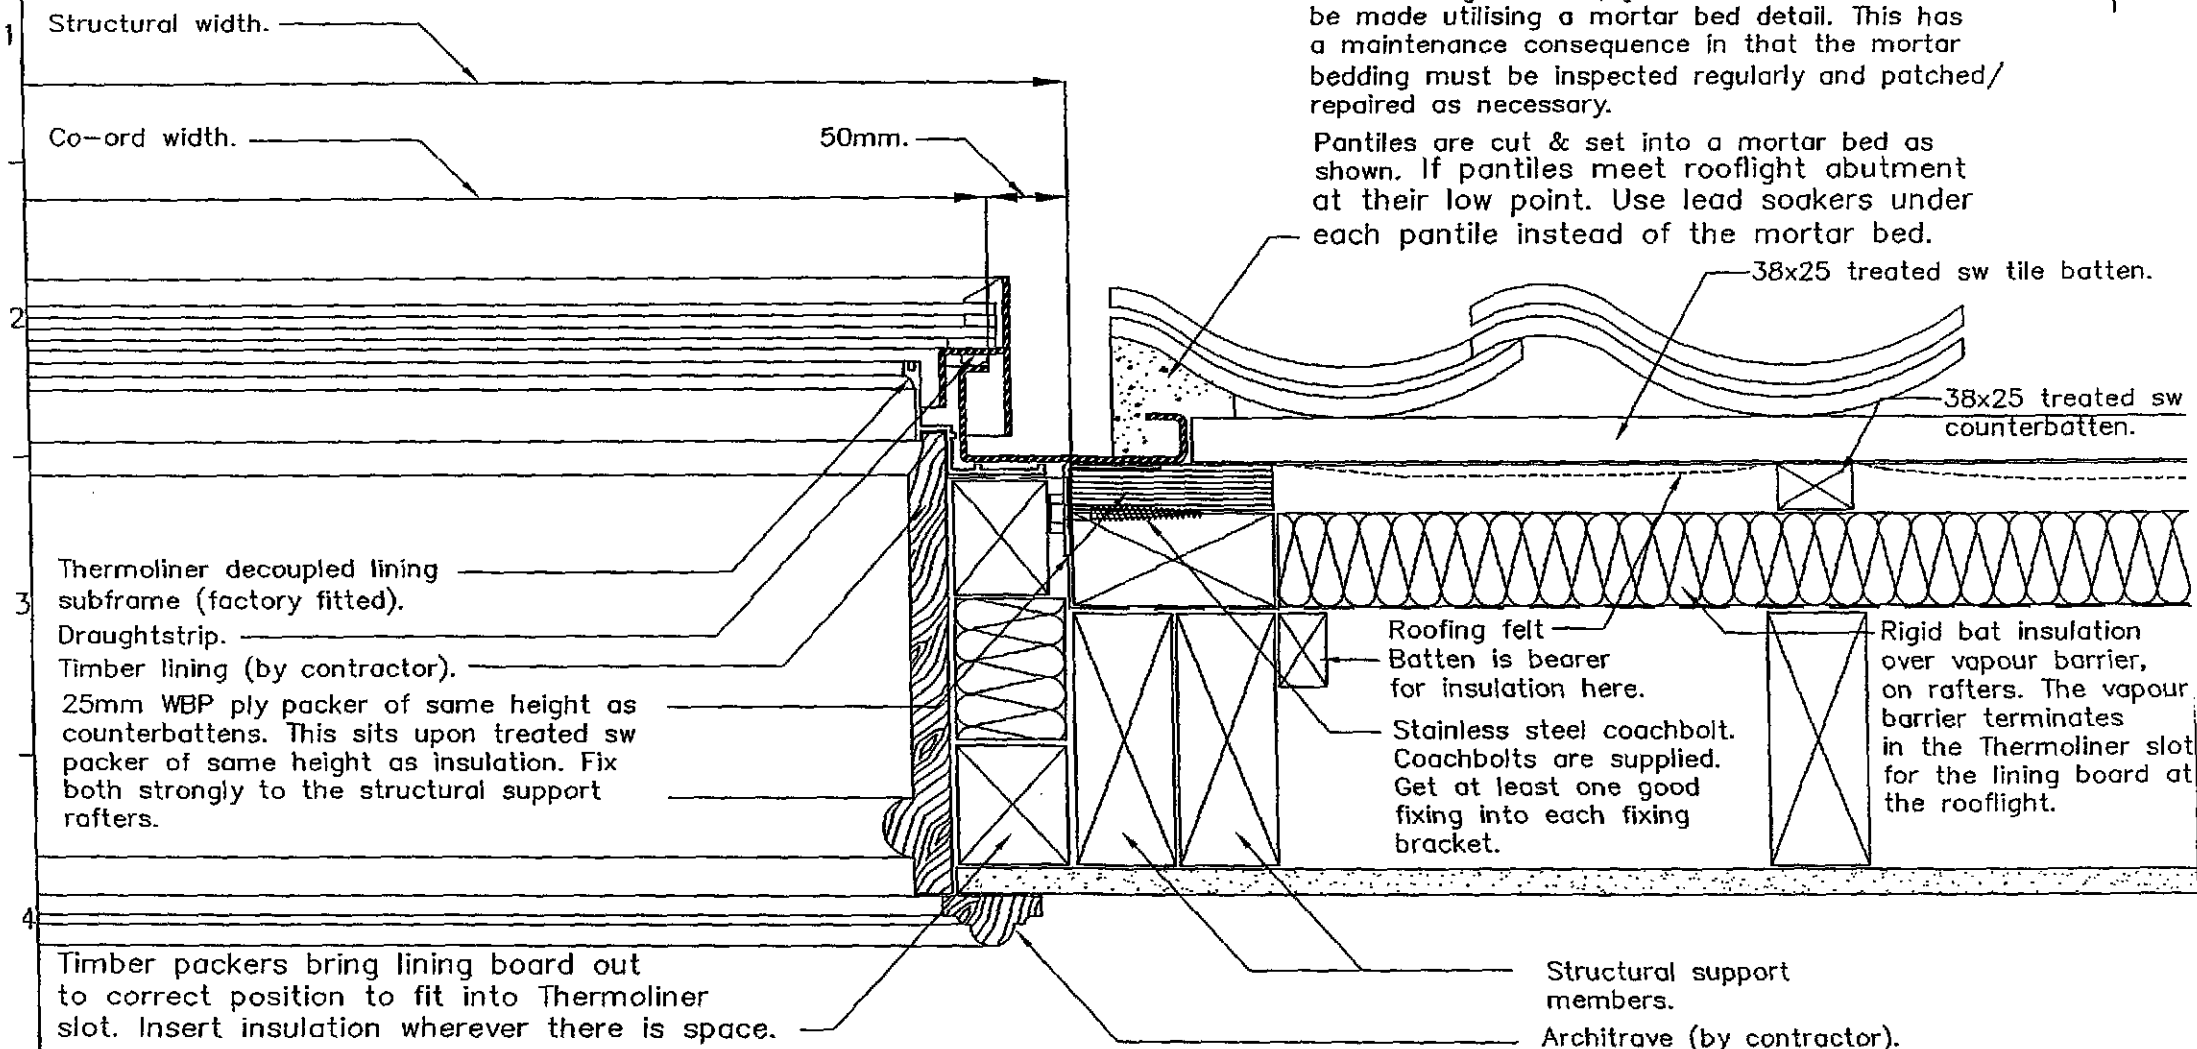
Please note that due to the nature of pantiles as a roofing material, jamb abutments must be made utilising a mortar bed detail. This has a maintenance consequence in that the mortar bedding must be inspected regularly and patched/ repaired as necessary.

Pantiles are cut & set into a mortar bed as shown. If pantiles meet rooflight abutment at their low point. Use lead soakers under each pantile instead of the mortar bed.
