# APPLICATION FOR APPROVAL OF DETAILS RESERVED BY CONDITION

Application Numbers:  
H21/1006/08 & H21/1007/08

Roman Lodge, Mill Lane, Tydd St.  
Mary, Spalding PE13 5SB

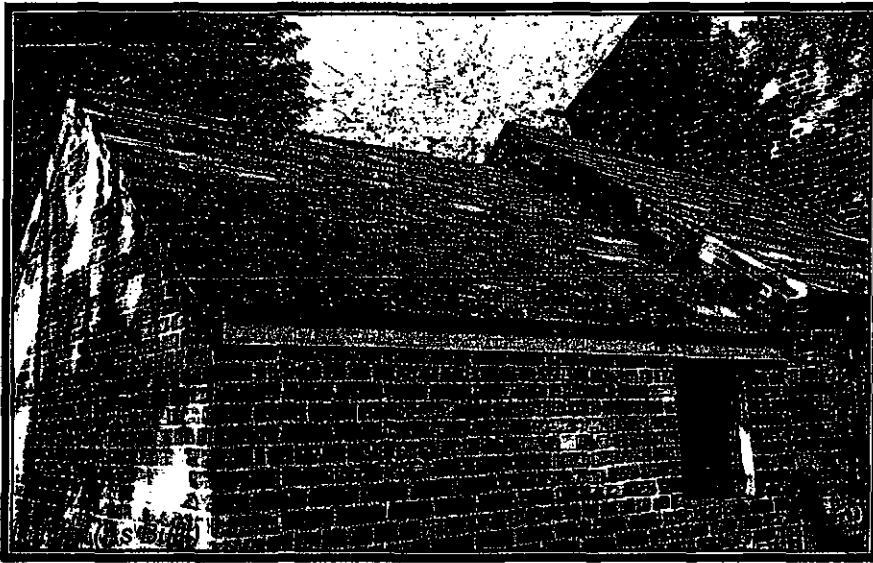
Slates for the new Utility roof have been agreed on site with the Conservation Officer.

The barn will be roofed with pantiles that have been set aside following removal. Tiles that require replacement will be done so in a tile of matching colour, profile and size. A sample of which will be provided for agreement on site prior to installation. Any new tiles will be installed on the West side of the roof.

- i. Eaves details for both new/replacement roofs will be simple timber fascias to match the depth and profile of the existing fixed to the face of the bricks as shown on dwg. no. B2043-16A and as shown on the photograph above.
- ii. Verge details for the proposed Utility match the existing Kitchen gable with two courses oversailing and proposed slates bedded on mortar as shown on the photograph above. The Utility structure has been constructed on site and the Conservation Officer has approved the work carried out so far. At her request the verge detail has been amended to match the adjacent gable.
- iii. Taskers' metal contractor has provided a sketch of the proposed railings as shown below:

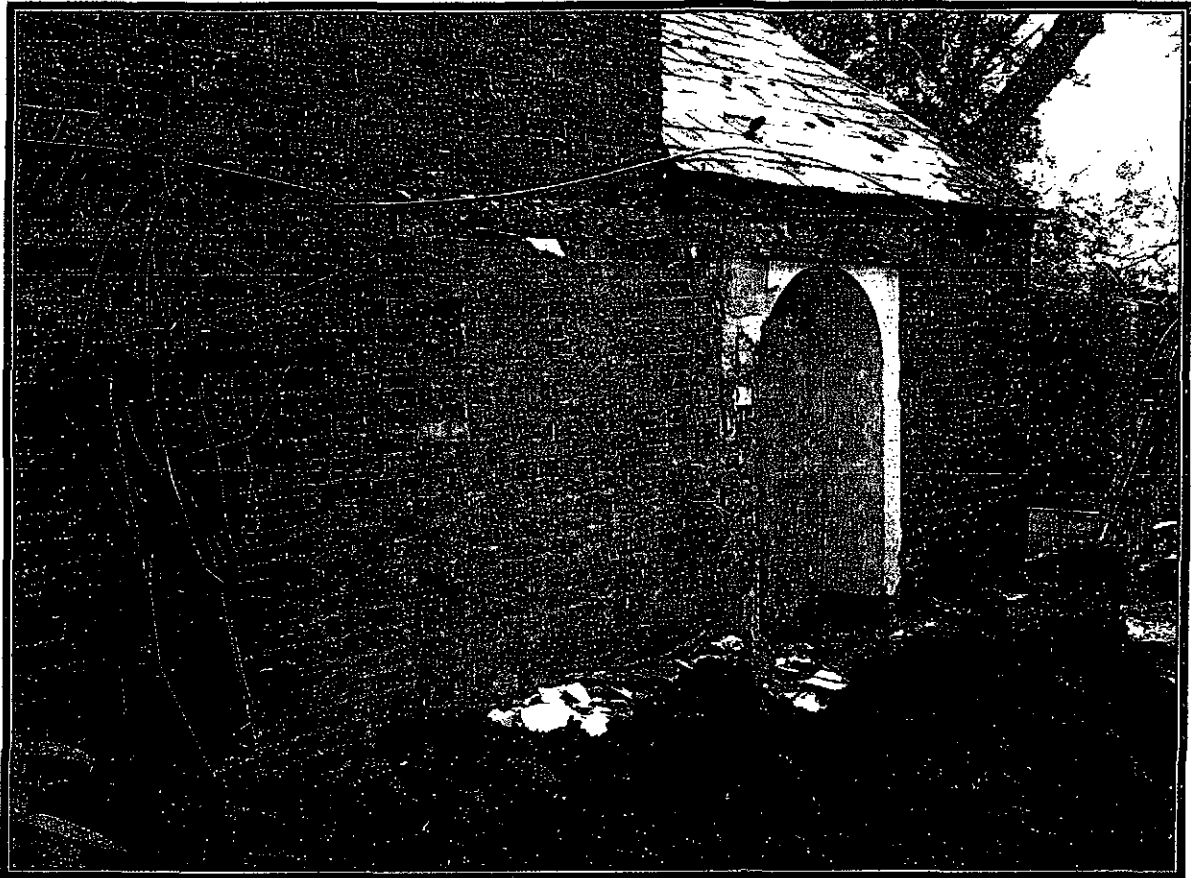
- 3.5 The builders will carefully remove all cement pointing from the elevation before commencing to break out the window to be formed in the back wall of the Dining Room. This will be carried out carefully using an angle grinder in the middle of each line of mortar taking care

not to cut into brick faces. The ground out channel will then ease the removal of the remaining cement mortar. The damaged brick panel will then require rebuilding.
