**PRELIMINARY STRUCTURAL REPORT**

**AGRICULTURAL BARNES**

**CARTERS FARM, OXCROFT BANK**

**DOCUMENT REF: SW 22-144-REP-01**

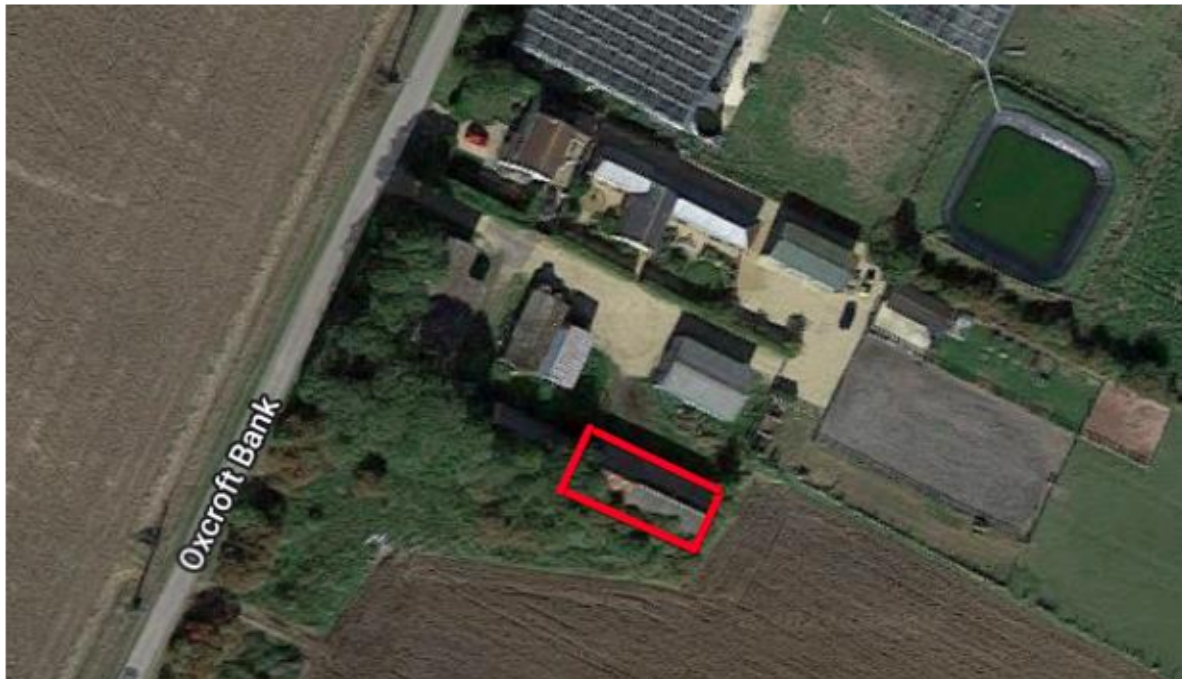
Site location plan, GR Merchant drawing 3911-21/01 is contained within Appendix A.
