## **GROUND INVESTIGATION REPORT**

**LAND OFF PETERBOROUGH ROAD**  
**CROWLAND**  
**LINCOLNSHIRE**

**Report Reference C14639**

**PROPOSED RESIDENTIAL DEVELOPMENT**

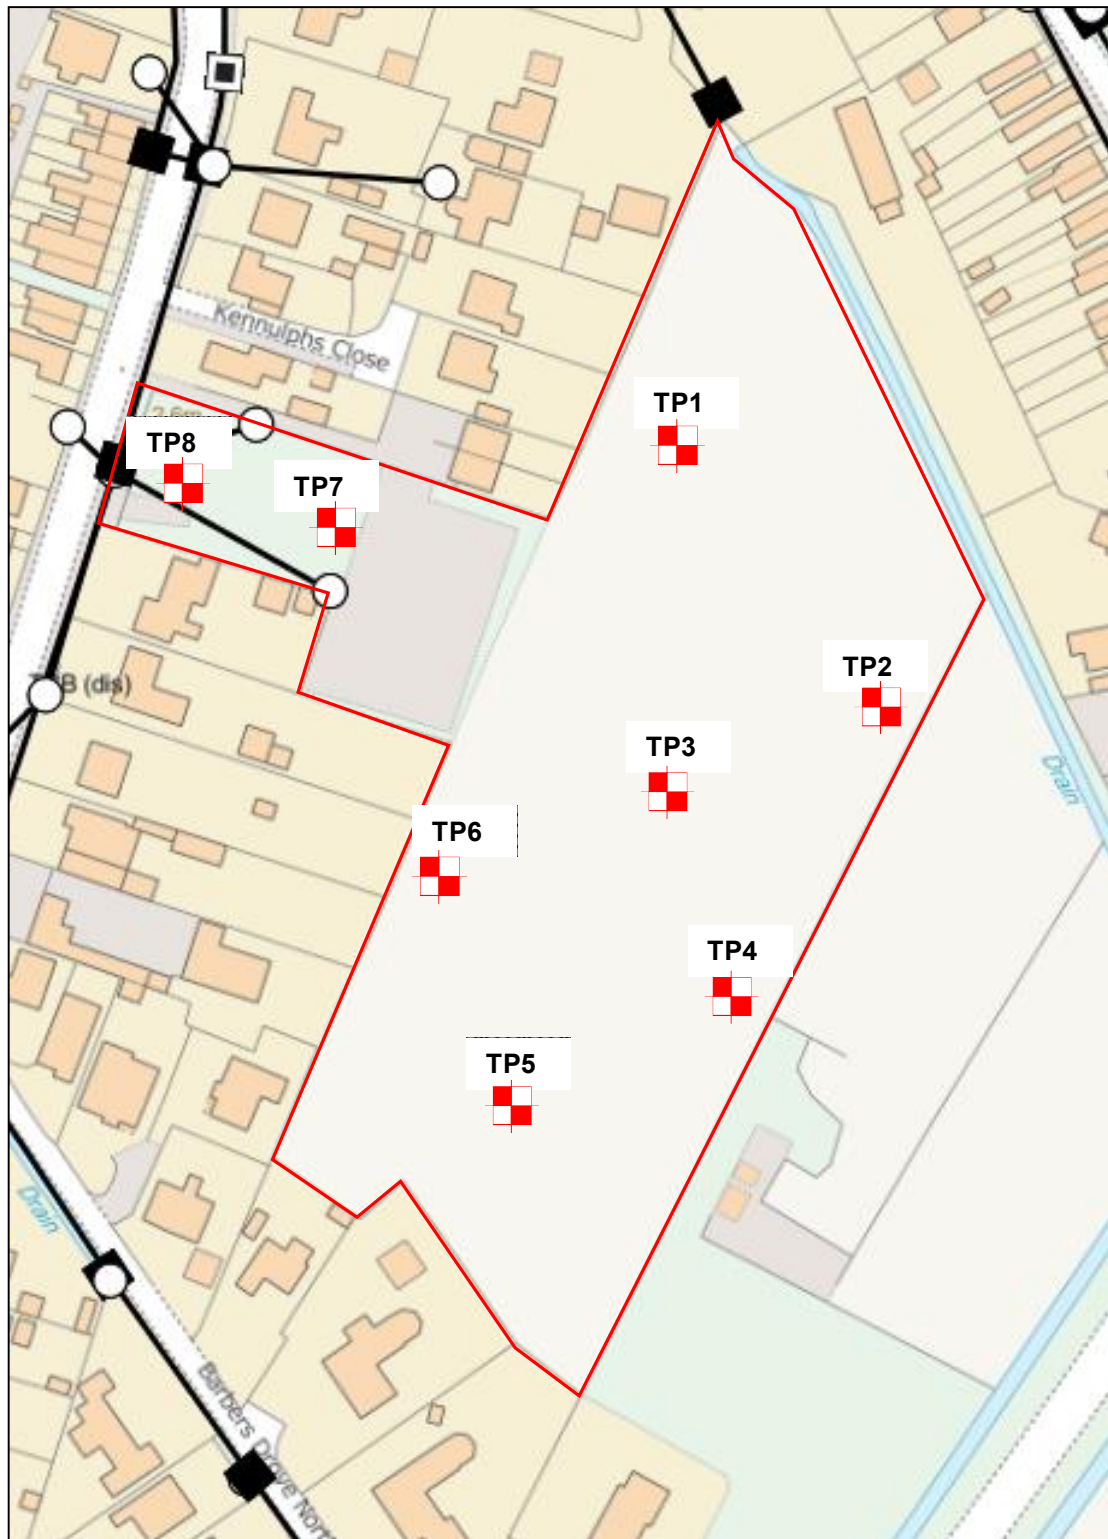
# Exploratory Hole Location Plan

The site work conducted on 7<sup>th</sup> December 2018 comprised eight machine excavated trial pits (TP1 to TP8). The trial pit positions are shown on the exploratory hole location plan following this report text.

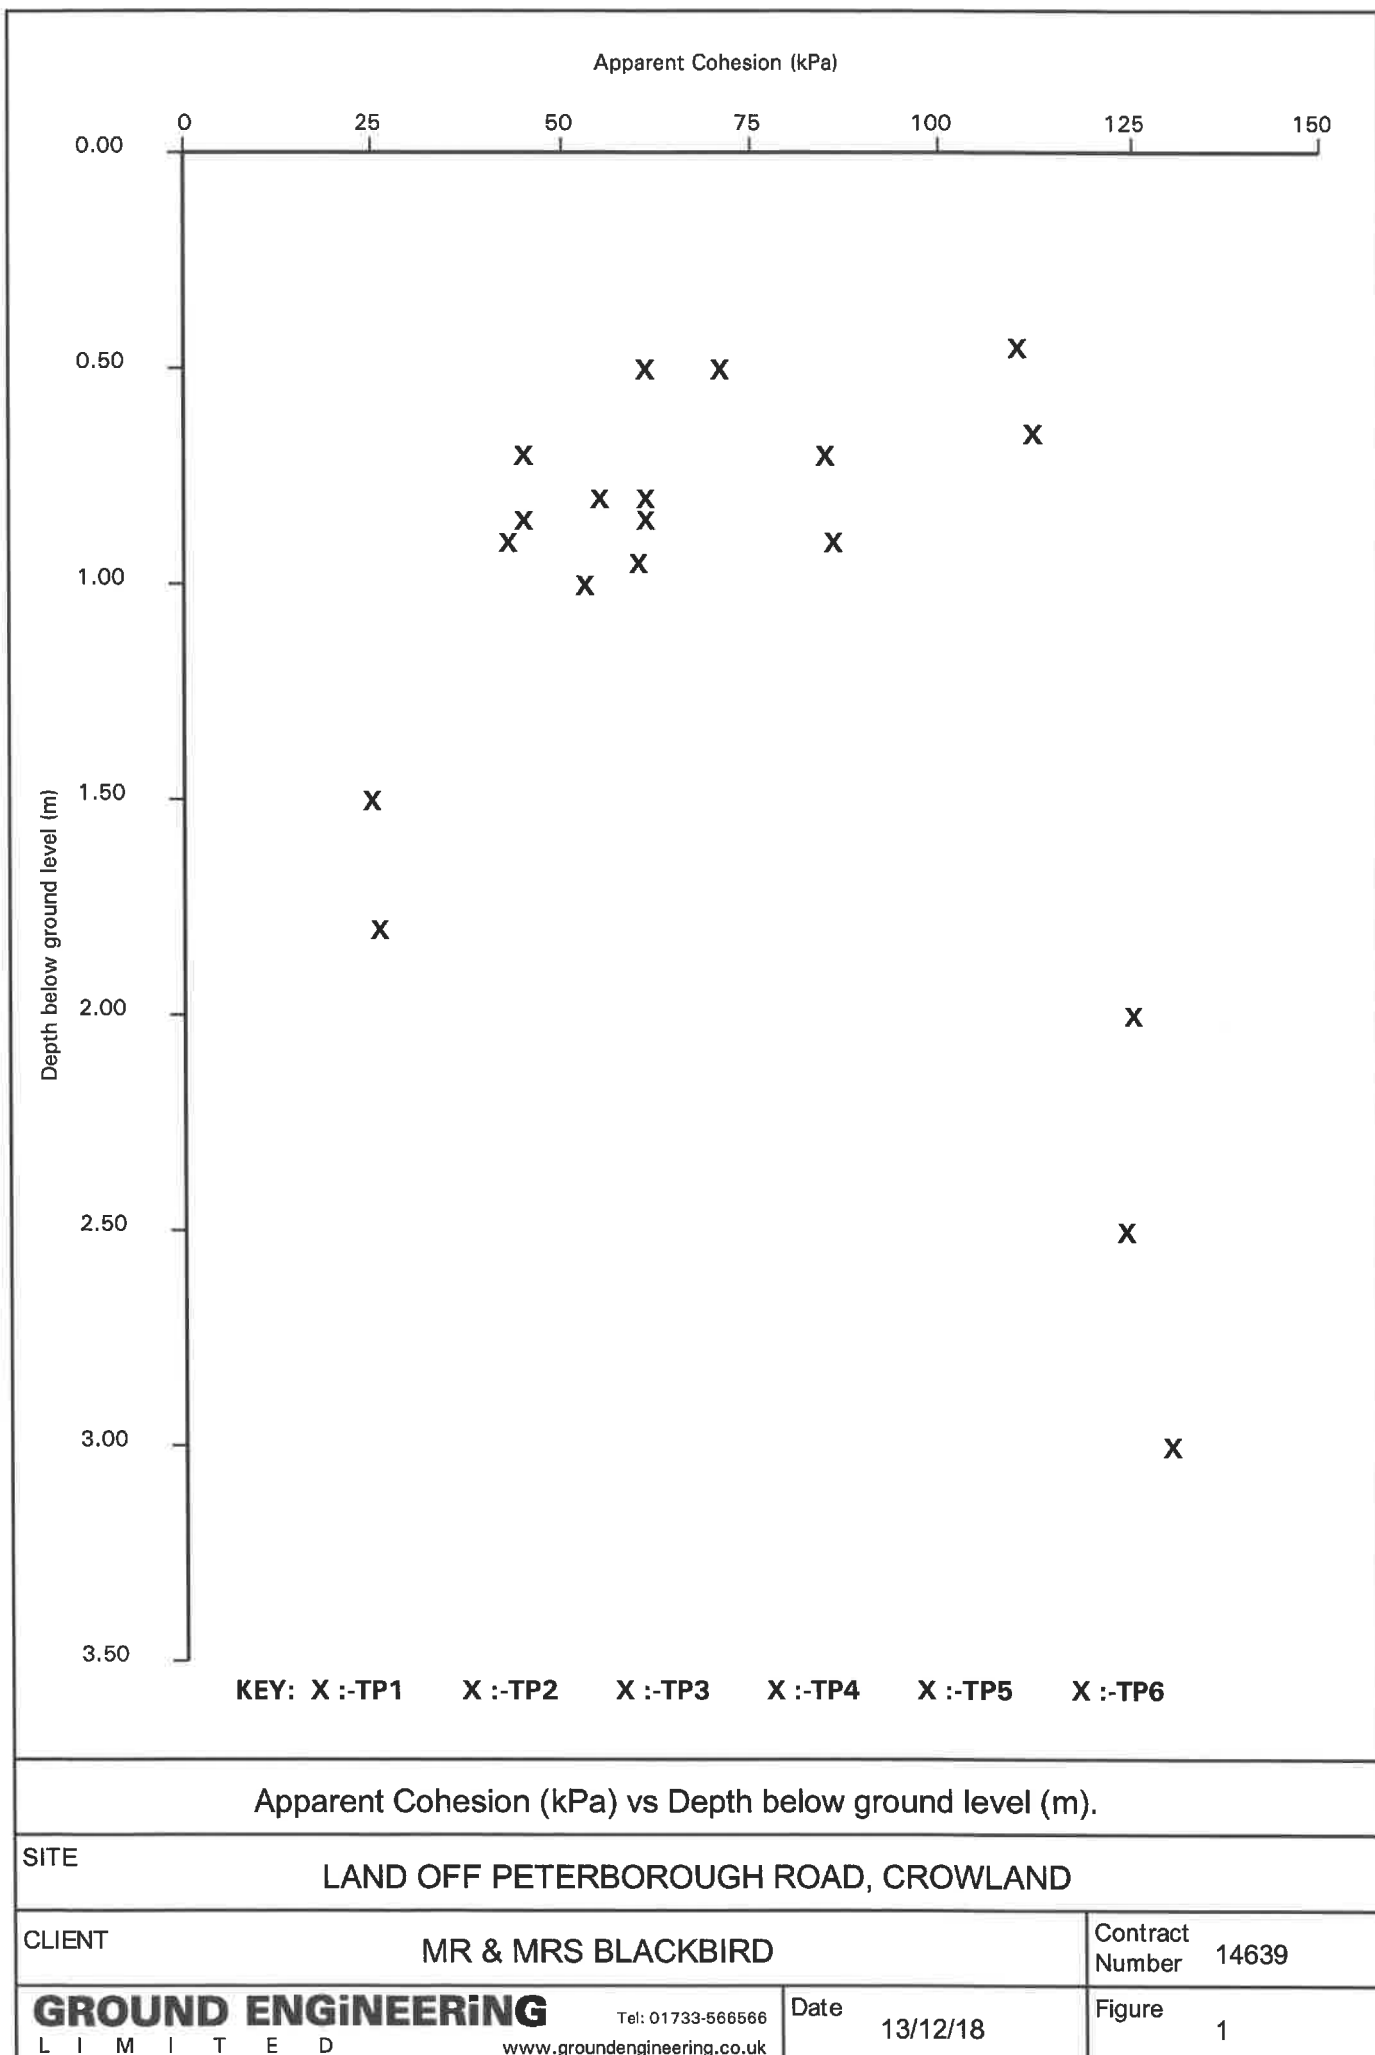
An indication of the shear strength of clay soils within the trial pits was made using a hand shear vane (V) where possible and the readings are presented on the trial pit records. The apparent cohesion results have been plotted against depth in Figure 1.

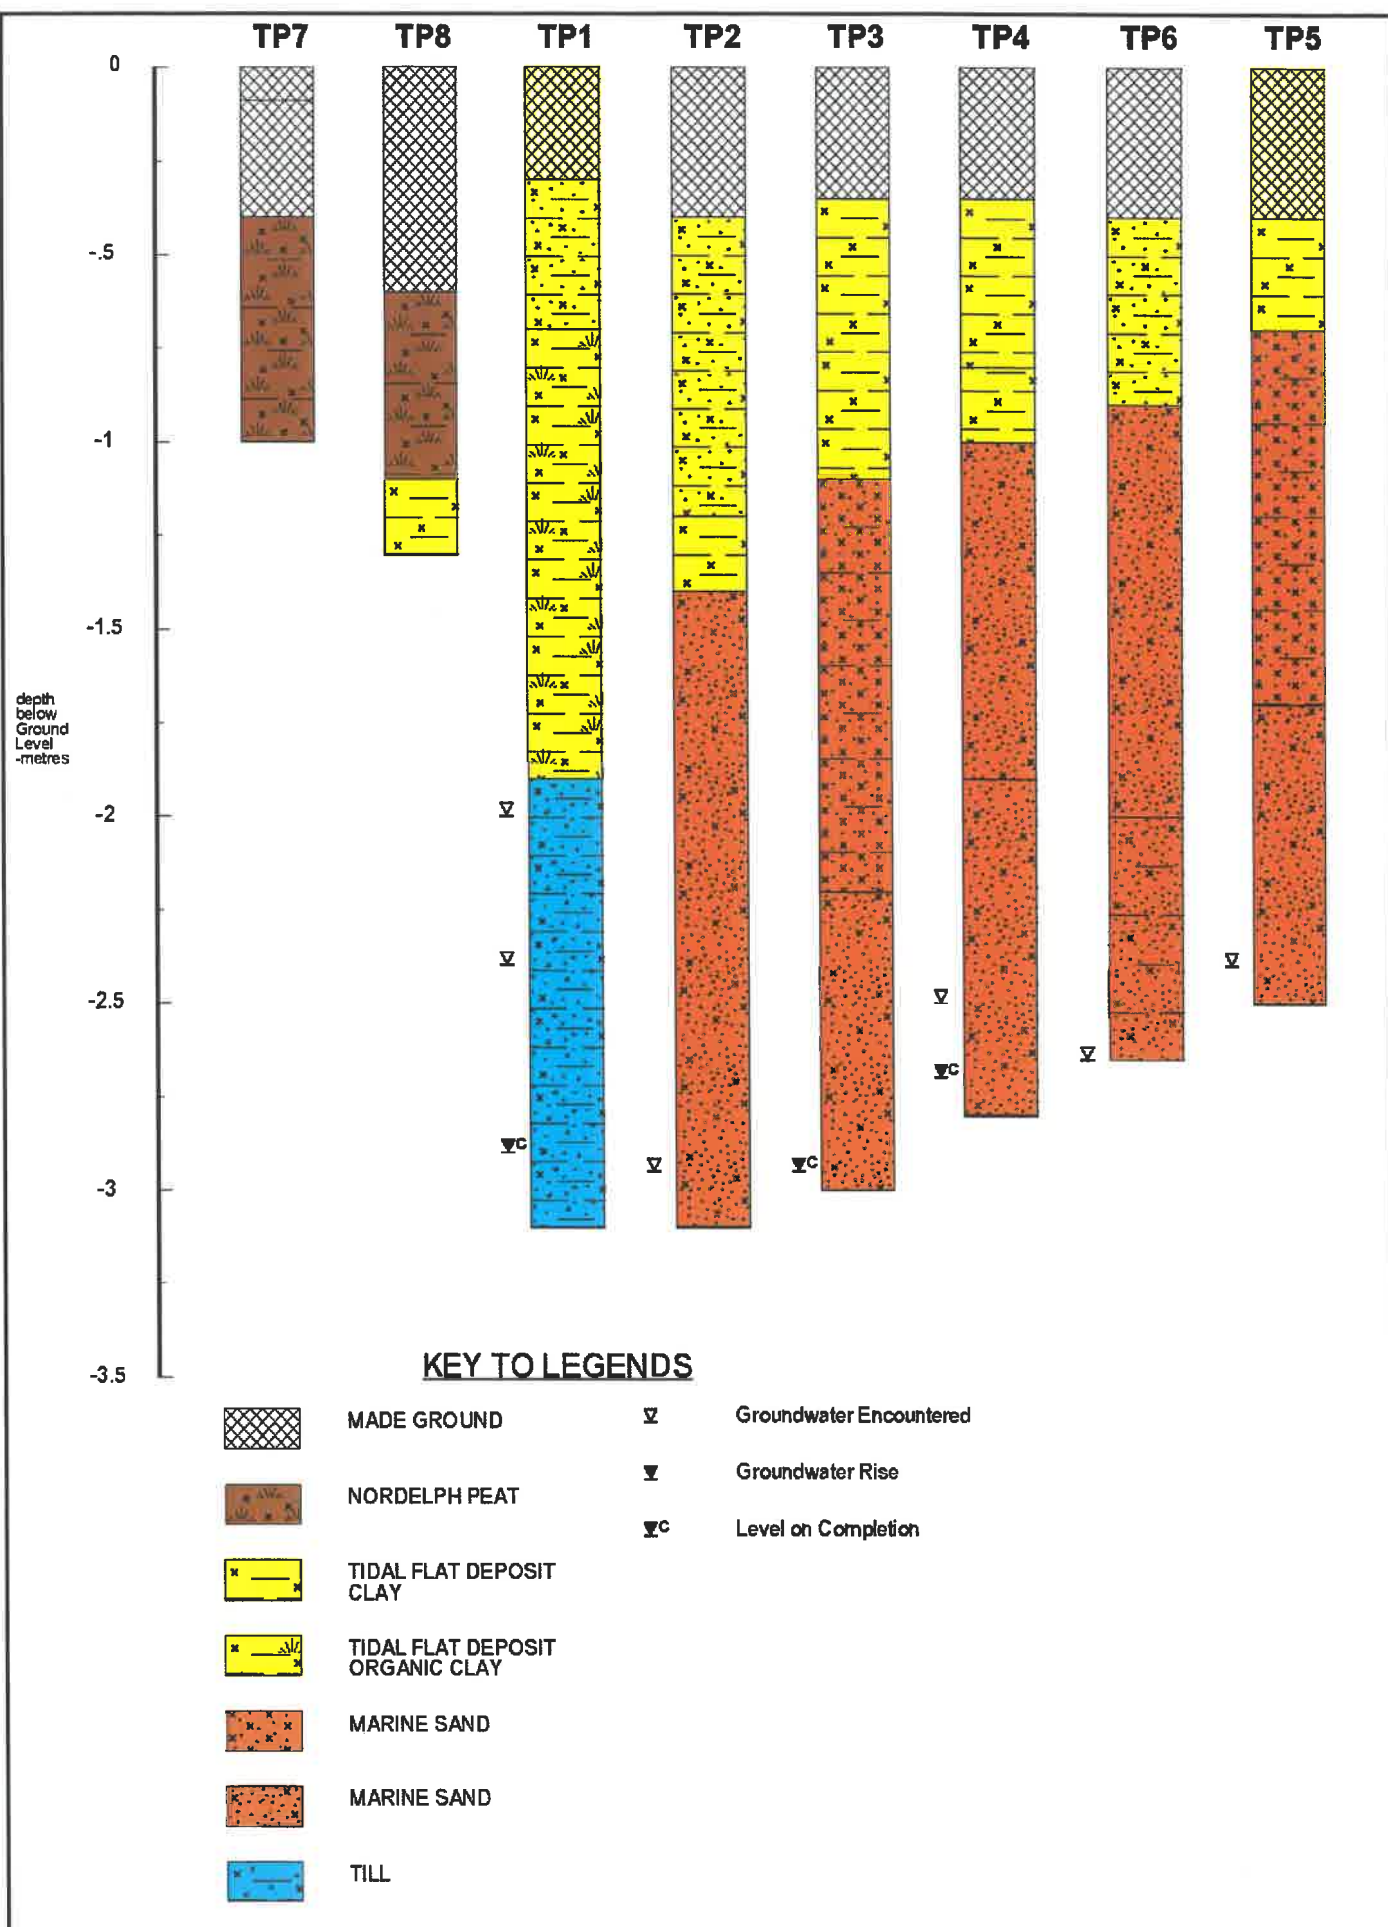
The ground conditions found by the investigation have been plotted as a soil profile in Figure 2. The ground conditions encountered comprised made ground to depths of between 0.30m and 0.60m, which rested locally on the expected superficial Nordelph Peat, Tidal Flat Deposits, Marine Sand and locally in turn superficial glacial Till (TP1). The underlying solid geology of the Oxford Clay was not reached during this shallow investigation.
