# CREASE DROVE, CROWLAND

## REMEDIAL STRATEGY FOR PARTNER CONSTRUCTION LTD & WATERLOO HOUSING GROUP LTD

**Project Ref:**  
P8723

**Date:**  
September 2019

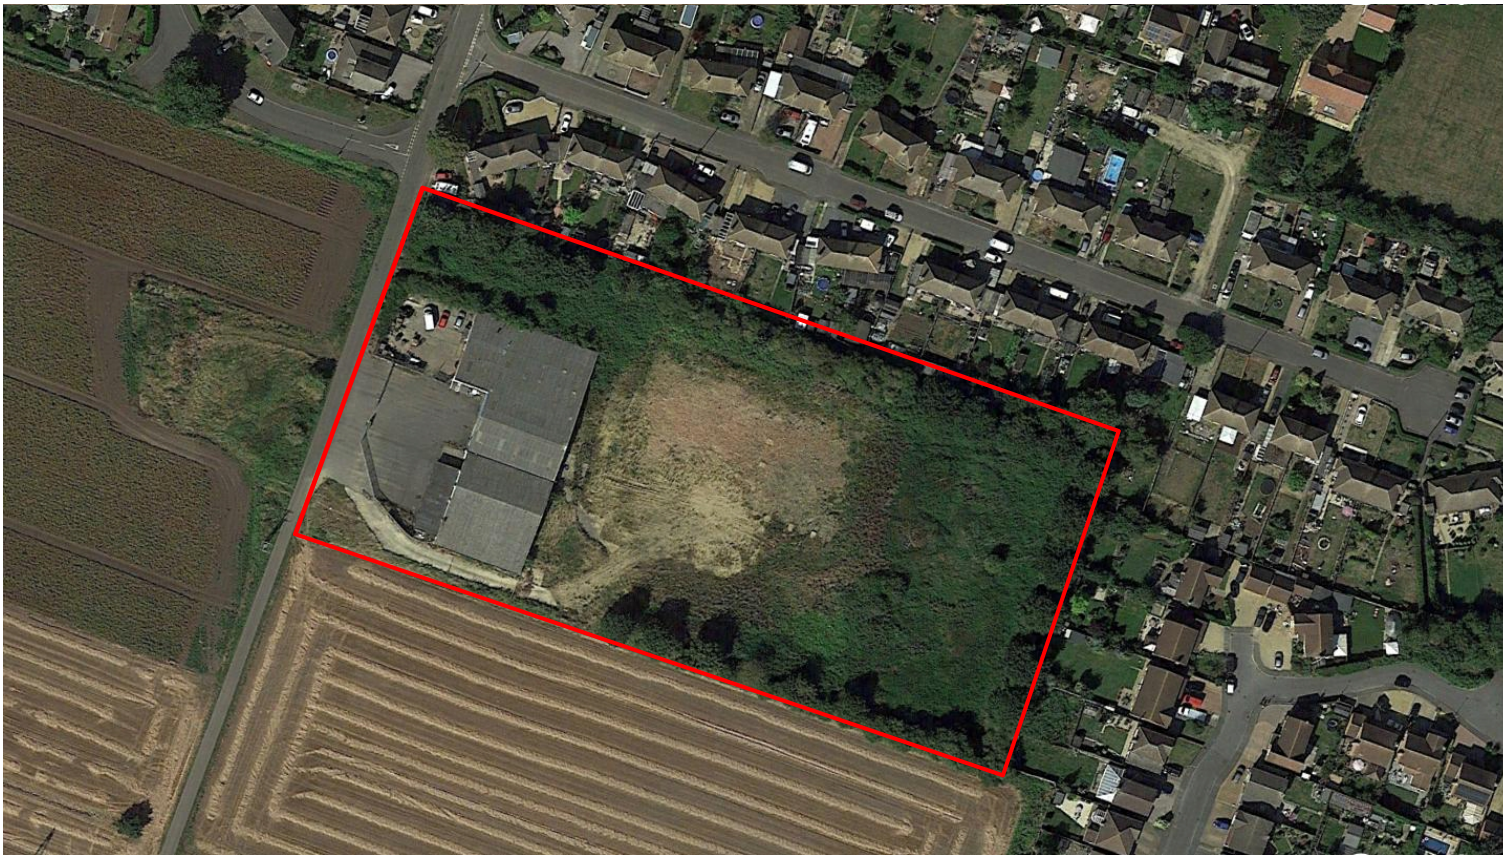
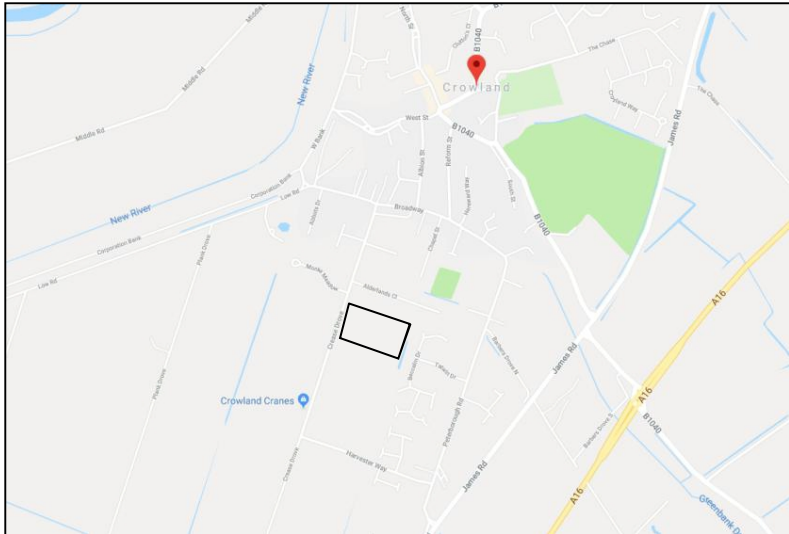
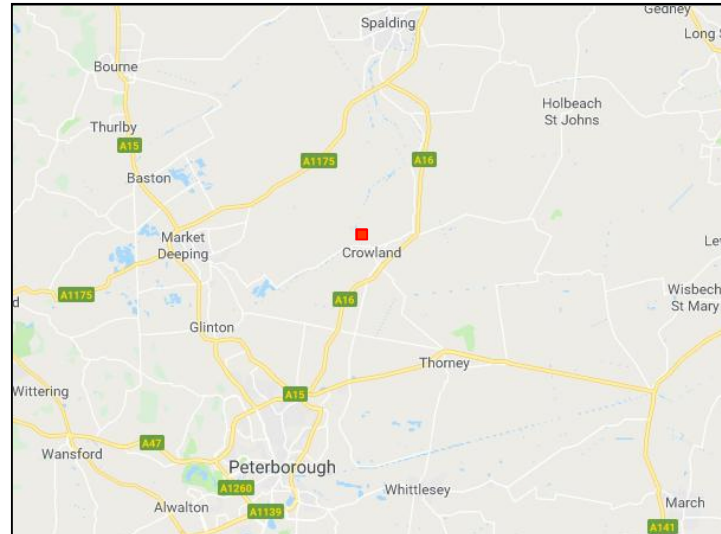
| Site Location and Boundary Plan ..... | Appendix B |

A Site Location and Site Boundary Plan are included as Appendix B.

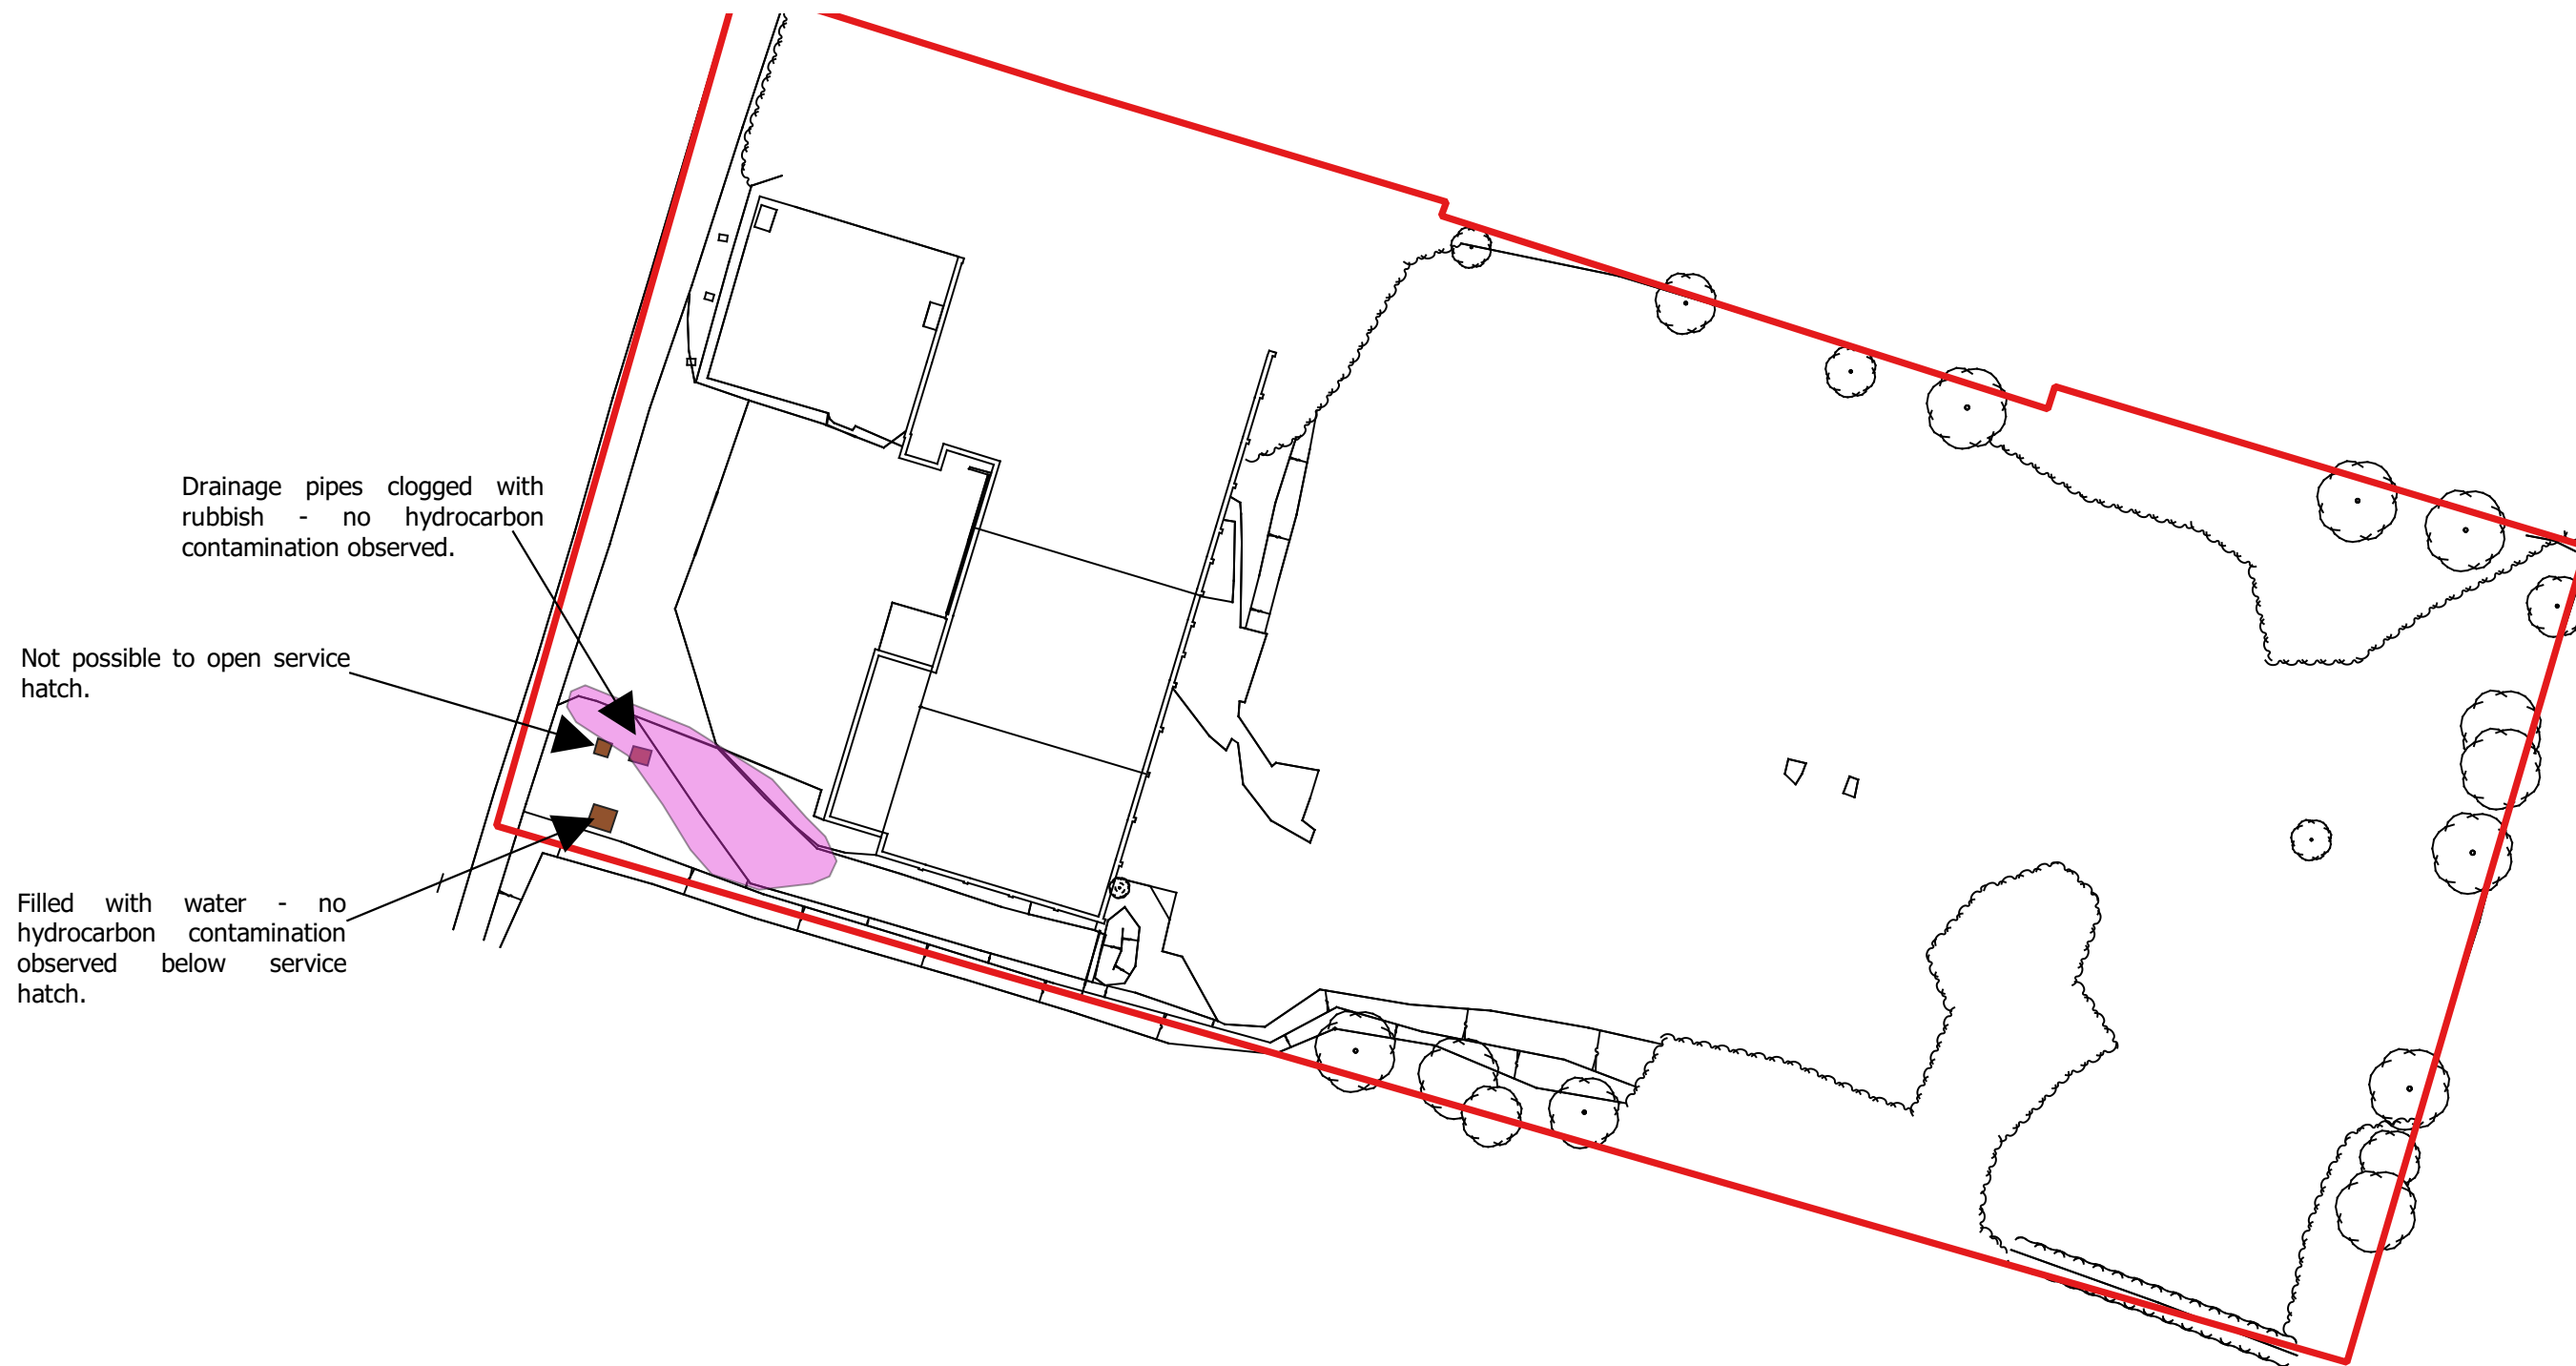
| Remediation Plan..... | Appendix D |

Site Boundary
