**PHASE 1 ENVIRONMENTAL SITE  
ASSESSMENT REPORT**

**Land at Goxhill Avenue,  
Donington  
Spalding  
Lincolnshire  
PE11 4ZS**

**Prepared for:**  
Sips Building Services

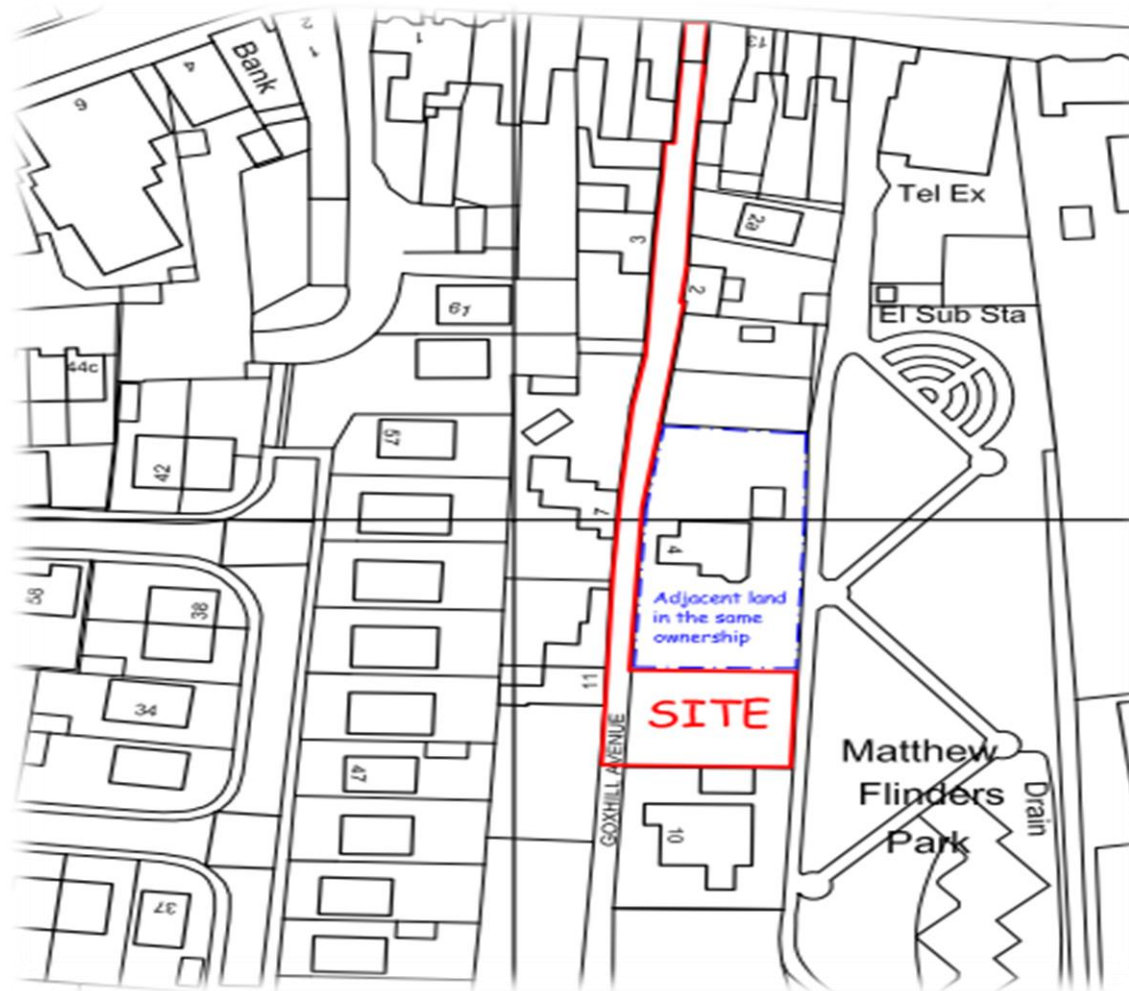
Figure 2

The site is rectangular in shape and has an approximate area of 0.039 ha.

The site presently forms the southern part of the garden for Number 4 Goxhill Avenue. The site fronts onto Goxhill Avenue to the east and is bounded by wooden fences to the north, south and west. The majority of the site is occupied by a lawn. A number of small shrubs skirt the garden, and no signs of discolouration to the leaves or soil was noted.

Existing Site Plan

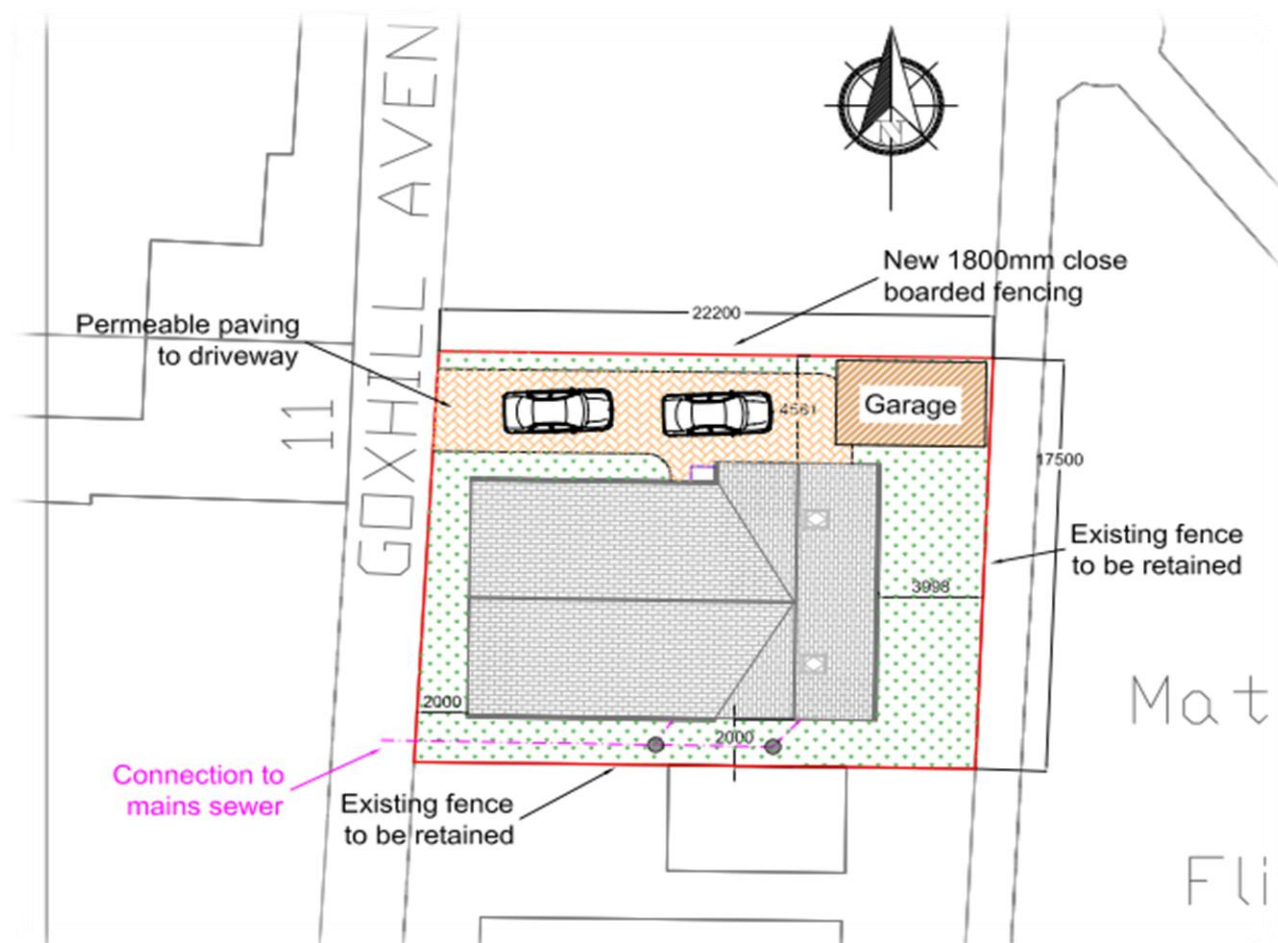
Figure 3

It is understood that the development proposals comprise the erection of a new detached bungalow and garage. It is further understood there will be external areas associated with the new development including areas of soft landscaping.

Proposed Site Plan

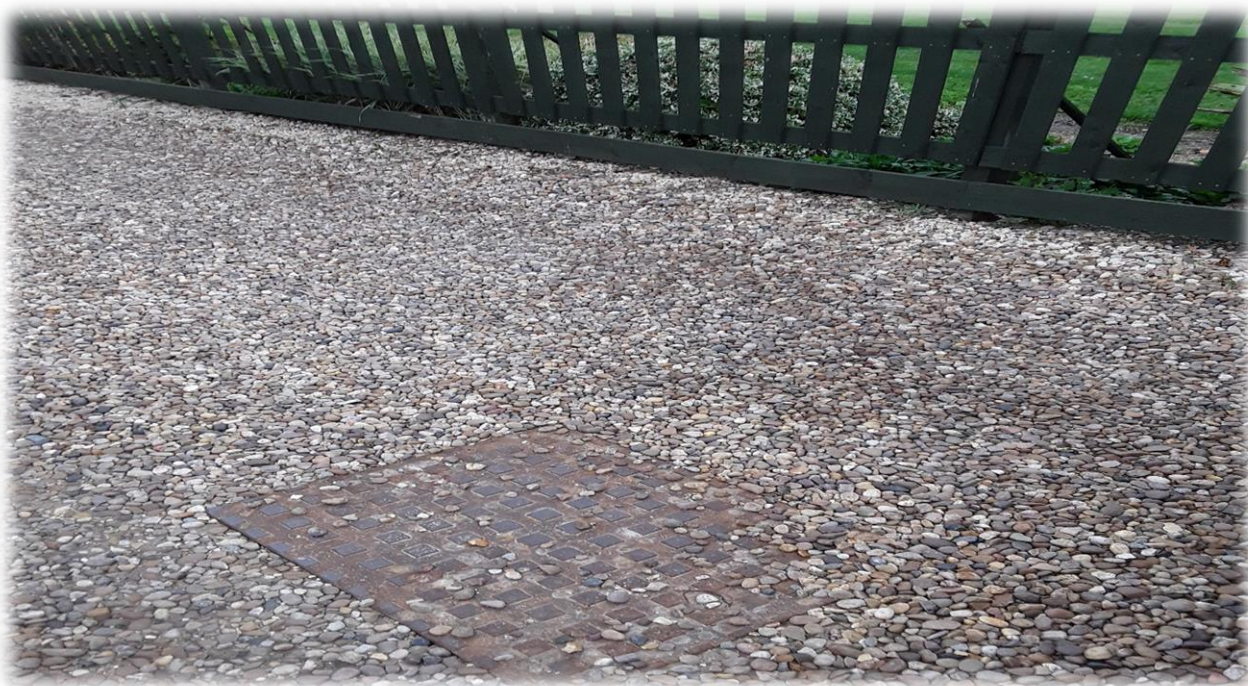
Drain just outside the property

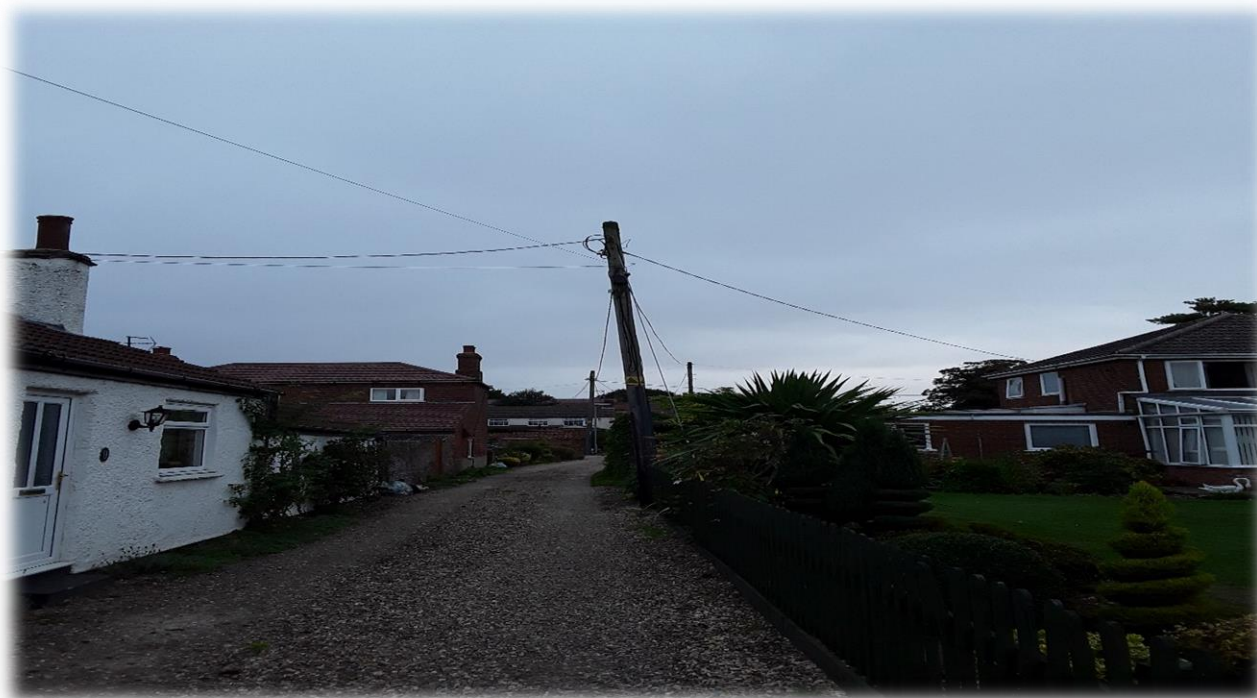
Adjoining road and electric pole access

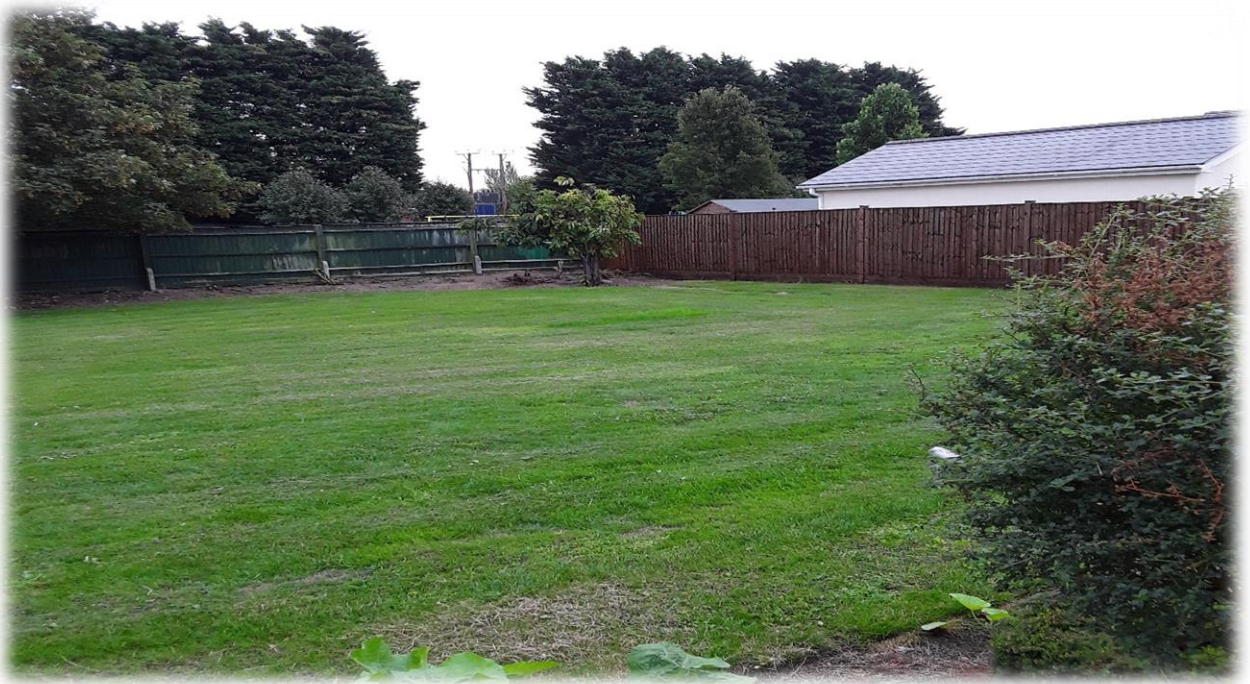
A view of the plot taken looking southeast

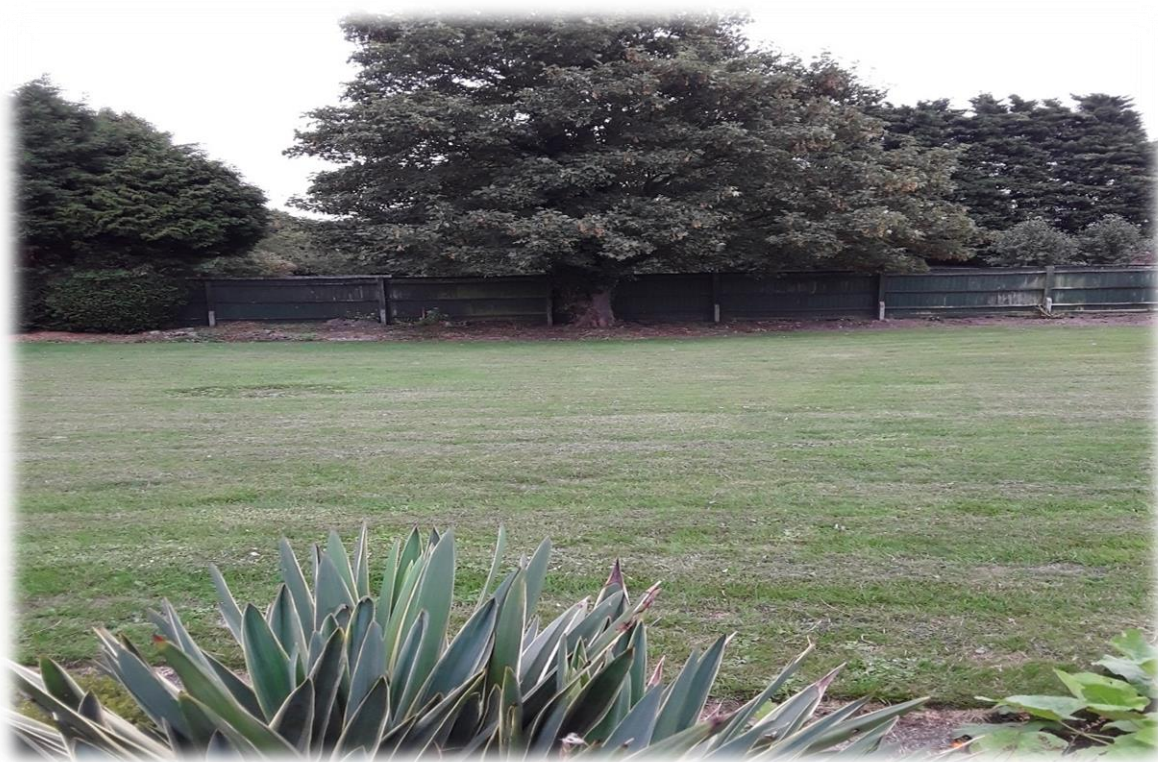
A view of the plot taken looking east

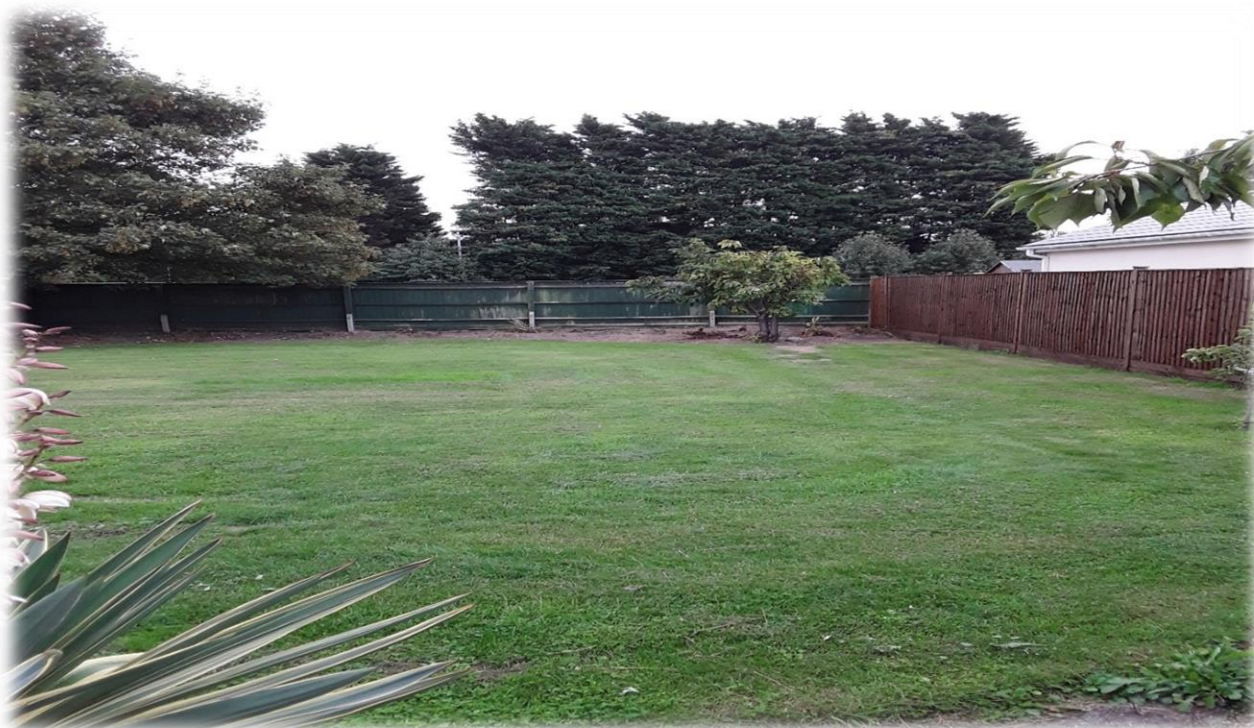
A view of the southernmost point of the plot looking east

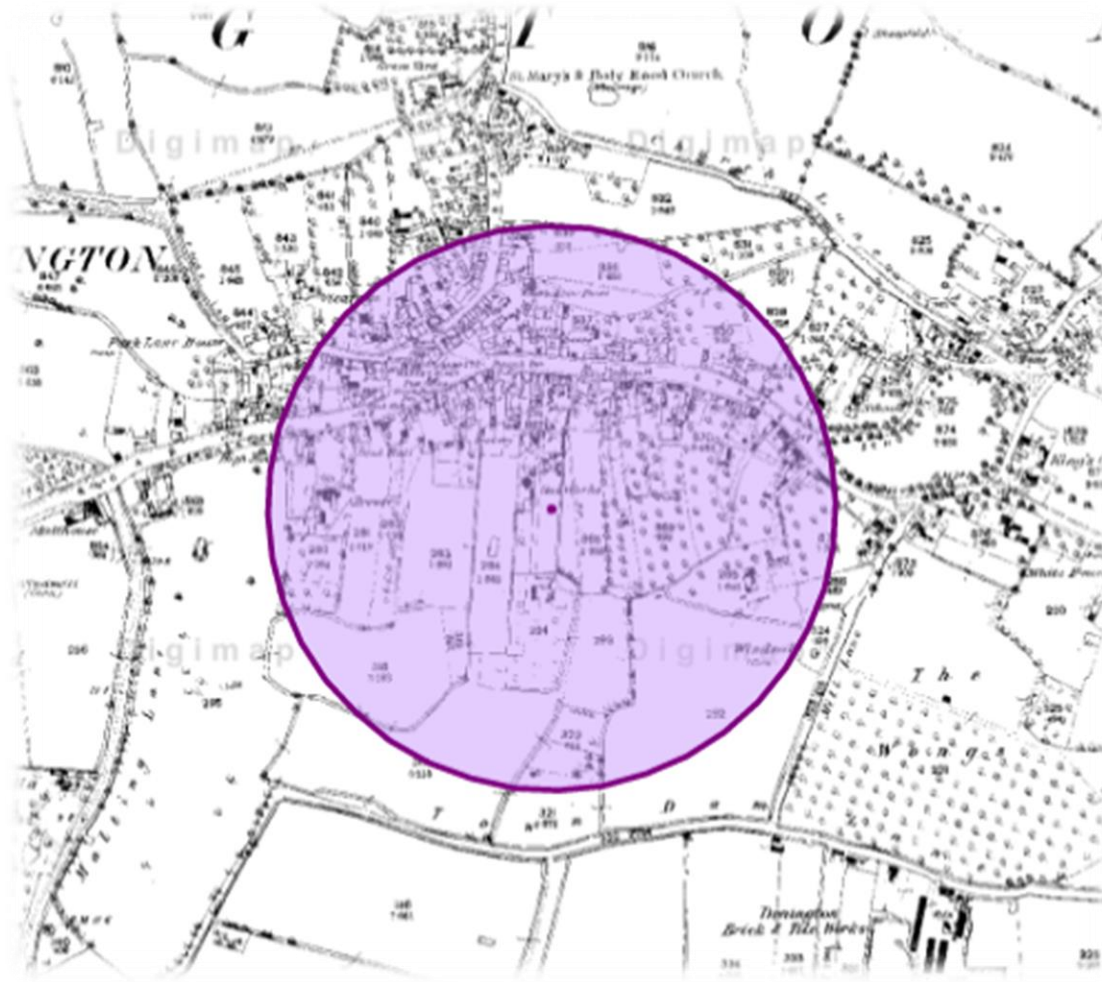
Date: 1889

| <b>Date</b> | <b>Scale</b> | <b>On Site</b> | <b>Off Site</b> |
|---|---|---|---|
| 1889 | 1:2500 | Gasworks with gasholder adjacent to western site boundary. | Breweries 62m north, 138m northeast and 150m west.<br>Smithy 150m northeast.<br>Pond 233m southeast.<br>Corn mill 250m southeast. |

Historic Map (250m search buffer)

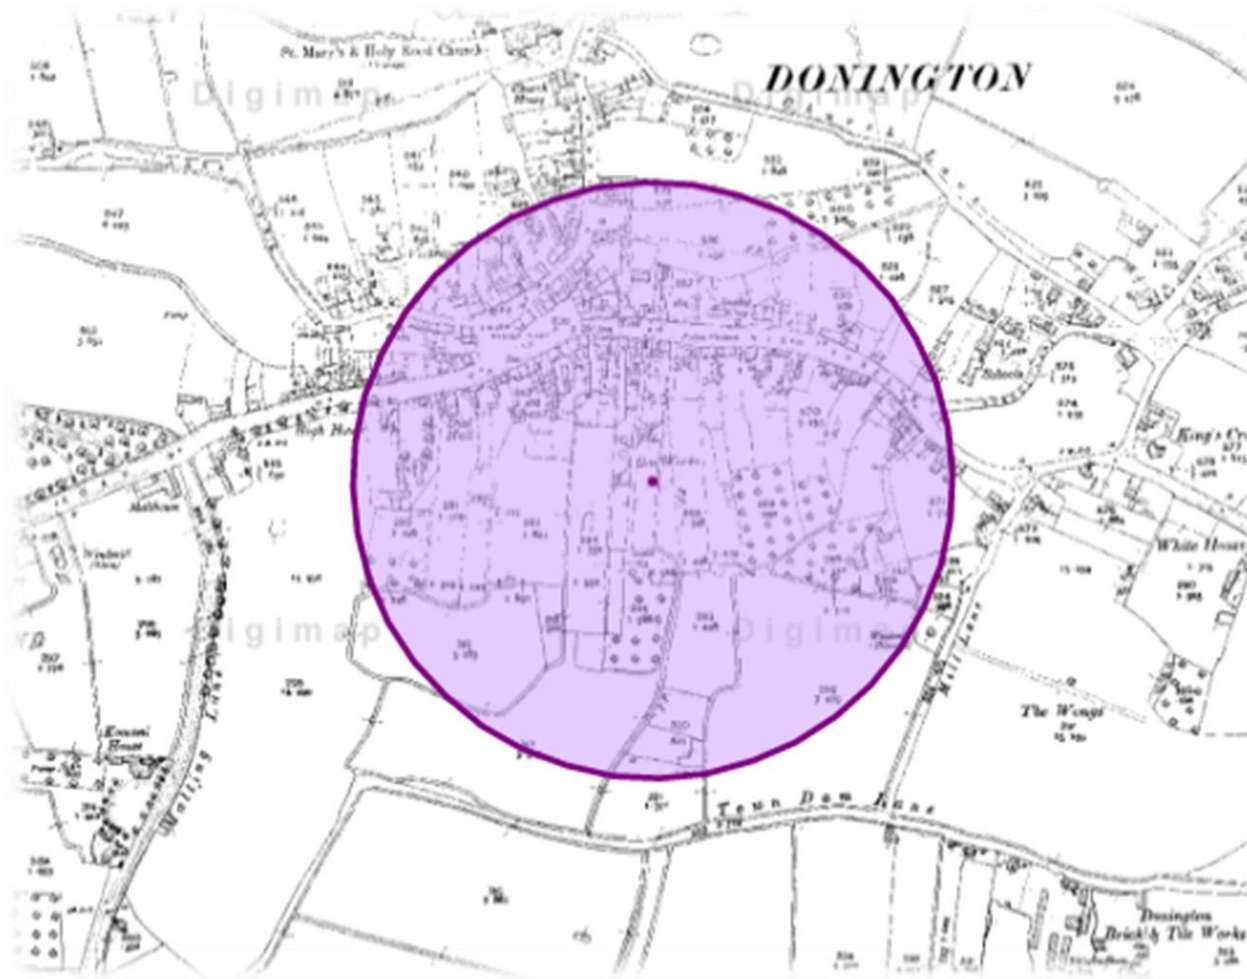
Date: 1905

| <b>Date</b> | <b>Scale</b> | <b>On Site</b> | <b>Off Site</b> |
|---|---|---|---|
| 1905 | 1:2500 | Site remains a gasworks. | Breweries have been replaced by residences.<br>Mill is now disused. |

Historic Map (250m search buffer)

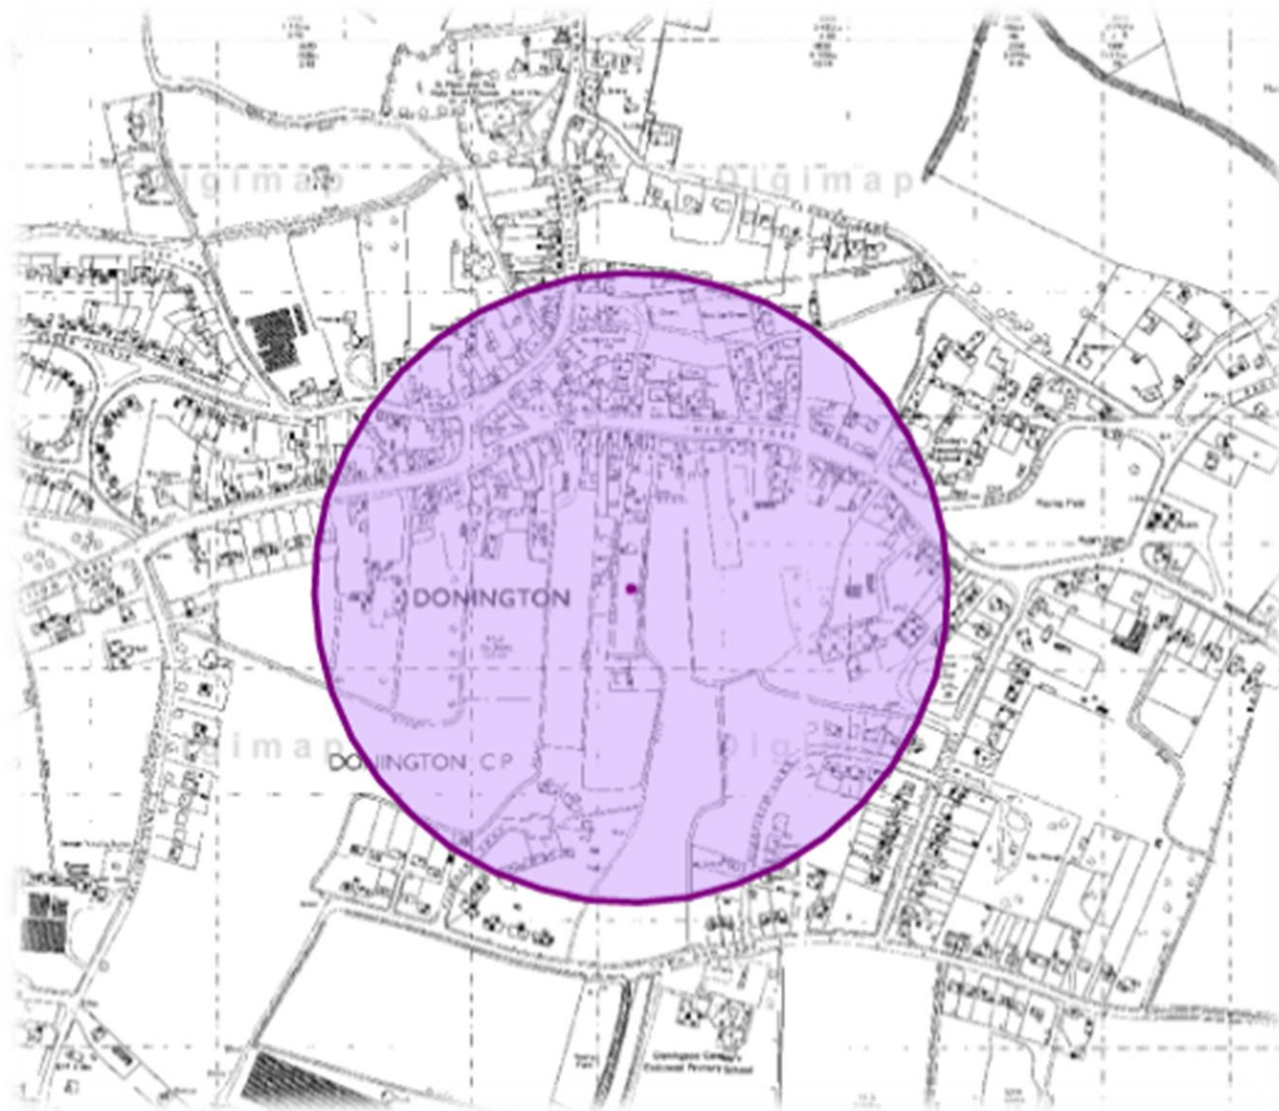
Date: 1973

| <b>Date</b> | <b>Scale</b> | <b>On Site</b> | <b>Off Site</b> |
|---|---|---|---|
| 1973 | 1:2500 | Gasworks demolished. | Drains 8m and 45m east, 32m, 65m and 124m west.<br>Electrical substation 75m north.<br>Builders yard 180m north.<br>Engineering works 180m east.<br>Works 150m north, 186m east, 190m northeast, 210m northeast, 240m north.<br>Tanks 190m east, 220m southeast.<br>Timber yard 230m northeast. |

Historic Map (250m search buffer)

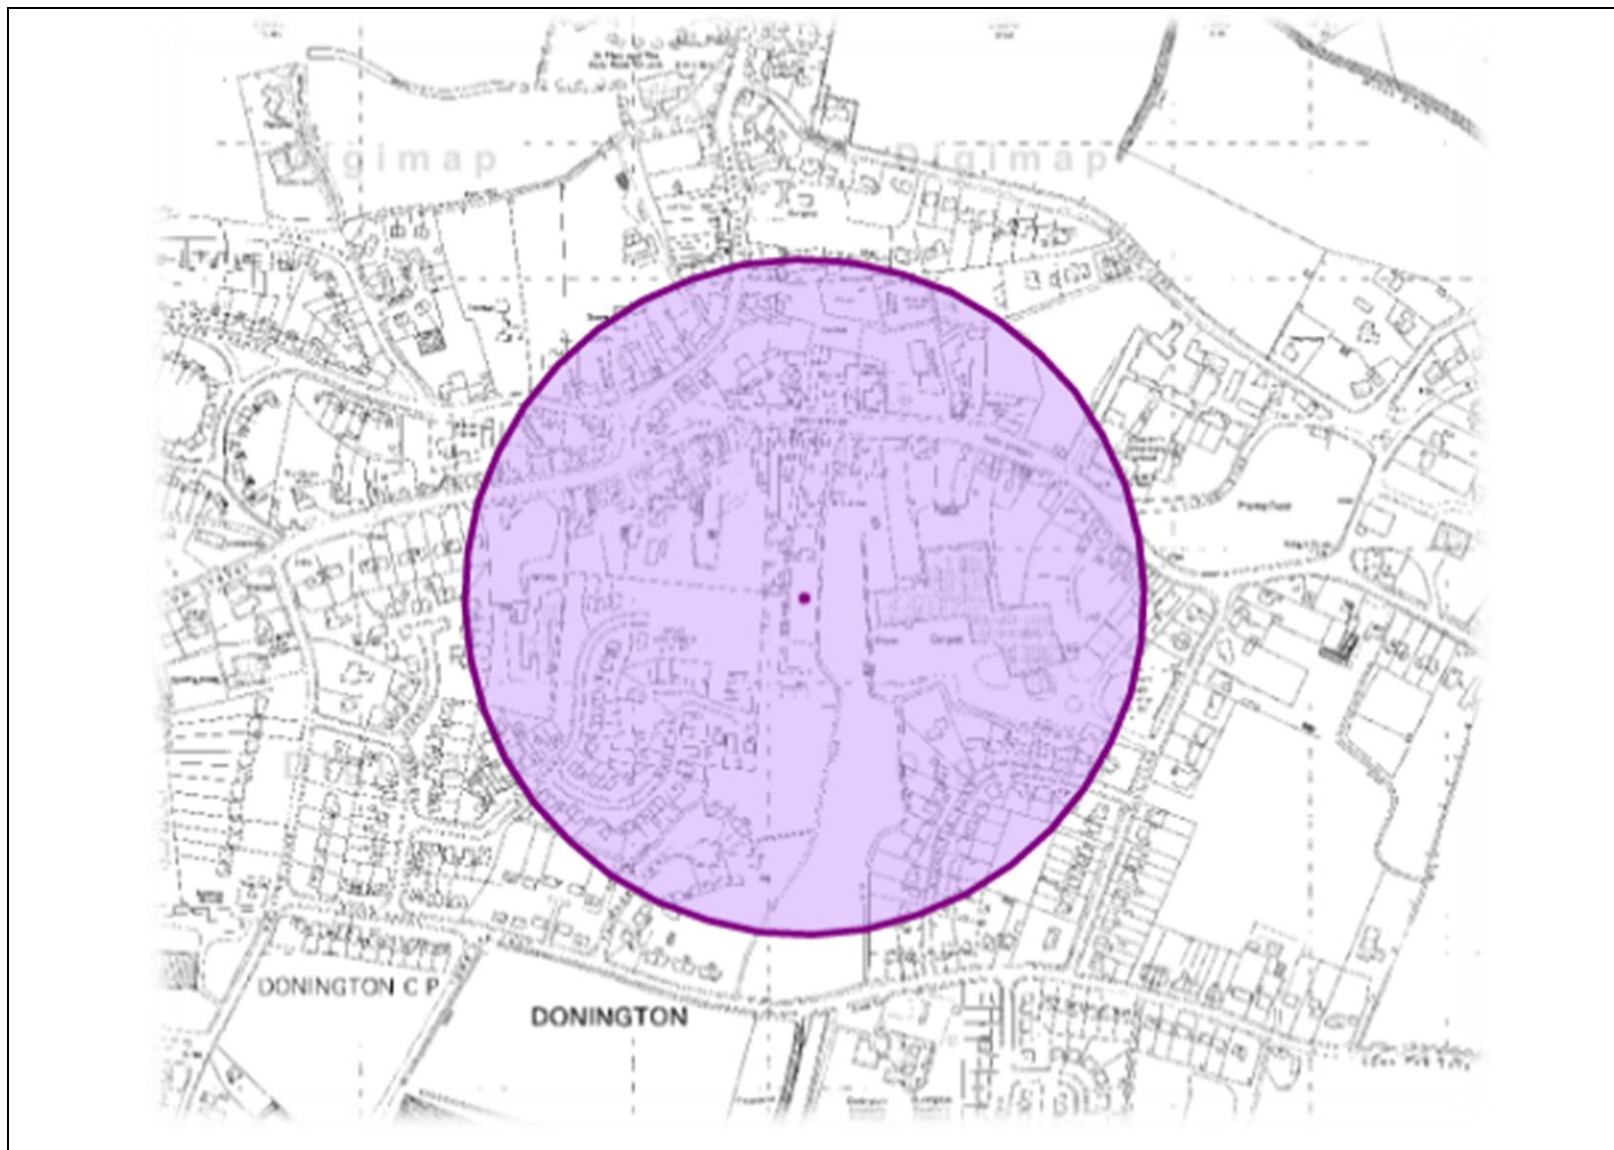
Date: 1988

| <b>Date</b> | <b>Scale</b> | <b>On Site</b> | <b>Off Site</b> |
|---|---|---|---|
| 1988 | 1:2500 | Site now garden of adjoining plot. | Many of previously mentioned works are still in use.<br>Depot 54m east. |

Historic Map (250m search buffer)

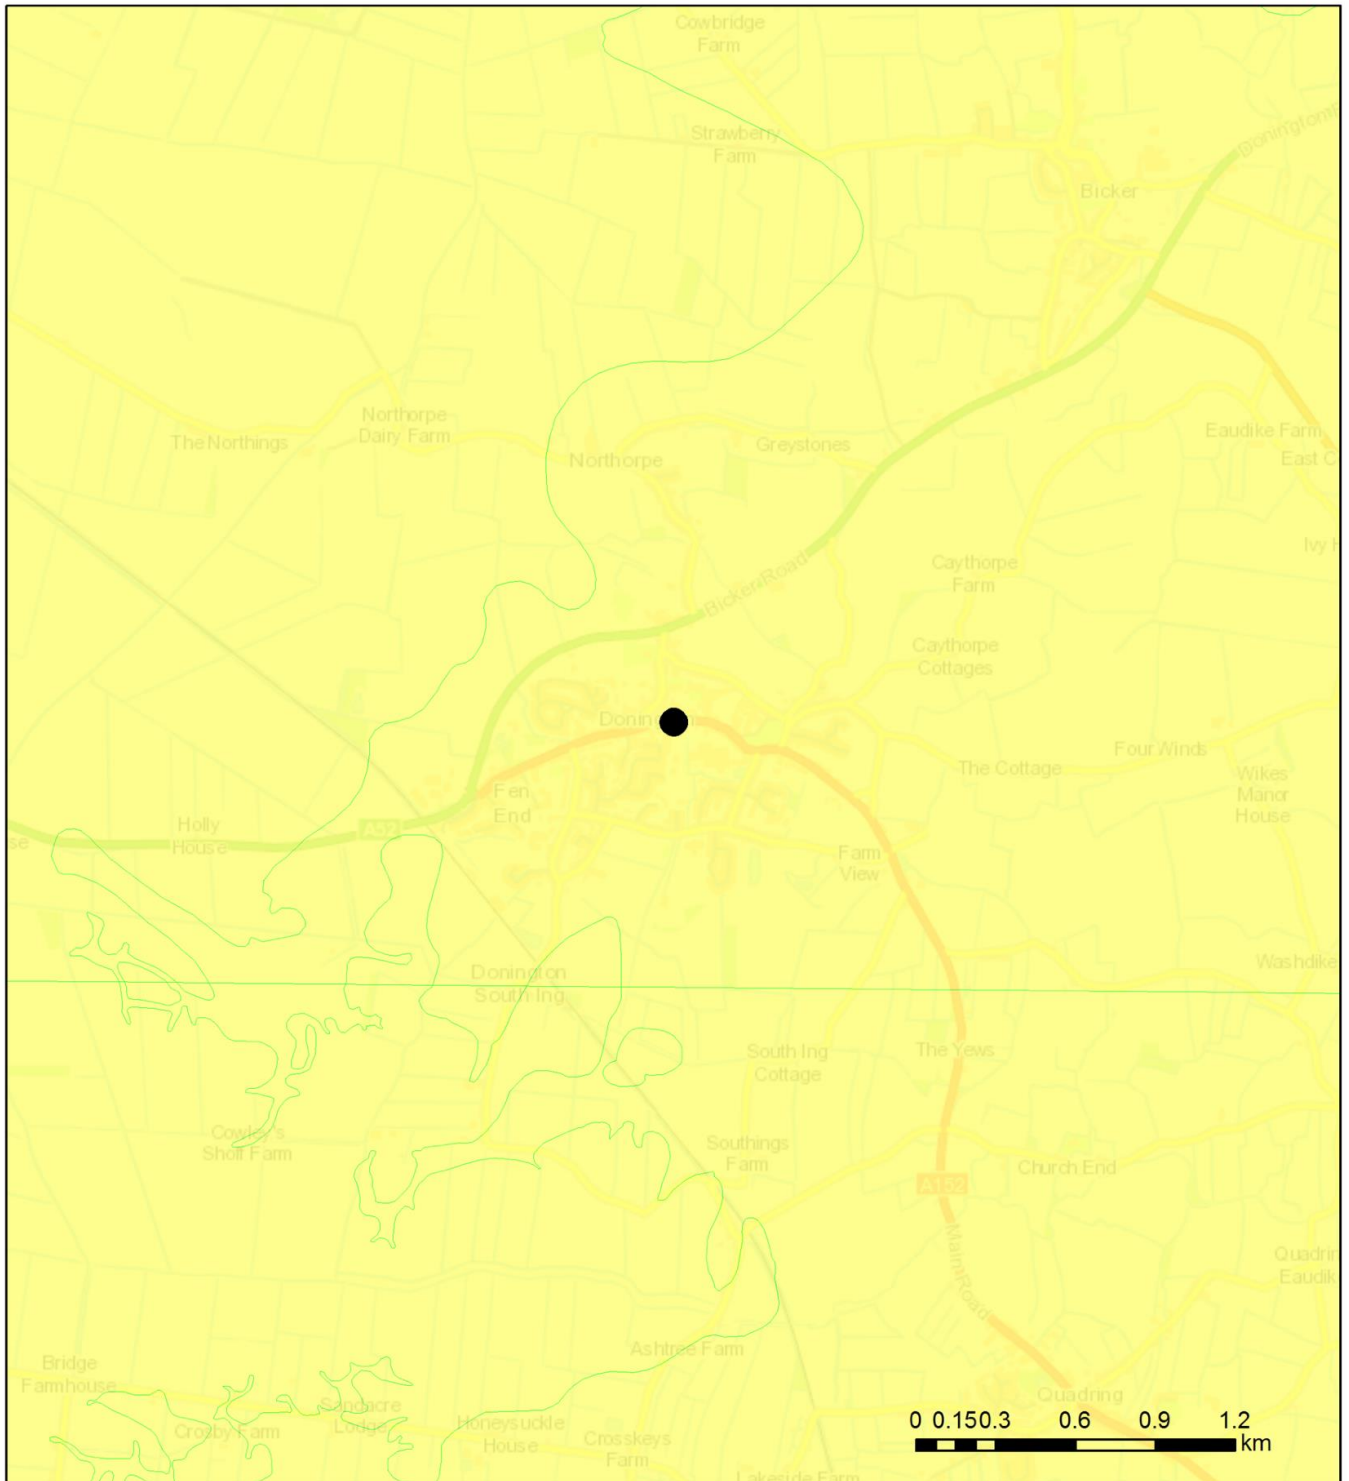
### Superficial Geology

Geological maps of the area indicate tidal flat deposits of clay and silt from the Holocene epoch. This consists of consolidated soft silty clay, with layers of sand, gravel and peat.

**TIDAL FLAT DEPOSITS - CLAY AND SILT**

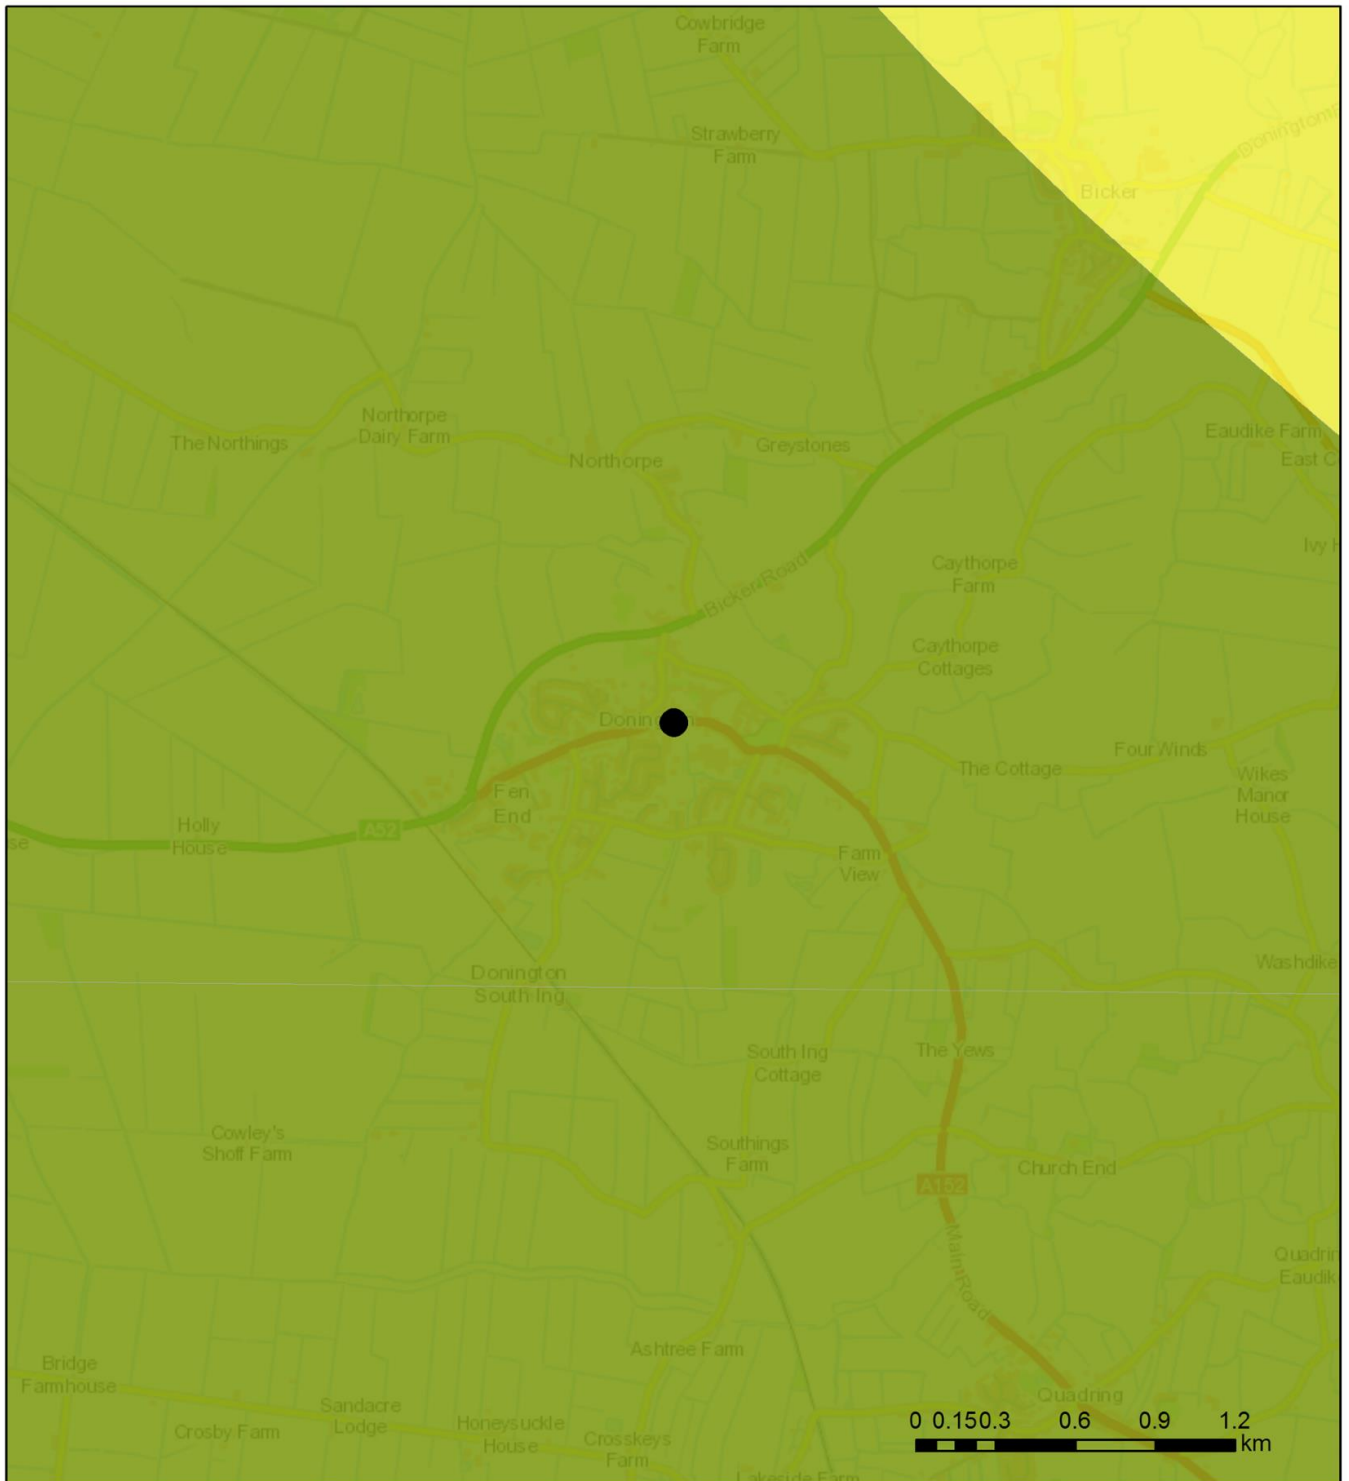
## Bedrock Geology

The underlying bedrock consists of material from the Oxford Clay Formation of the Callovian to Oxfordian age ranges. It is described as silicate-mudstone, grey, generally smooth to slightly silty, with sporadic beds of argillaceous limestone nodules.

**WEST WALTON FORMATION - MUDSTONE AND SILTSTONE**

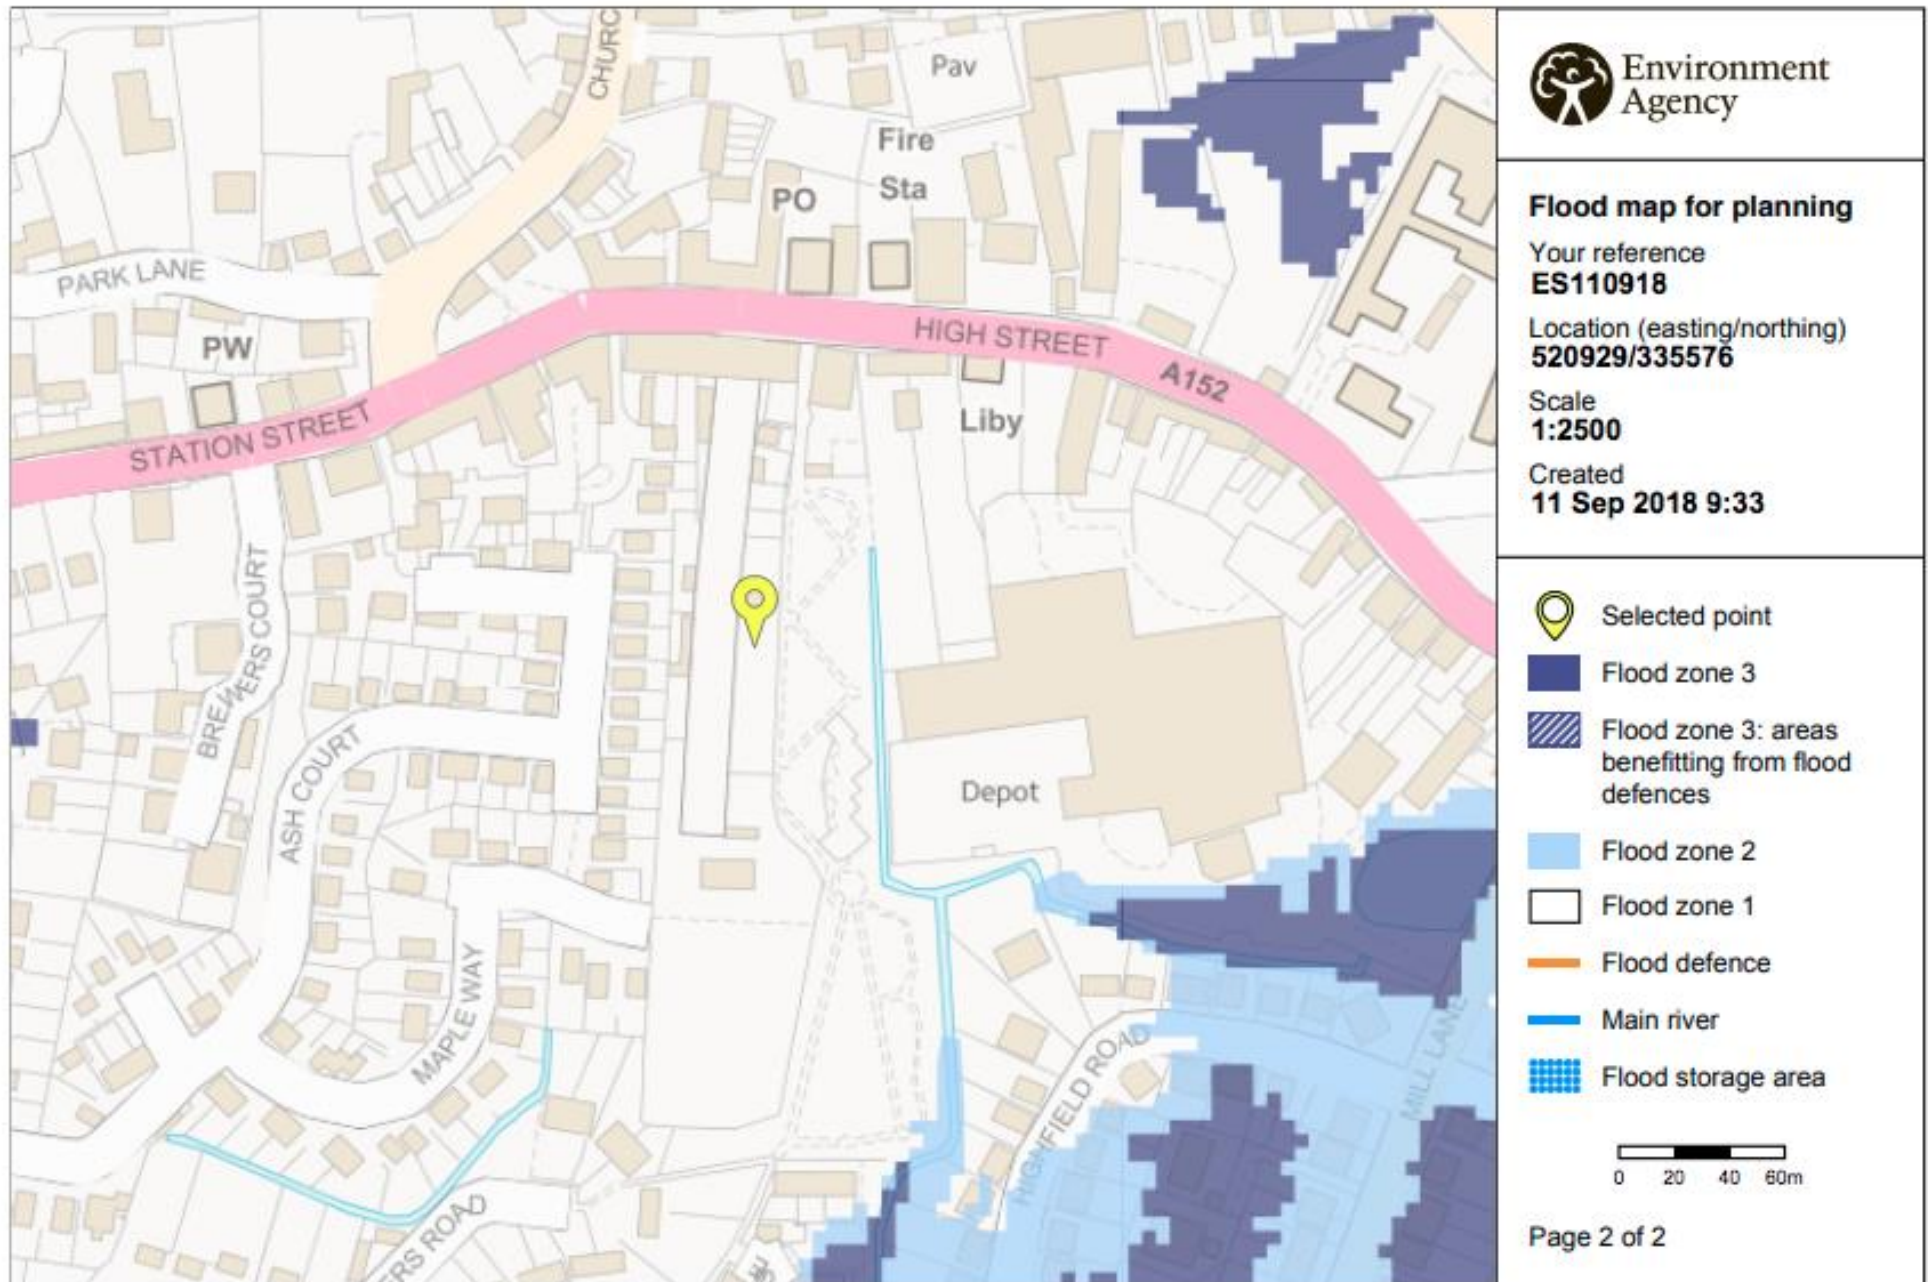
## Appendix F - Flood Risk Map

The site is in an area designated 'Flood Risk 1', defined as; land assessed as having a less than 1 in 1,000 annual probability of river or sea flooding (<0.1%).
