proposed elevations

for house and block plans  
see drg. 1.

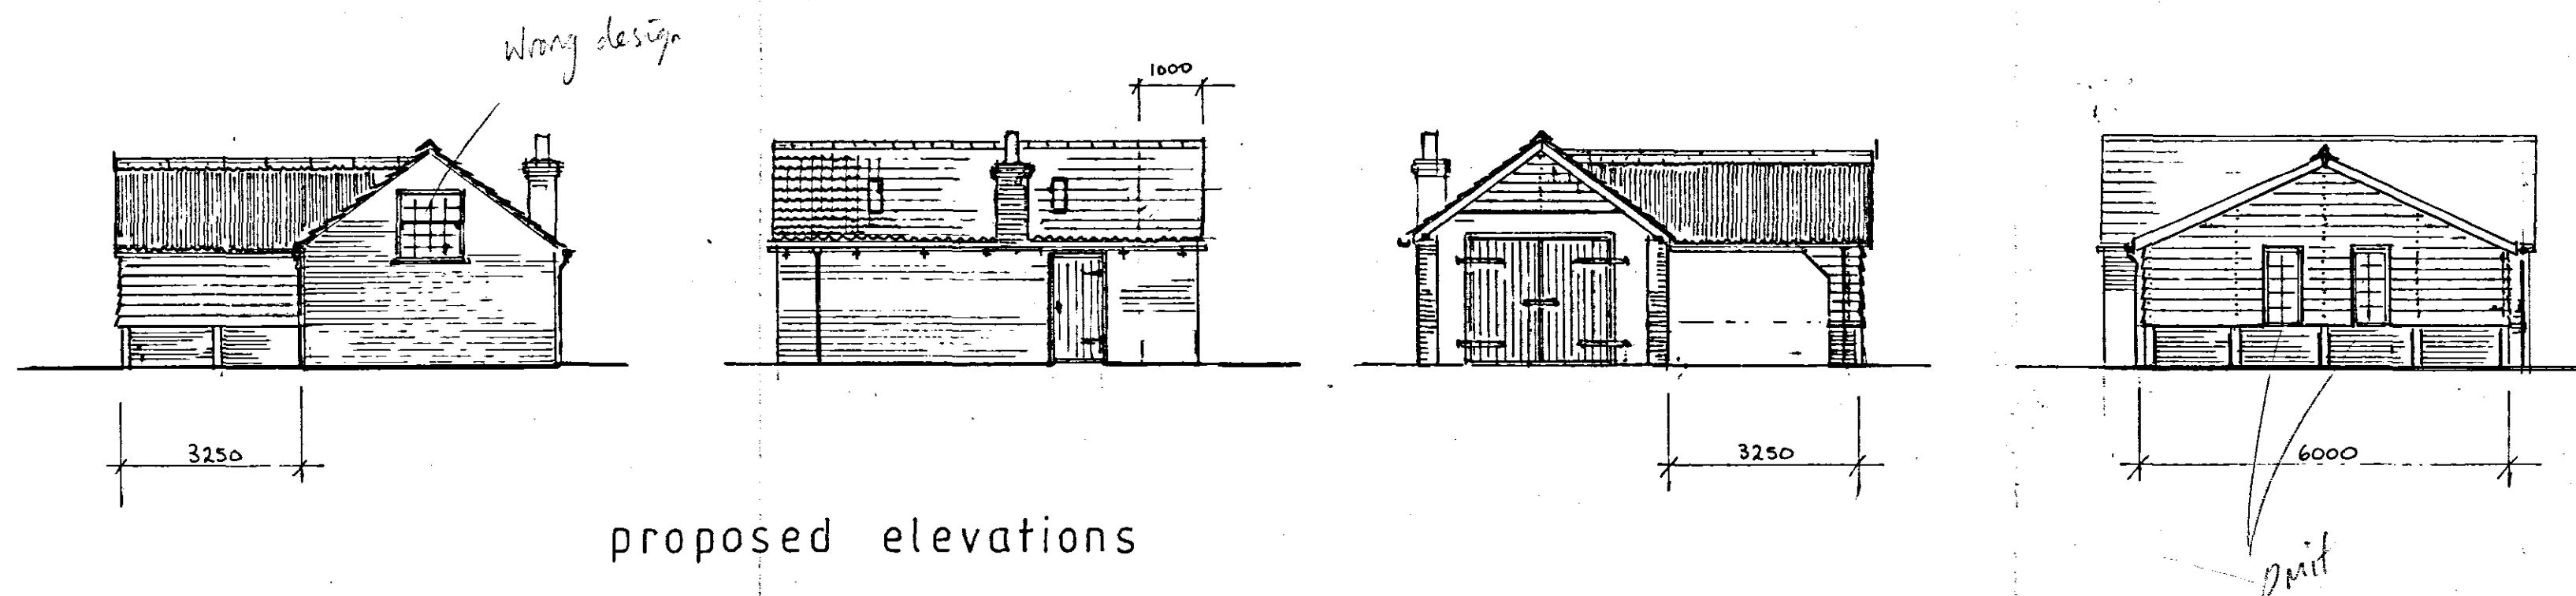
ROOF. BARN. RE-USED NORFOLK PANTILES.  
LEAN-TO. BLACK CORRUGATED SHEET.  
WALLS. BARN. RENOVATED BRICKWORK USING  
SUITABLE RESTORATION PRACTICES. N.B. SOUTH FACING  
WALL TO BE ADAPTED TO PROVIDE FOR EXISTING WALL  
BORING BEES.  
LEAN-TO. LOWER SECTION. RECLAIMED BRICKS.  
UPPER. ROUGH SAUN BORDING WITH  
BLACK TIMBER STAIN.  
WINDOWS/DOORS. TIMBER UNITS. TO MATCH REMAINS OF EXISTING.  
DOORS VERTICAL BOARDED.  
R.W. GOODS 1/2 ROUND CAST METAL ON RISE & FALL BENTS  
PAINTED BLACK.
