## PHASE I DESK TOP STUDY

MULBERRY BARN

TORRINGTON LANE

REPORT REF: R0160/19

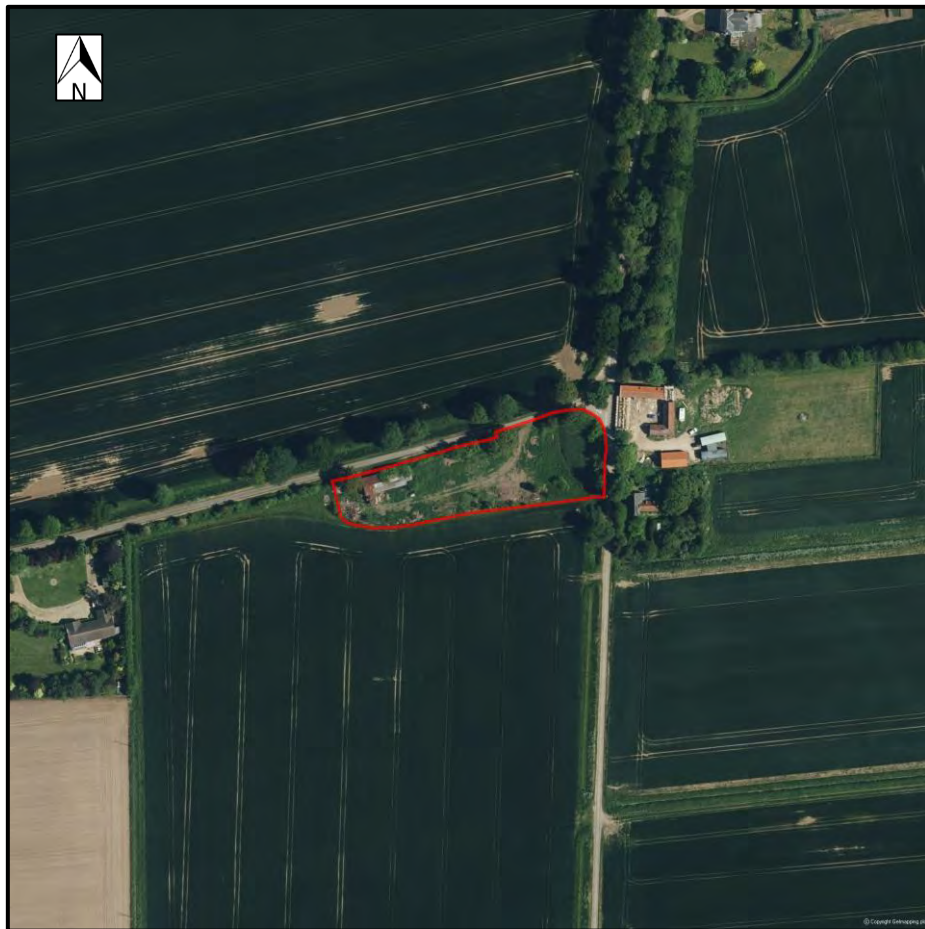
Figure 1: Aerial Photograph Showing Site Location

- 2.1 The site is located along Torrington Lane in Fleet, Spalding. The approximate National Grid Reference for the centre of site is 538804,322856.
- 2.2 The site location is shown in Figure 1 below.

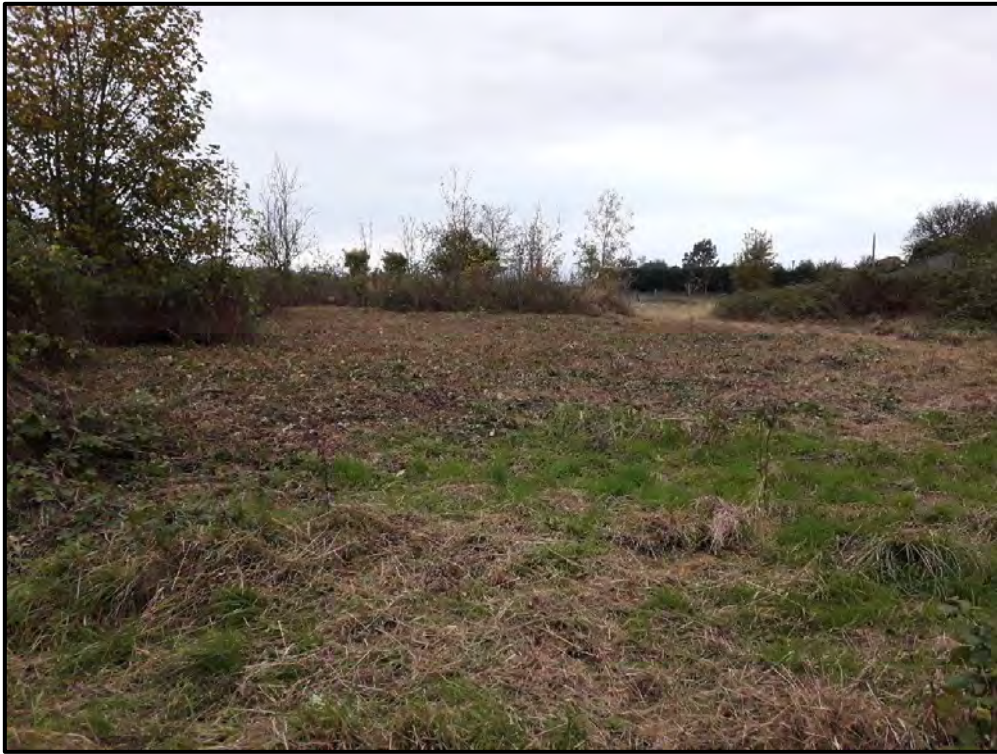
Figure 2: View from the East of Site Looking West Towards the Barn

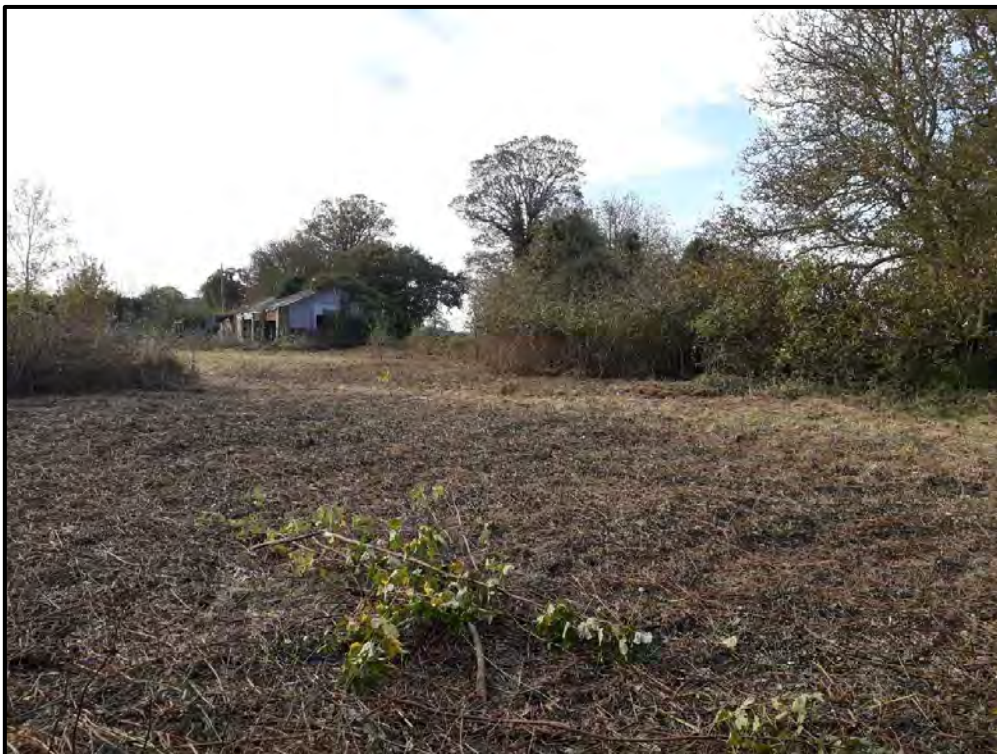
Figure 3: Photograph Showing the Current Barn Present on Site

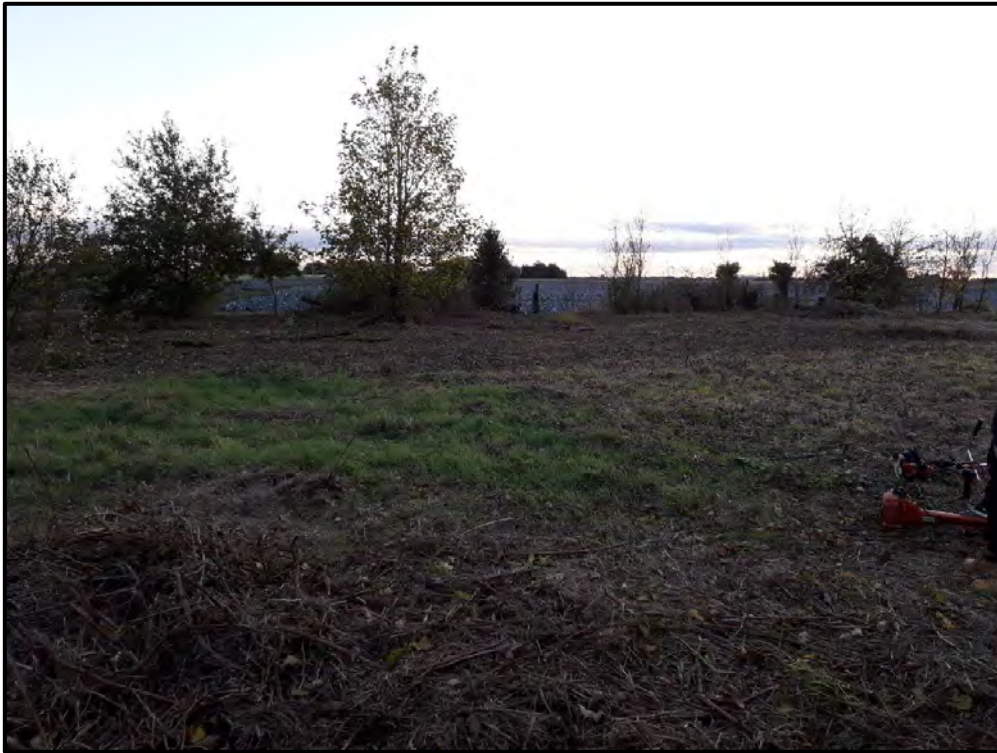
Figure 4: View from the Centre of Site Looking South

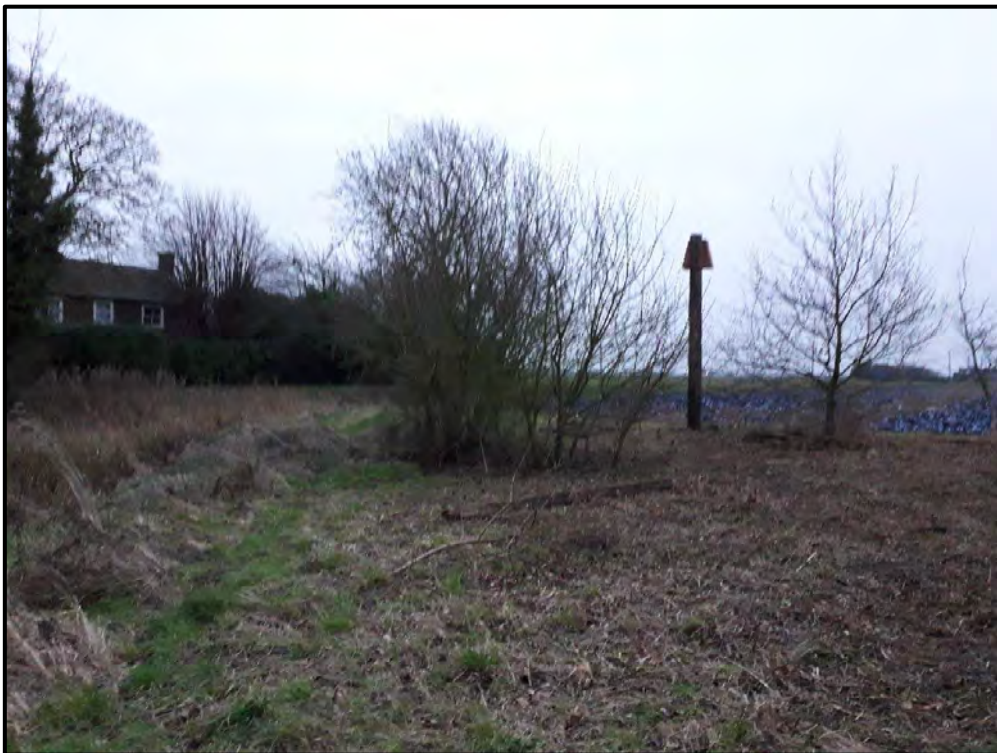
- 2.3 The site covers an area of approximately 0.41ha and is generally flat. A pond occupies the eastern extent of site and leads into a field drain which extends further to the south. The site is occupied by several small outbuildings and a dilapidated brick barn with a sheet metal roof.
- 2.4 The property is bordered on the north, west and south by open fields and to the east by Poplar Farm and Maisdyke House. The wider area is dominated by agricultural fields with few developments present.
- 2.5 Photographs showing the general layout of the assessment site are provided within figures 2 to 5.

Figure 5: Photograph Showing the Eastern Area of Site with the Pond and Ditch Running South

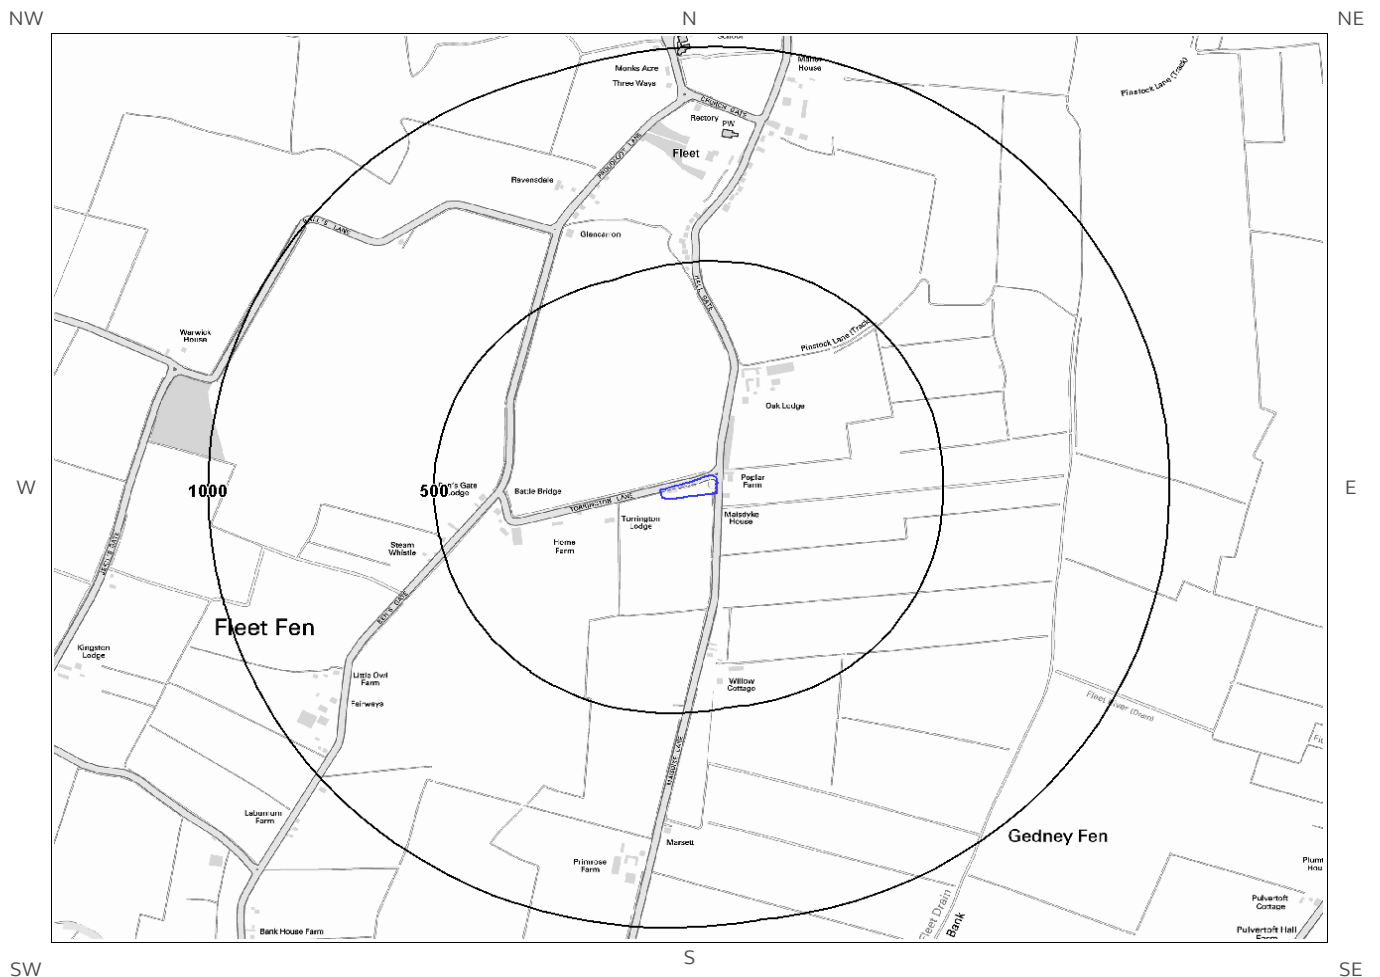
## 1.1 Artificial Ground map (1:10,000 scale)

Database searched and no data found.

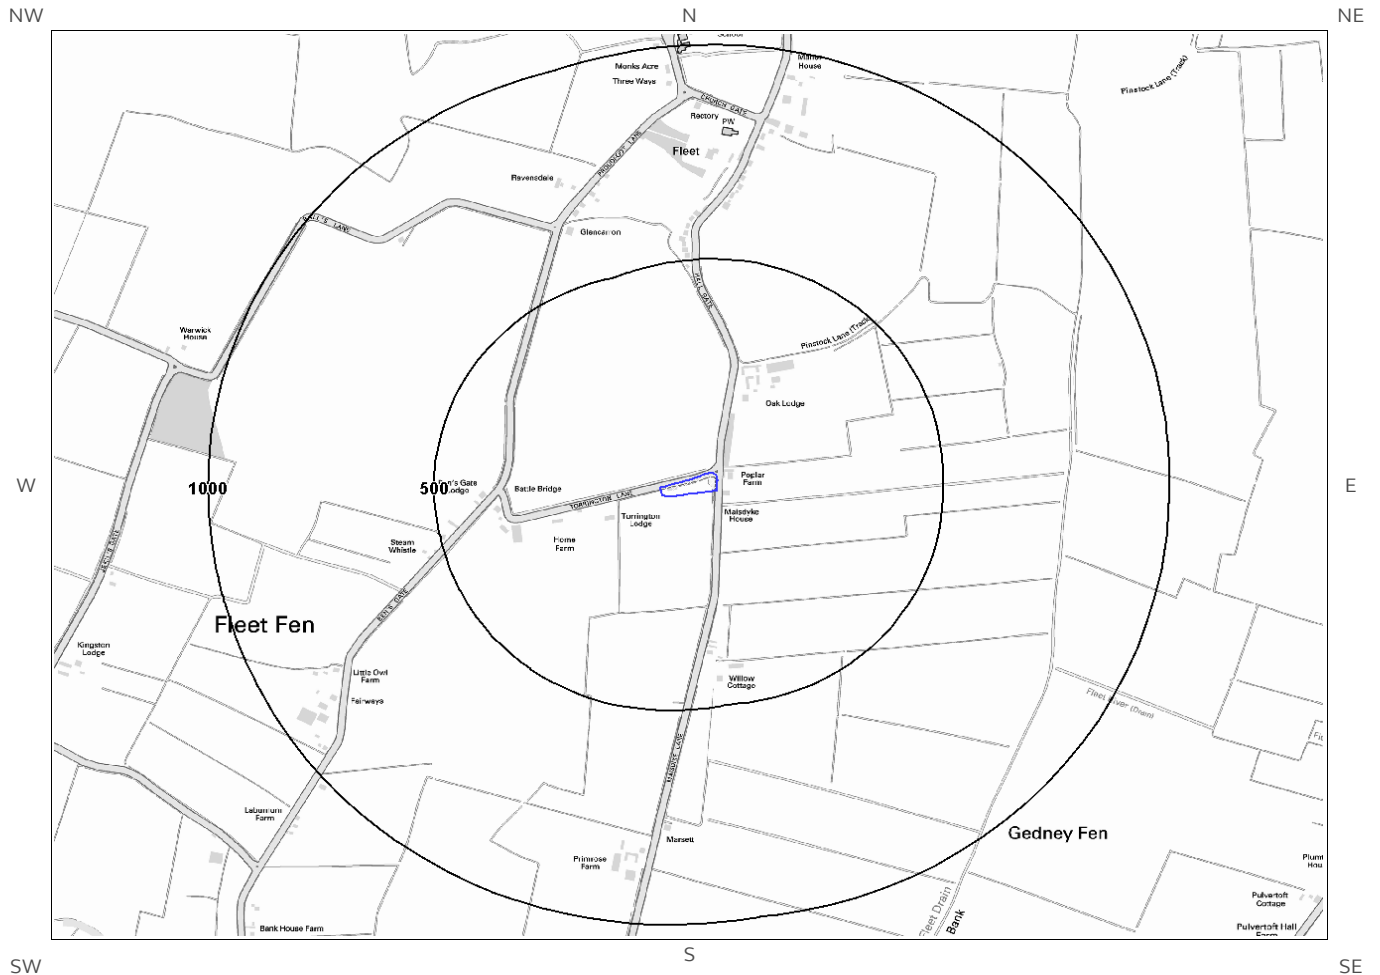
# 1.2 Superficial Deposits and Landslips map (1:10,000 scale)

Database searched and no data found.

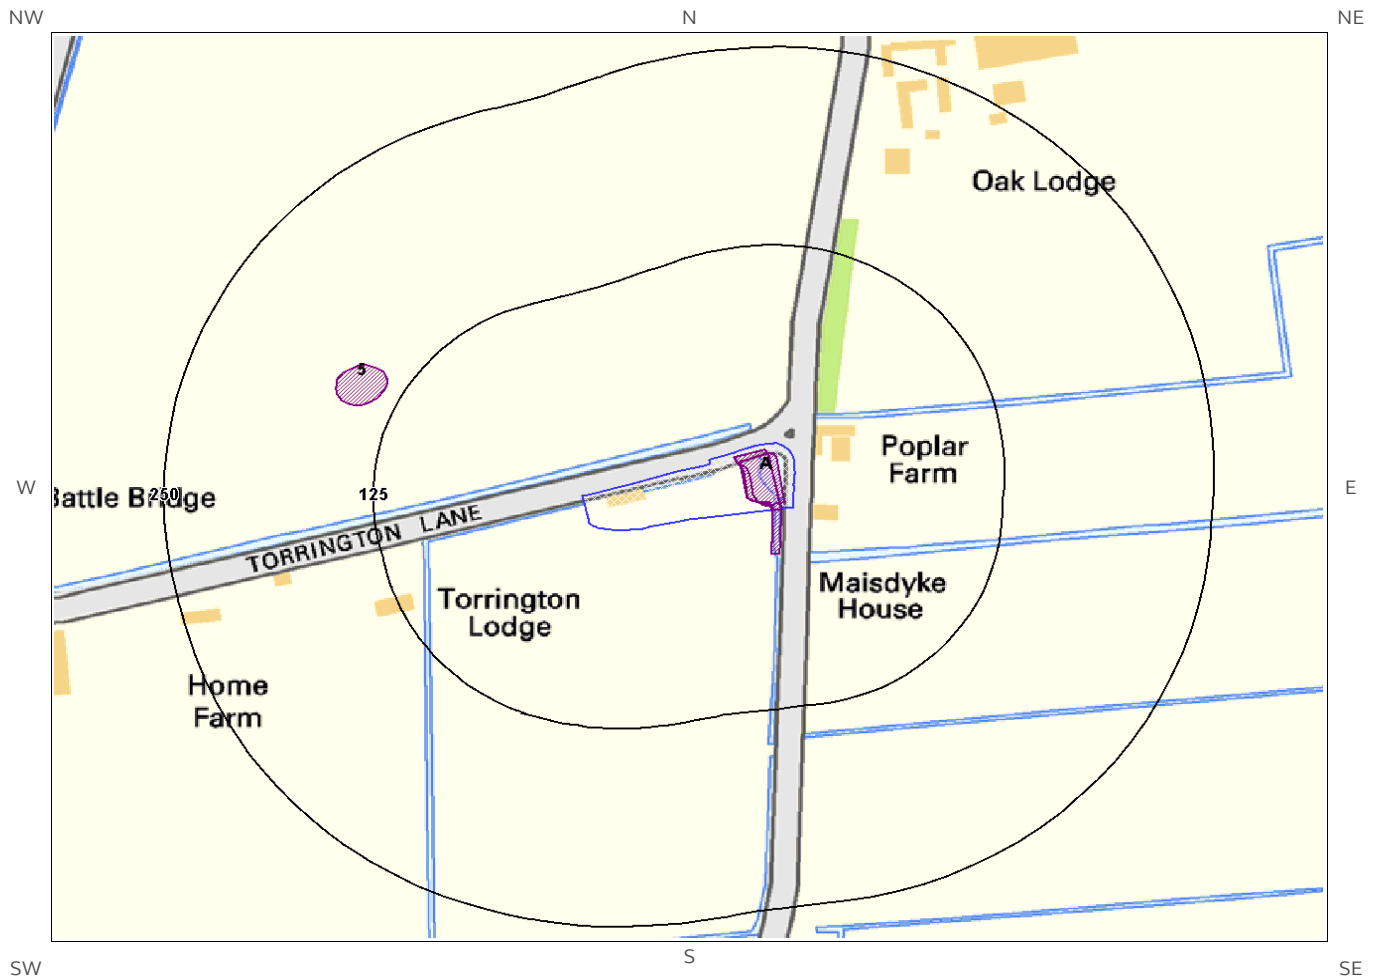
# 4 Ground Workings map

Database searched and no data found.

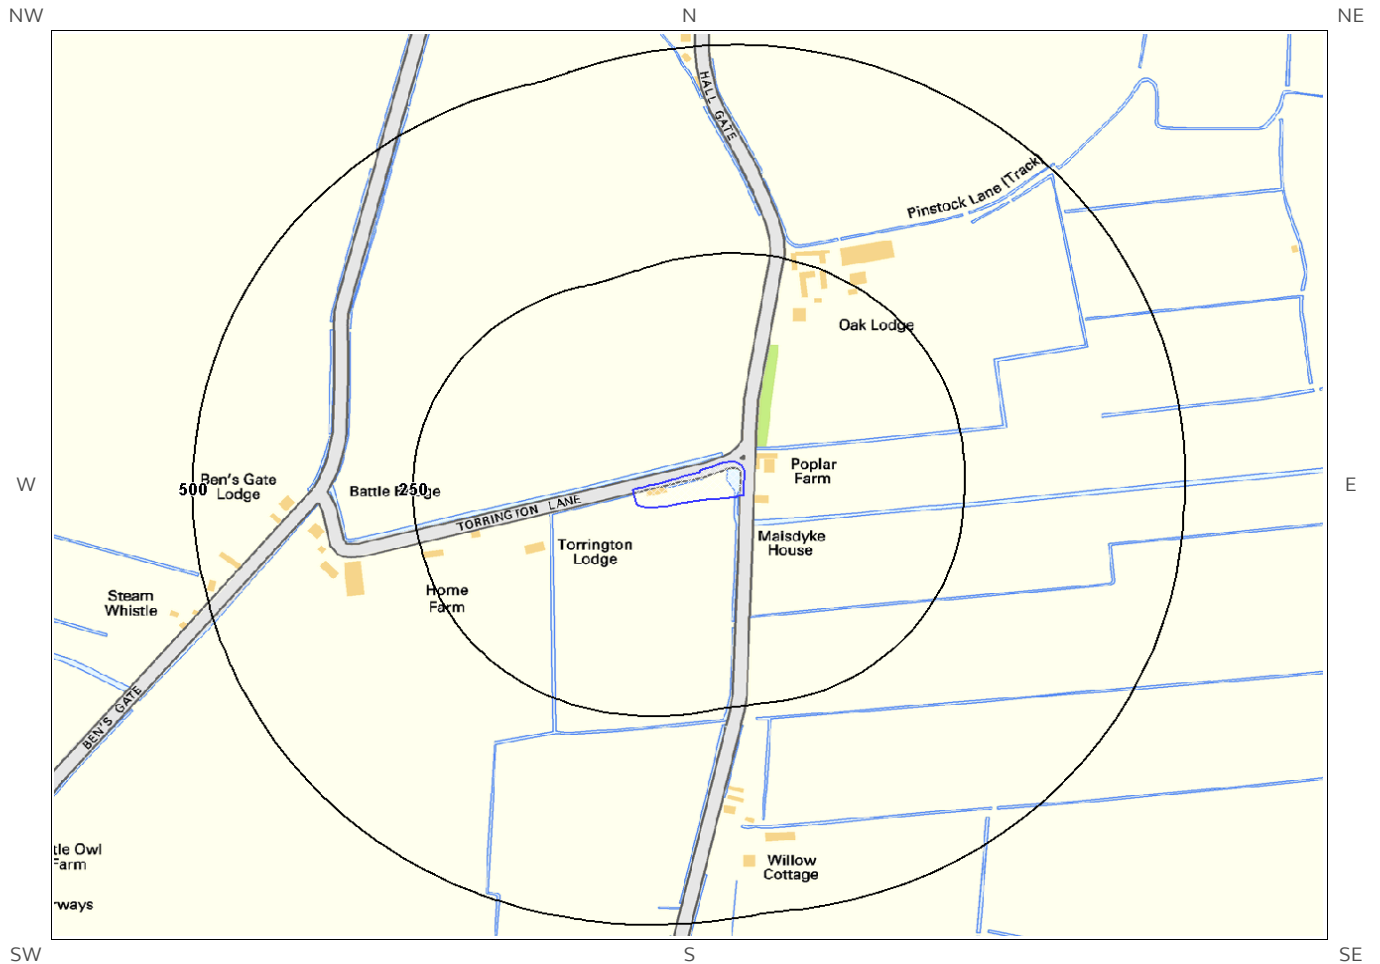
# 5 Mining, Extraction & Natural Cavities map

Database searched and no data found.

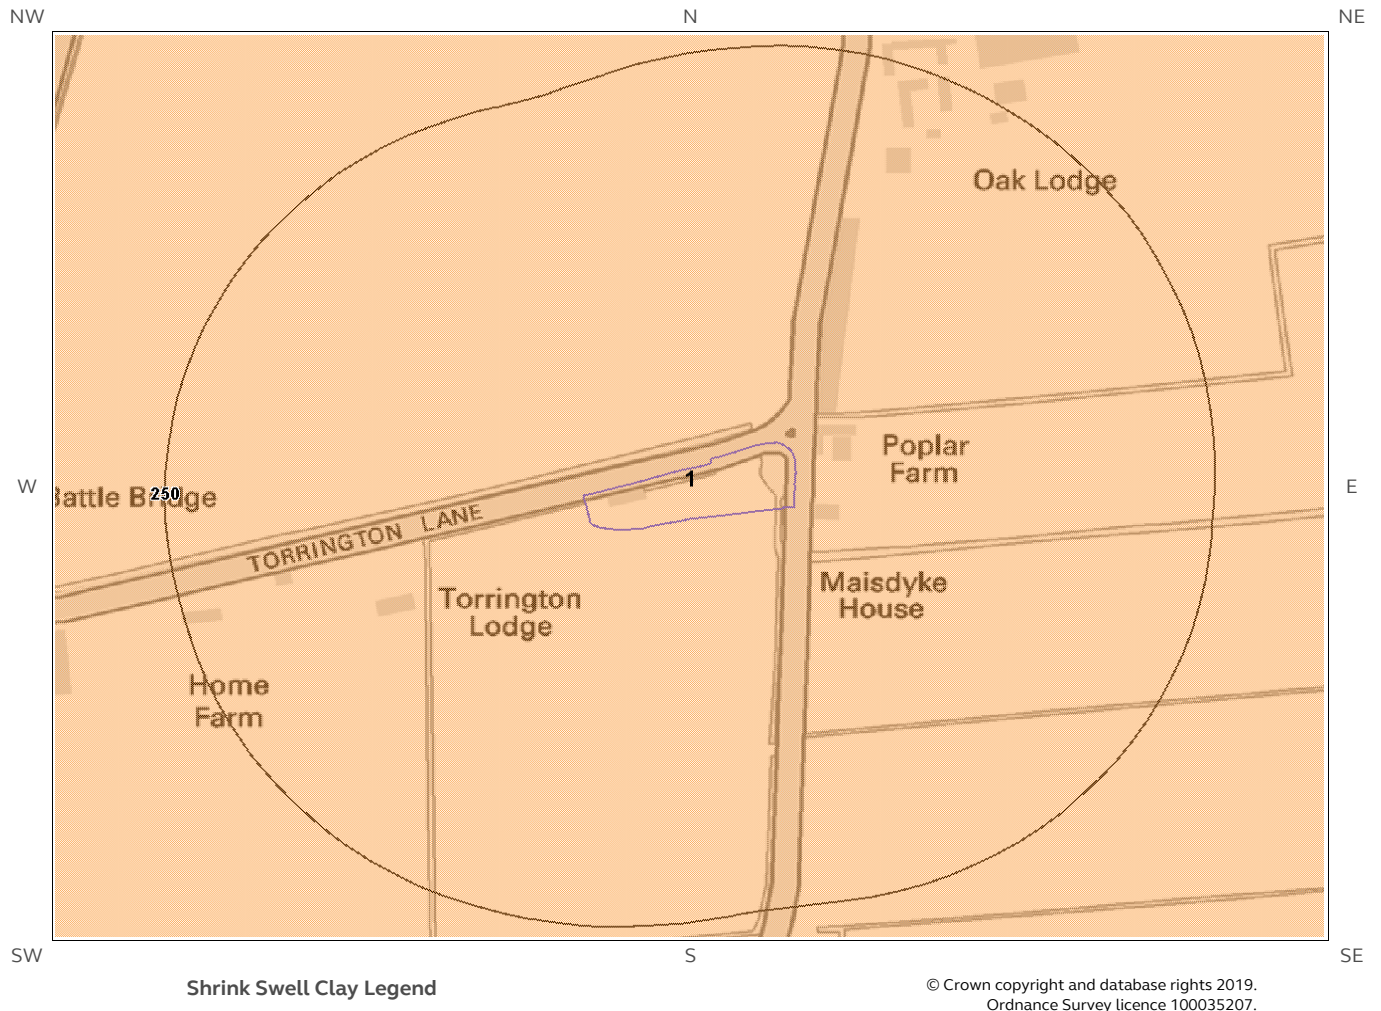
## 6.1 Shrink-Swell Clay map

| ID | Distance (m) | Direction | Hazard Rating | Details |
|---|---|---|---|---|
| 1 | 0.0 | On Site | Low | Ground conditions predominantly medium plasticity. Do not plant trees with high soil moisture demands near to buildings. For new build, consideration should be given to advice published by the National House Building Council (NHBC) and the Building Research Establishment (BRE). There is a possible increase in construction cost to reduce potential shrink-swell problems. For existing property, there is a possible increase in insurance risk, especially during droughts or where vegetation with high moisture demands is present. |

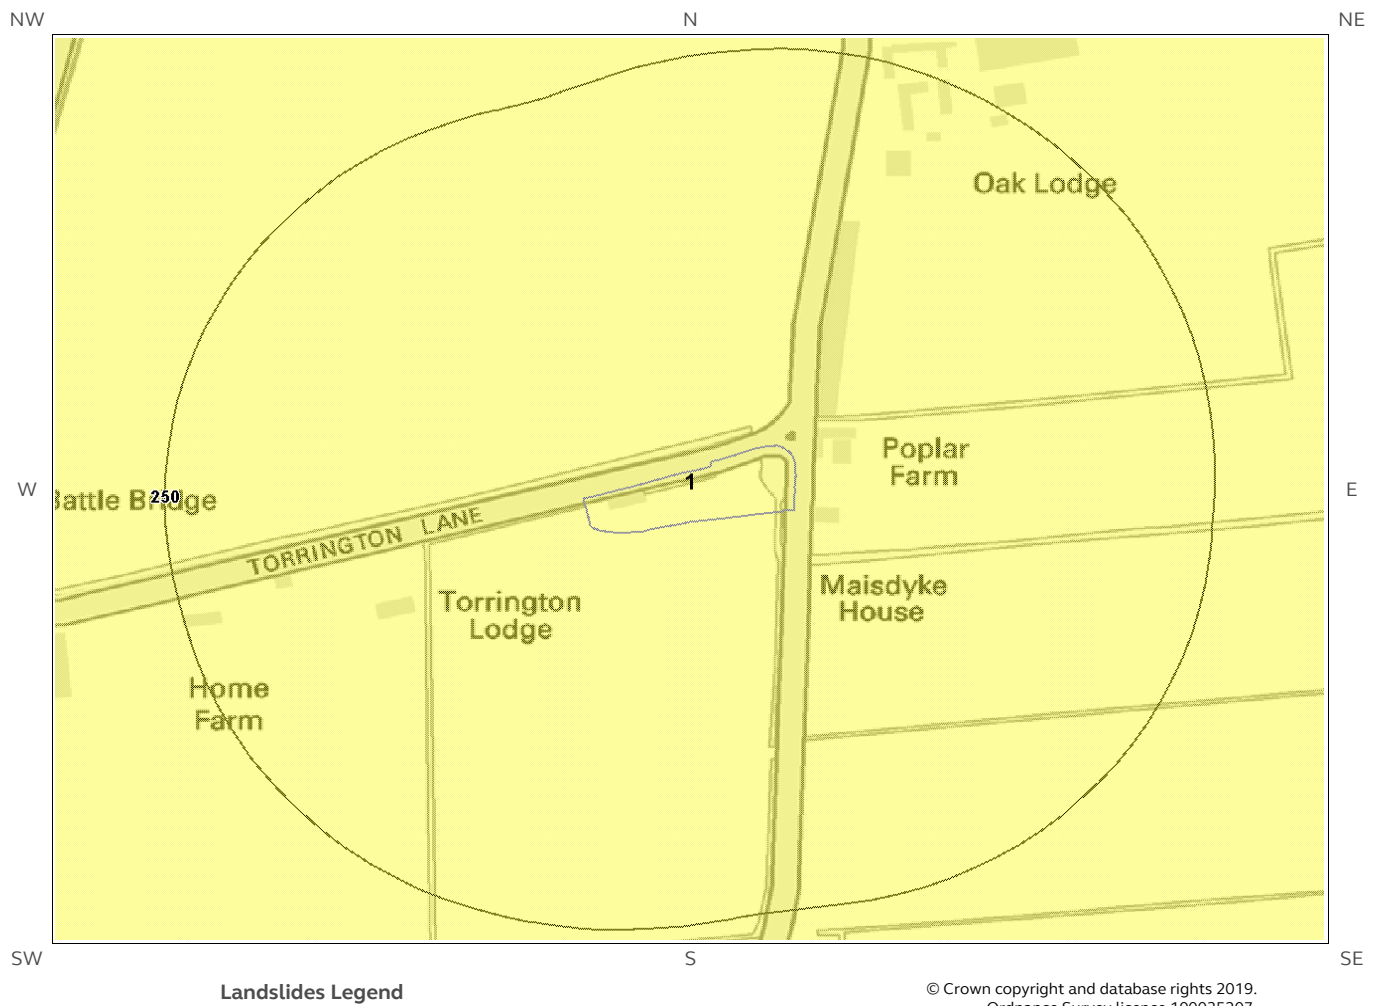
## 6.2 Landslides map

| Section 9: Natural Hazards | |
|---|---|
| 9.1.2 Maximum Landslides hazard rating identified on the study site | Very Low |

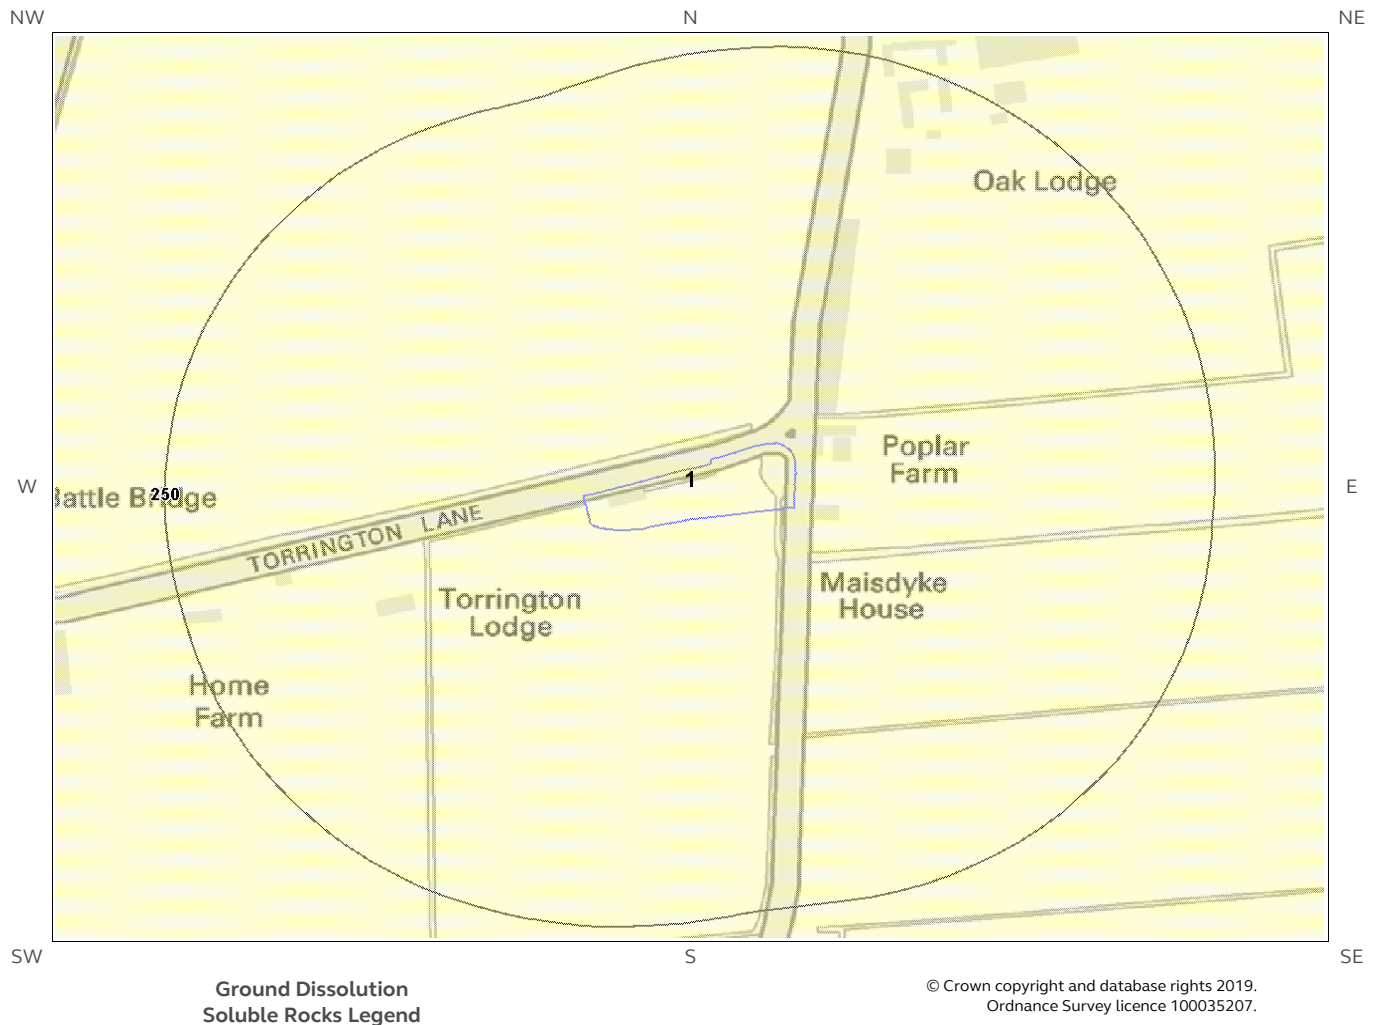
## 6.3 Ground Dissolution of Soluble Rocks map

| ID | Distance (m) | Direction | Hazard Rating | Details |
|---|---|---|---|---|
| 1 | 0.0 | On Site | Negligible | Soluble rocks are present, but unlikely to cause problems except under exceptional conditions. No special actions required to avoid problems due to soluble rocks. No special ground investigation required, and increased construction costs or increased financial risks are unlikely due to potential problems with soluble rocks. |

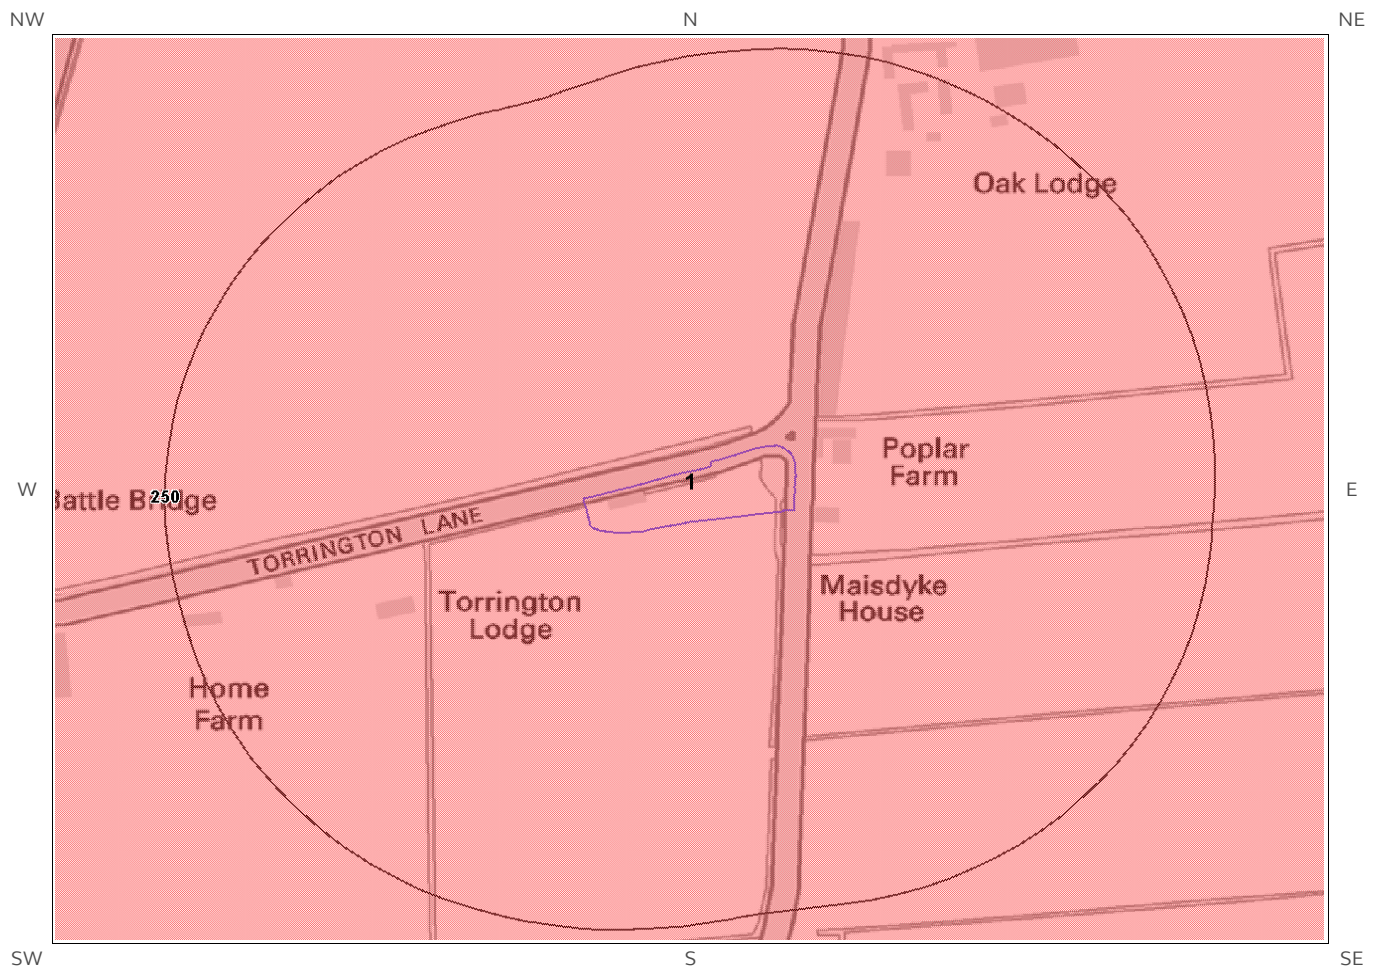
## 6.4 Compressible Deposits map

3.8 The site is in an area where the hazard rating is Moderate with regard to compressible deposits and running sands.

| ID | Distance (m) | Direction | Hazard Rating | Details |
|---|---|---|---|---|
| 1 | 0.0 | On Site | Moderate | Significant potential for compressibility problems. Avoid large differential loadings of ground. Do not drain or de-water ground near the property without technical advice. For new build - consider possibility of compressible ground in ground investigation, construction and building design. Consider effects of groundwater changes. Extra construction costs are likely. For existing property - possible increase in insurance risk from compressibility, especially if water conditions or loading of the ground change significantly. |

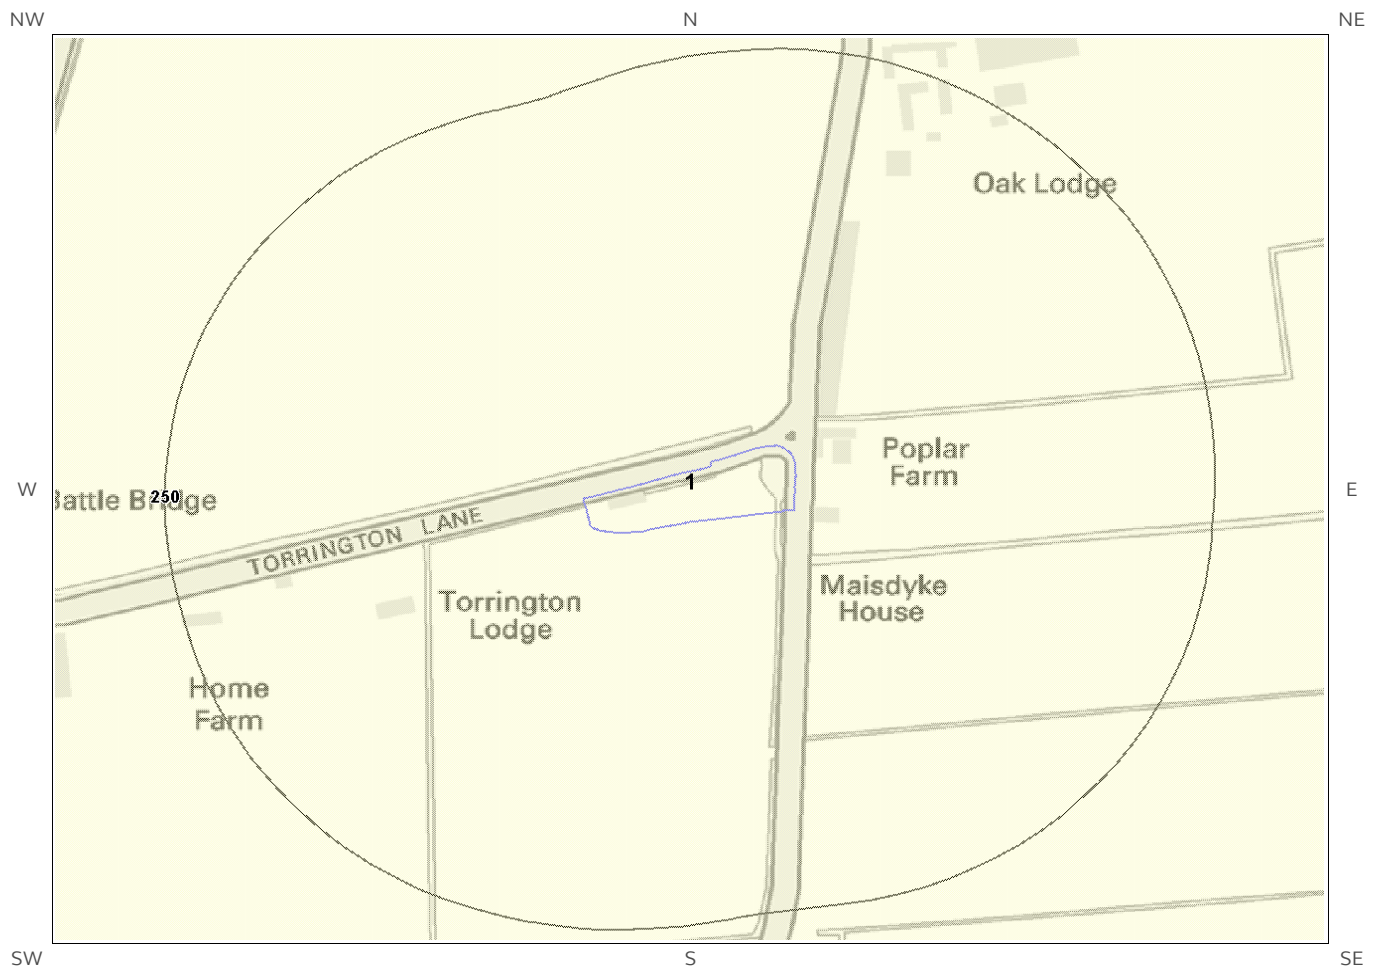
## 6.5 Collapsible Deposits map

| Section 9: Natural Hazards | |
|---|---|
| 9.1.5 Maximum Collapsible Rocks hazard rating identified on the study site | Negligible |

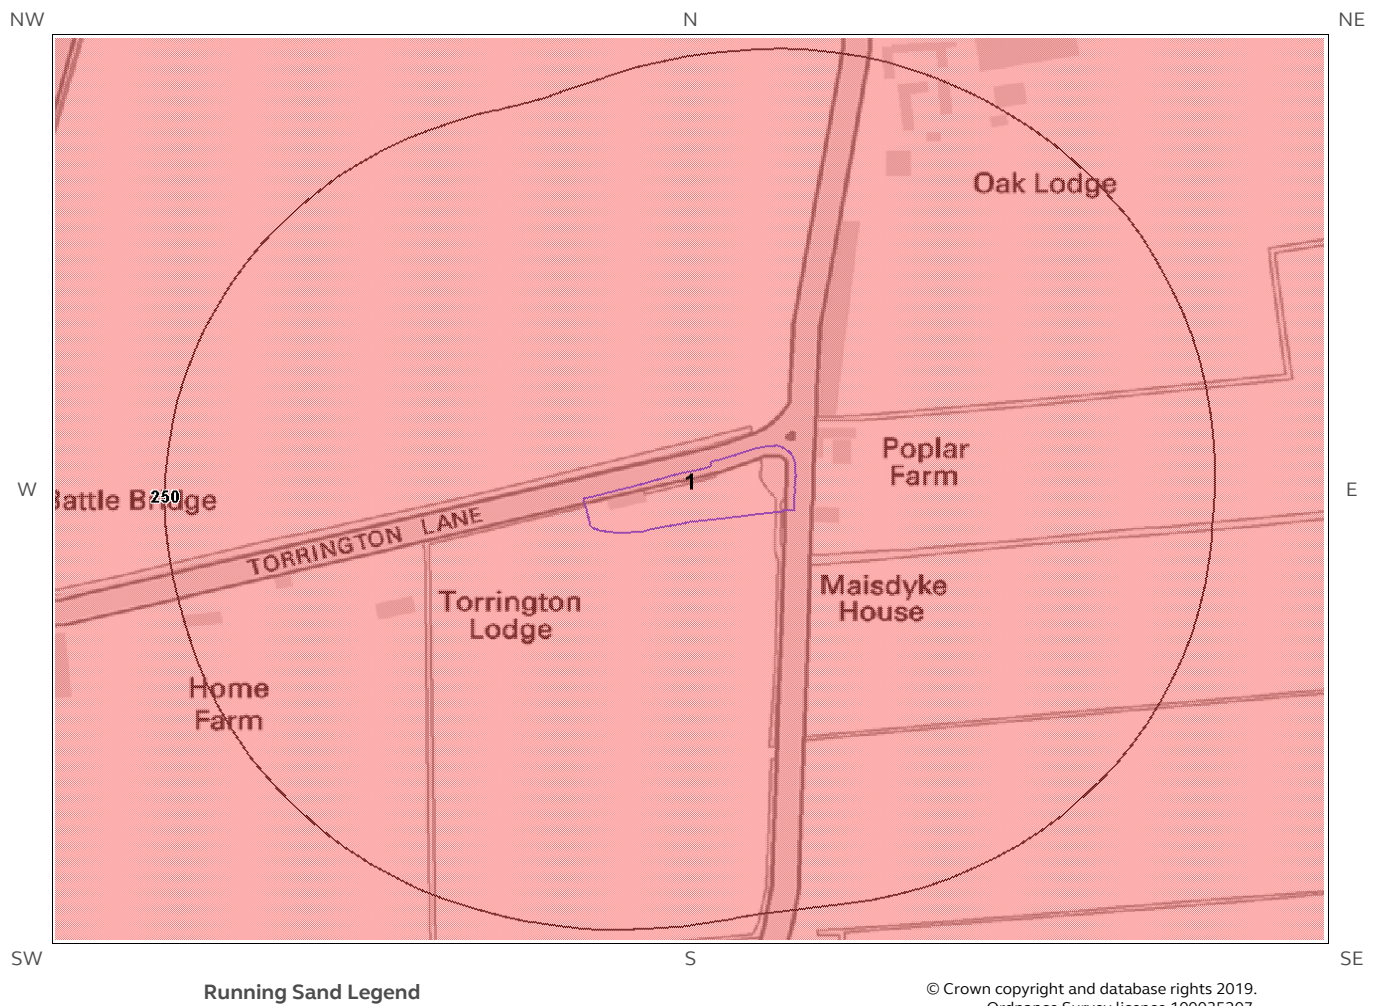
## 6.6 Running Sand map

| ID | Distance (m) | Direction | Hazard Rating | Details |
|---|---|---|---|---|
| 1 | 0.0 | On Site | Moderate | Significant potential for running sand problems with relatively small changes in ground conditions. Avoid large amounts of water entering the ground (for example through pipe leakage or soak-aways). Do not dig (deep) holes into saturated ground near the property without technical advice. For new build - consider the consequences of soil and groundwater conditions during and after construction. For existing property - possible increase in insurance risk from running sand, for example, due to water leakage, high rainfall events or flooding. |

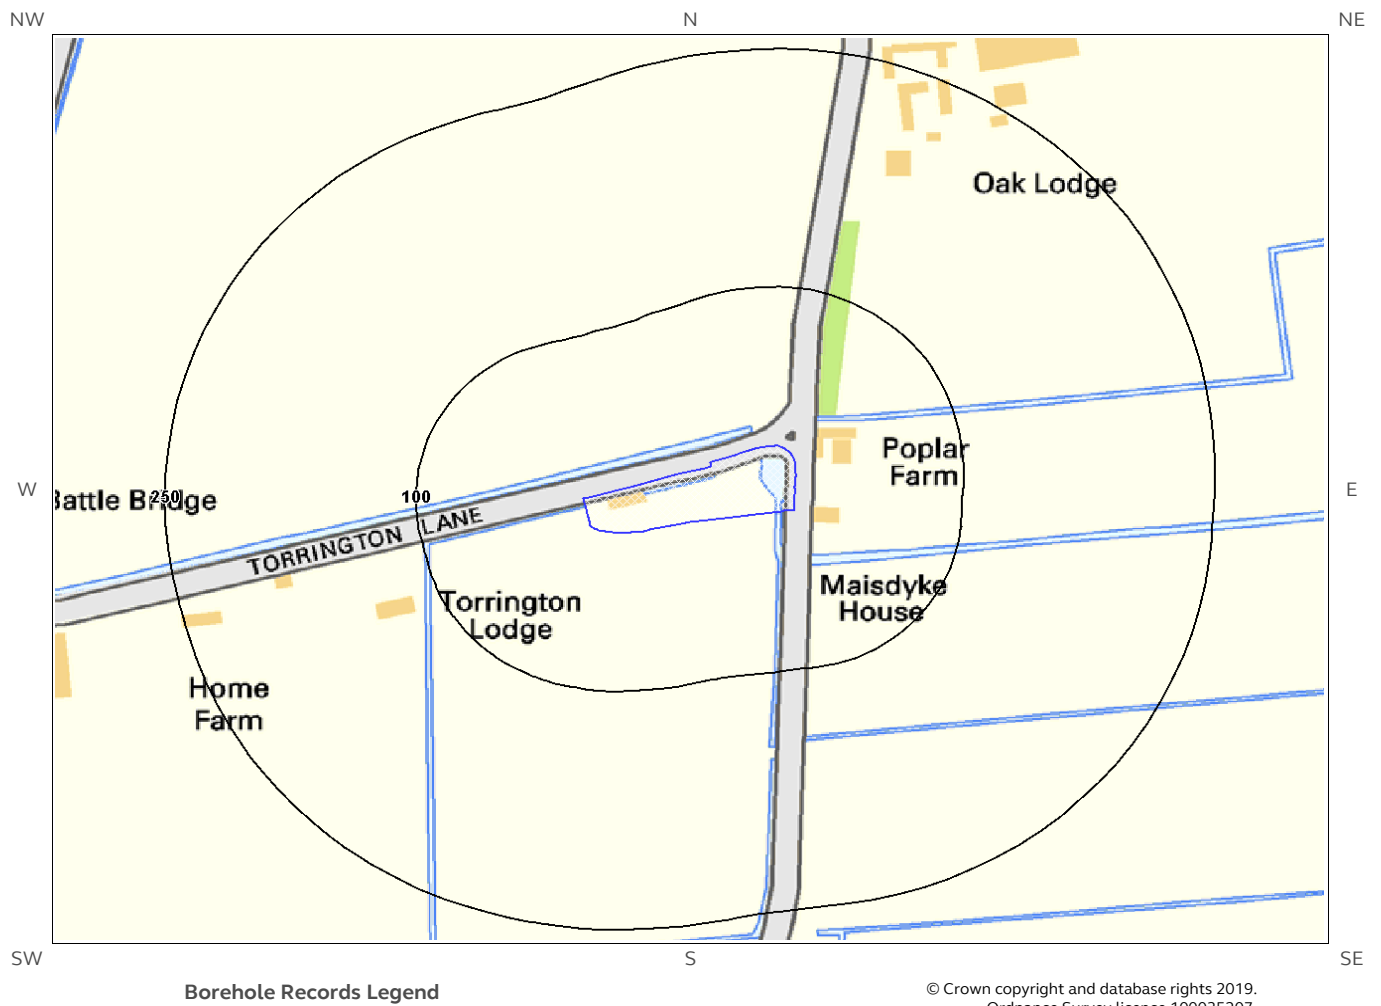
# 7 Borehole Records map

Database searched and no data found.

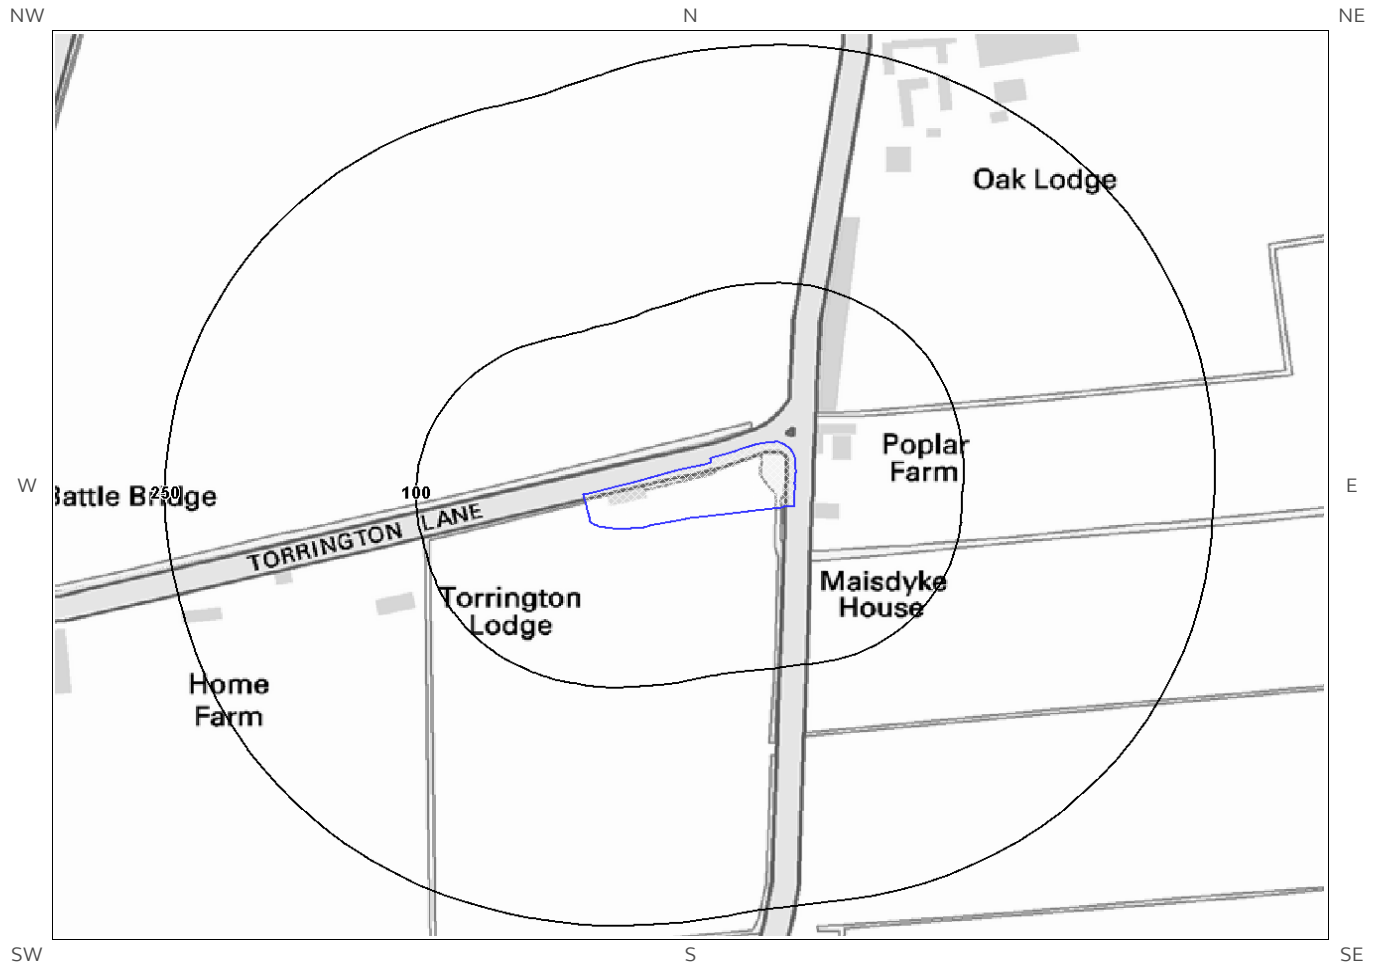
# 9 Railways and Tunnels map

This data is derived from OpenStreetMap and provides information on the possible locations of underground railway systems in the UK - the London Underground, the Tyne & Wear Metro and the Glasgow Subway.

Database searched and no data found.

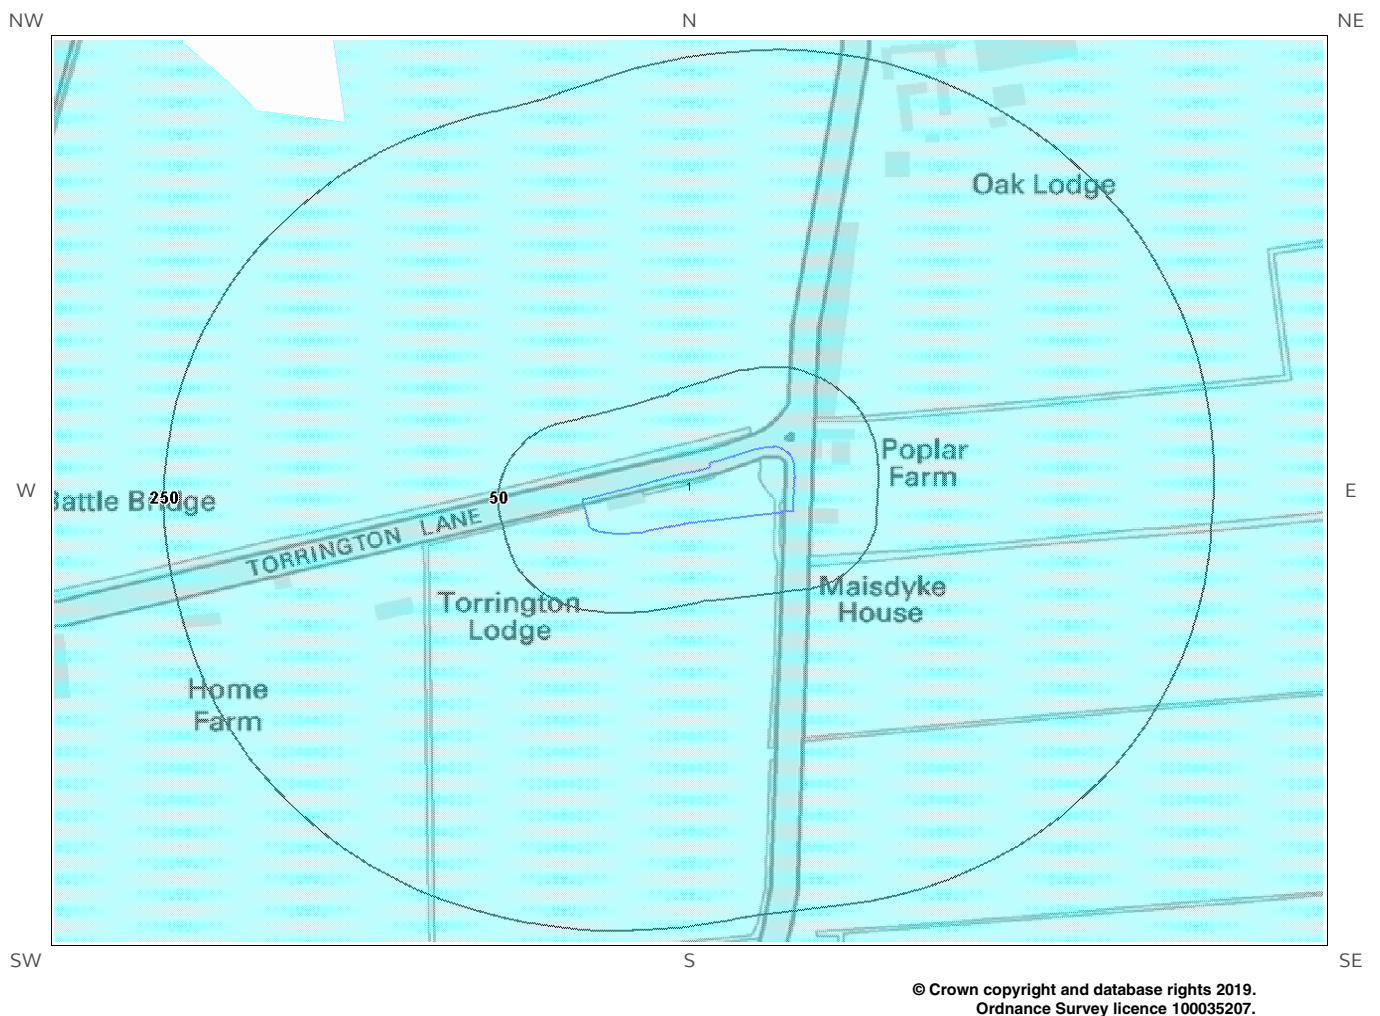
# 7b. Environment Agency/Natural Resources Wales Risk of Flooding from Rivers and the Sea (RoFRaS) Map

The Environment Agency/Natural Resources Wales RoFRaS database provides an indication of river and coastal flood risk at a national level on a 50m grid with the flood rating at the centre of the grid calculated and given above. The data considers the probability that the flood defences will overtop or breach by considering their location, type, condition and standard of protection.
