BALL HALL

GOSBERTON

Sketch to Show Proposed  
areas of mortar repair.

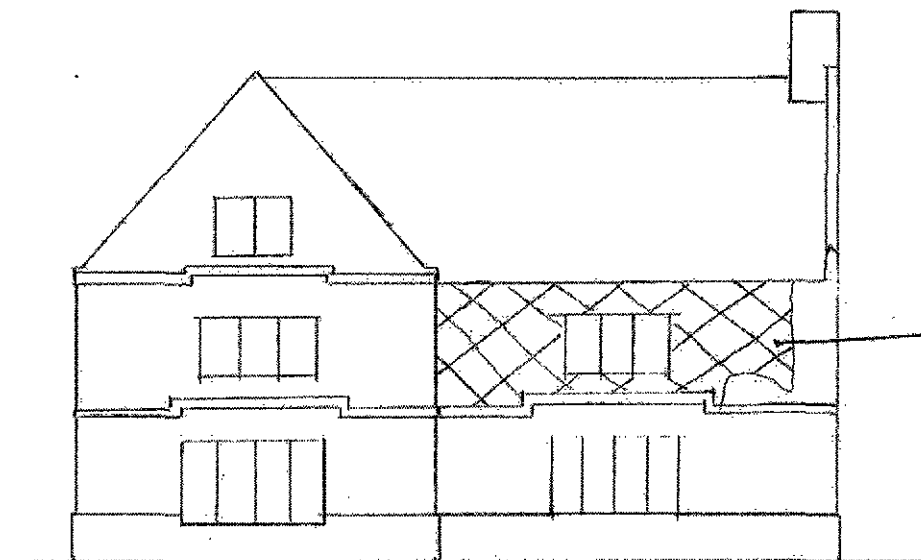
West Elevation

Like for Like  
mortar repair  
area

'like for like'  
mortar repairs in  
slaked lime putty  
and sand. 1:3 mix.

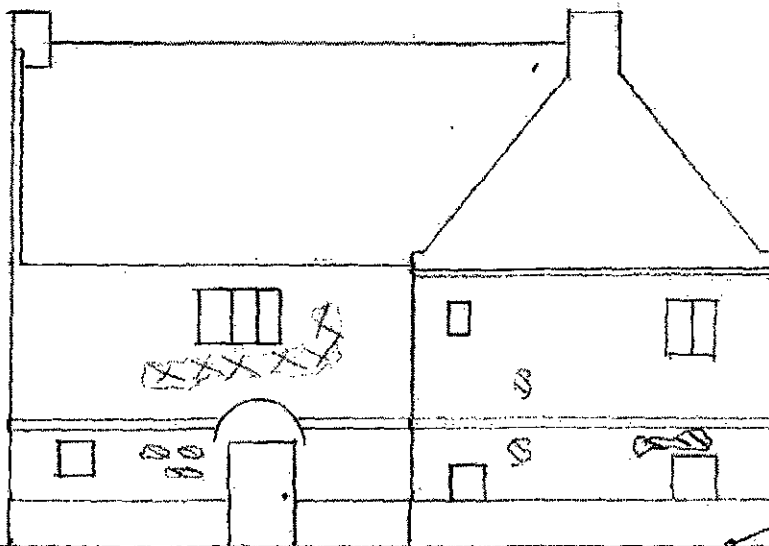
East Elevation

Lower ground level  
150mm below floor level

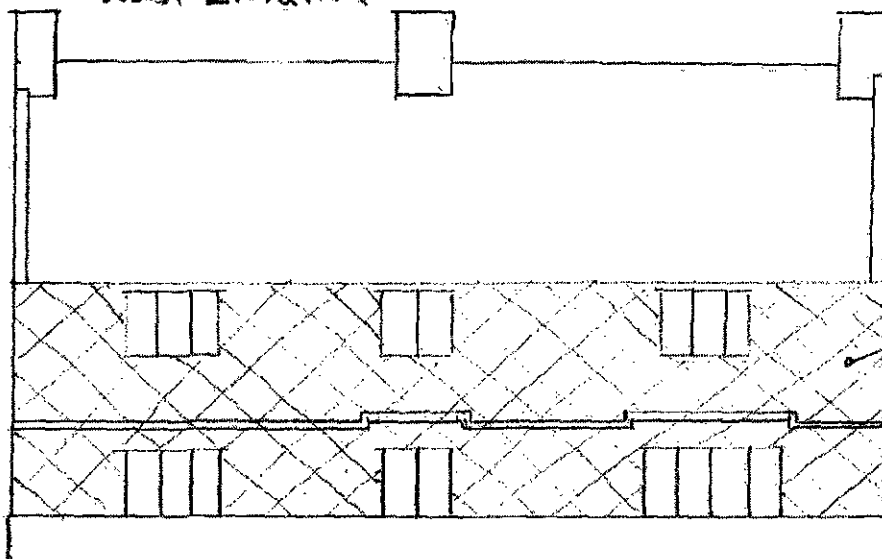
North Elevation

Generally weathered  
North wall  
Repoint. (Not urgent)
