EXISTING LISTED BARN REFURBISHMENT:

Project:  
Proposed Barn Conversion, Panton House Barns, Hedgefield Hum

Drawing title:  
Elevations

| Drawing No. | Rev. | Drawn |
|---|---|---|
| 1182-1-SK02 | - | RaC |

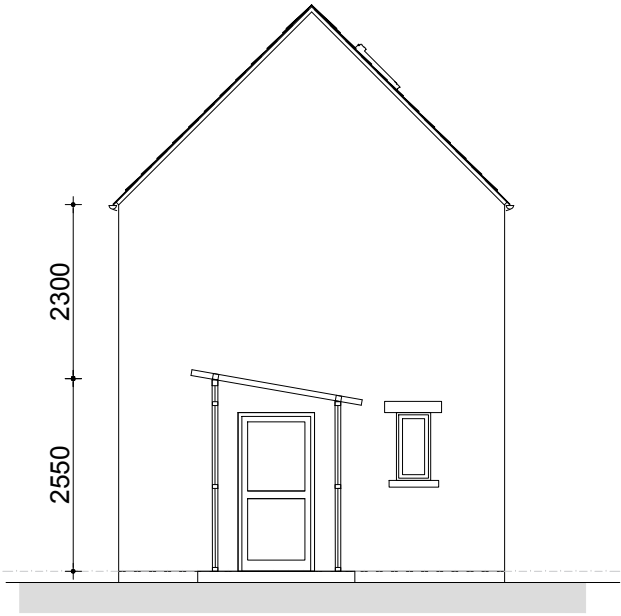
SECTION A-A

Roof: new slates on insulation on extg. exposed purlins and rafters

Walls: brickwork repointed; dry lined with insulated boarding.

Ground Floor: dig out existing, relay new ground bearing slab with insulation.  
(Subject to flood risk assessment)

New first floor joists, boarding and ceiling.
