PROPOSED EXTENSION TO  
40 - 42 HIGH STREET,  
HOLBEACH TO PROVIDE  
SHOP & FLAT FOR

FENBANK BUILDERS

SKETCH

1:50 1:100 FB07-010/4

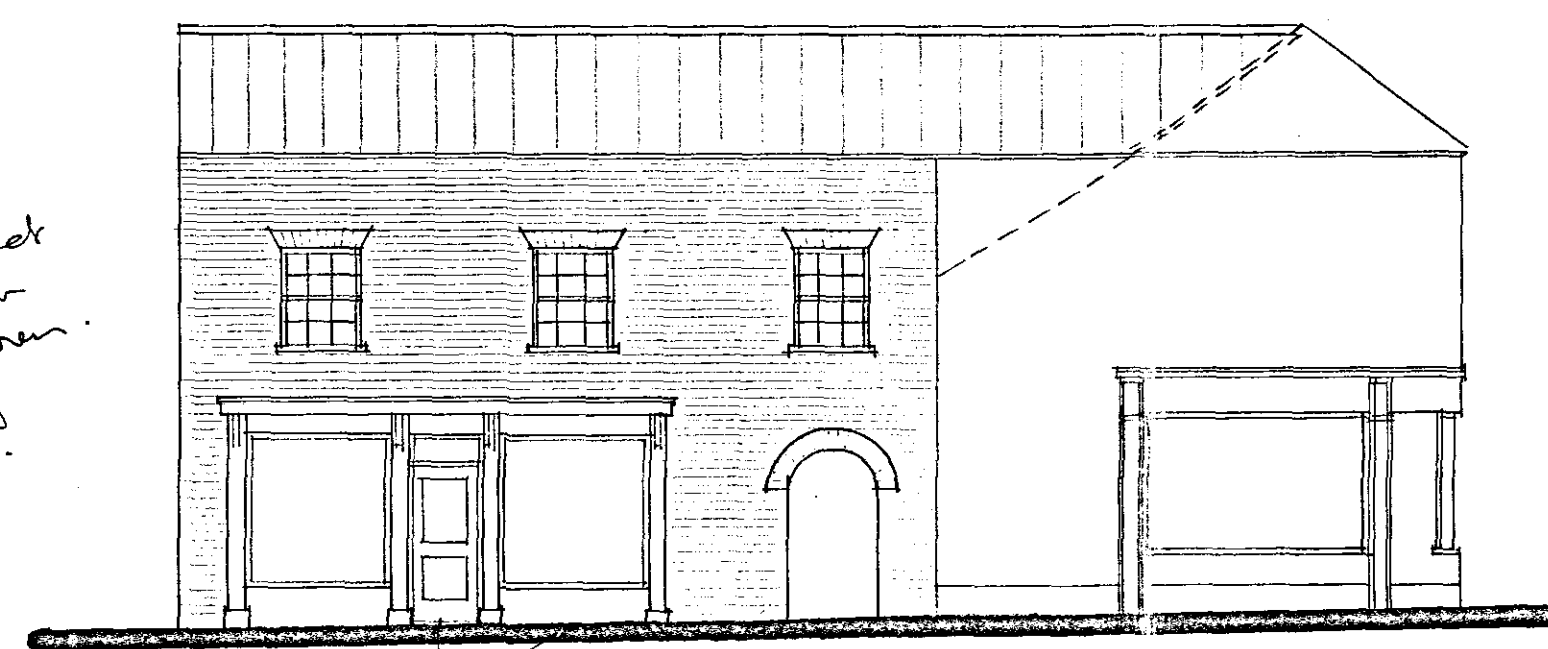
FRONT

Windows set  
for far down  
the elevation.  
lots of  
space.

Shopfronts appear  
discontinuous compared  
to host building.

door panel  
to better of

door should  
use large

not full rise  
vertical substructure.

better detail to  
carriage brackets - for finish  
- Pasco - all things deeper - no railing  
nor structural

rear profile to be  
substantive
