## **Landscape and Site Management Plan**

### **Development at Low Lane, Holbeach**

**Erection of four detached two-storey dwellings,  
two detached garages and demolition  
of existing bungalow (H09-0801-20)**

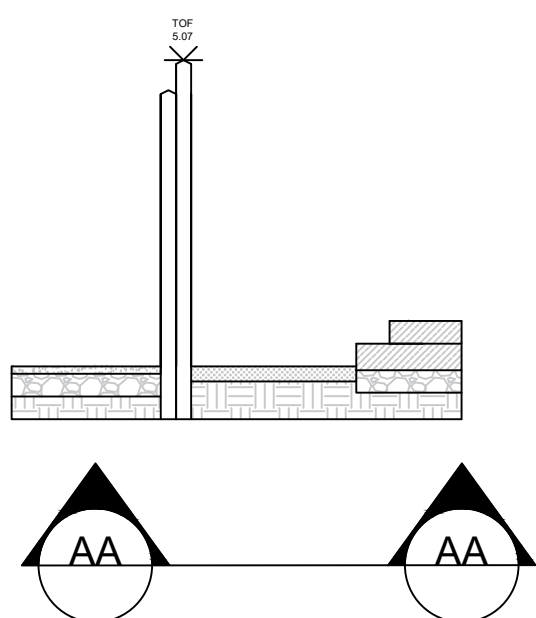
Timber fence with concrete post and gravel boards. AA or AB preference to be agreed with neighbour.

AA showing existing fence retained and new 1950mm fence erected adjacent

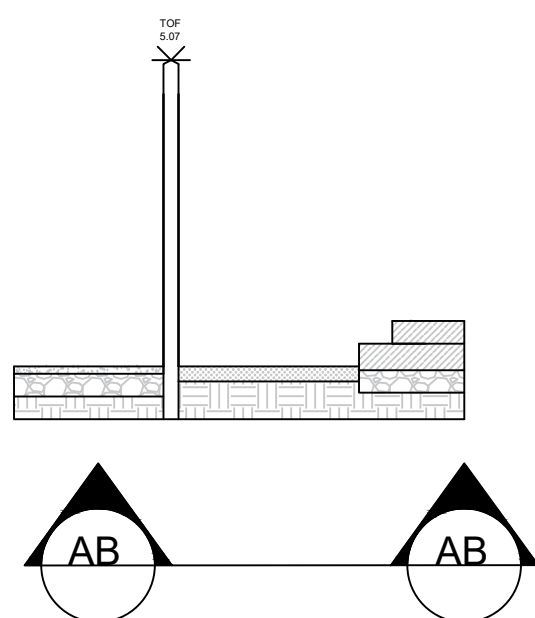
Timber fence with concrete post and gravel boards. AA or AB preference to be agreed with neighbour.

AB showing existing fence removed and new 1950mm fence erected

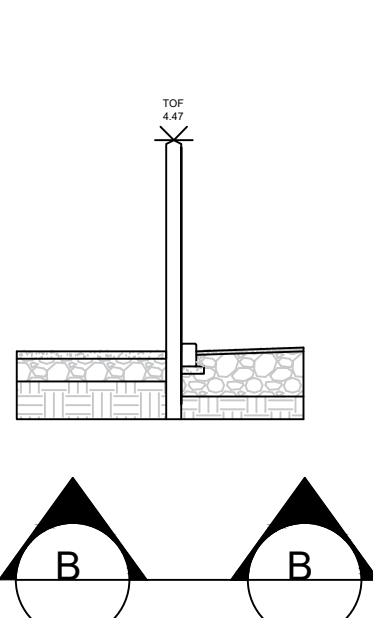
Low level timber fence with concrete post and gravel boards

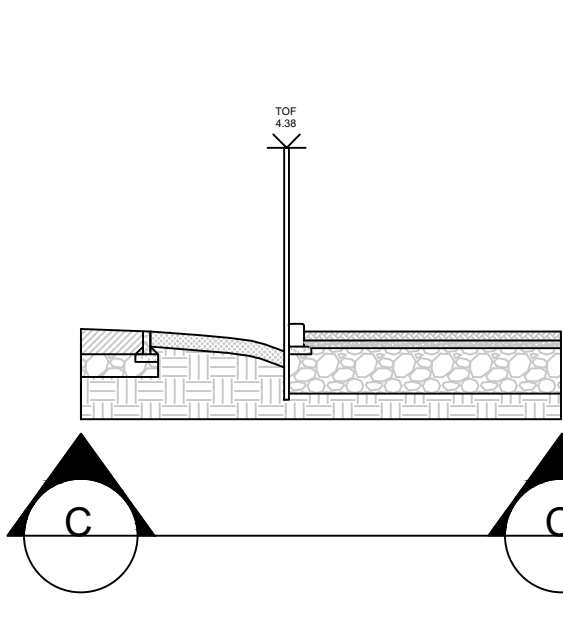
Black metal estate fencing

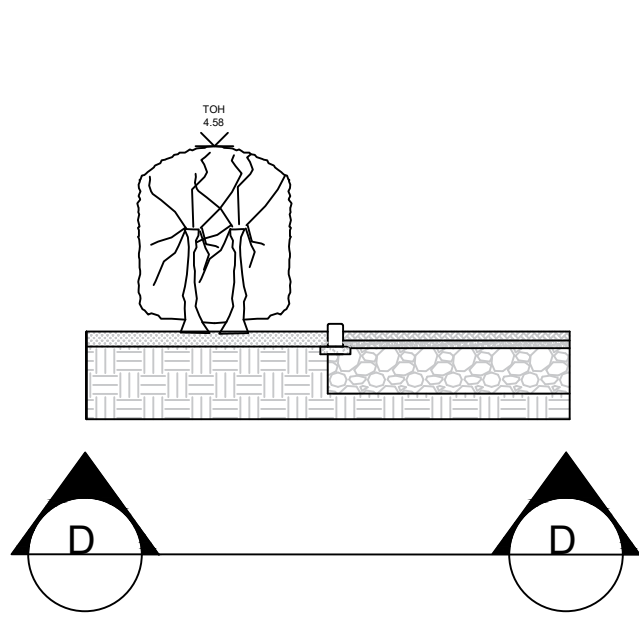
Beech hedge

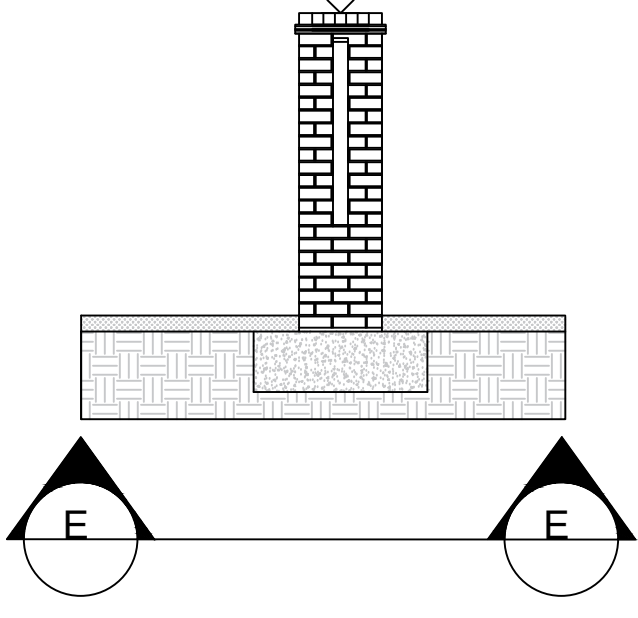
Brick wall with timber infill panels

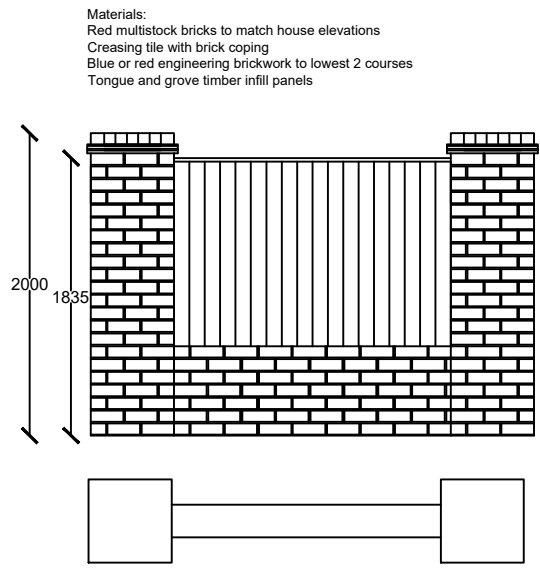
Brickwall with timber infill panels

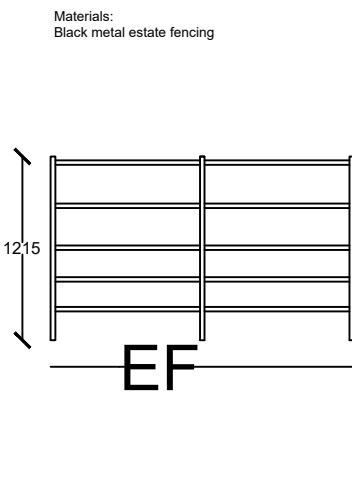
Estate fencing

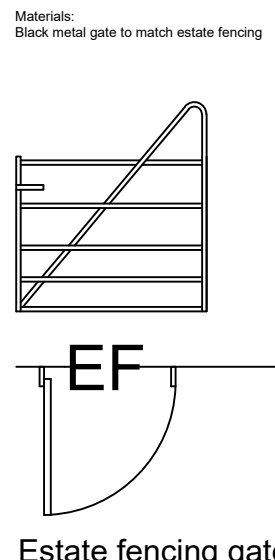
Estate fencing gate

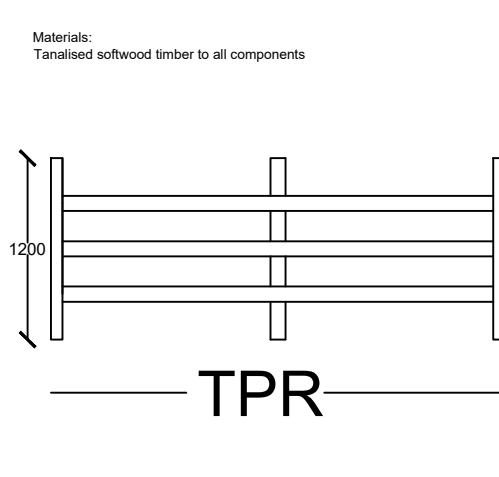
Timber post and rail fence

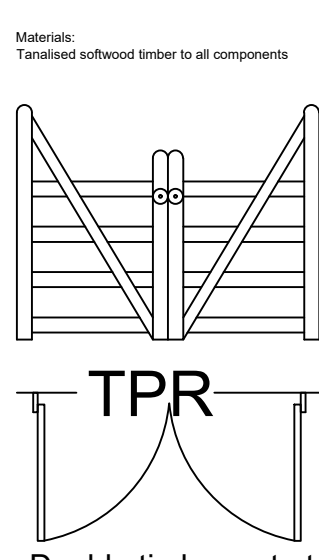
Double timber gate to match post and rail fence

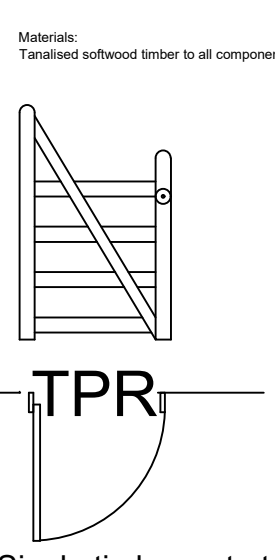
Single timber gate to match post and rail fence

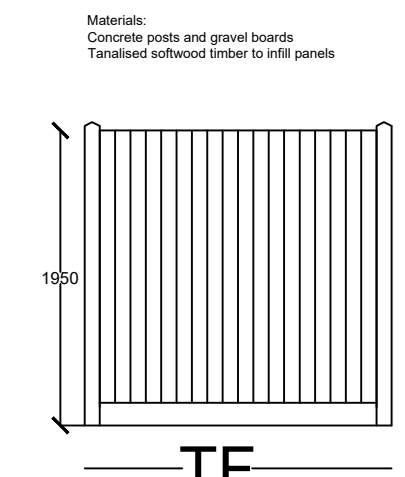
Timber double sided tongue and groove fence

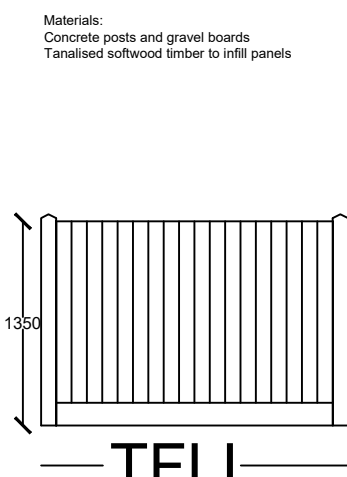
Low level timber double sided tongue and groove fence

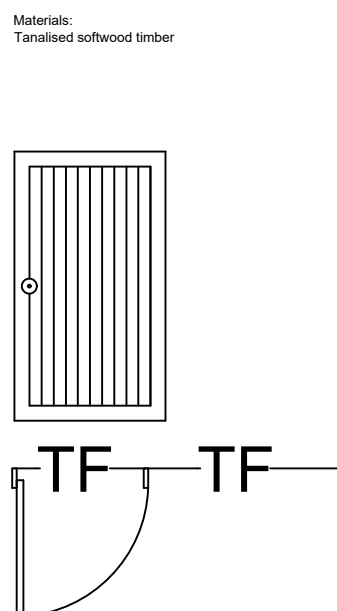
Timber fence gate

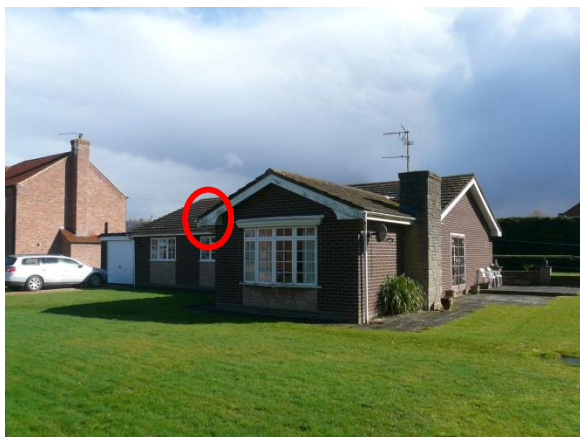
Plate 1: West and south aspects of the bungalow. Red circle indicates small crack at gable verge. No bat evidence found.

2.3.1. The bungalow was found to have limited potential for roosting bats. The pitched roof consisted of concrete inter-locking tiles with no obvious gaps with the exception of a small line of cracked mortar (approximately 70mm x 30mm) on the west facing gable verge. Upon checking with an endoscope no bat evidence was found with some leaf debris inside the feature, possibly indicative of mouse (*Mus musculus* or *Apodemus sylvaticus*). Internally there was no evidence of bats within the roof void with the underfelt being intact and well-sealed. A small section of the roof void above the west facing extension could not be fully accessed but from a limited view there were no droppings apparent upon insulation material within this section of the roof void. The garage was found to have negligible potential for roosting bats.

3.1.1. Demolition of the bungalow is required to facilitate the development. This is considered to have a limited risk of impacting upon roosting bats given the well-sealed structure of the building and absence of any evidence of bat activity. However it would be prudent to demolish the bungalow under a precautionary method statement to ensure no opportunistic bat(s) is present in association with the cracked mortar upon the west gable.

4.1.1. As a precaution a tool box talk will be given to contractors by a licenced bat ecologist upon the day of works and/or prior to works commencing. The roof tiles in association with the small crack upon the west gable verge will be lifted carefully one at a time and the area beneath the tiles checked for the presence of any bat evidence, including individual bats and/or bat droppings. In the highly unlikely event of a bat, evidence of bat activity is found then works will halt immediately. A licenced bat ecologist will then advise on the best way to proceed. This may involve a requirement to obtain a Natural England Bat Mitigation Class Licence (BMCL) or European Protected Species Licence (EPSL) prior to works re-commencing

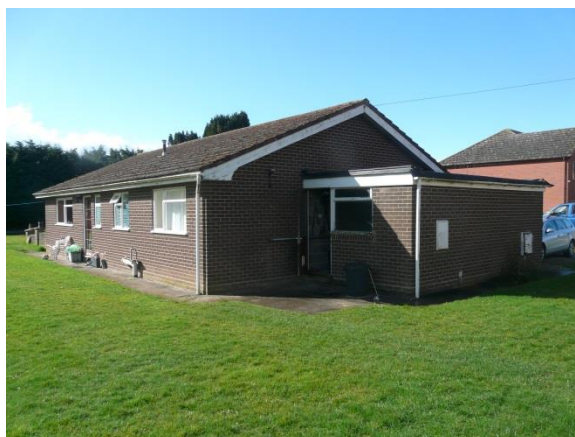
Plate 2: North and west aspects of the bungalow and garage.

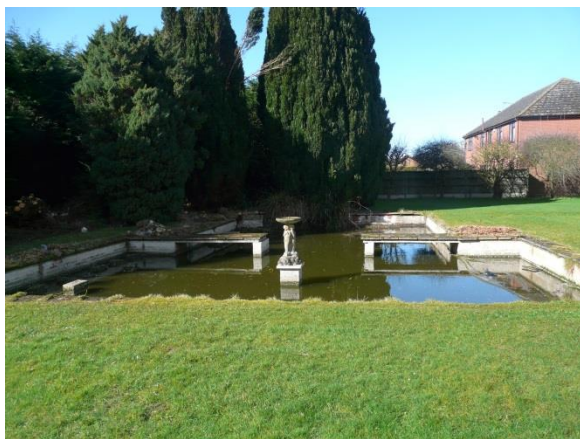
Plate 3: Ornamental pond with conifers in background. eDNA test for great crested newts was negative.

2.4.2. The ornamental pond, fish filter and three smaller ponds located under the canopy of the coniferous trees adjacent the ornamental pond scored 'Poor' for breeding great crested newts when applying the HSI assessment. A drain located just over 100m to the west and within connective habitat to the site was also subject to a HSI assessment which scored 'Good' for breeding great crested newts. A further two drains were assessed, one to the immediate rear of the site that connected to the drain to the west, and another to the northeast within 100m of the site, but both were found to be dry with no evidence of aquatic vegetation.

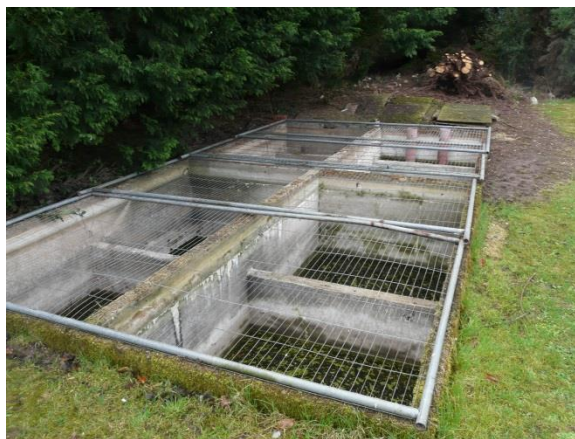
Plate 4: Fish filter. Common toad identified under boarding adjacent filter.

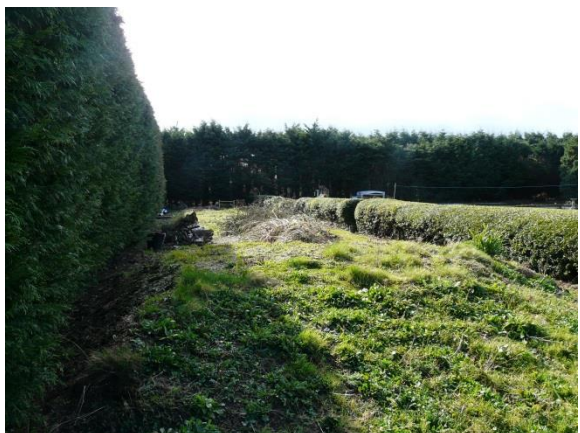
Plate 5: Tall Leylandi hedgerows on south and east site boundaries. Smaller hedgerow to right hand side of disturbed ground.

3.2.2. Leylandi hedgerows will be retained as part of the development. Undertaking construction works without protecting the hedgerows from unnecessary damage during construction works may affect their integrity and functionality if roots are damaged from compression or if uprooting occurs during ground works.

7.1.1. The retention of the leylandi hedgerow upon the south and east boundaries is a condition of planning and therefore apart from residences undertaking regular cutting to maintain height and shape there should be no specific aftercare required.

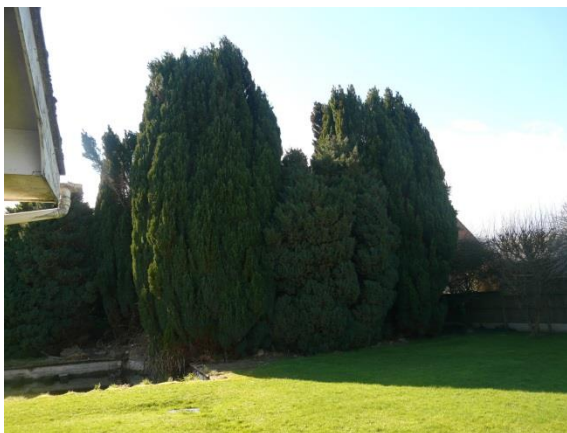
Plate 6: Conifer trees at southeast corner of site. Potential for hedgehog and common amphibians under brash piles under trees.

4.2.2. All brash piles and garden paraphernalia should be removed by hand. Should any hedgehog or common amphibian be found, they should be removed from the working area, checked for injuries and placed under the leylandi hedgerow to the rear (south) end of the garden. A dry ditch is present that connects to adjoining garden habitat and the drain to the west which will help with wildlife dispersal. Prior to vegetation clearance log piles should be created beneath the leylandi hedgerow. This will at least provide some refuge for any displaced animals and could continue to be used in the longer-term.
