# VERIFICATION REQUIREMENTS FOR COVER SYSTEMS

Technical Guidance for  
Developers,  
Landowners and  
Consultants

**Yorkshire and Lincolnshire  
Pollution Advisory Group**

**Version 3.4 – November 2017**

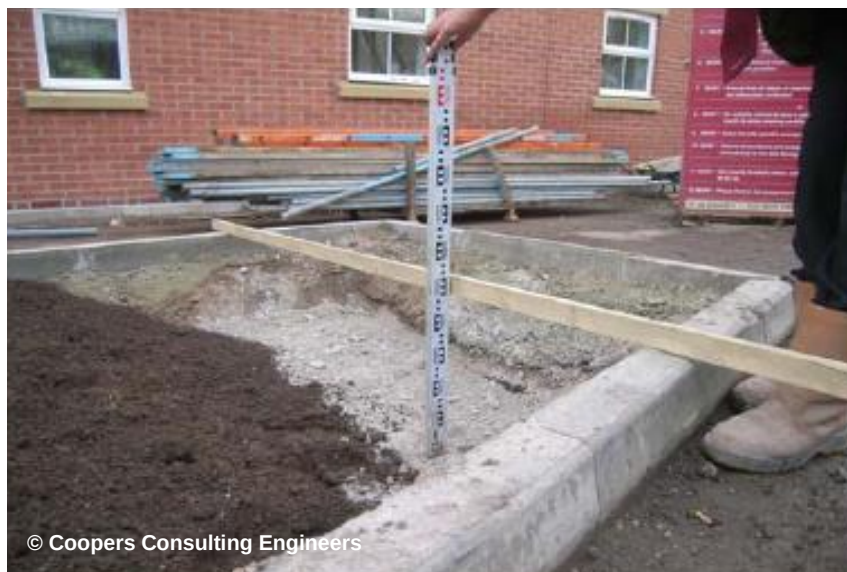
Photograph 1: Depth check of inert cover within area of public open space. Physical break layer and topsoil visible.
