**PROPOSED RESIDENTIAL  
DEVELOPMENT  
LAND OFF LOW LANE  
HOLBEACH  
SPALDING  
LINCS..**

**GEOENVIRONMENTAL  
DESK STUDY**

**Report Ref.: 0575/1**

November 2018

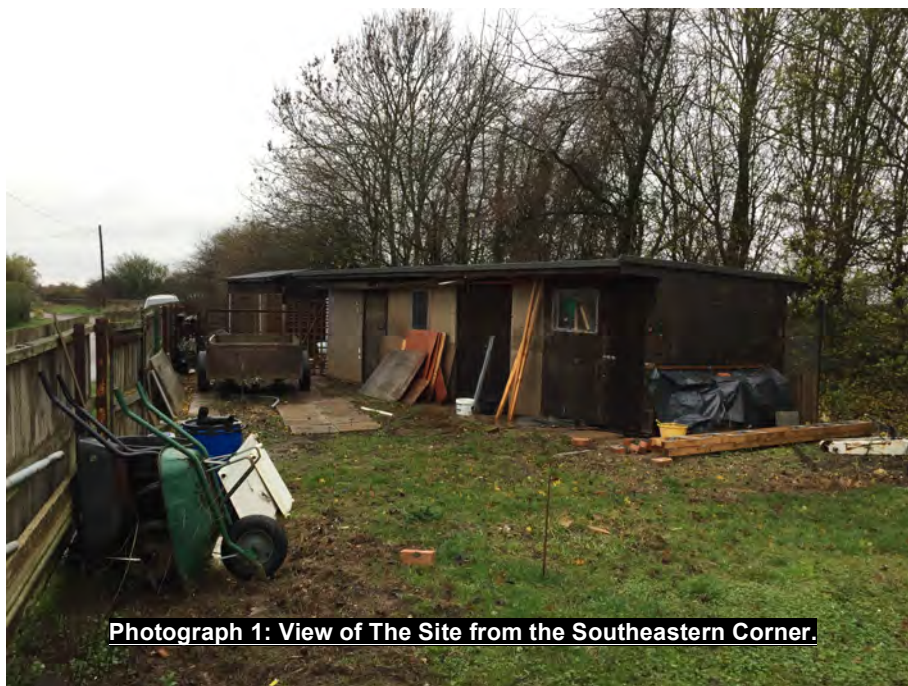
**Photograph 1: View of The Site from the Southeastern Corner.**

Topographic levels at the site, by visual inspection, appeared to change little across the site.

At the time of the site walkover survey the site was capped with soft cover of exposed soils and the footprint of two wooden buildings as can be seen in Photograph 1.

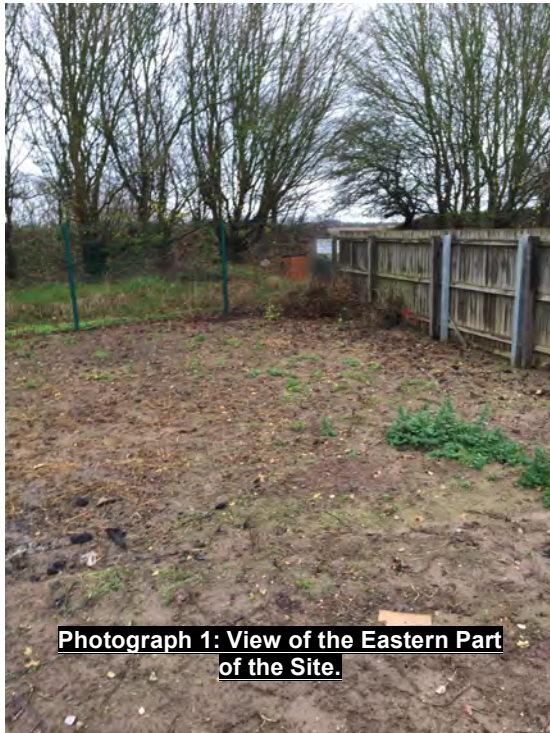
The western part of the site was being used to accommodate chickens and on the northern side (rear) of this part of the site was some external racking, which held lengths of plastic guttering and metal with, nearby some wire mesh and a small (empty) trailer.

The eastern part of the site was down to a cover of exposed soils (which had possibly been used for plant cultivation in the past) with some short grass between the eastern end of the building and the eastern boundary of the site.

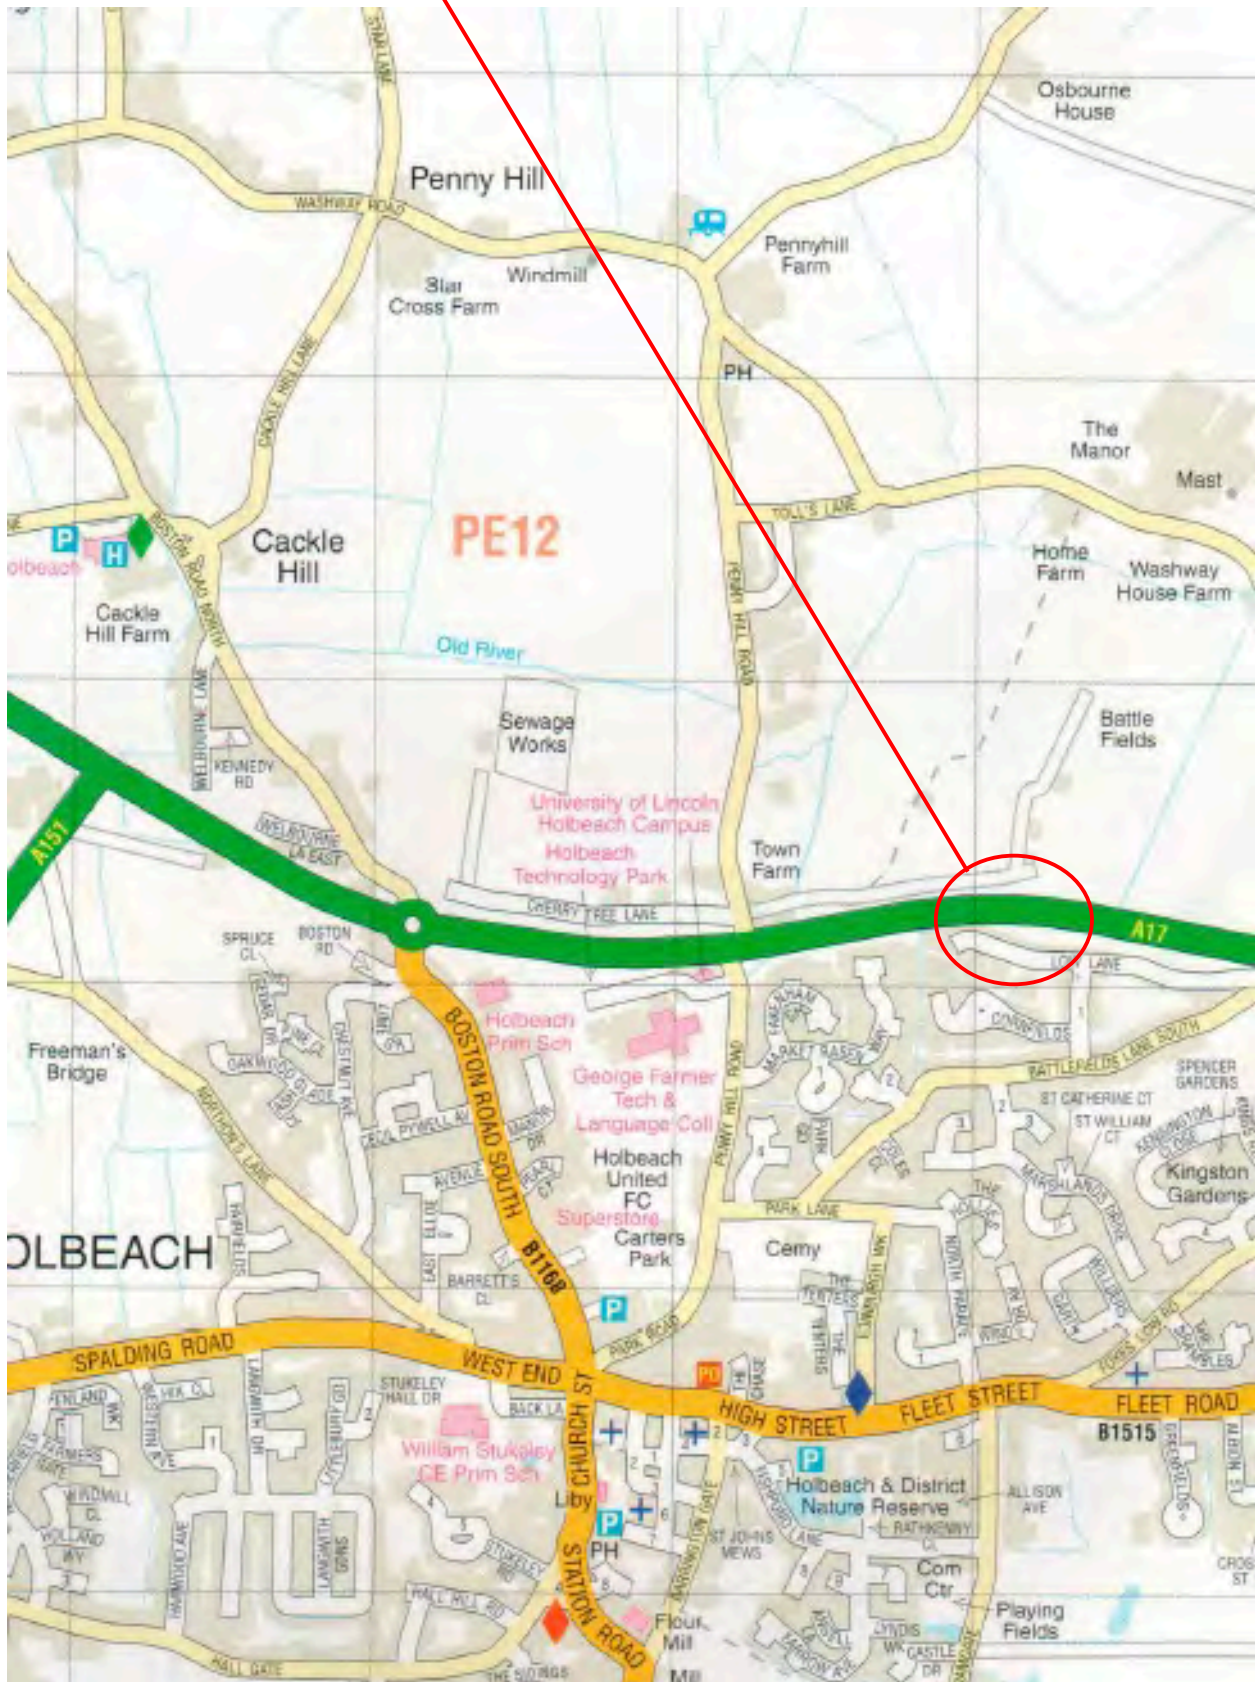
## Site Location Plan

A site location plan has been included as Figure 1 with the proposed layout shown in Figure 2 towards the back of this report to assist the reader.

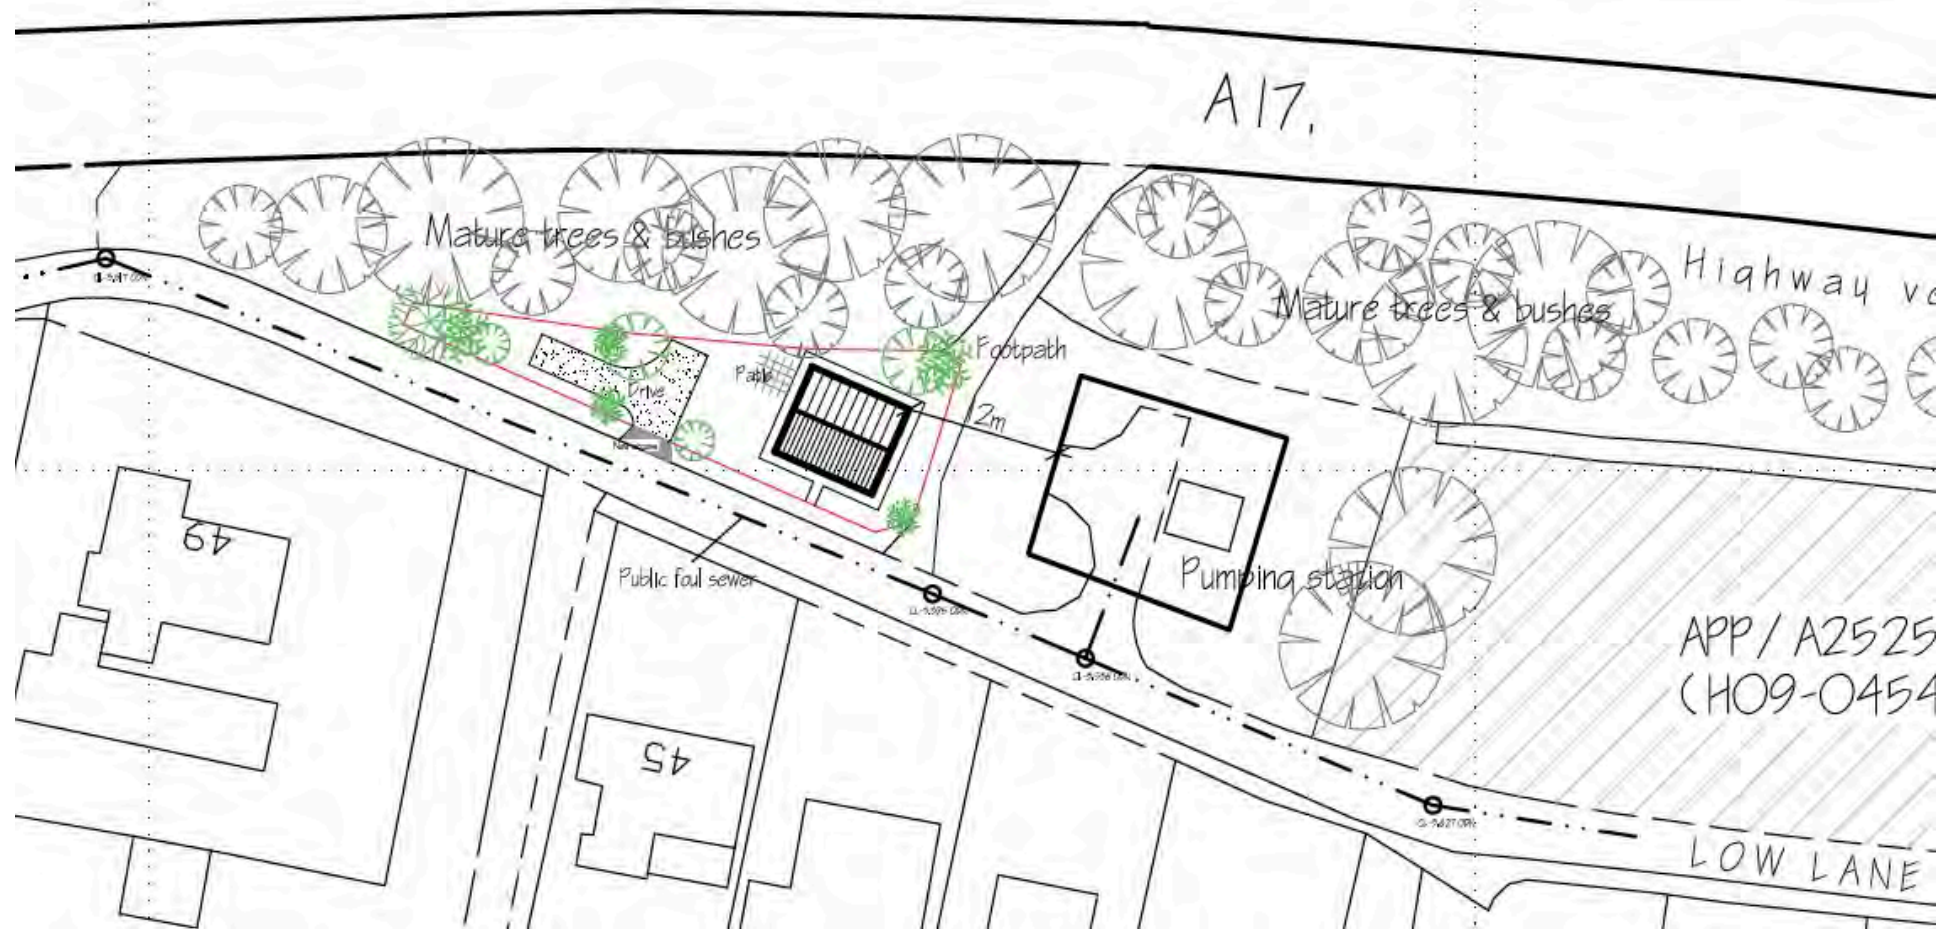
Figure 2

INDICATIVE DWELLING :-

3 BEDROOM HOUSE & PARKING SPACE,

Proposed Layout Plan

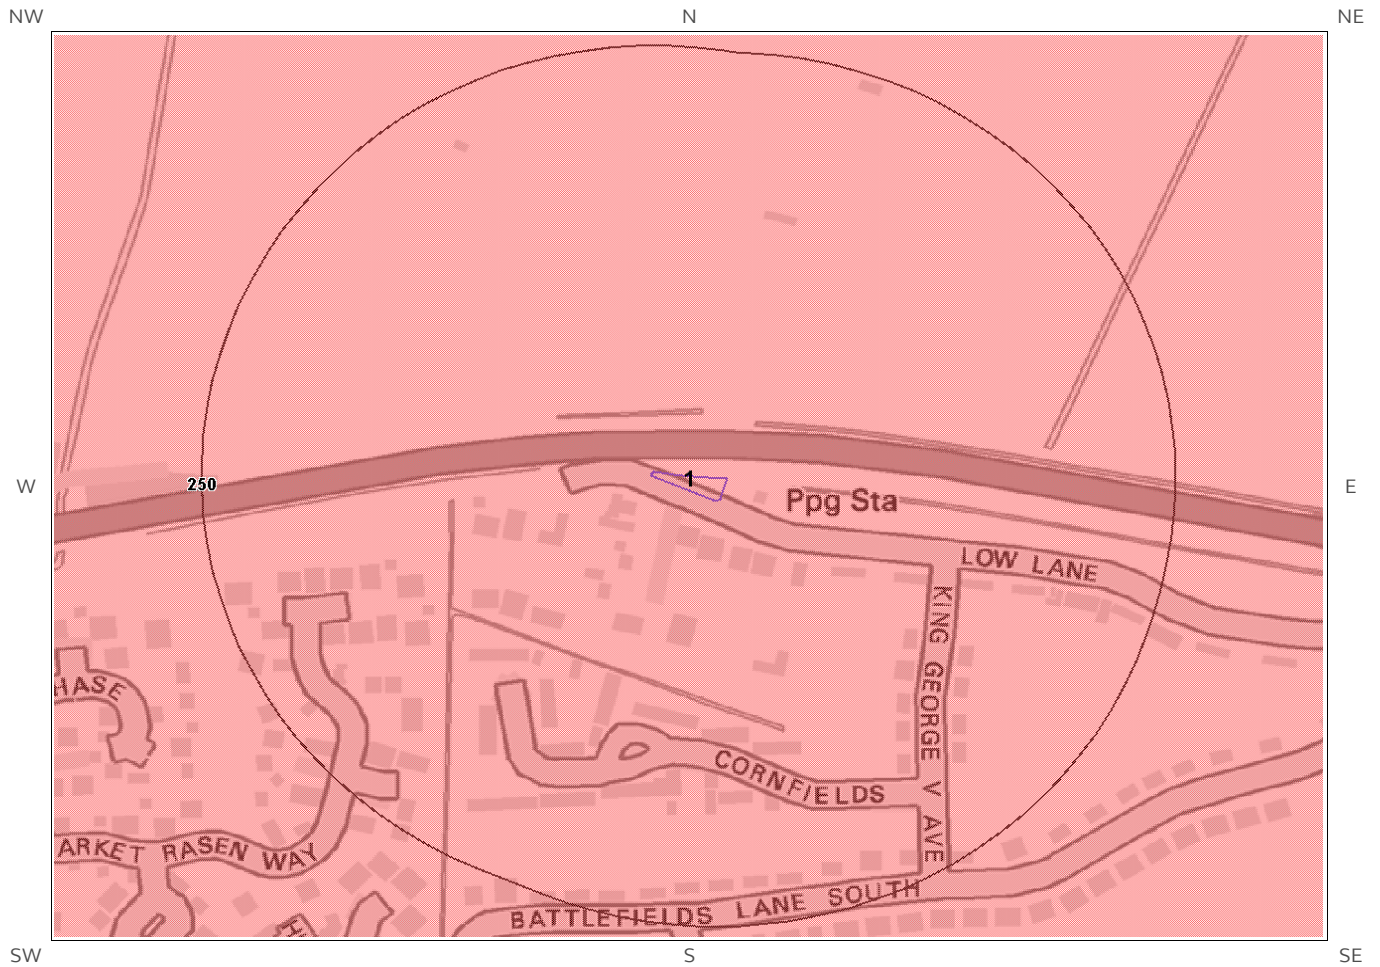
## 6.6 Running Sand map

| ID | Distance (m) | Direction | Hazard Rating | Details |
|---|---|---|---|---|
| 1 | 0.0 | On Site | Moderate | Significant potential for running sand problems with relatively small changes in ground conditions. Avoid large amounts of water entering the ground (for example through pipe leakage or soak-aways). Do not dig (deep) holes into saturated ground near the property without technical advice. For new build - consider the consequences of soil and groundwater conditions during and after construction. For existing property - possible increase in insurance risk from running sand, for example, due to water leakage, high rainfall events or flooding. |
