# **Proposed Swimming Pool Sutton House, Long Sutton**

## **Tree Survey and Arboricultural Impact Assessment**

November 2020

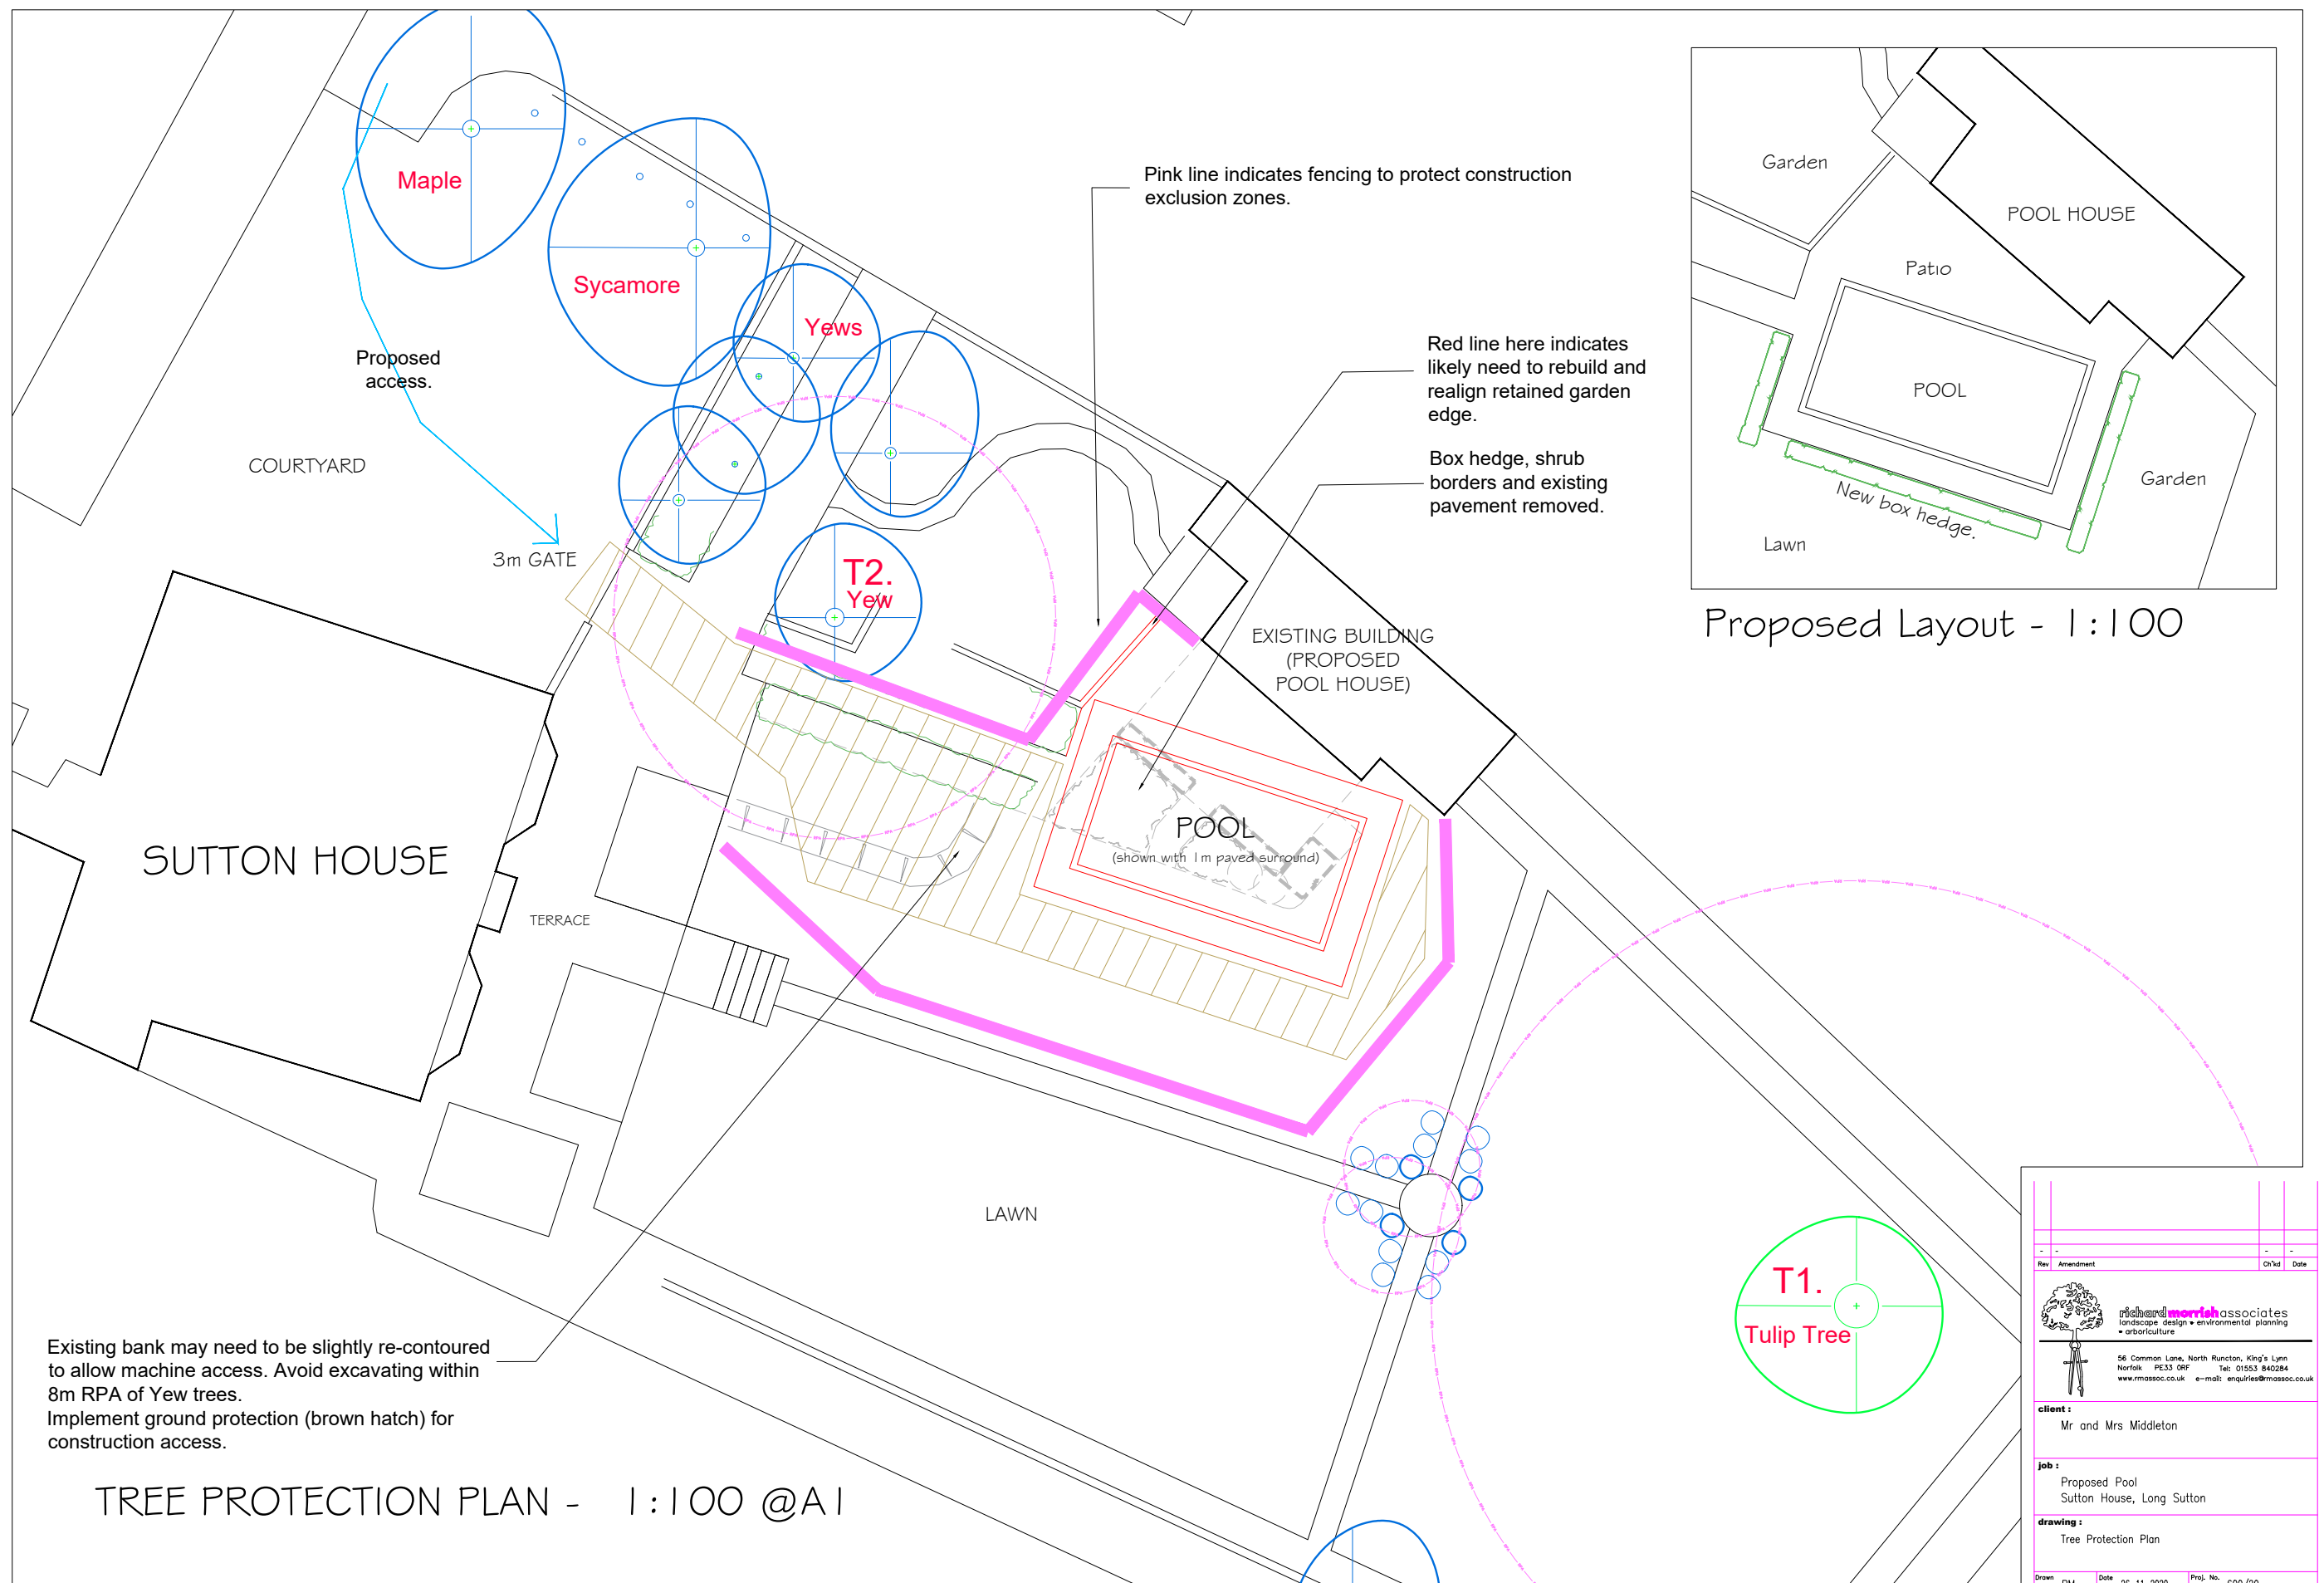
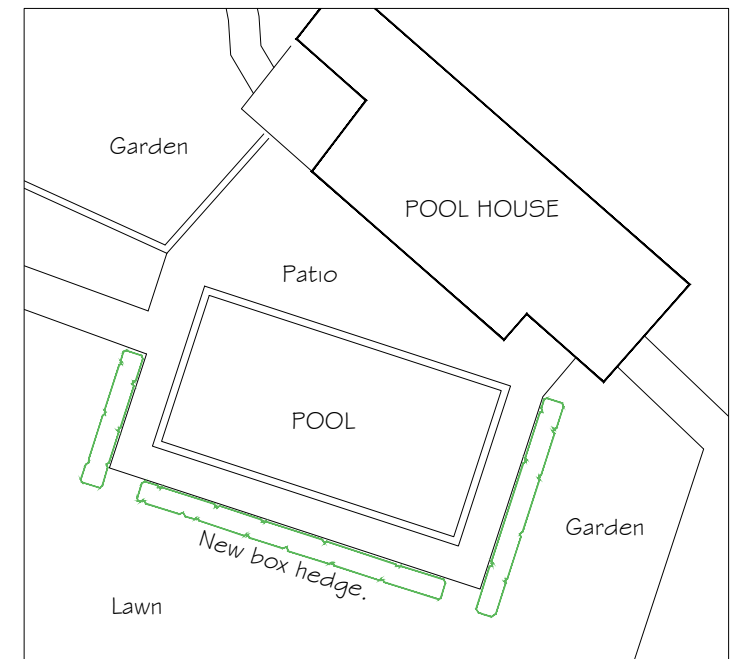
TREE PROTECTION PLAN - 1:100 @A1

| Tree Protection Plan | | | |

- 5.1 Issues that are to be addressed by the Arboricultural Method Statement and illustrated on the Tree Protection Plan are summarised below:
1. Removal of hedge/shrubs.
  2. Establishment of construction exclusion zones.
  3. Soil stripping, storage.
  4. Ground protection; root pruning – if required.
  5. Other details that may emerge.
- 5.2 Where possible, stripped topsoil that might be re-used in new planting should be retained on site and spread over beds – but the existing soil level under or near trees should not be altered by more than 100mm.

- 1.4 Supply and erect fixed, rigid barriers as indicated on TPP 01 and described in BS 5837:2012 (or similar approved by the arboricultural consultant). The construction exclusion zone (CEZ) shall be clearly marked with an all-weather notice 'Construction Exclusion Zone – No Access'. The protective fencing shall be in place before the demolition works and groundworks commence.
- 1.5 The barrier fencing shall be maintained throughout the works. If for any reason works are required within the CEZ during the construction period the main contractor must seek advice from the arboricultural consultant before allowing such work to proceed.
- 1.6 Demolition / Site clearance  
Ensure ground protection is in place before excavation begins. Some minor levelling of existing bank may be required in order to create an even access gradient to the site.

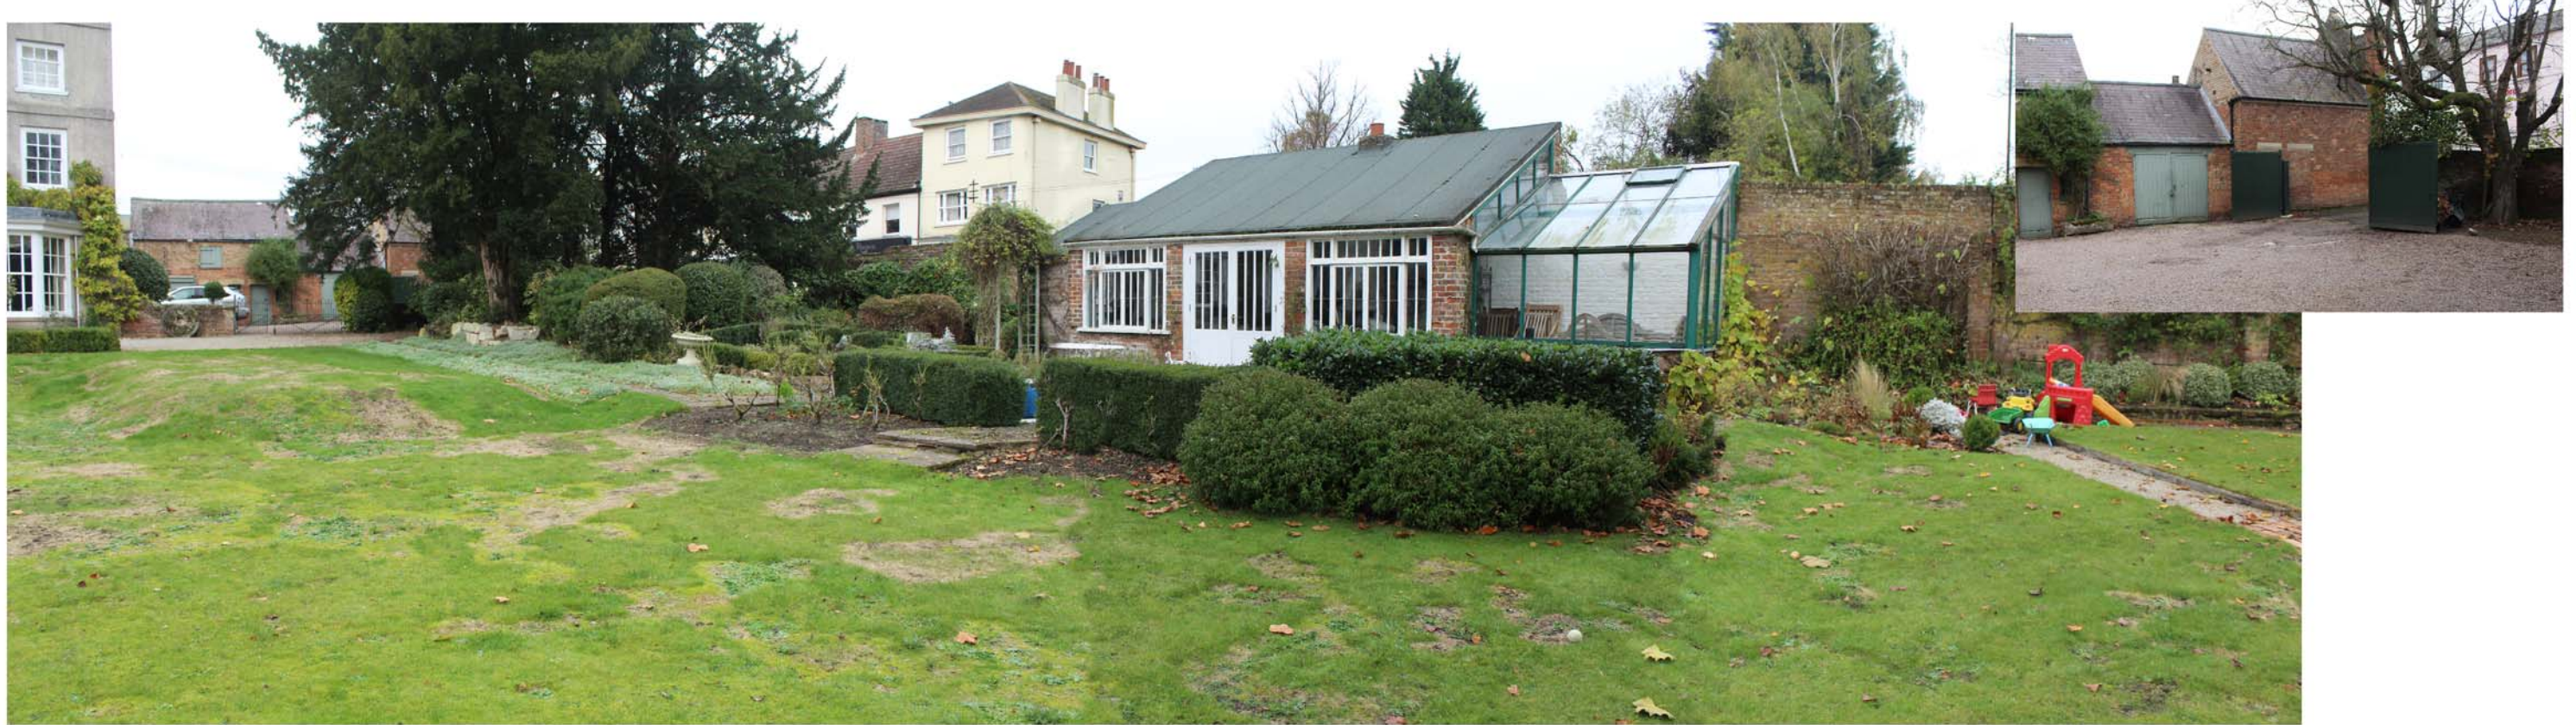
Proposed location of pool in front of existing Summer House. Note gate access to garden and (inset) street access to yard.

- 4.5 H1 (low box hedge of modern origin) and other shrubs (Cistus, Rose, Prunus) adjacent the existing summer house and patio will need to be removed in order to construct the proposed pool. These losses will not be seen from outside the garden.

- 4.6 Excavation will be required for groundworks. The depth of construction will require mainly subsoil to be removed from site. (Clean topsoil will ideally be retained on site for garden areas). Access for an excavator and truck/trailer to remove the soil must be considered. It is anticipated this will be easiest to achieve from the street, via the yard to the north of the house, and through existing gates onto the lawn. Ground protection to protect the yews at G1 is recommended. A Norway Maple adjacent to the street entrance is unlikely to be affected. Adequate protection will be required to avoid contaminating garden areas and lawns with building materials during the construction process.

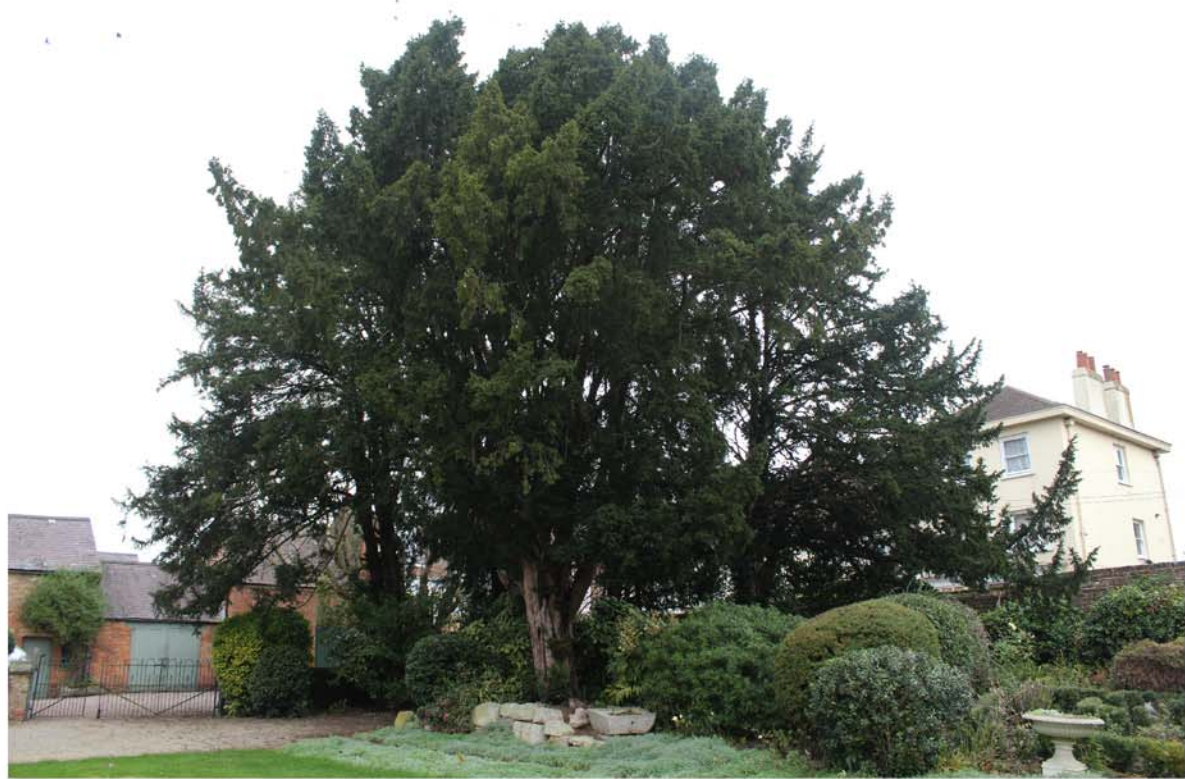
- 4.2 G1 (Yews) is a group of yew trees apparently planted to formalise an entrance from the street to the front of the house. The planting is probably late Victorian or Edwardian. The yew nearest the proposed pool is the largest tree (probably because it has had the most light and most garden to grow within). The proposed pool can be located outside of the calculated RPA – but construction access will need to cross the root zone. Temporary ground protection (for the root zone, paving and lawn) is recommended. With appropriate ground protection through construction the scale of impact to G1 and associated garden areas is expected to be *slight* or neutral.

G1 - Yew trees.

| Ref | Species | Height (m.) | Stem Dia. (mm) | Canopy spread and height (m) (x4 cardinals) | Branch Height (m) (Clearance) (x4 cardinals) | Life Stage | Physiological Condition | Structural Condition | Remaining Contribution ? (Yrs) | Mature size? (Hght /spread) | CATEGORY | Notes + Preliminary management recommendations | RPA Area sqm (Radius in m in brackets) |
|---|---|---|---|---|---|---|---|---|---|---|---|---|---|
| G1 | Yews (6 stems)<br><i>Taxus baccata</i><br>Also Privet, Viburnum, Aucuba | 6-8 | 250-650 | N. E. W. S.<br>3 3 3 3<br>1-2 | N. E. W. S.<br>2 | M | G/F | G/F | 40+ | - | Biii | Established Yews with evergreen shrubs under them. Will not be affected. No work required – except ground protection of RPA – refer to TPP. | 191 sqm<br>(7.80m) |

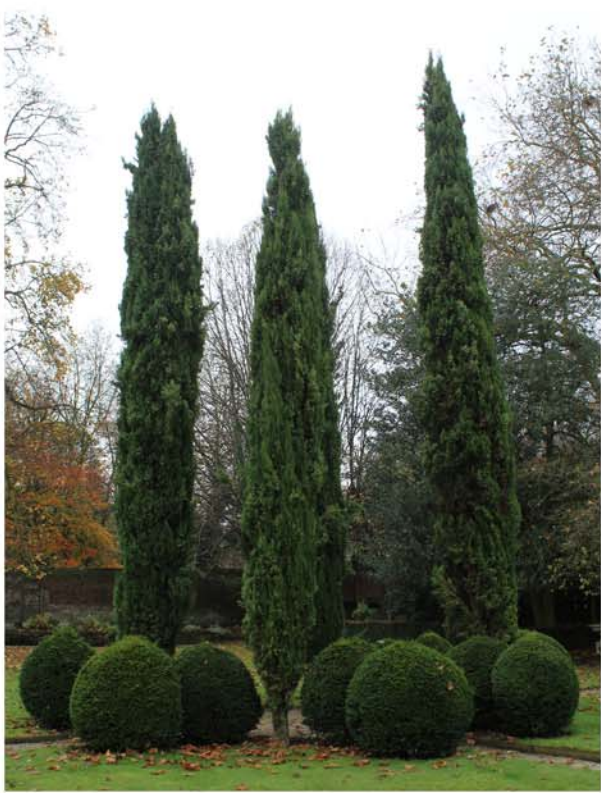
- 4.3 G2 is a feature group of fastigate cypress trees with spherical box shrubs. The age of the planting is not established but appears to be modern. It is not expected that the proposed construction will affect this group. Fencing will ensure the group and surrounding lawn are not accidentally affected by site activities. With this provision no impacts are anticipated.

G2 - Evergreen specimen planting.

| Ref | Species | Height (m.) | Stem Dia. (mm) | Canopy spread and height (m) (x4 cardinals) | Branch Height (m) (Clearance) (x4 cardinals) | Life Stage | Physiological Condition | Structural Condition | Remaining Contribution ? (Yrs) | Mature size? (Hght /spread) | CATEGORY | Notes + Preliminary management recommendations | RPA Area sqm (Radius in m in brackets) |
|---|---|---|---|---|---|---|---|---|---|---|---|---|---|
| G2 | Cypress and Box specimens<br><i>Cupressocyparis + Buxus</i> | 5-7 | 200 | N. E. W. S.<br>-<br>- | N. E. W. S.<br>- | M | G | G | 40+ | ? | Bi | Established focal point planting. No work required. Protect from construction activities | 18 sqm<br>(2.40m) |

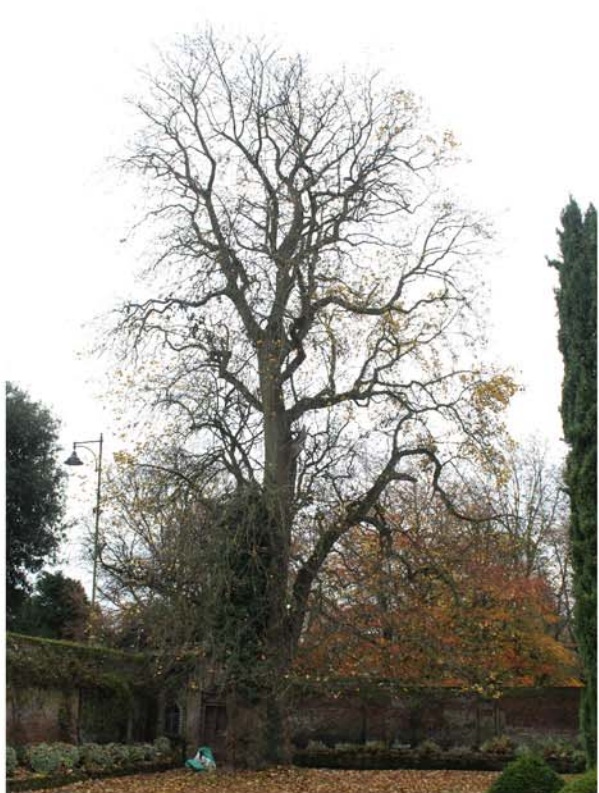
- 4.4 T1 is a very large Tulip Tree – probably Victorian and one of the largest specimens I have seen in the area. It is not expected that the construction will affect this tree. Fencing will ensure the RPA is not accidentally affected by site activities. With this provision, no impacts are anticipated.

T1 - Tulip tree

| Ref | Species | Height (m.) | Stem Dia. (mm) | Canopy spread and height (m) (x4 cardinals) | Branch Height (m) (Clearance) (x4 cardinals) | Life Stage | Physiological Condition | Structural Condition | Remaining Contribution ? (Yrs) | Mature size? (Hght /spread) | CATEGORY | Notes + Preliminary management recommendations | RPA Area sqm (Radius in m in brackets) |
|---|---|---|---|---|---|---|---|---|---|---|---|---|---|
| T1 | Tulip tree<br><i>Liriodendron tulipifera</i> | 22 | 1550 | N. E. W. S.<br>3 3 5 3<br>2-3 | N. E. W. S.<br>3 - 4 | LM<br>V | G | G/F | 40+ | - | Aiii | Very large veteran tree. No work required. Protect from construction activities | 707 sqm<br>(15.00m) |

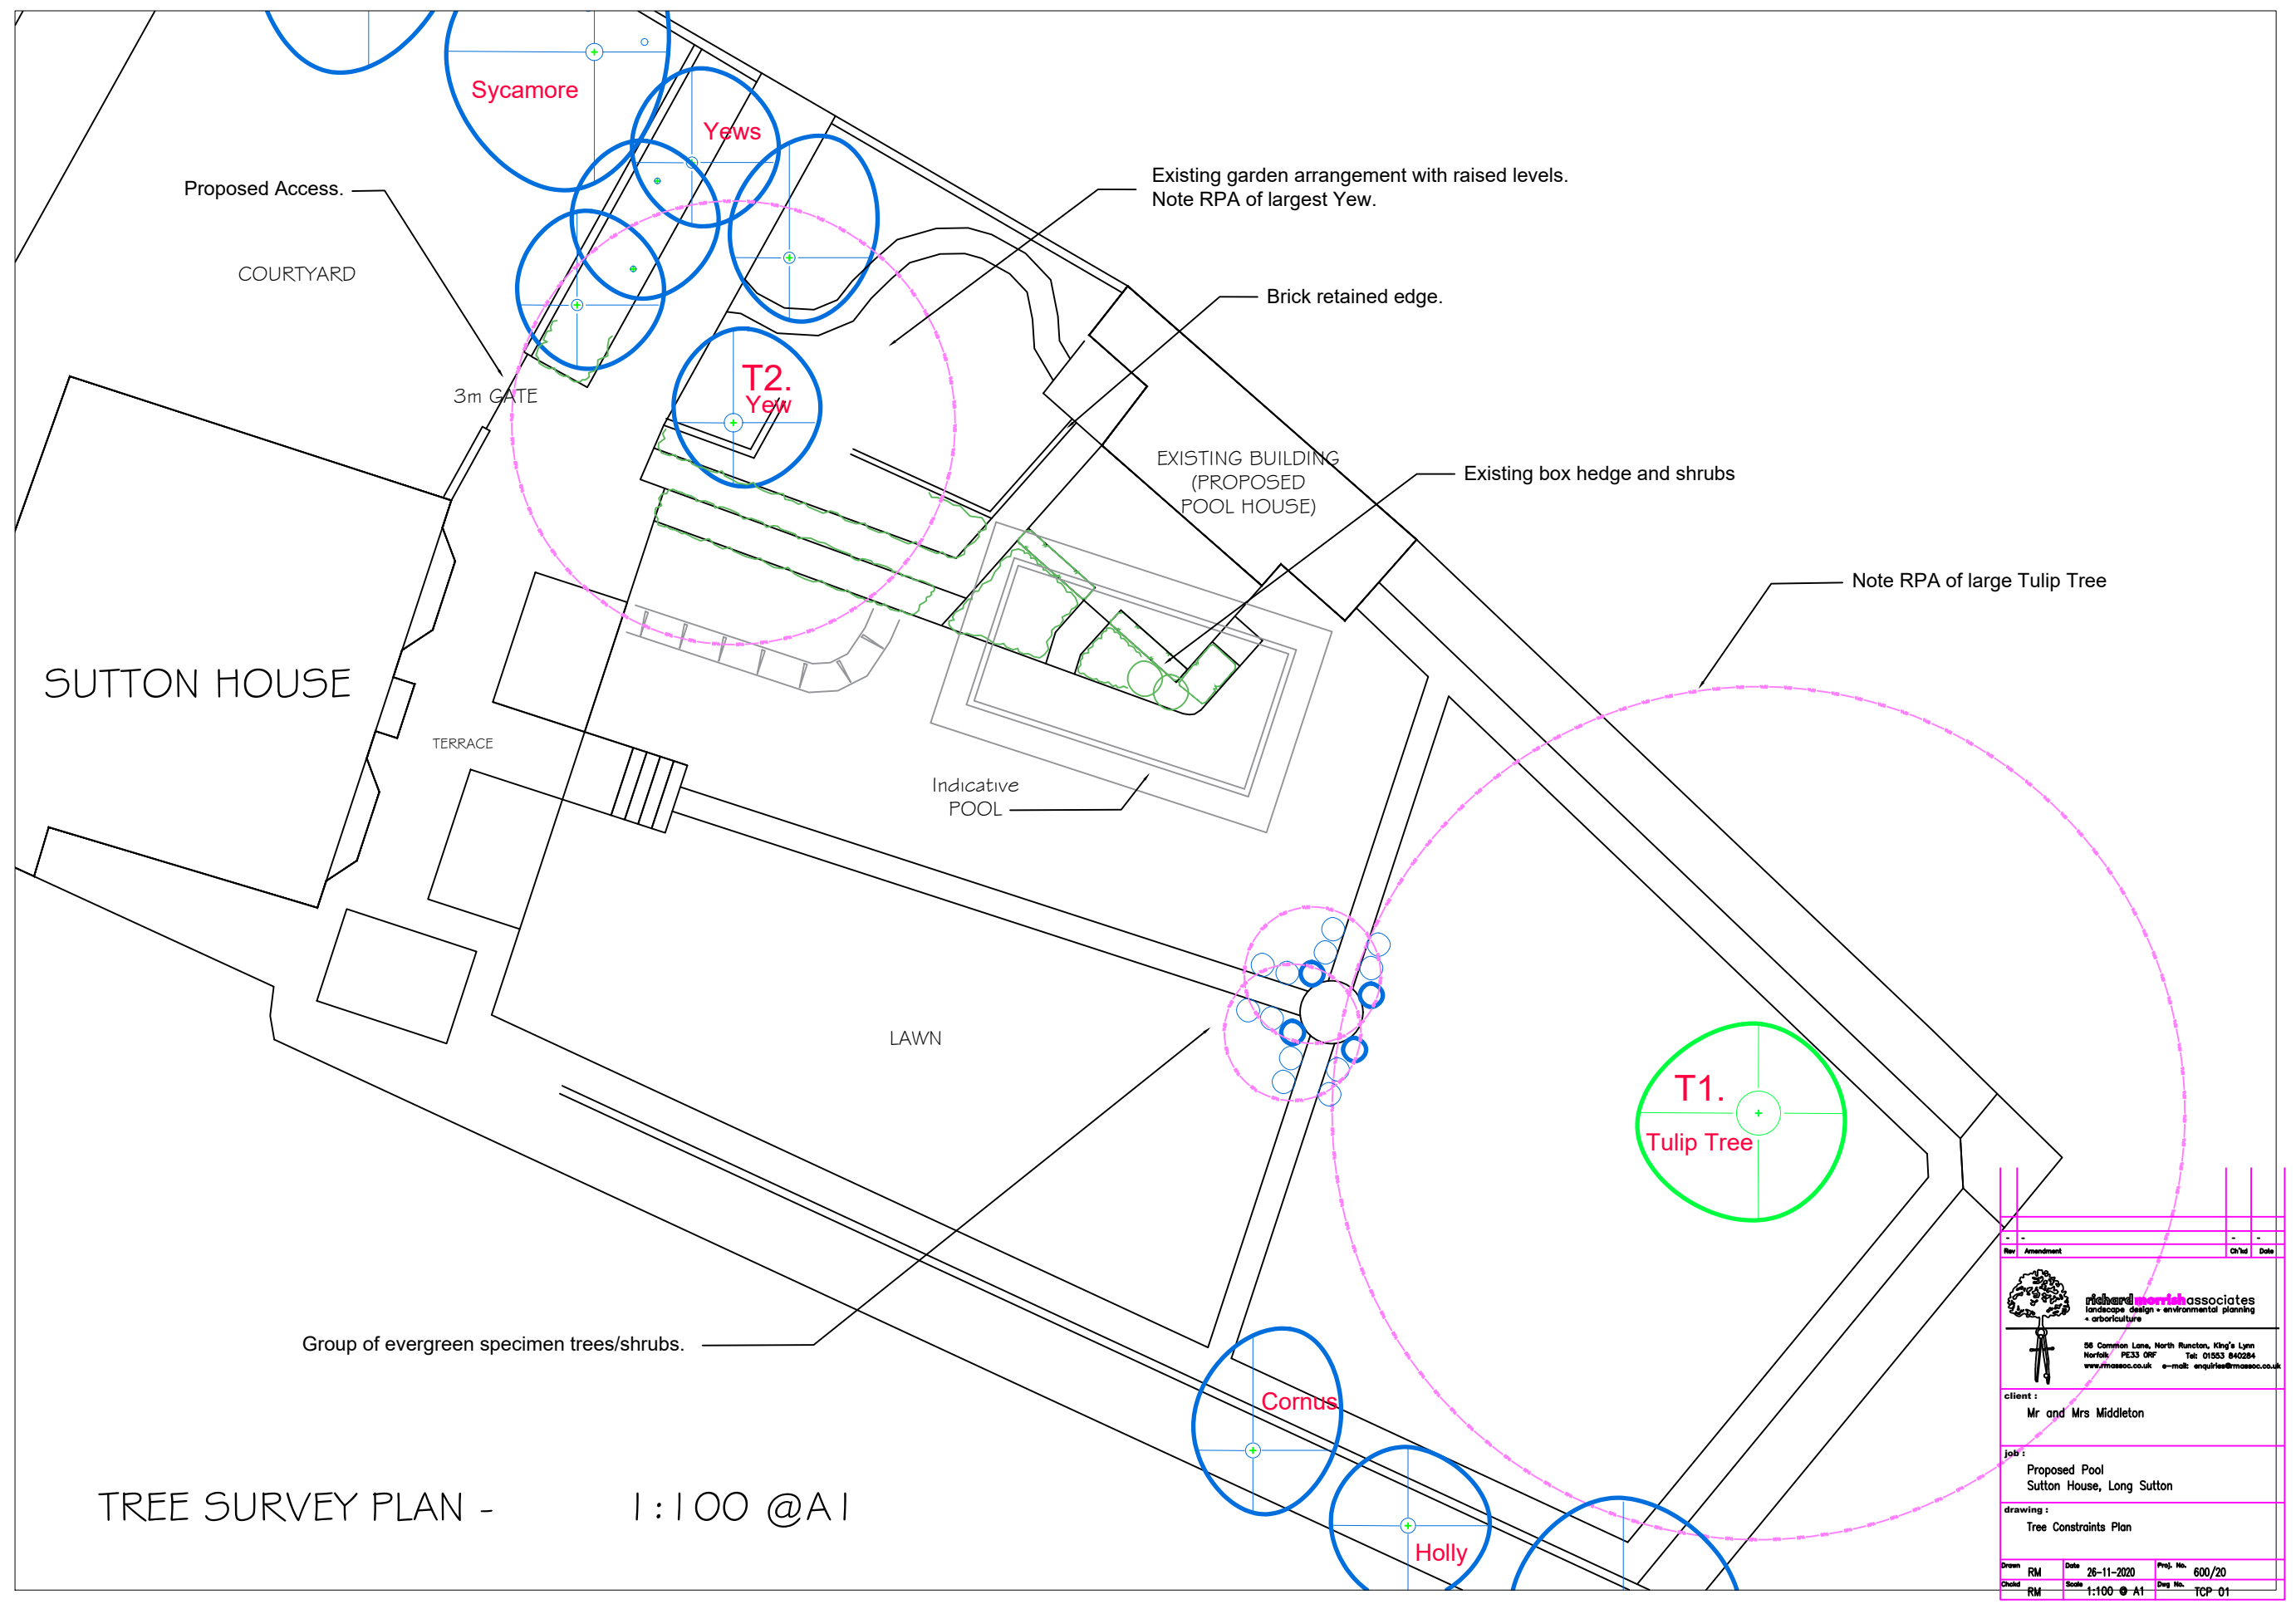
drawing : Tree Constraints Plan

- 2.2 The survey allows development of a *Tree Constraints Plan* (refer to drawing TS01, Appendix A) based on the calculation of *Root Protection Areas (RPA's)* for each of the trees on or near the study site. The RPA is defined as a "*layout design tool indicating the minimum area around a tree deemed to contain sufficient roots and rooting volume to maintain the tree's viability, and where the protection of the roots and soil structure is treated as a priority.*". The RPA is generally shown as a circle. In reality the distribution of roots around a tree will frequently prove to be asymmetrical due to the presence of physical constraints or a variety of conditions that may affect root development. Where it is considered likely that root growth has been restricted in one direction and favoured in another the arboriculturist may propose to modify the RPA shape to better protect the tree's viability.
