## **FURTHER GROUND INVESTIGATION AND REMEDICATION SCHEME**

**PEAR TREE FARM**

**Report Reference C15075C**

*October 2023*

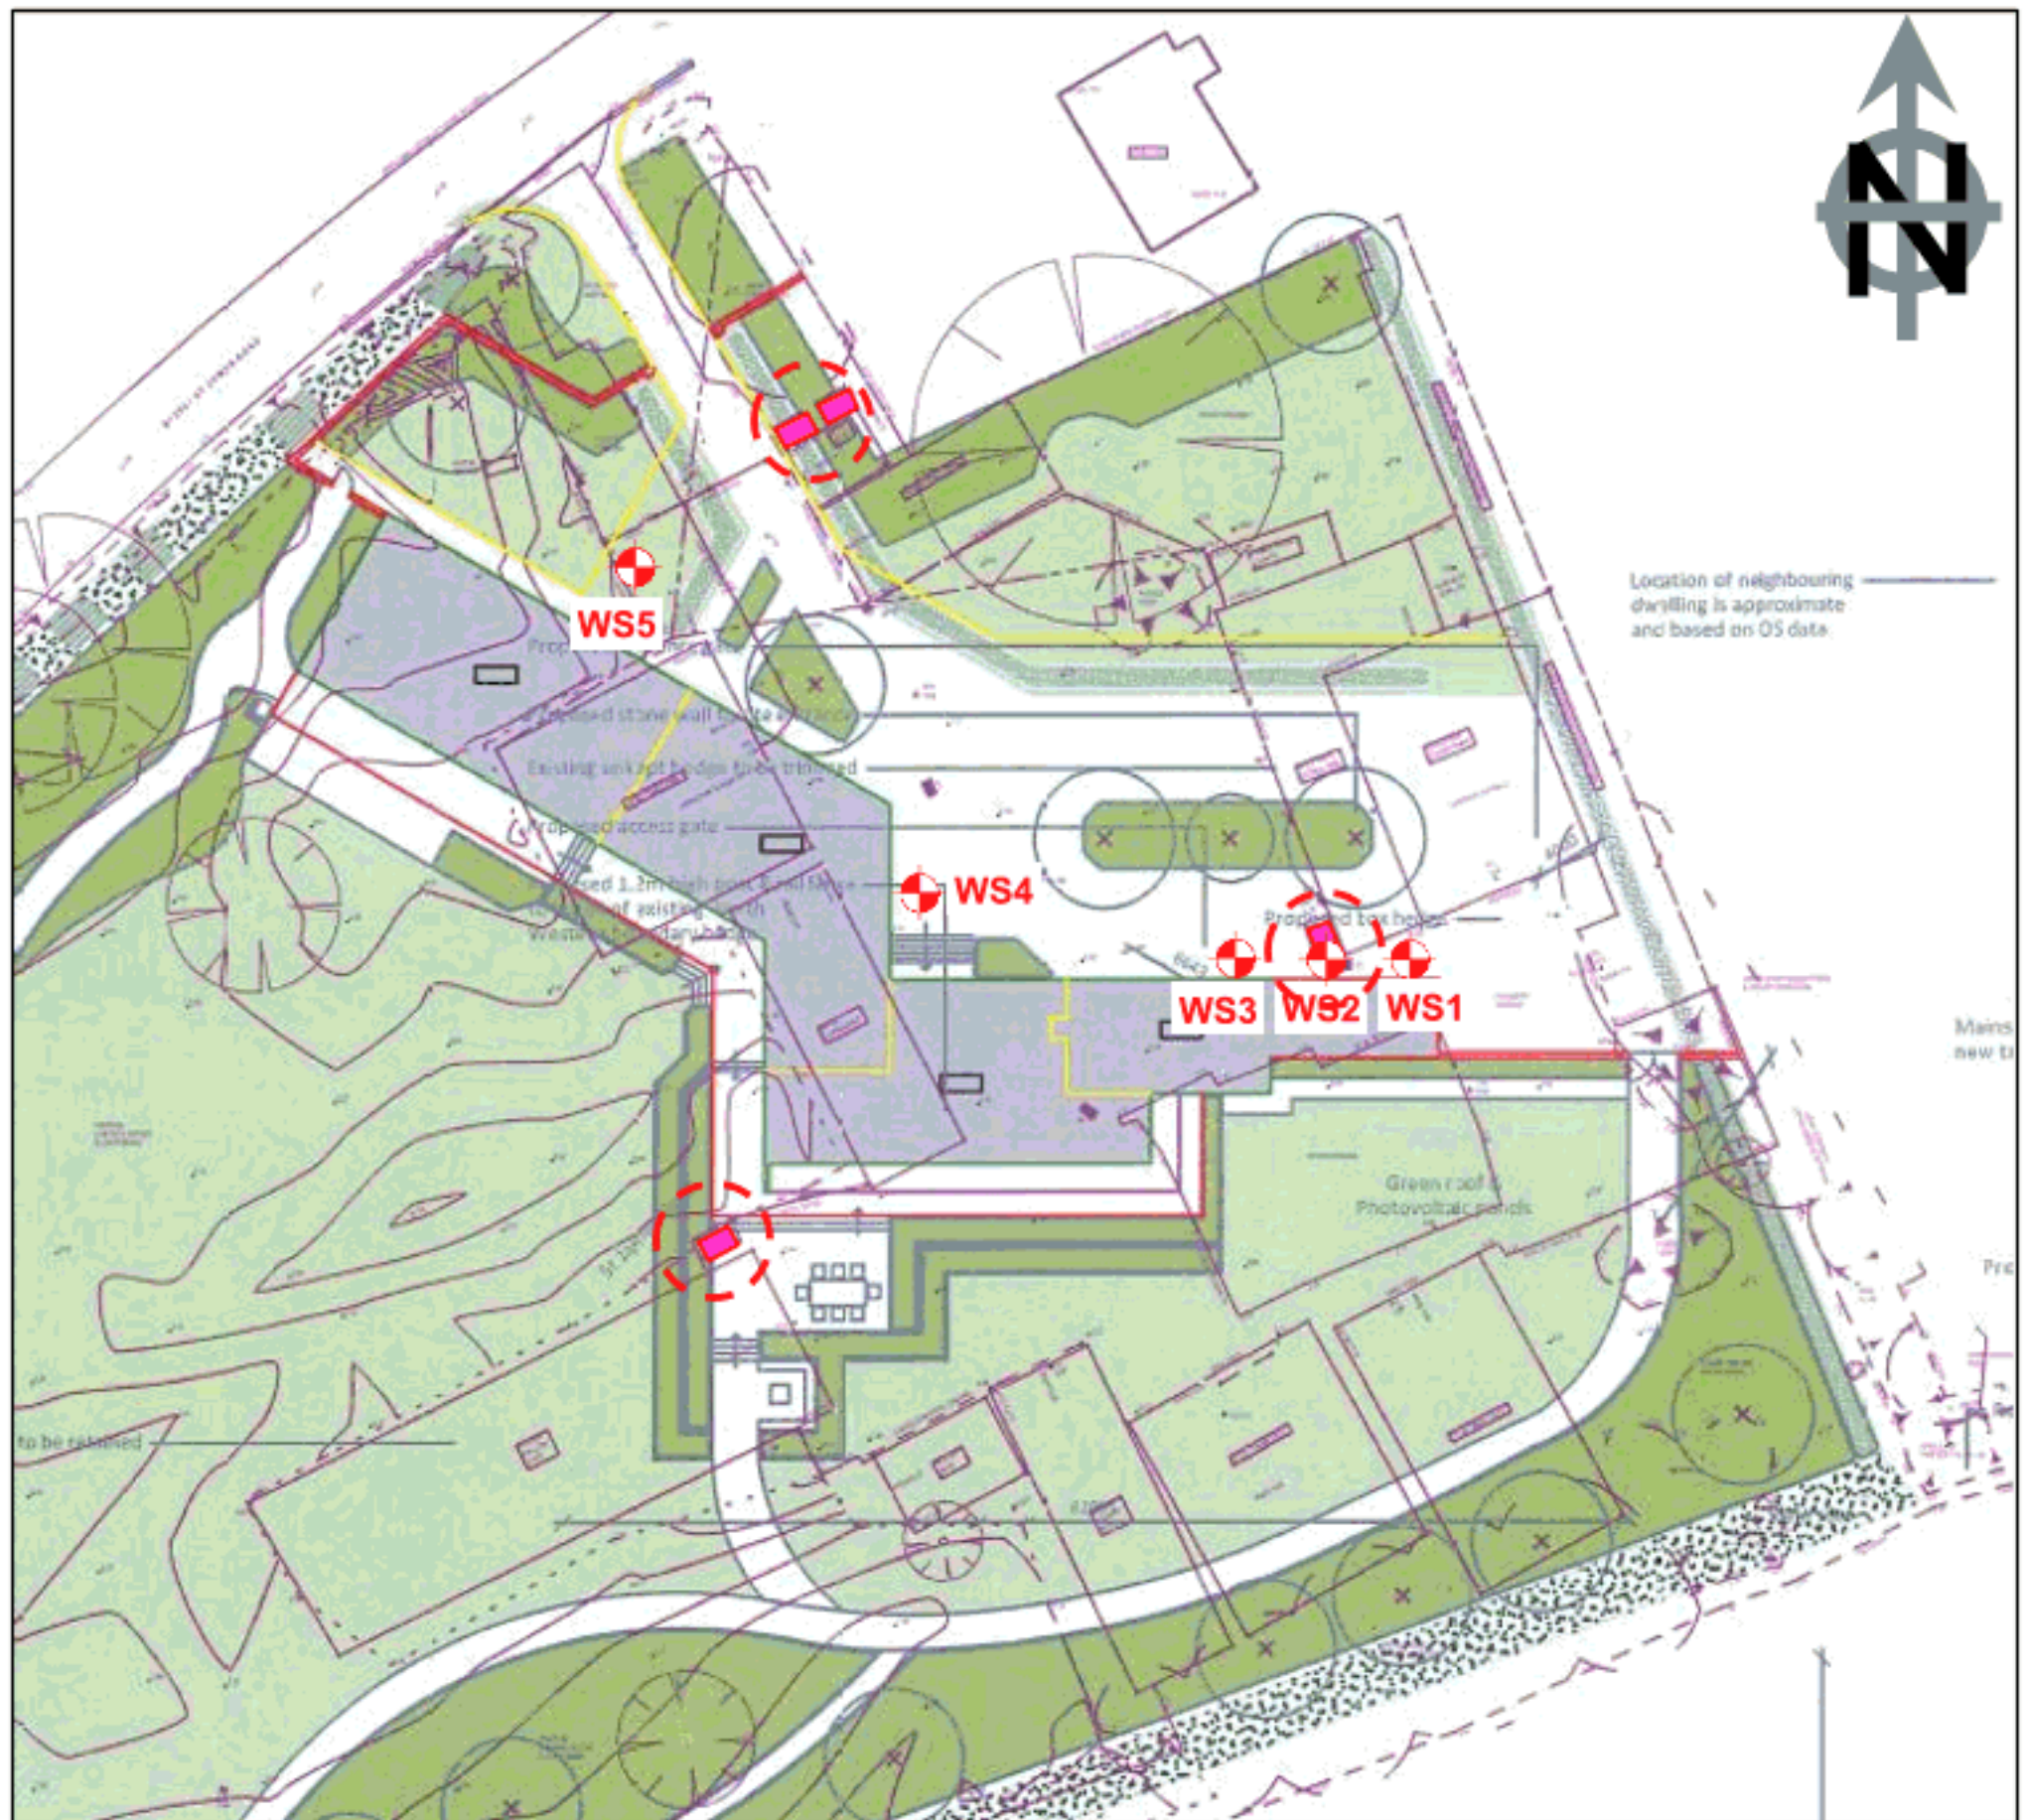
Figure 2

**Figure 2: Borehole Location Plan**

Window Sample Borehole WS1 to WS5

Former Surface Mounted Tanks

The site work was carried out on 14 August 2023 and comprised five window sample boreholes (WS1 to WS5) whose locations are shown in Figure 2. Service plans were consulted, and a cable avoidance tool (CAT) was used to check for the absence of buried services prior to boring.

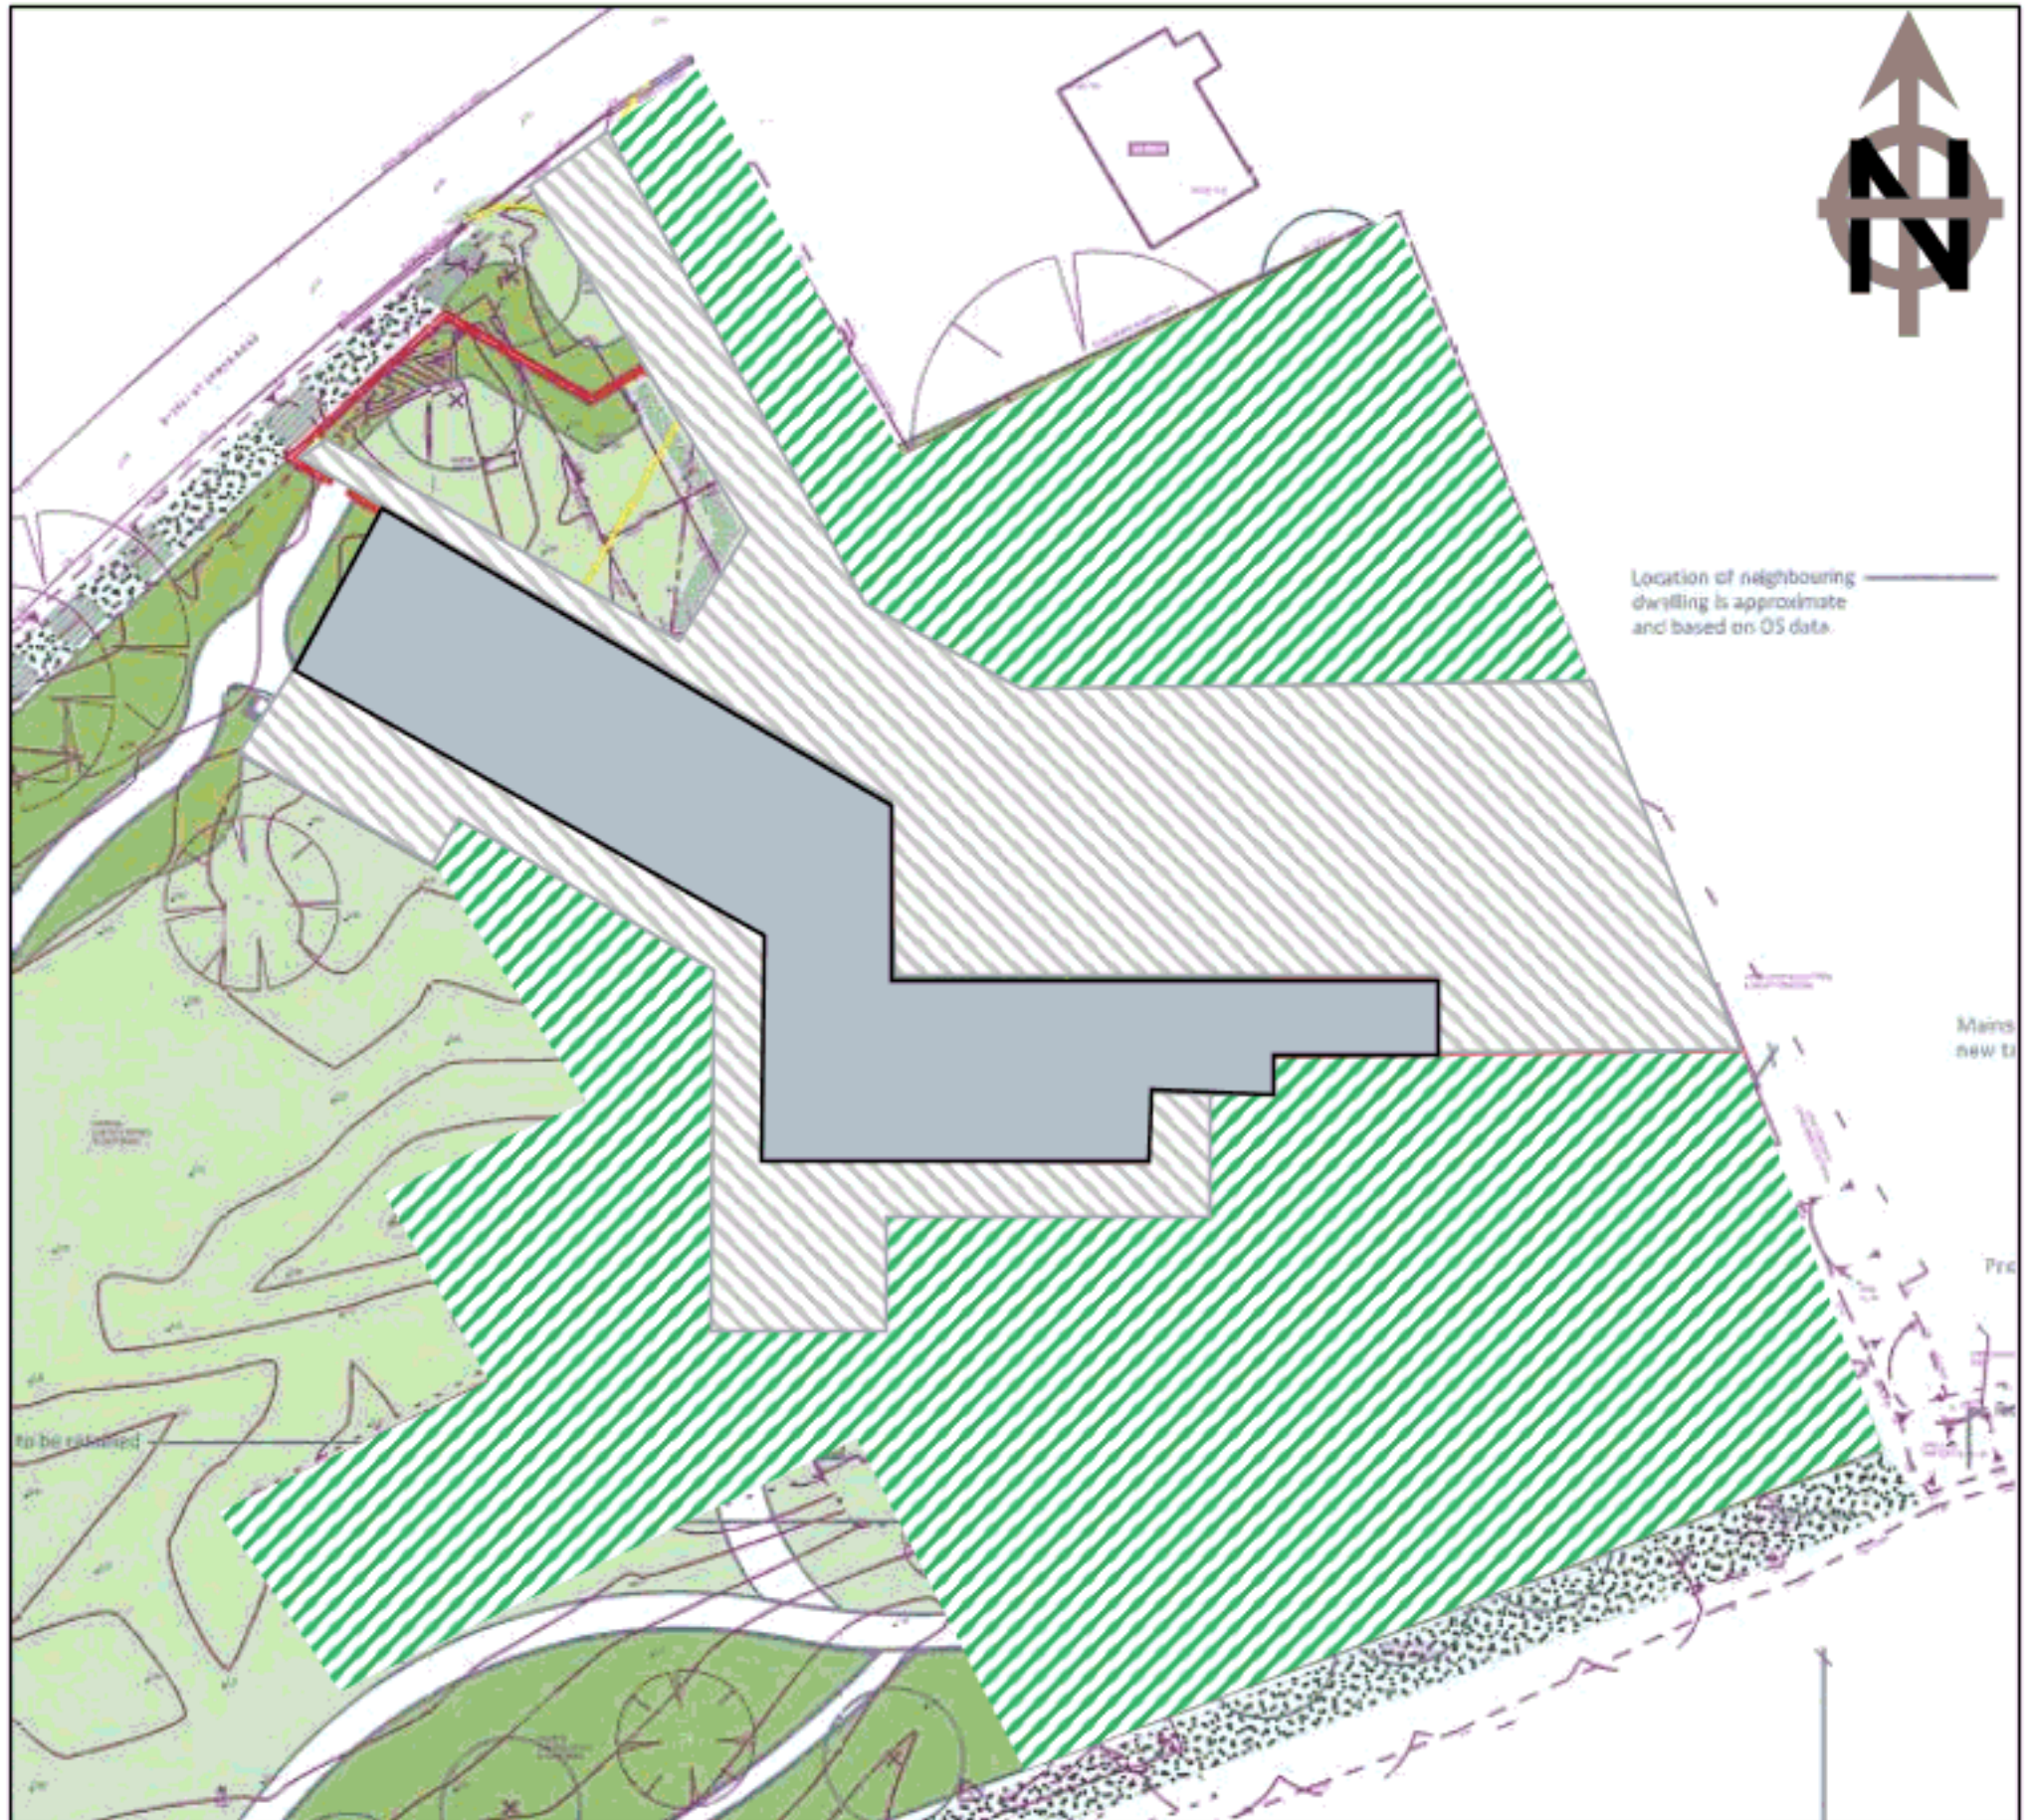
Figure 3

**Figure 3: Plan Showing Proposed Development**

Building

Hardstanding

Clean imported topsoil required to provide a suitable growing medium within former farmyard area

A plan showing the proposed development is provide as Figure 3.
