Allison Homes

Moulton Chapel  
Spalding

Headwall Detail (Headwall 7)

| Drawing No. | 40-19-07 | Rev. | P2 | | |

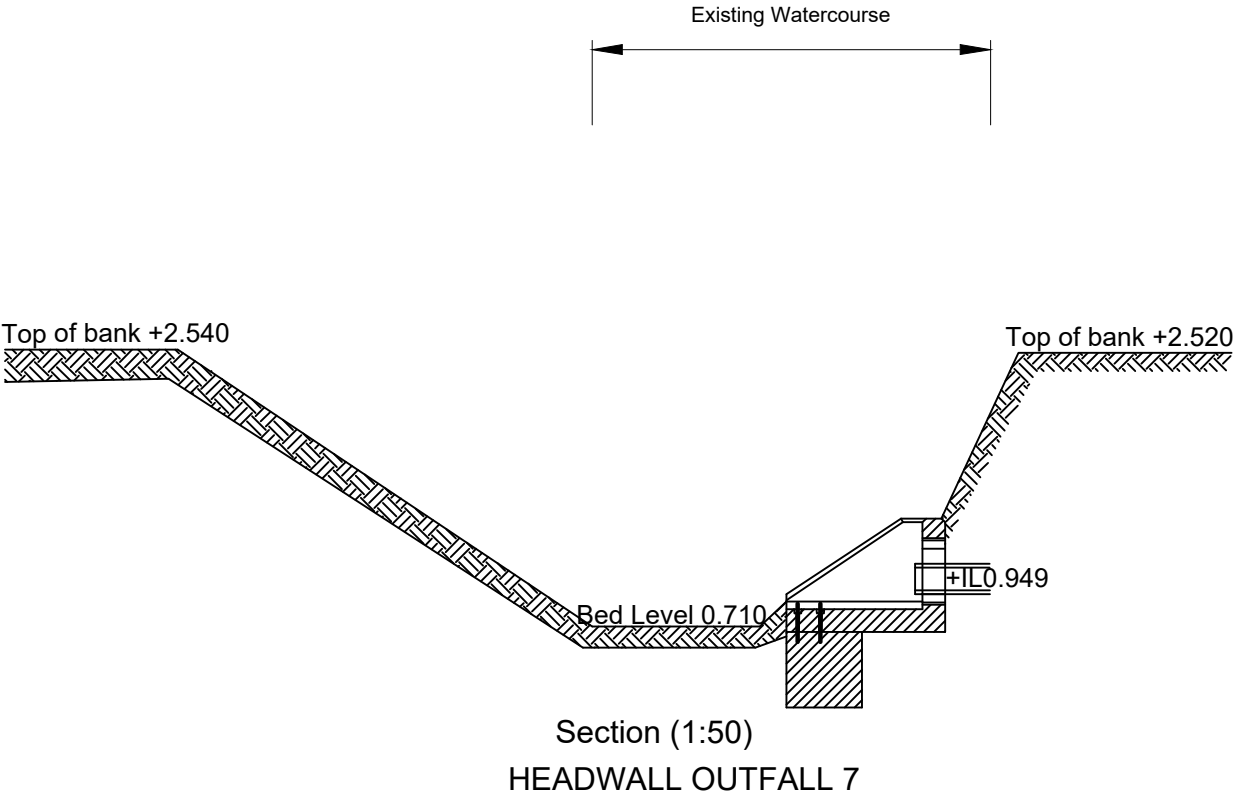
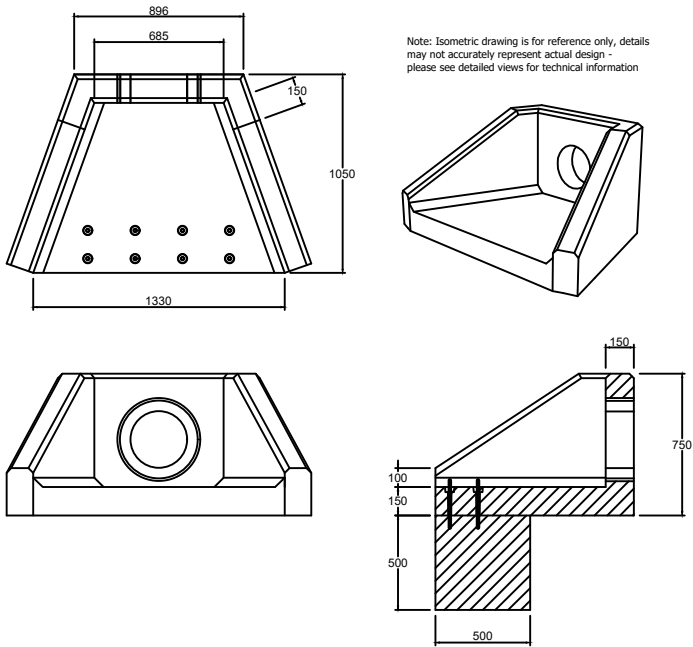
Sections through watercourse not needed as it is uniform throughout.
