## **GROUND GAS RISK ASSESSMENT**

### **The Bell Inn, Pinchbeck M25-083/GAS**

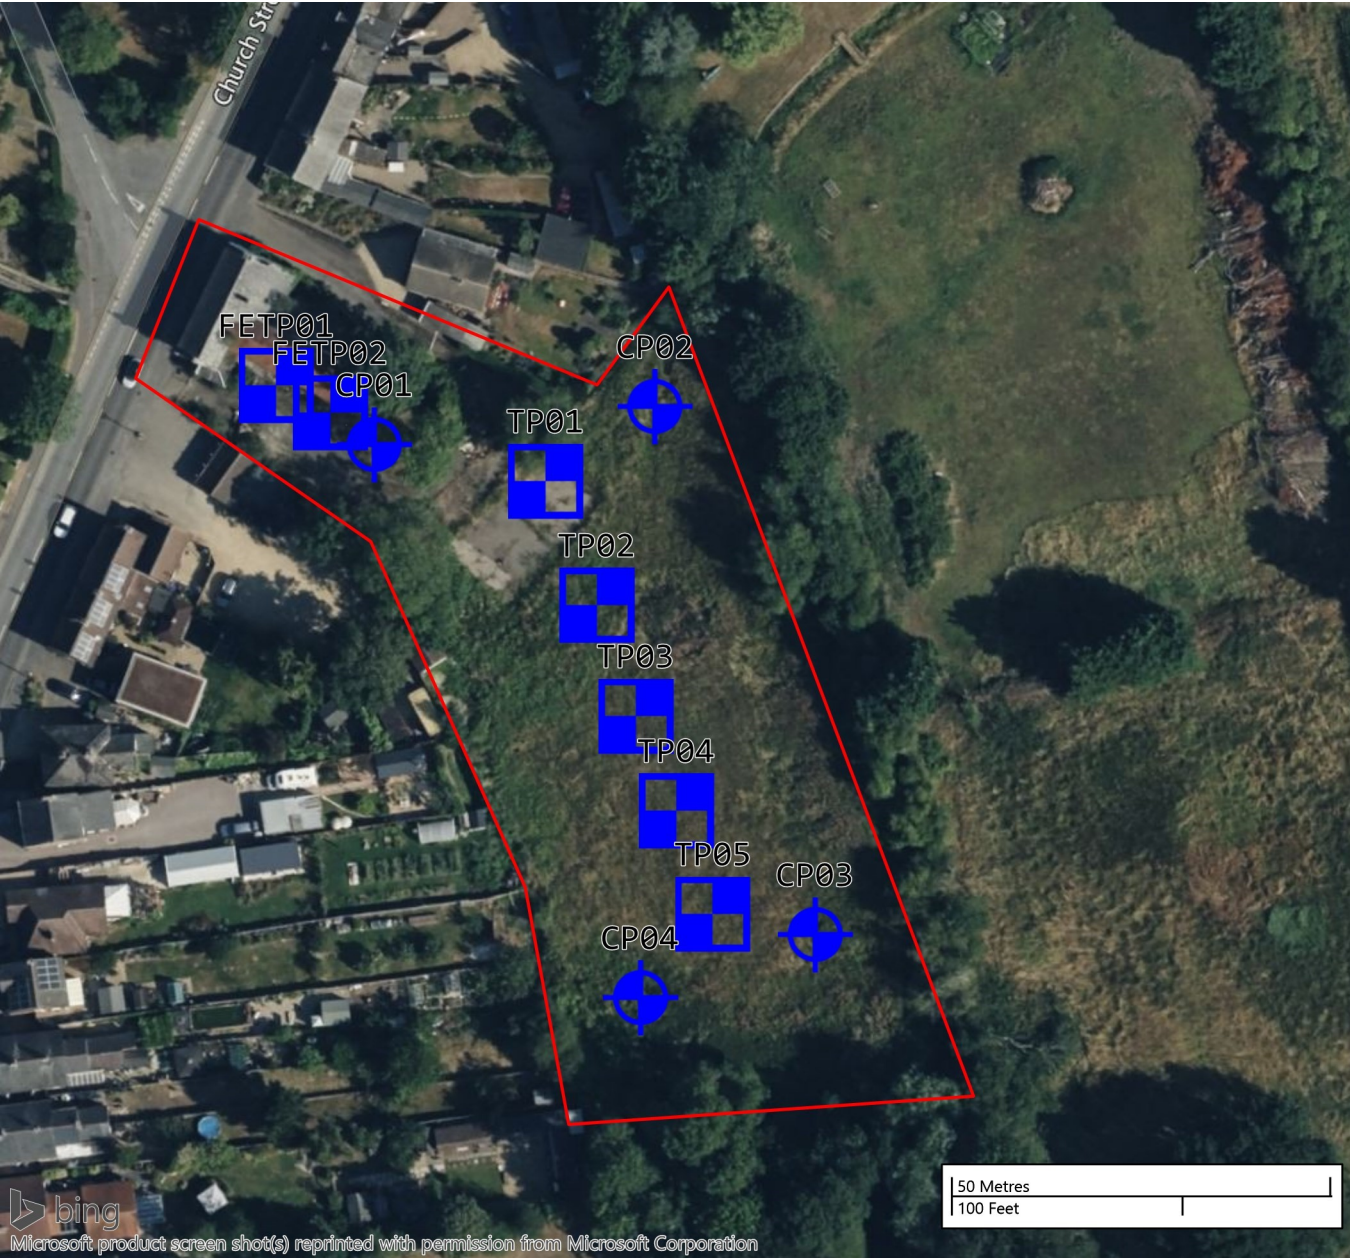
Exploratory Hole Location Plan

The gas was monitored by measuring emissions from monitoring points installed into CP01, CP03 and CP04 during the fieldwork. The results are attached, and the positions of the boreholes are presented in Figure 2 also attached. The monitoring was generally carried out in accordance with current guidance provided within CIRIA C665:2007.
