HERITAGE IMPACT ASSESSMENT

PROPOSED ALTERATIONS AND EXTENSION  
at  
THE YEWS  
207 SPALDING ROAD  
PINCHBECK Lincs

**10/106 Yew Tree Farmhouse**

**Grade II**

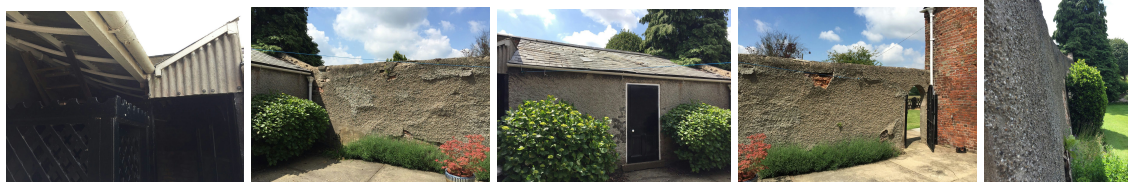
The courtyard is a later addition to the house and in much need of either being rebuilt or repaired as the following photos show. Therefore we propose the extension.

It is intended to remove the walls, lean to outhouse and verandah of the the courtyard and build the wall facing the river anew in English garden wall bond in new handmade bricks to match the existing. The height of the wall is to be the same as existing. The area that was the courtyard will be enclosed within a new extension with glass walls overlooking the rear garden. The extension must be no higher than the height of the wall.

Although some fabric to the building is being removed or altered it is happening to less significant areas of the building. The courtyard if left unattended for much longer will become very dangerous and needs instant attention. We feel the extension will address this and with the stipulations advised by the conservation officer it is only visible from the rear elevation with the elevation facing the river pretty much the same as it was. The extension makes for a better relationship between house and garden.

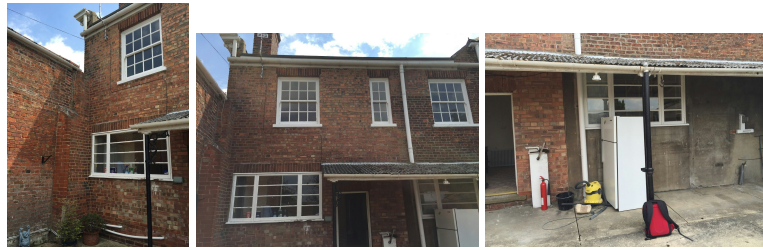
The access into the extension is through the existing kitchen but we propose to open the wall between both so that the kitchen flows into the proposed. This means removing fabric of the existing house, however there appears that there have already been alterations to this part of the house, most notably the different style of windows. Please see photos below.

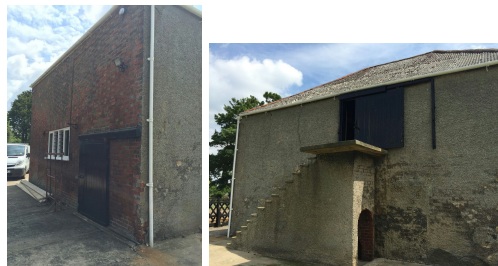
The proposal is also to change part of the ground floor and first floor of the garage block into living accommodation. The upstairs is to house two further bedrooms with ensembles while the ground floor houses a hallway for the stairs and then connects the office to the living area. In order to achieve these changes some floor fabric will be lost to introduce the stairwell. The existing sliding doors to the upstairs and at ground level are to be made into feature screens while some existing openings are re-introduced to the hall area. Please see photos below.

The inclusion of parts of the garage into the living area makes use of redundant areas with little loss to original fabric. It is intended to reuse original features such as the sliding doors in a different way.
