Project
 1 Holland Road
 Spalding
 PE11 1UL

Title
 Topographical Survey

Surveyor	LR & JKR	Client Ref:	
Date	November 2024	Drawn By	JKR
Scale	1:200@A1	Checked By	JKR
Contract No.	24063	REVISION	
Drawing No.	01		*

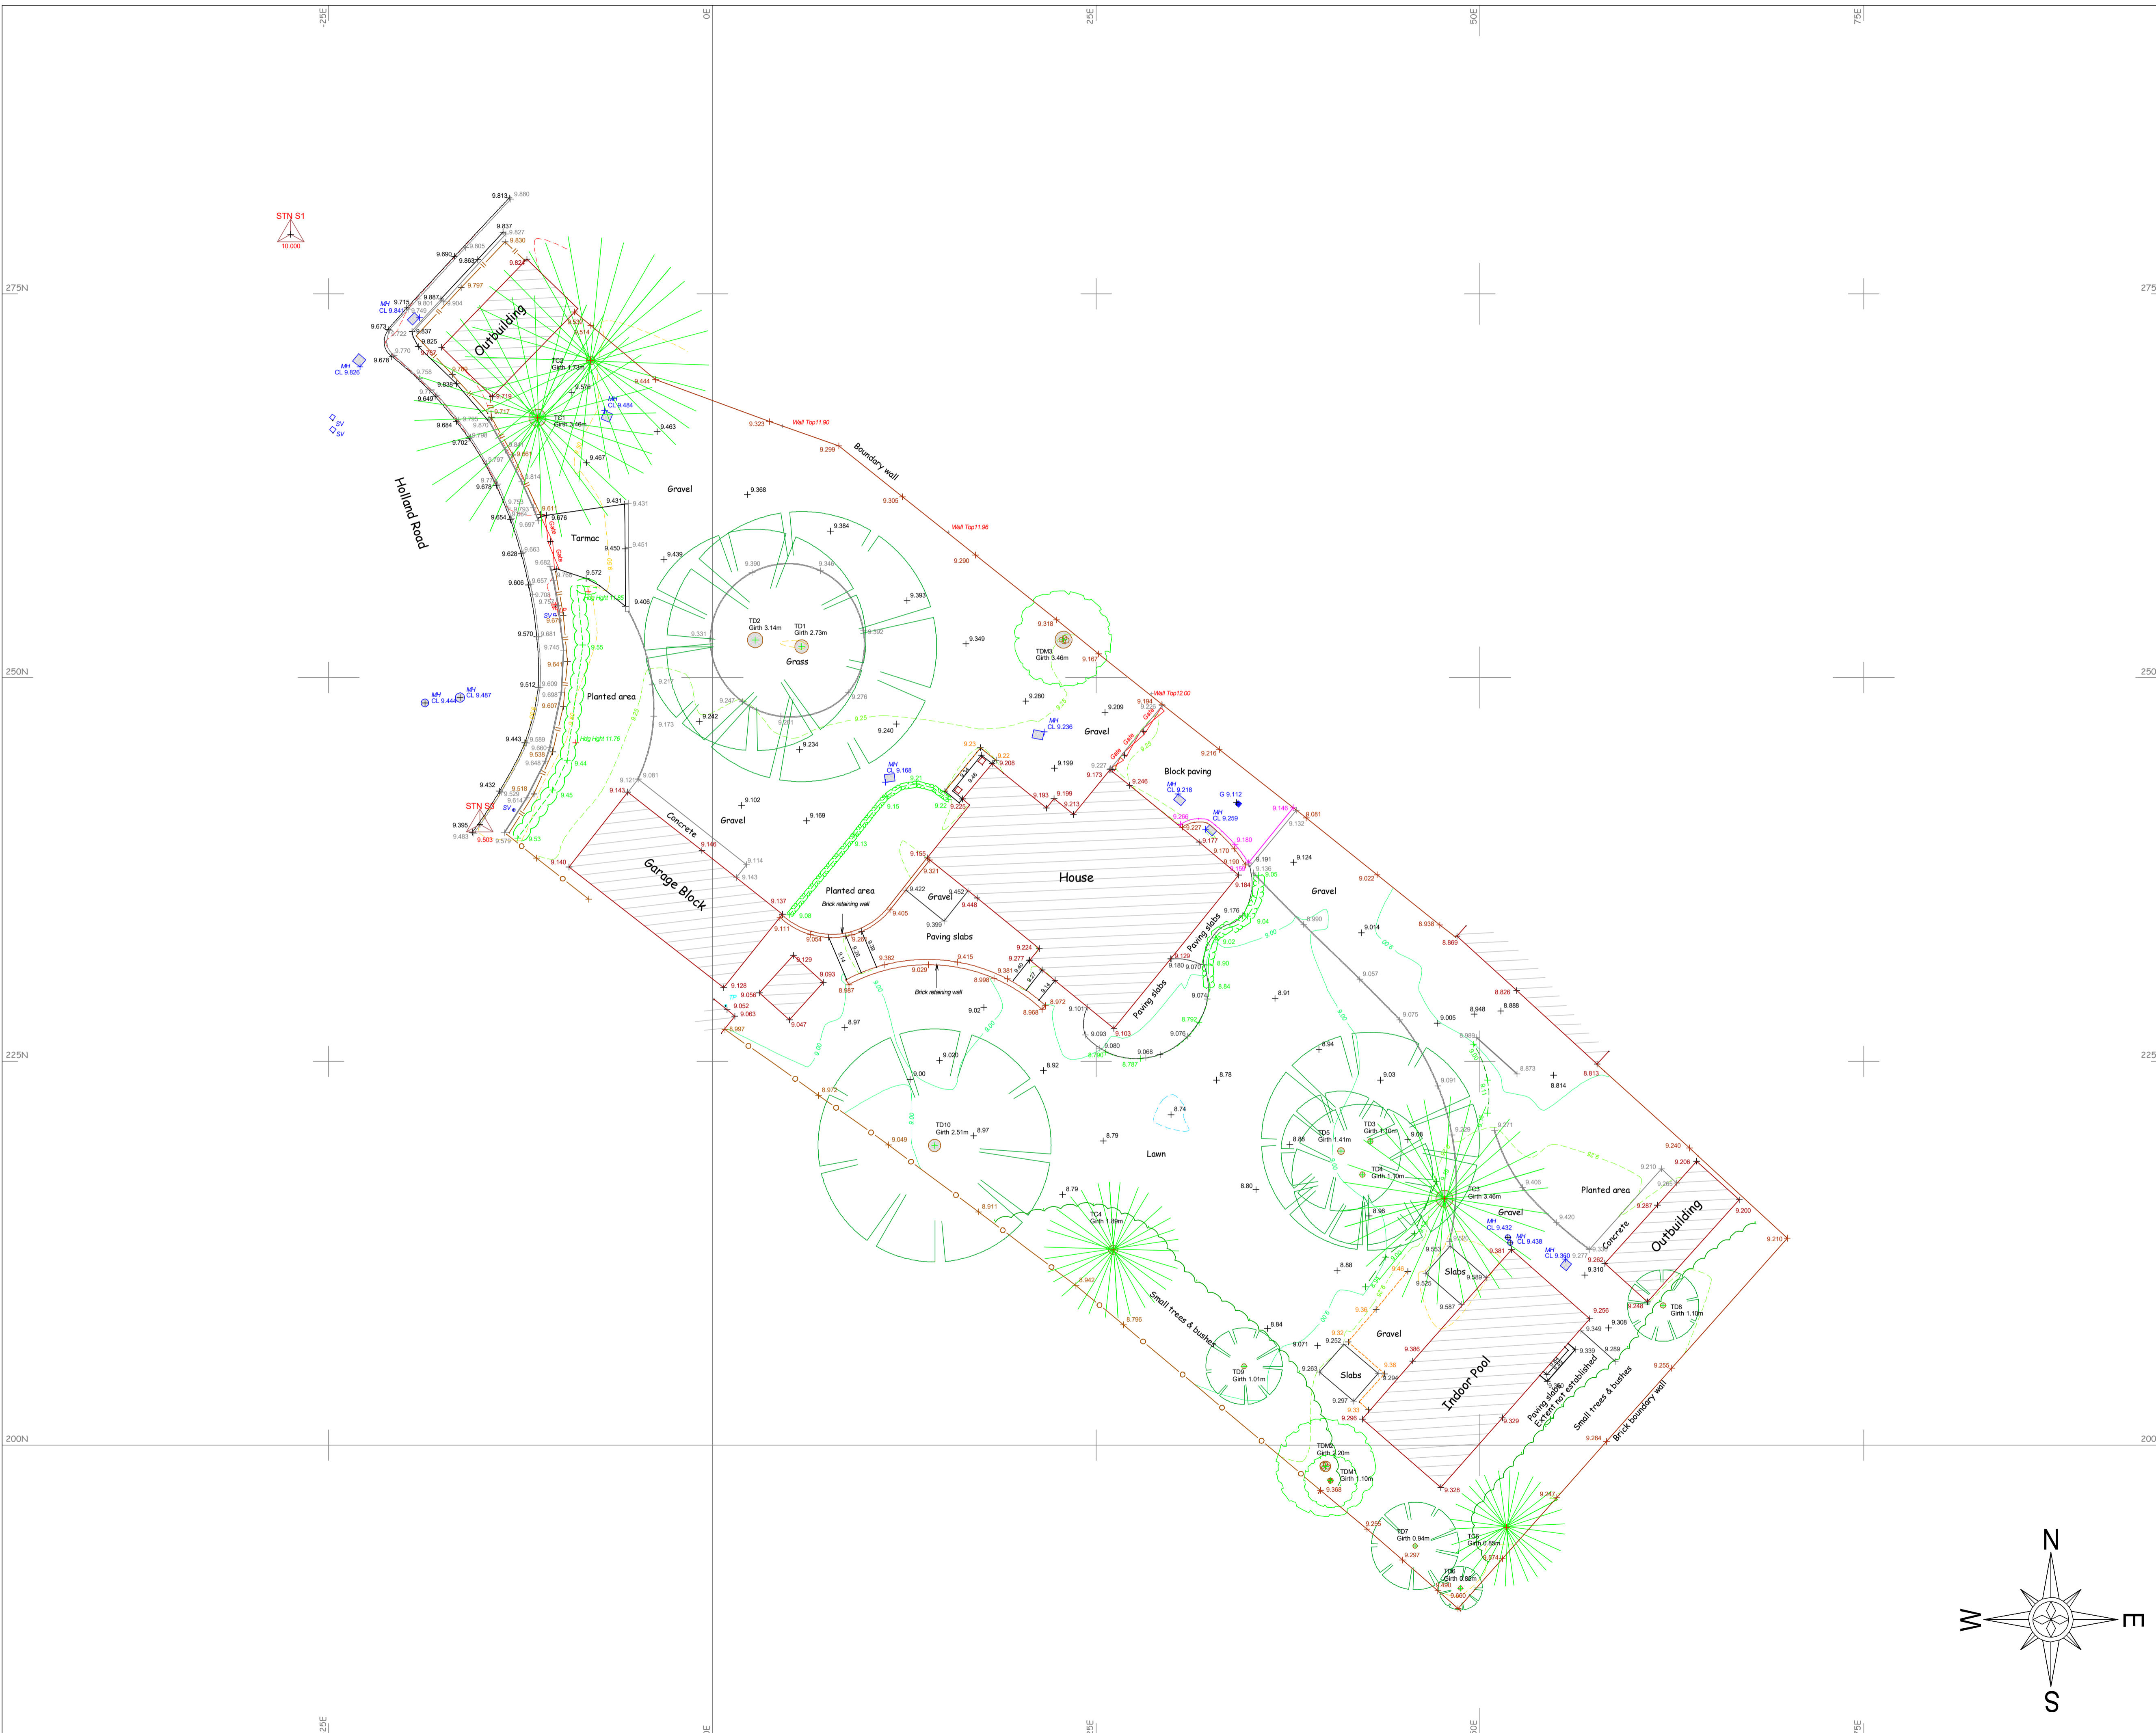
SURVEY STATIONS				
Name	Easting	Northing	Height	Remark
STN_S1	-7.465	278.879	10.000	
STN_S3	-15.147	240.444	9.503

The survey grid is Local at STN S1
 Surveyed boundary features are not necessarily legal boundaries
 All utilities have been identified to the best of the surveyors knowledge.
 The correct identification can not be 100% guaranteed and should be independently verified prior to use in any design or building works.
 Services may be obscured by parked cars, leaf litter or building materials etc.
