Client:  
**South Holland District Council**

Project:  
**Proposed Conservation Works to  
Spalding War Memorial  
Ayscoughfee Hall Gardens  
Church Gate  
Spalding  
PE11 2RA**

Drawing Title:  
**Reflected Ceiling Plan as existing  
identifying works required**  
**LBC APPLICATION ISSUE**

| <b>A1660-12</b> | <b>T1</b> |

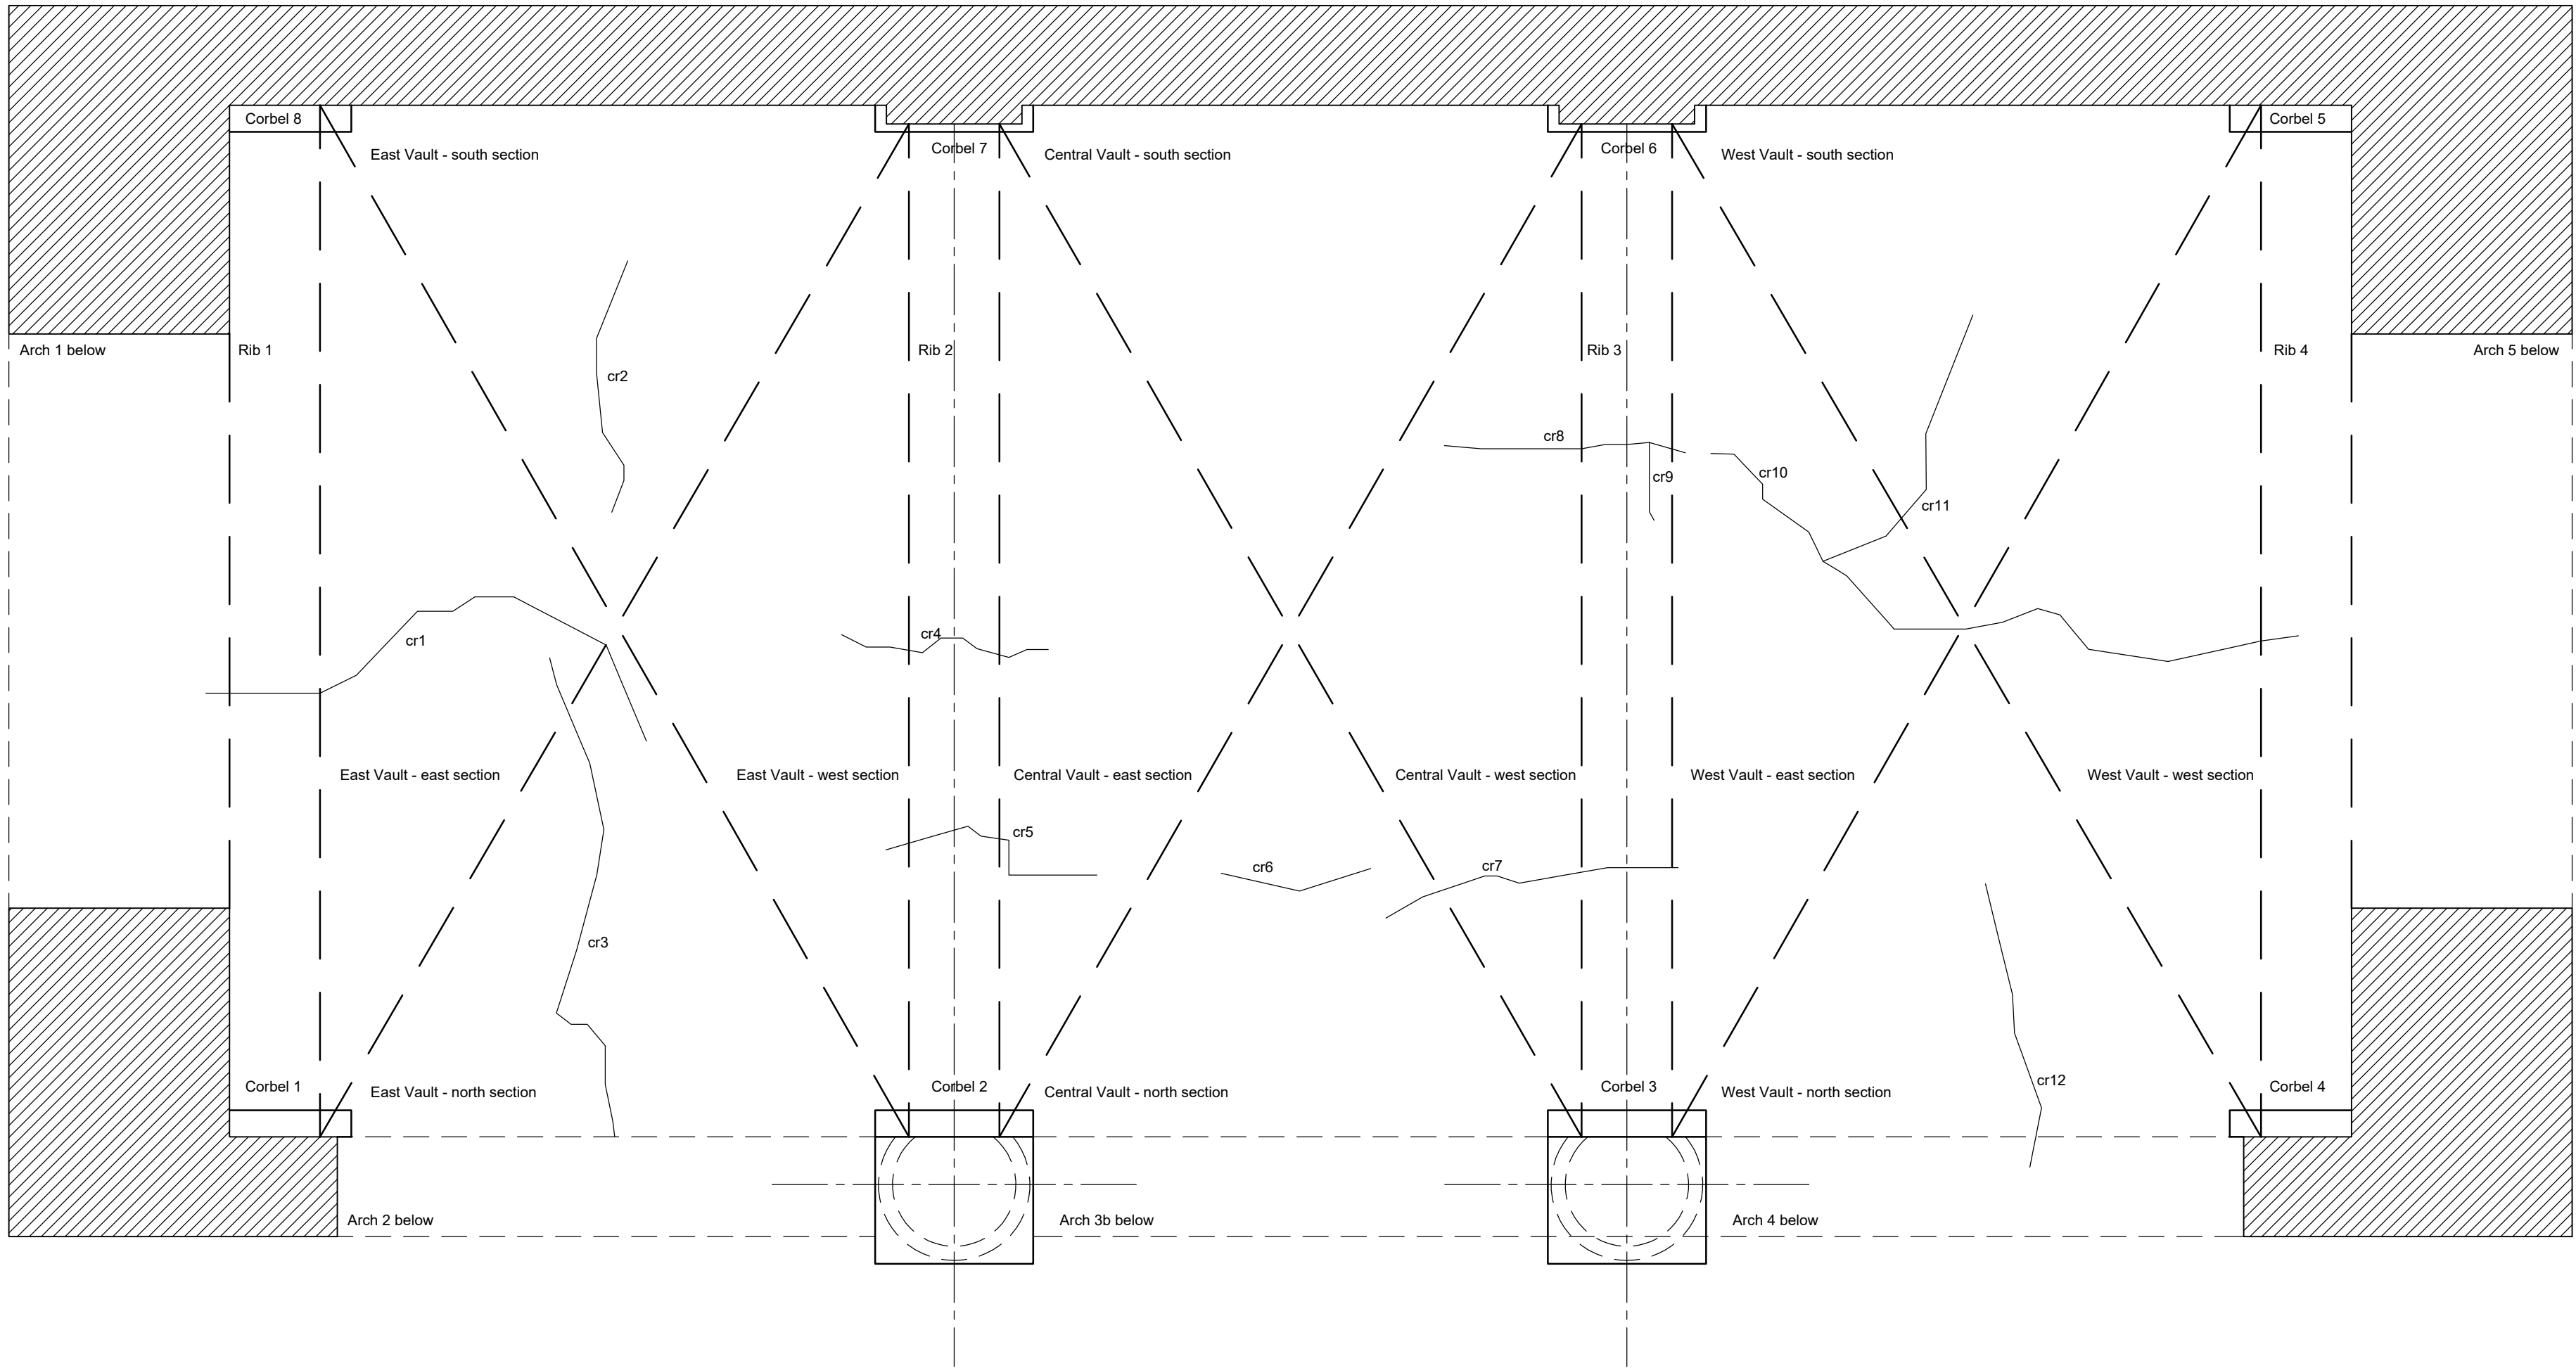
Reflected Ceiling Plan as existing  
Scale 1:20  
SCALE 1 : 20  
SCALE 1 : 1

Repairs to be undertaken to repairable cracks (cr) in locations as indicated on plan and described below.

cr1 - Crack running through rib 1, extending across east vault east section and into east vault north section.

cr2 - Crack within east vault south section.

cr3 - Crack from Arch 2 through east vault north section and into east vault east section.

cr4 - Running through rib 2 into east vault west section and central vault east section.

cr5 - Running through rib 2 into east vault west section and central vault east section.

cr6 - Crack within central vault north section.

cr7 - Crack running from central vault north section, through central vault west section and into rib 3.

cr8 - Crack running from central vault west section, through rib 3 and into west vault east section.

cr9 - Crack from cr8 within rib 3.

cr10 - Crack running from west vault east section through west vault west section and into rib 4.

cr11 - Crack running from cr10 from west vault east section into west vault south section.

cr12 - Crack from arch 4 running through west vault north section.

General  
Doff clean complete area, prepare and redecorate in white.
