Heritage Impact Assessment

Proposed relocation of stone planter and installation of Historic Drinking Water Fountain within the gardens of Ayscoughfee Hall, Love Lane, Spalding, Lincolnshire

On behalf of South Holland District Council

A1572F – HIA rev P3

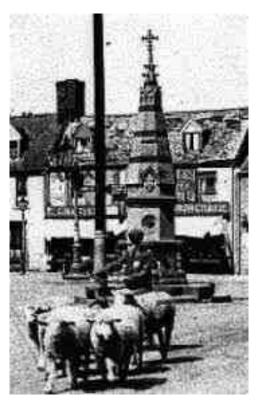
Image 1. Mary Ann Johnson drinking fountain

The 6metre (2oft) fountain is gothic in style and is made of sedimentary material (limestone or sandstone) with a granite plinth and is thought to weigh in the region of 78 tons. Through the centre of the fountain is an iron rod on which the parts of the fountain are assembled and this is topped with a metal cross. On alternate faces of the fountain are the Johnson family arms.

It was designed by the London Architect, Robert Jewell

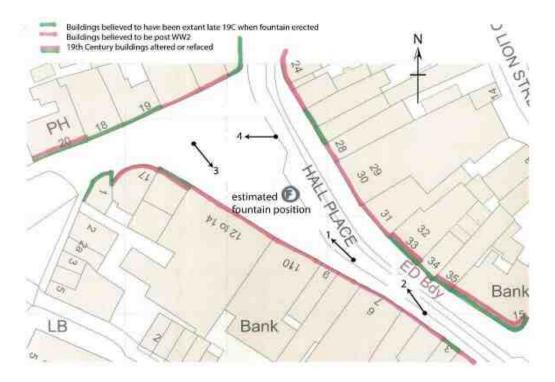
Image 2: Marked-up present day Ordnance Survey showing the estimated location of the fountain.

Buildings are colour coded to show which are believed to have existed when the fountain was erected and those that are post war and those that have been altered.

The numbered arrows relate to views provided in this document.

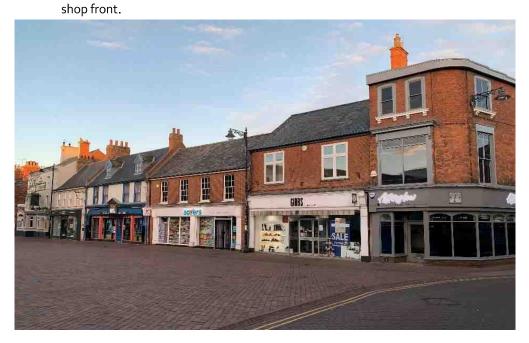
Image 5 (View4) northwest parade – Hall Place, February 2022

Comparing Image 4 with Image 5, it can be seen that in addition to the road layout changes, the buildings on the northwest side of Hall Place have been extensively altered,

No.20 Sheepmarket is the building to the far left of the group and is used as a public house. The roof has been altered. The dormer windows removed and it appears that another storey has been added.

No. 18 Hall Place, has a modern shop front and two dormer windows have been removed.

No. 19 Hall Place, Grade2 listed has a modern shop front and the windows have been replaced

No. 20/21 Hall Place was rebuilt after 1985

No. 22 Hall Place has been completely rebuilt

No. 23 Hall Place has a modern shopfront and the first floor fenestration has been changed. The slate pitched roof appears to have been removed and a deep fascia added.

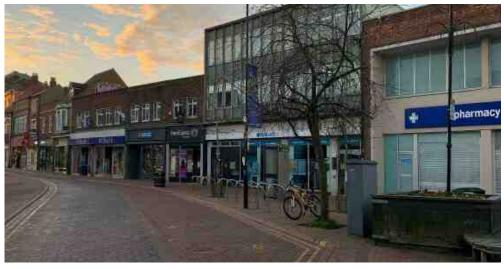
Image 7 (View3) Hall Place southwest side, February 2022 (Note: The photograph foreshortens the view, see Image 10)

Comparing Image 6 with Image 7, it can be seen that the southwest side of Hall Place has been completely rebuilt. The decorated three storey building have been replaced with angular mainly two storey structures. The road layout has been changed with traffic original passing both sides of the fountain. It is thought that the fountain's relative position would now be near the tree and the lay-by (See Image 7 and Image 10).

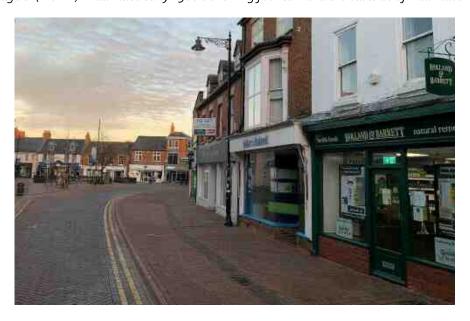
Image 9 (View2) Hall Place east side, February 2022

Comparing Image 8 with Image 9, it can be seen that the road is much narrower in the modern photograph. While there have been new shopfronts installed and modern windows there are still some features remaining from the early 1900's photograph.

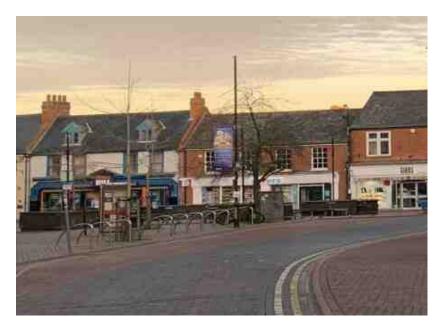
Image 10 Detail from Image 9 (View2)

As previously discussed, it can be estimated that the original site of the fountain would now be close to the tree and the lay-by shown in Image 10 above (also shown in Image 7).

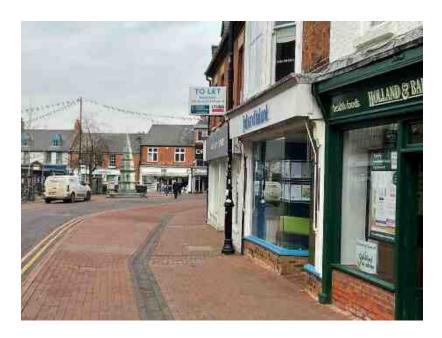
Image 11 (View2) The fountain shown in its estimated original position in the new road layout

It is difficult to be 100% accurate in assessing exactly where the fountain originally stood. Whilst the historic photographs give a good impression, the viewpoints and perspectives lead to some uncertainty into the exact centre point of the fountain. However, having studied various photographs, the estimated original position for the fountain would now appear an impractical proposition. The fountain would require suitable foundations and there is now infrastructure that would be very difficult to move to allow a foundation to be formed. Working to the original location we also believe that the fountain would sit very close to the road and the lay-by area would have to be changed. Siting the fountain in this location may dictate a change to the paving and kerbing layout which in itself may be problematic, doing so would also mean that the fountain would be relatively close to the carriageway.

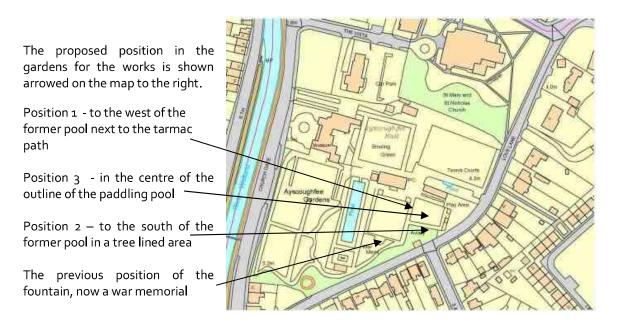
Image 15 Extract form the 2020 Ordnance Survey Map Location Long/Lat 52°47″01′N. 0°08″53′W

North is to the top of the map

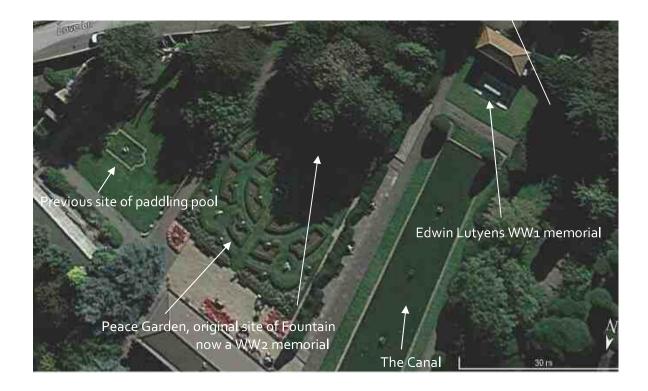
Image 16. Aerial View showing the relative positions of the features discussed in the document.

Dated after the removal of the fountain, the low level wall forming an entrance to the paddling pool has also been removed

South is approximately to the top of the photograph

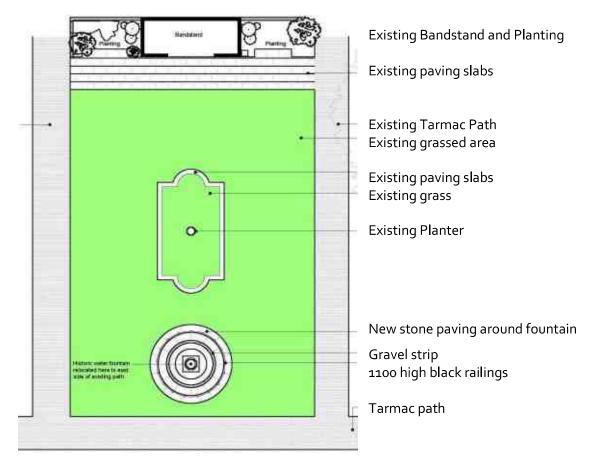
This proposal seeks to take the drinking fountain from storage and erect it to the west of the paddling pool area at the edge of the grassed area as shown below

Image 19 - Extract from Drawing A1572-03 Rev P2 - (Provided in the Appendices) showing the proposed position of the fountain at edge of the grassed area to the west of the paddling pool

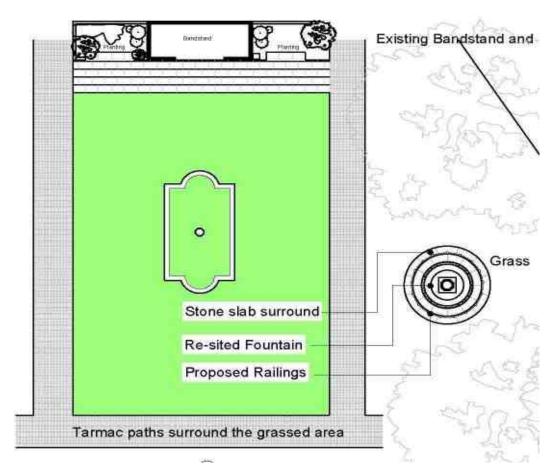
This proposal seeks to take the drinking fountain from storage and erect it to the south of the paddling pool area across the tarmac path at the edge of the tree area as shown below

Image 21 - Extract from Drawing A1572-04 Rev P_2 – (Provided in the Appendices) showing the proposed position of the fountain at edge of the tree area to the south of the paddling pool

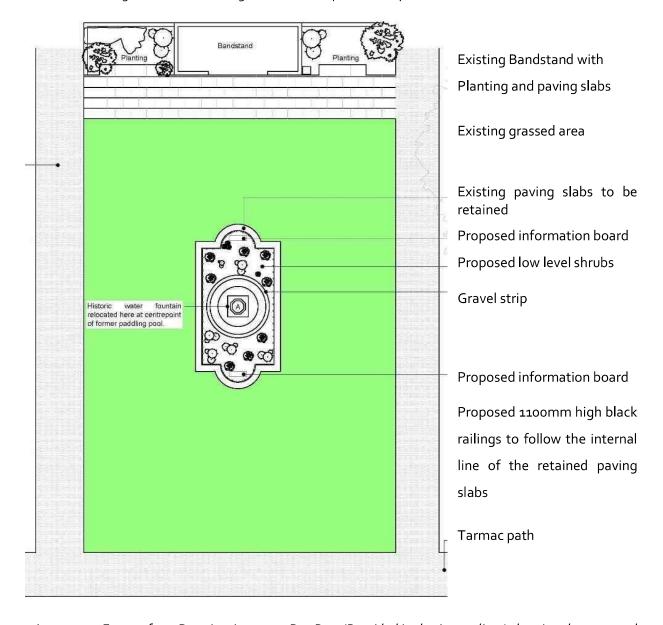
This proposal seeks to remove the existing stone planter (to be re-sited locally) and then to take the drinking fountain from storage and erect it in place of the planter.

Image 23- Extract from Drawing A1572-02 Rev P2 – (Provided in the Appendices) showing the proposed position 3 of the fountain at the centre of the former paddling pool

The origin of the planter that sits at the centre of the slabs had at one time sat in the centre of the pool when it had been drained. There are many similar planters around the gardens.

- 8.8 In contrast to the other positions, in position 3, at the centre of the former pool, the fountain does not overshadow the peace garden and stands in its own right. It can become a focal point in an empty area and could both be educational and allow for picnics or a new seating arrangement for families.
- 8.9 The new position for the Mary Ann Johnson drinking fountain has been informed by historical research and repositions it within an historic context. Its new position is intended to be sympathetic to the existing gardens and structures while ensuring that it is not vulnerable to damage or vandalism.

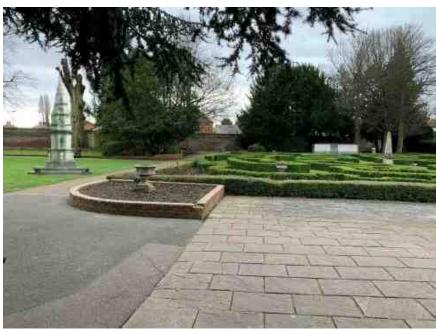
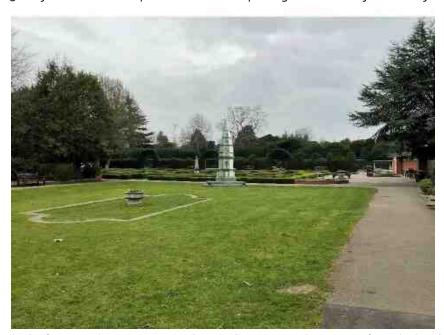
Image 25 The fountain shown in position close to the peace garden as seen from the cafeteria

${\it Image~26 The fountain shown in position close to the peace garden~as seen from~the~bandstand}$

7.1.1 This position, while giving a good view of the fountain from close to the cafeteria area, it dominates the area. At 6metres tall the fountain is more than twice the height of the obelisks within the garden, this can be seen from images 25 &26. Because of this it takes the eye away from the smaller obelisks and the memorial plaques that are at ground level.
