Side Elevation

### Rear Elevation

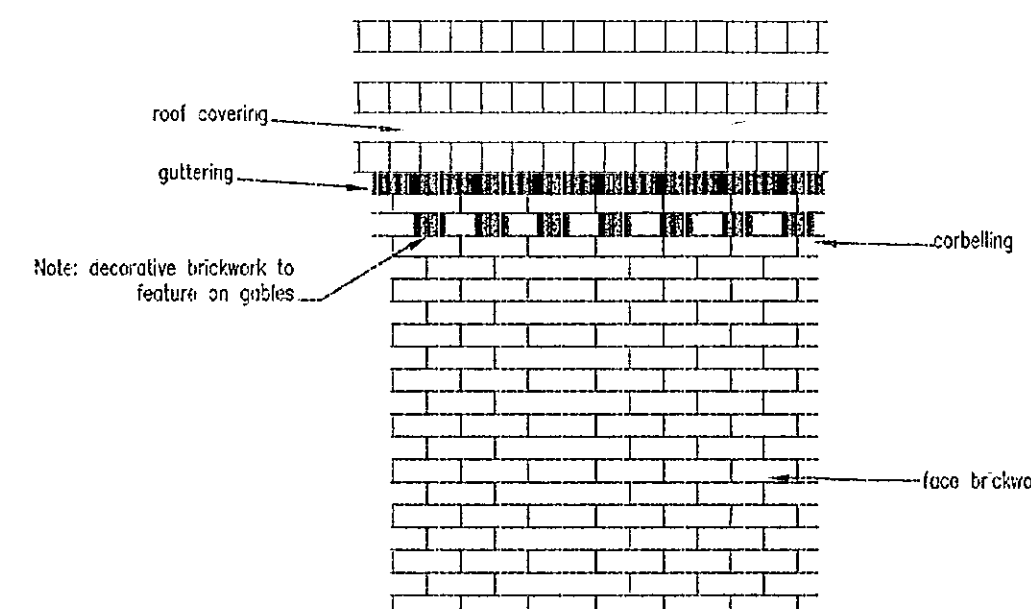
STONE CILL DETAIL 125

Note: decorative brickwork to

face bricks
