Client:  
**South Holland District Council**

Project:  
**Proposed Alterations To,  
The Square  
Church Street,  
Spalding**

Drawing Title:  
**North Block Proposed Ground Floor  
LBC & B.REGS & TENDER ISSUE**

Drawing Number:  
**A1103 - 15**

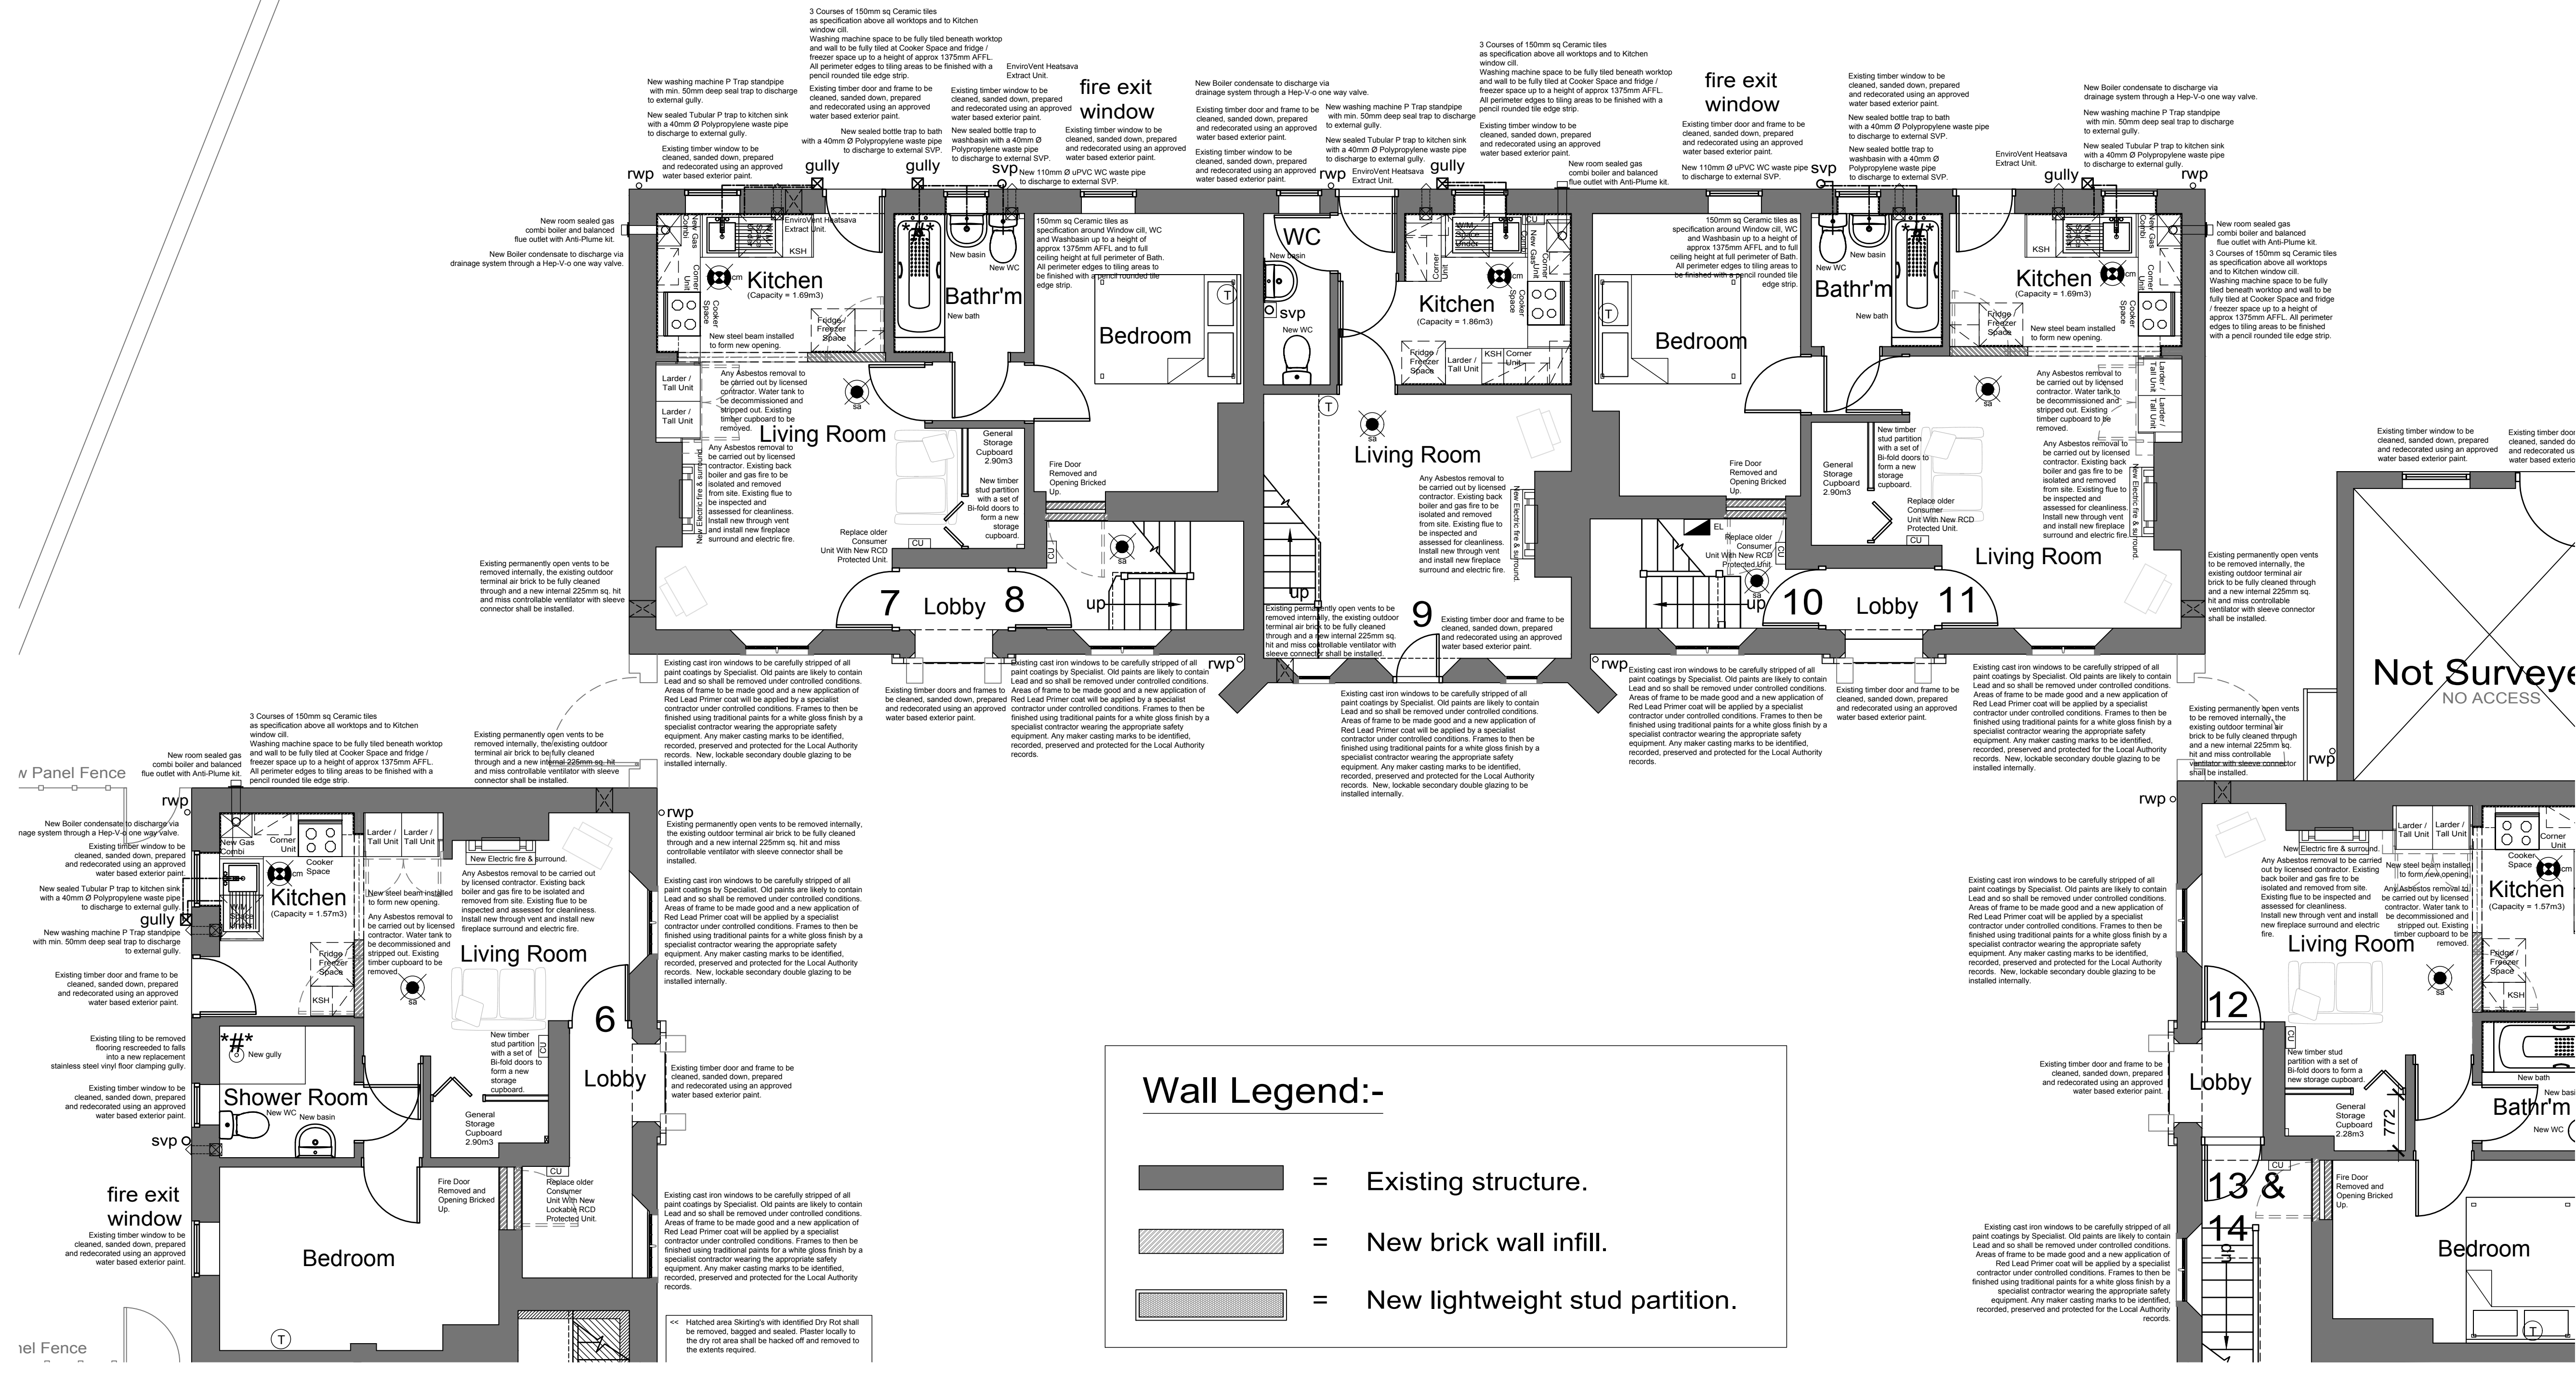
## Proposed Ground Floor Layout - (Scale : 1 to 50@ A1 Size) NORTH BLOCK

- The Works:-  
The Works generally comprise of the following:-
- Refurbishment & redecoration of all cast iron and timber windows.
  - Removal of internal secondary glazing and replacement with new.

- Refurbishment & redecoration of all external doors and frames.
  - Removal, refurbishment, repair, redecoration & refitting of cast iron rainwater goods.

- Removal of water storage cylinders, & demolition of encasing cupboards.
  - Formation of new openings through internal walls & installation of support structure.

- Strip out of kitchens and installation of new fitted kitchens complete with splashbacks etc.
  - Strip out of Bathrooms and installation of new sanitary appliances and splashbacks etc.

- Removal of gas fires and back boilers and their replacement with new electric fires.
  - Removal of kitchen radiators and their replacement with electric kick space heaters.

- Alterations and upgrading of electrical installation including installation of new consumer units.
  - Installation of new ventilation units.
  - Formation of new Store cupboards for general storage using stud partitioning and doors.

- Installation of new fire signage and detectors.
  - Installation of new Carbon Monoxide detectors in rooms with flues passing through or with gas appliances fitted within.
