| Ref. | Date | Description | Initial |
|---|---|---|---|
| Project:<br><b>Proposed Alterations To,<br/>The Square<br/>Church Street,<br/>Spalding</b> | | | |
| Drawing Title:<br><b>Unit Kitchen Layouts - Sheet 2 of 2</b><br><b>LBC &amp; B.REGS &amp; TENDER ISSUE</b> | | | |
| Drawing Number:<br><b>A1103 - 23</b> | | Rev:<br><b>-</b> | |

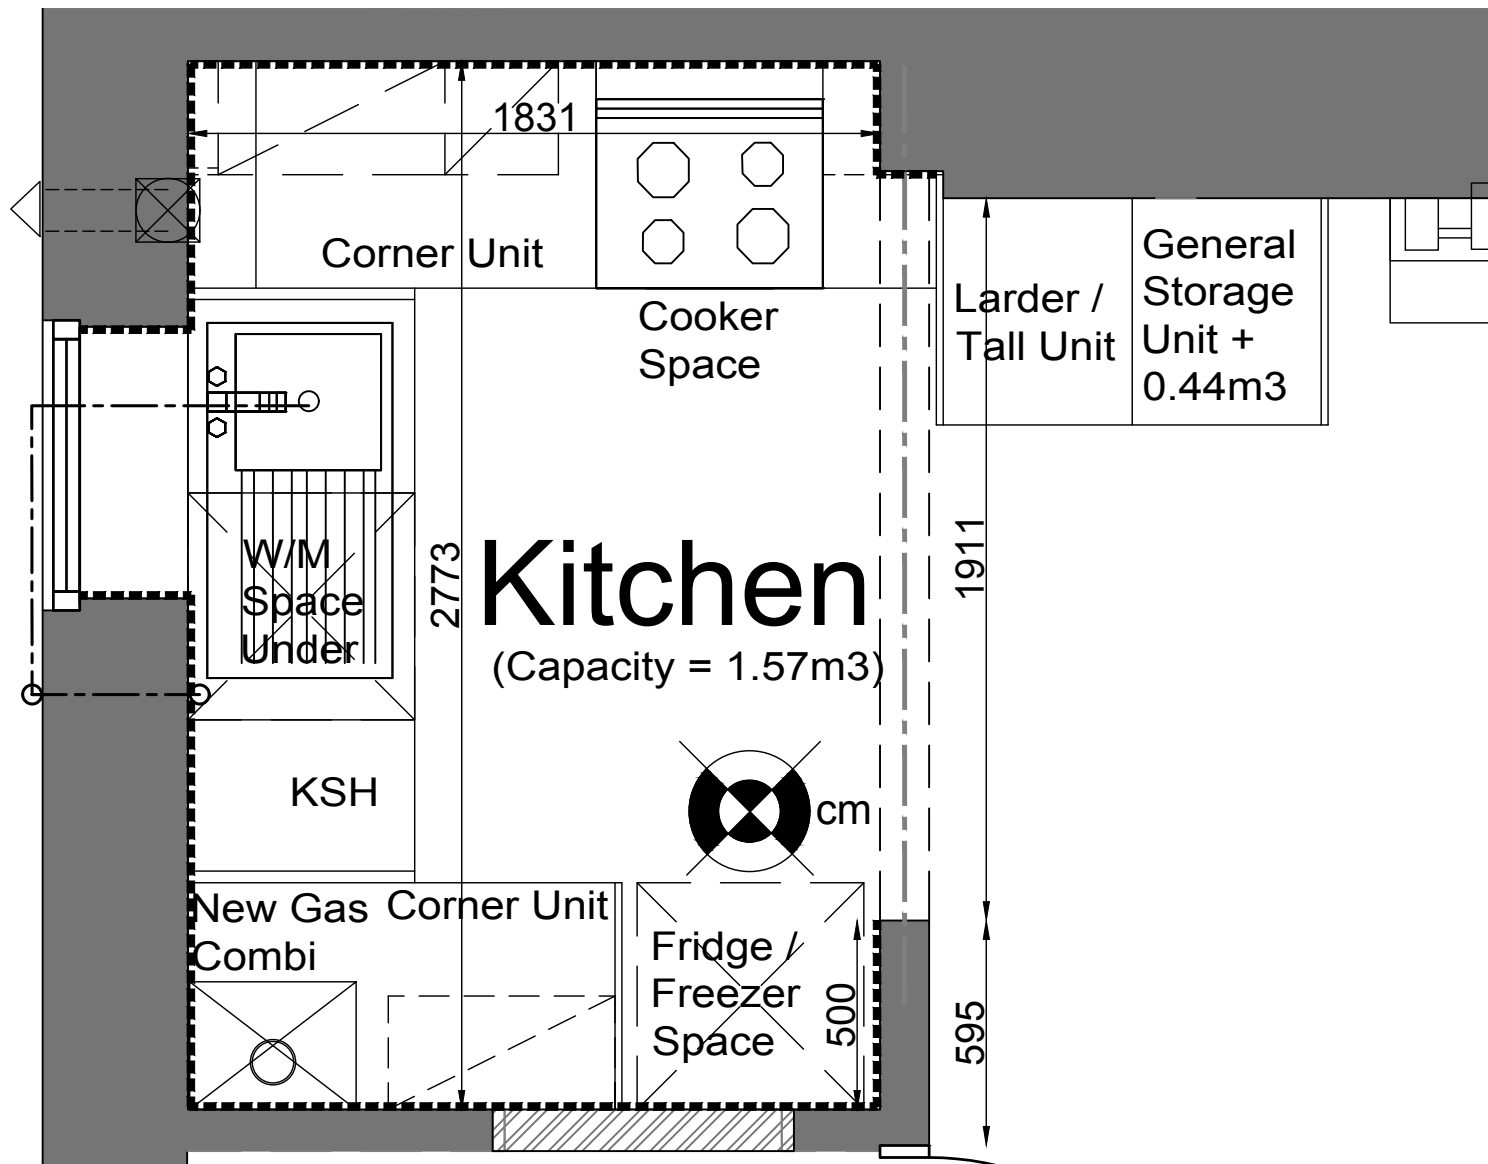
Units 1 and 14 and Units 4 and 13 (handed) Kitchen Layout - (Scale : 1 to 20@ A1 Size)

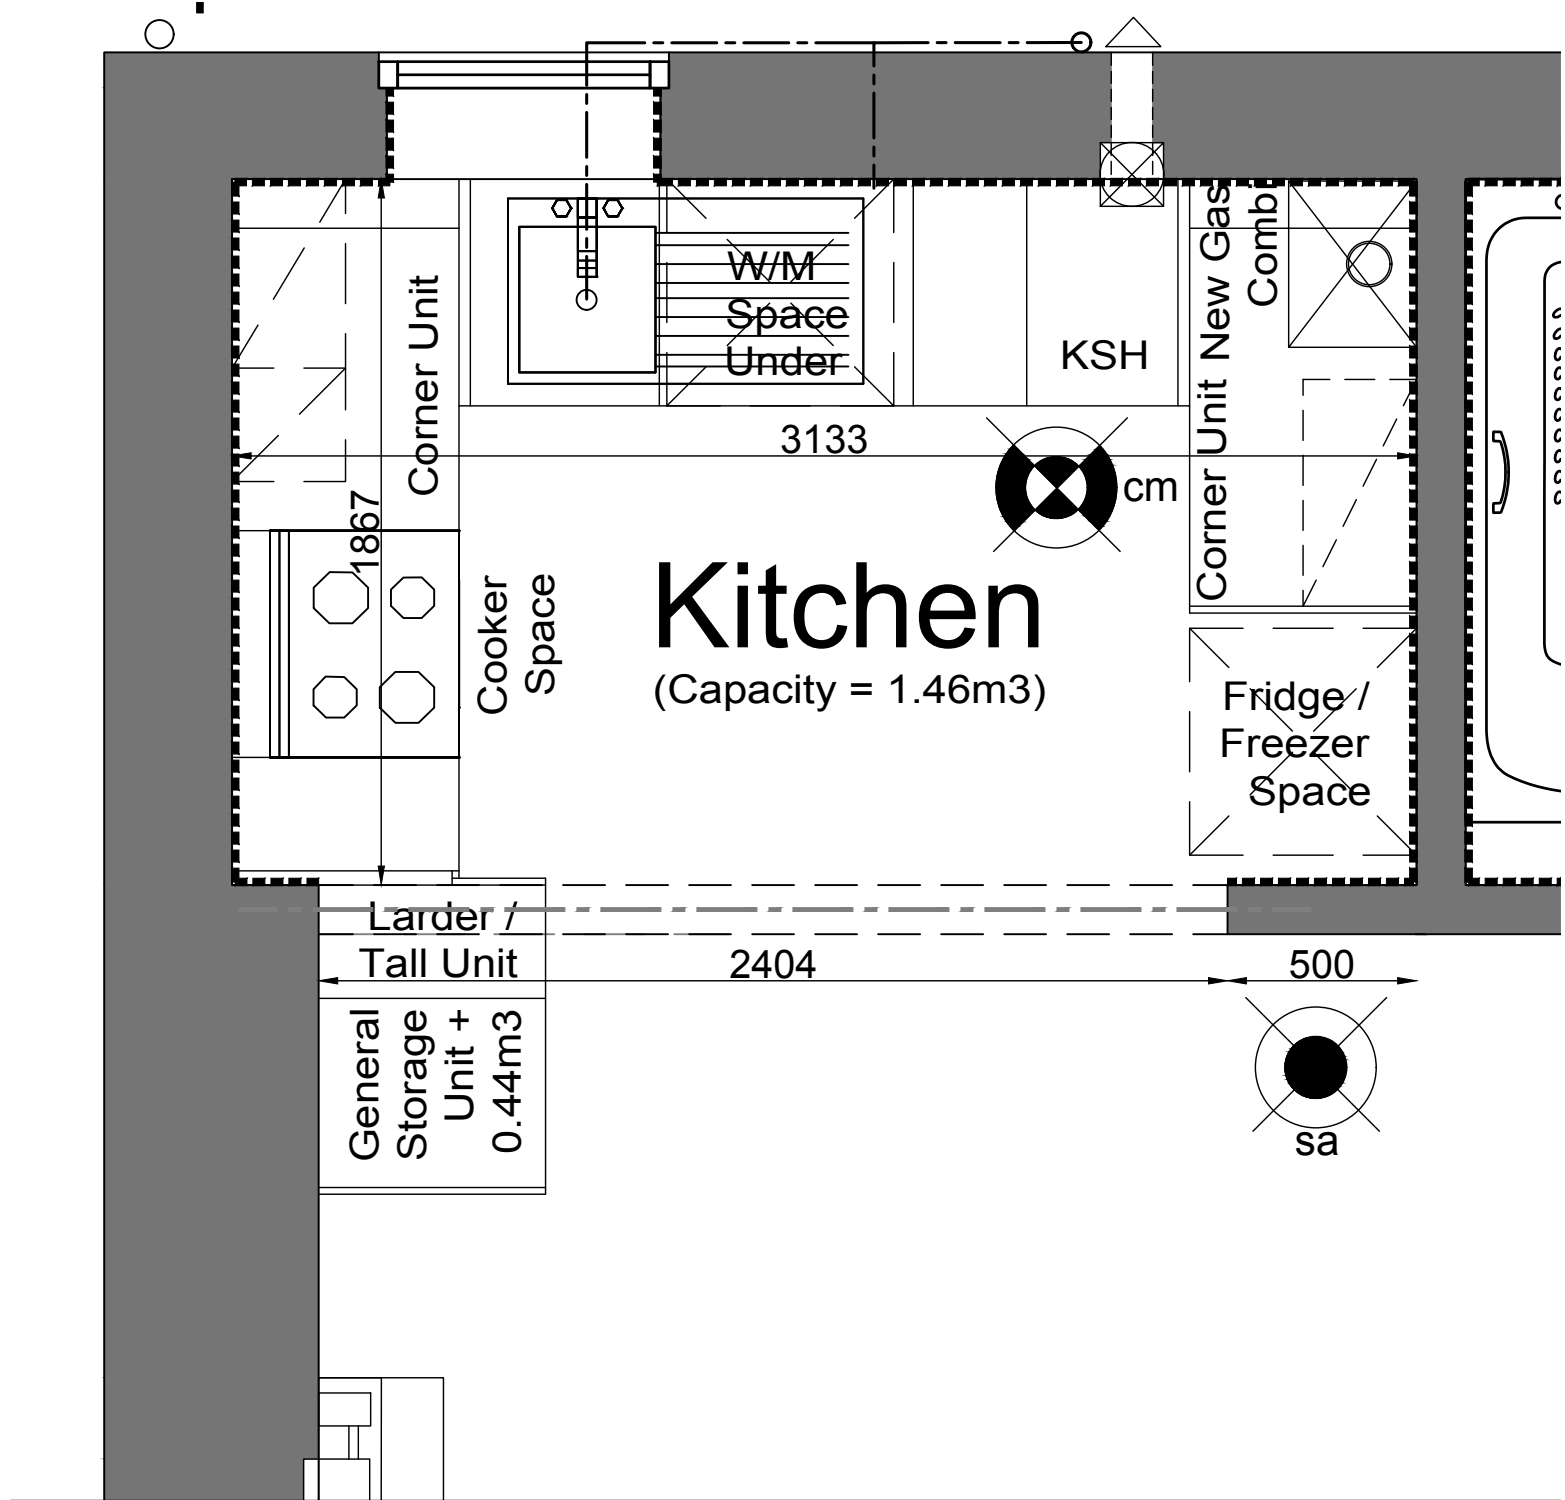
Unit 8 and Unit 10 (handed) Kitchen Layout - (Scale : 1 to 20@ A1 Size)
