Client:  
**South Holland District Council**

Project:  
**Proposed Alterations To,  
The Square  
Church Street,  
Spalding**

Drawing Title:  
**External Window Frontage Works  
And Key Plan.**  
**LBC, B.REGS & TENDER ISSUE**

| <b>A1103 - 27</b> | <b>-</b> |

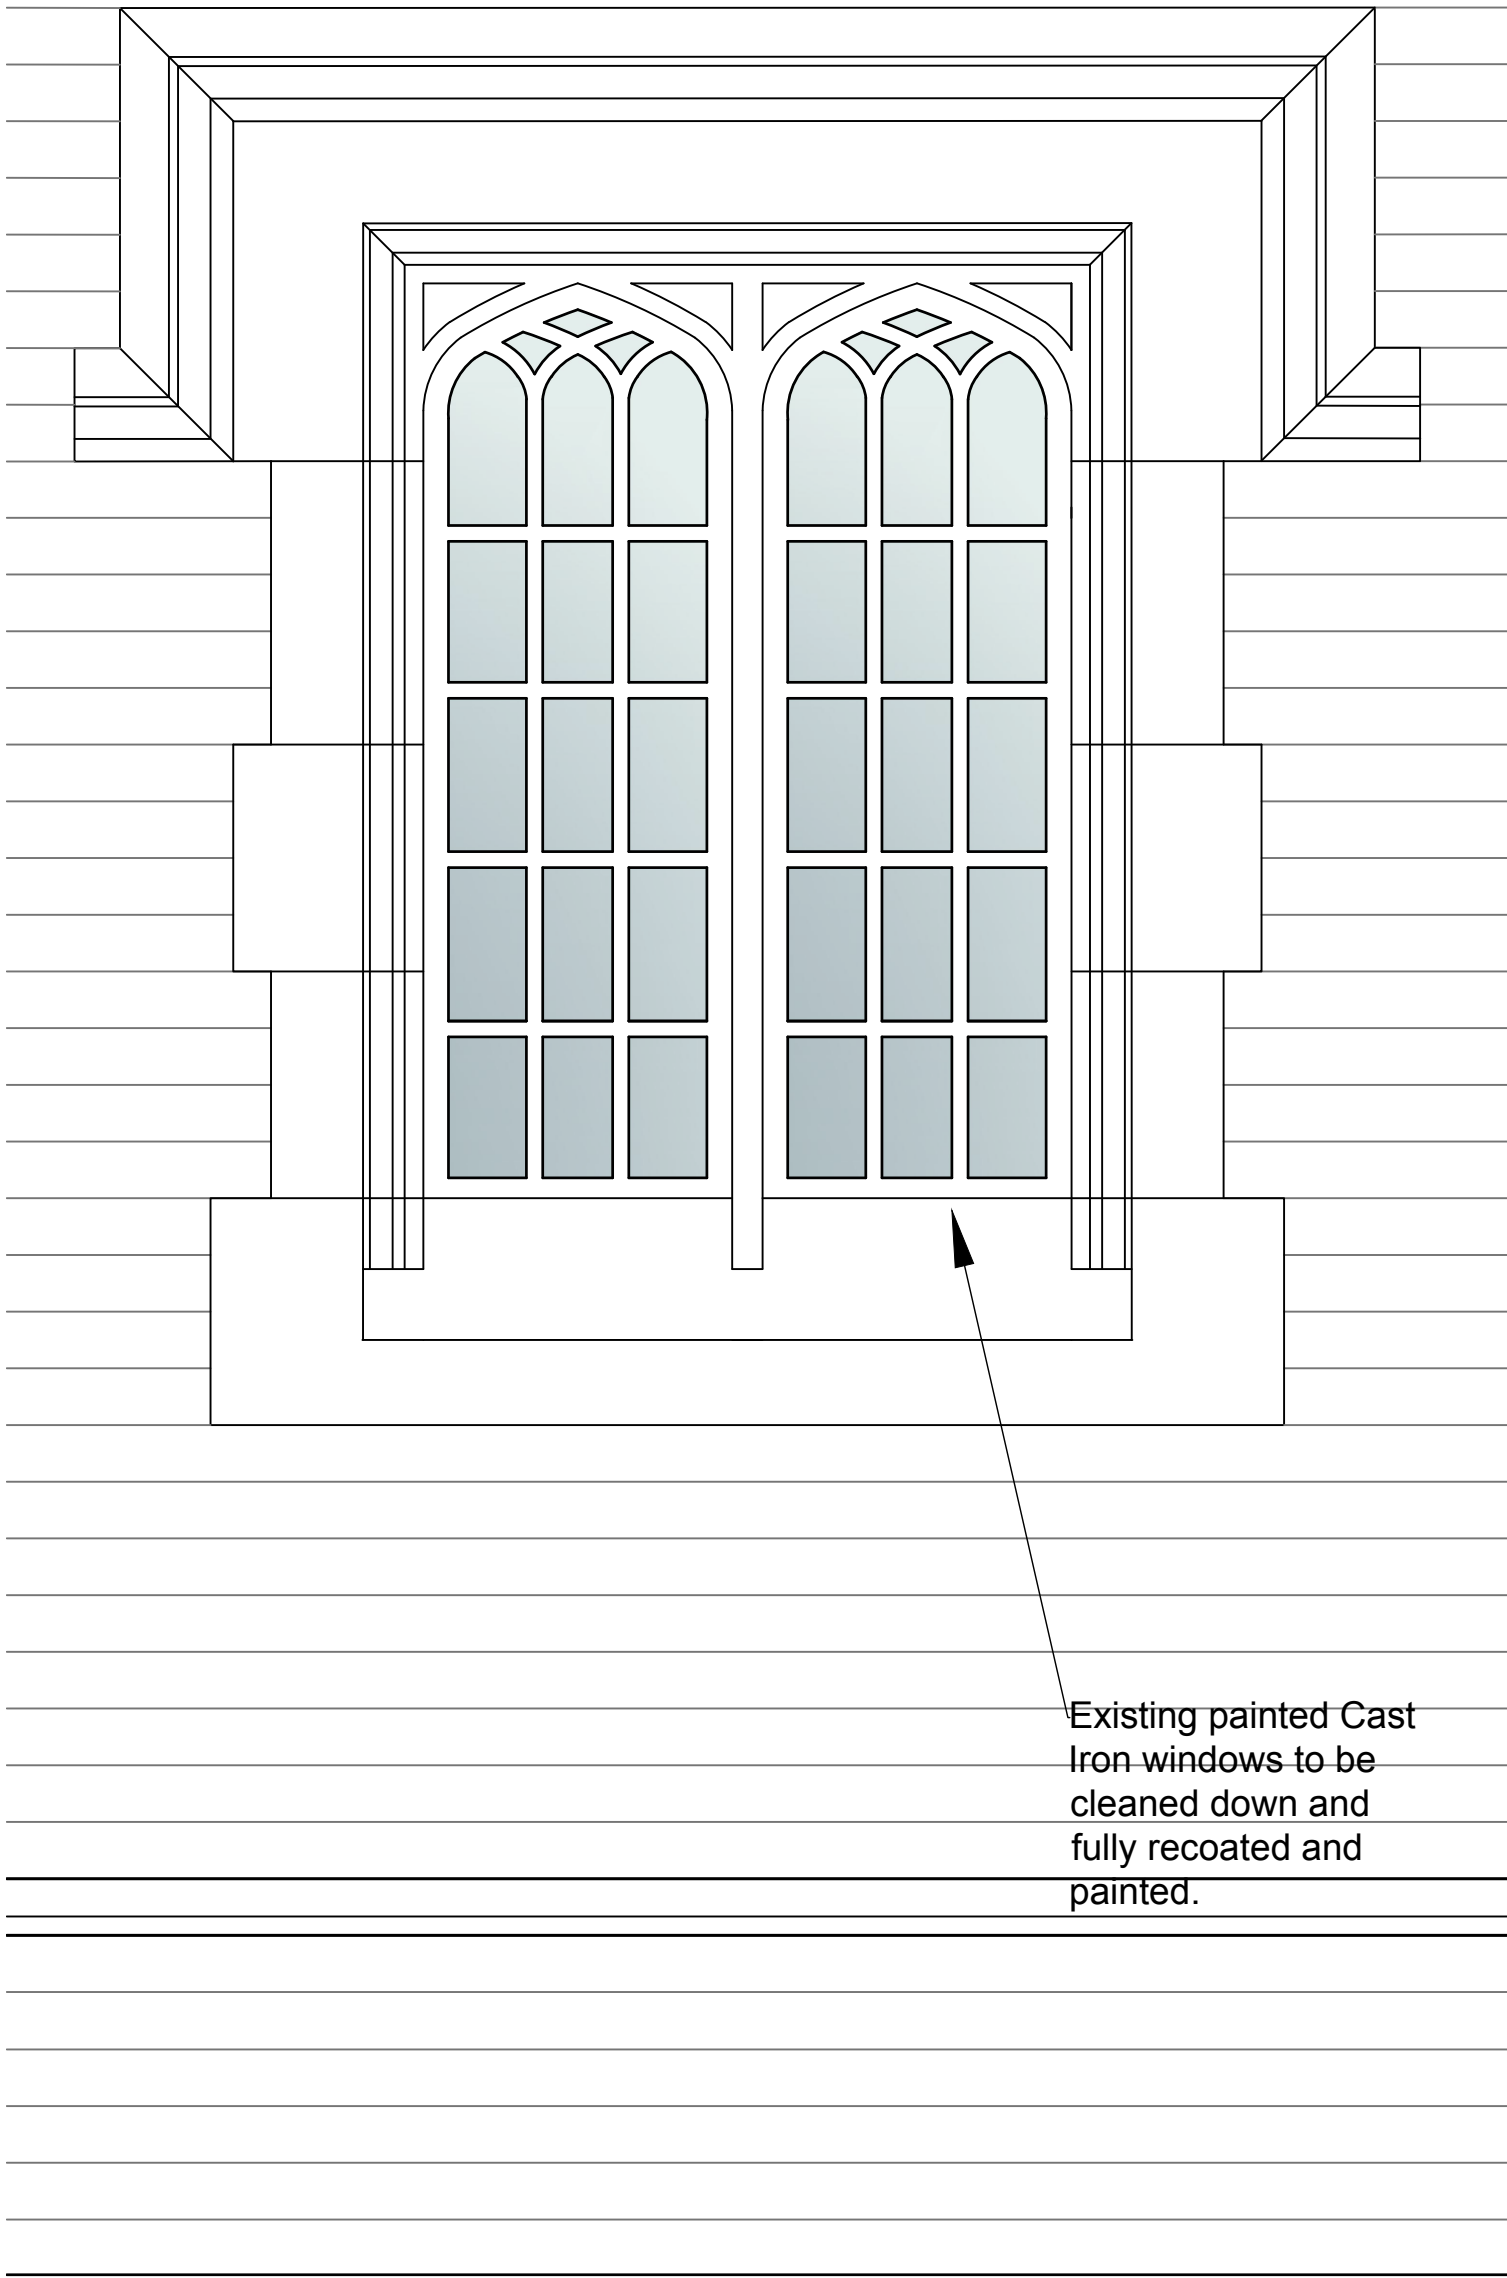
Typical Window External Elevation -  
(Scale : 1 to 10 @ A1 Size)

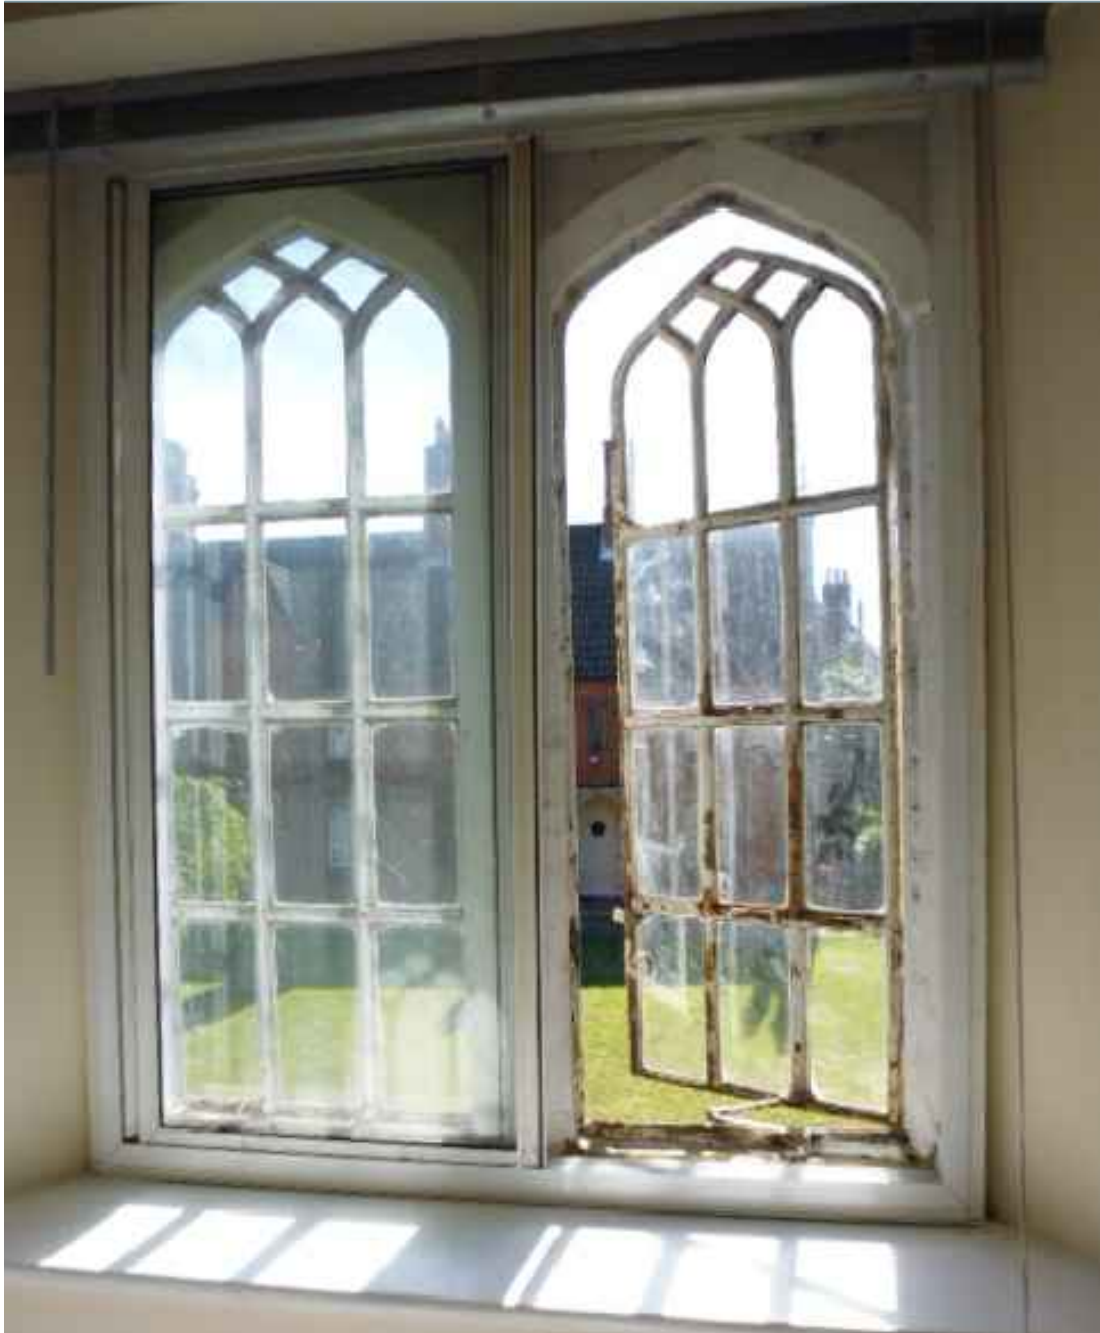
Internal Photo Of Cast Iron Period Window  
And Existing Secondary Glazing (Windows 1 to 35).

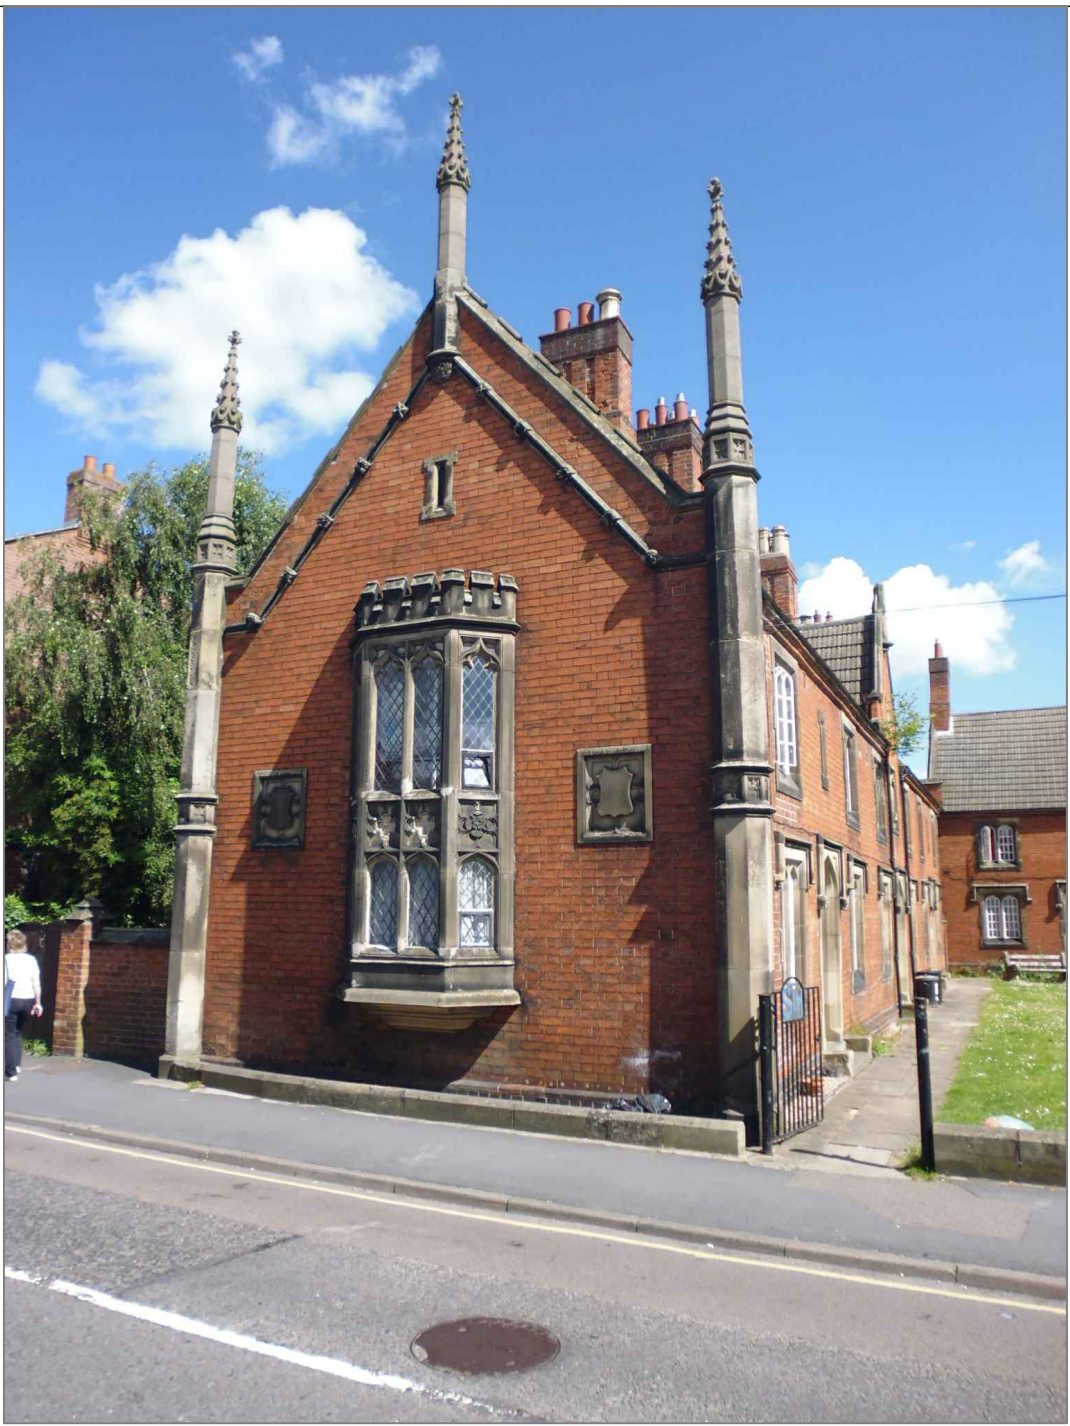
External Photo Of Cast Iron Period Window  
And Leaded Light Glazing.  
(Windows B1 to B4)

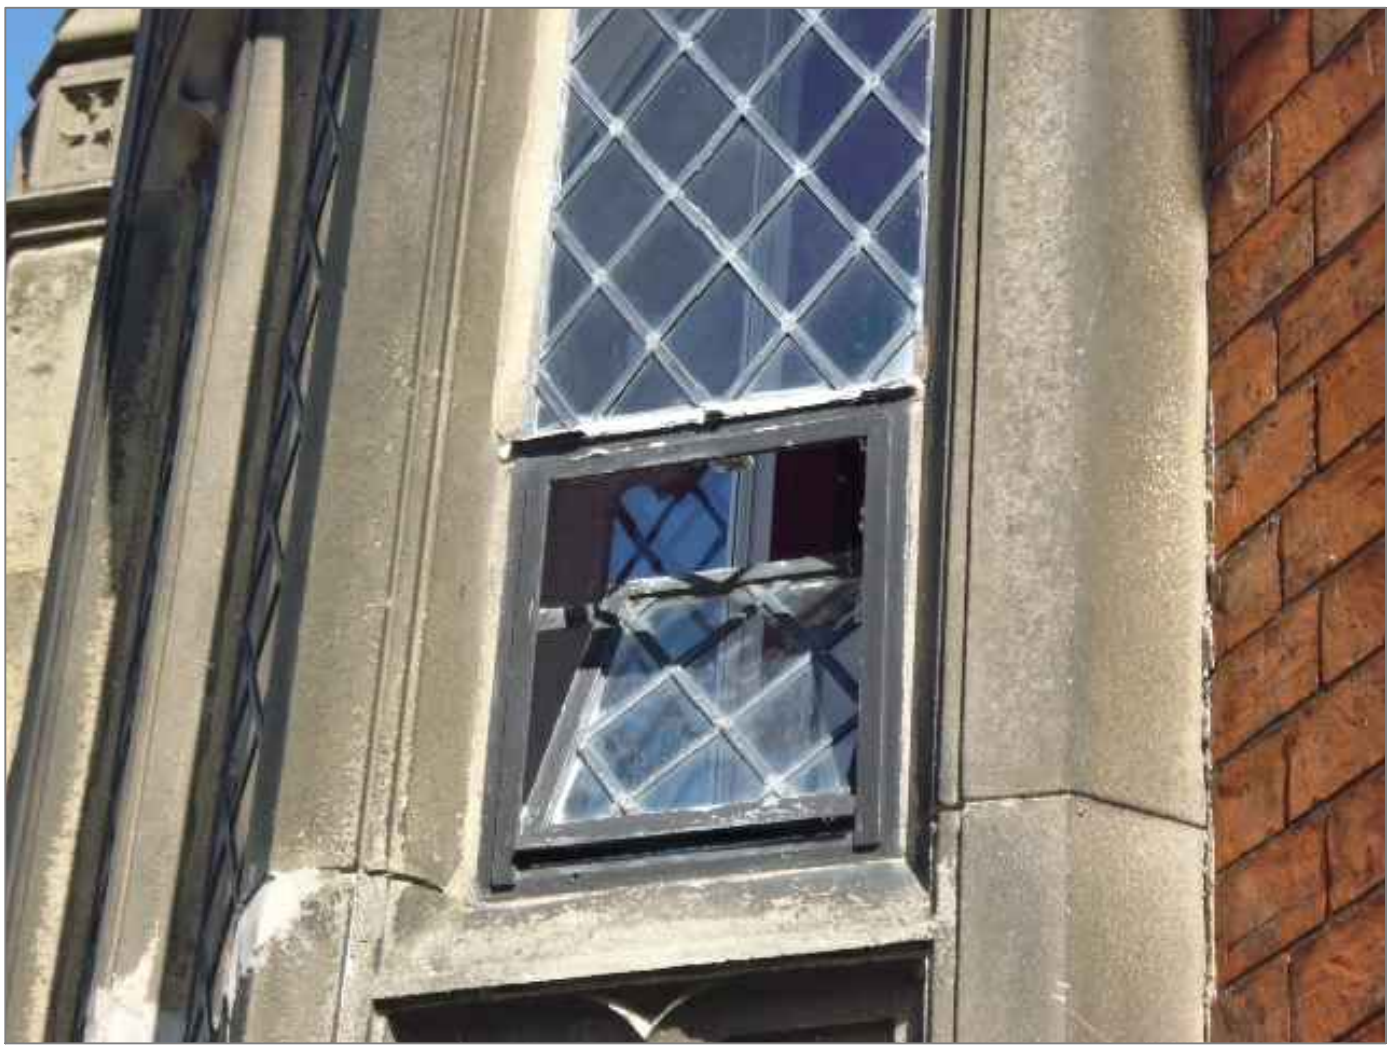
External Photo Of Cast Iron Period Window  
And Leaded Light Glazing.  
(Windows B1 to B4)

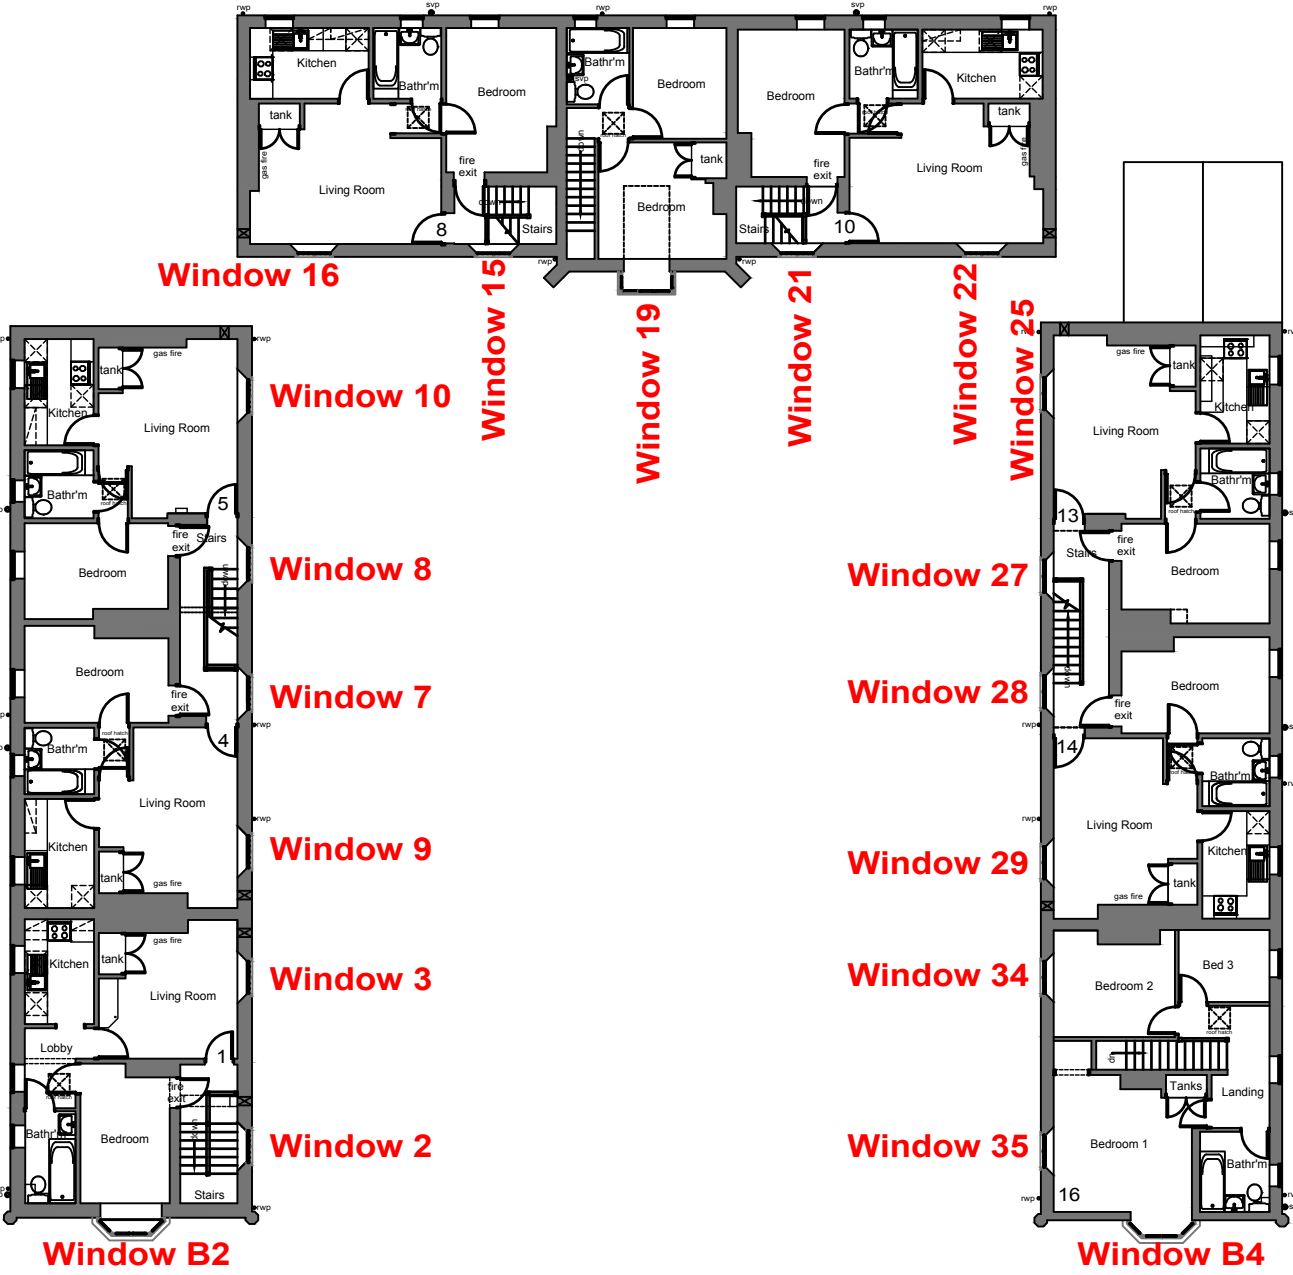
Key Layout First Floor Plan  
(Scale : 1 to 200 @ A1 Size)

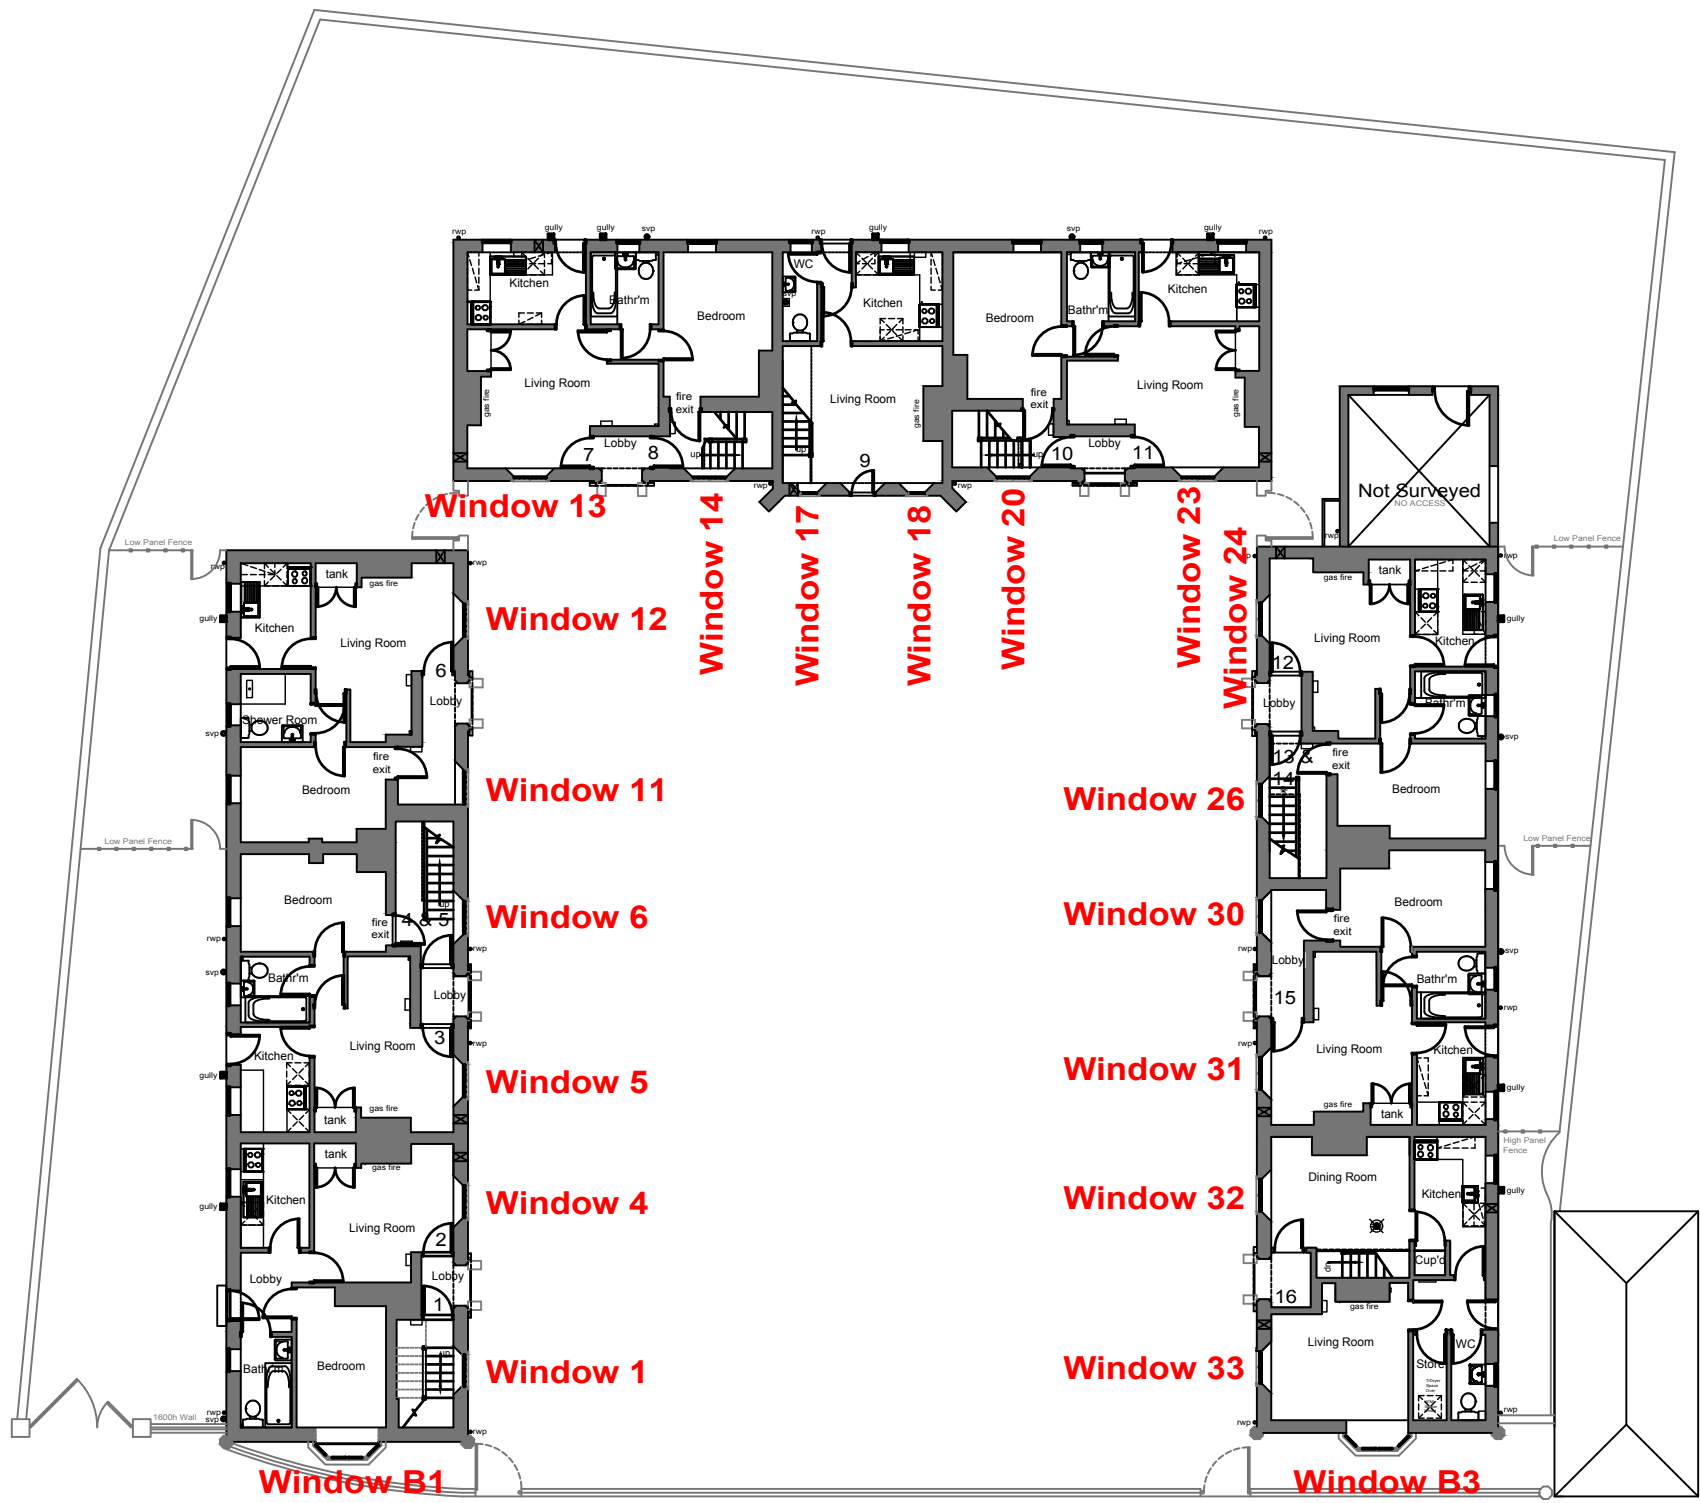
Key Layout Ground Floor Plan  
(Scale : 1 to 200 @ A1 Size)
