Project:  
**Proposed Conversion of Office to Dwelling at 15 High Street Spalding PE11 1TW**

**Elevations and Photos**

**PLANNING / LBC APPLICATION ISSUE**

| Drawing Number: | <b>A1609-03</b> | Rev: | <b>P2</b> |

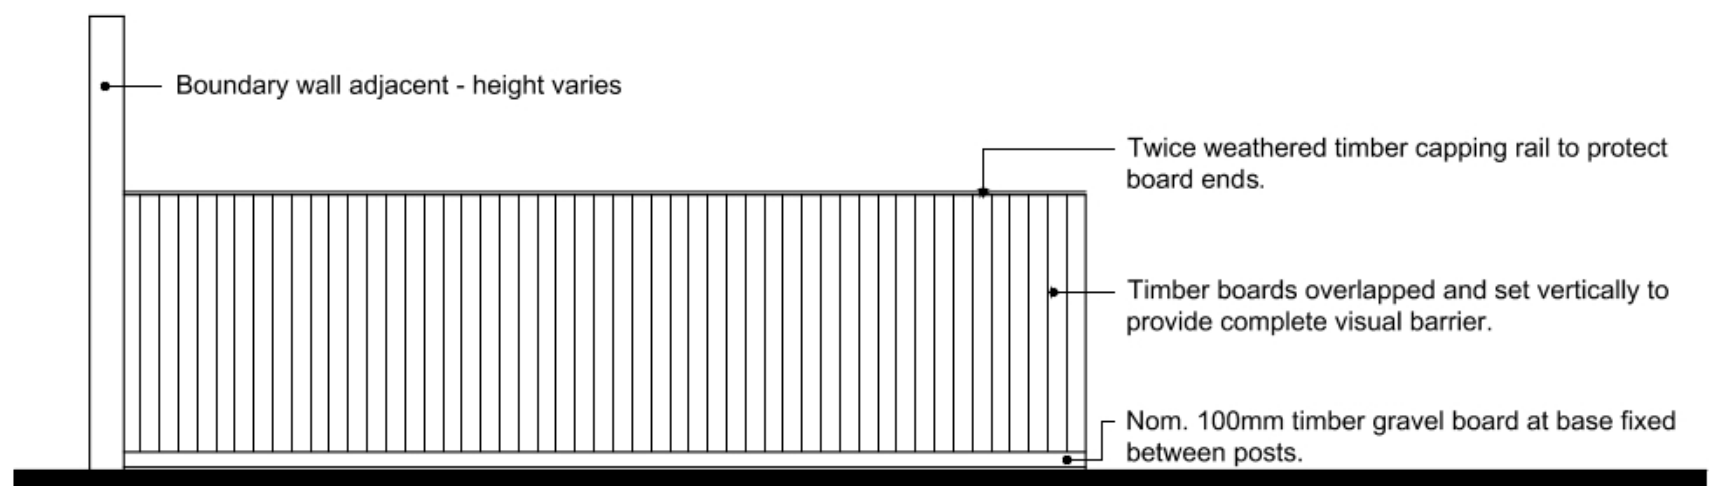
Rear Boundary Fence Details - Typical elevation from outside of site.

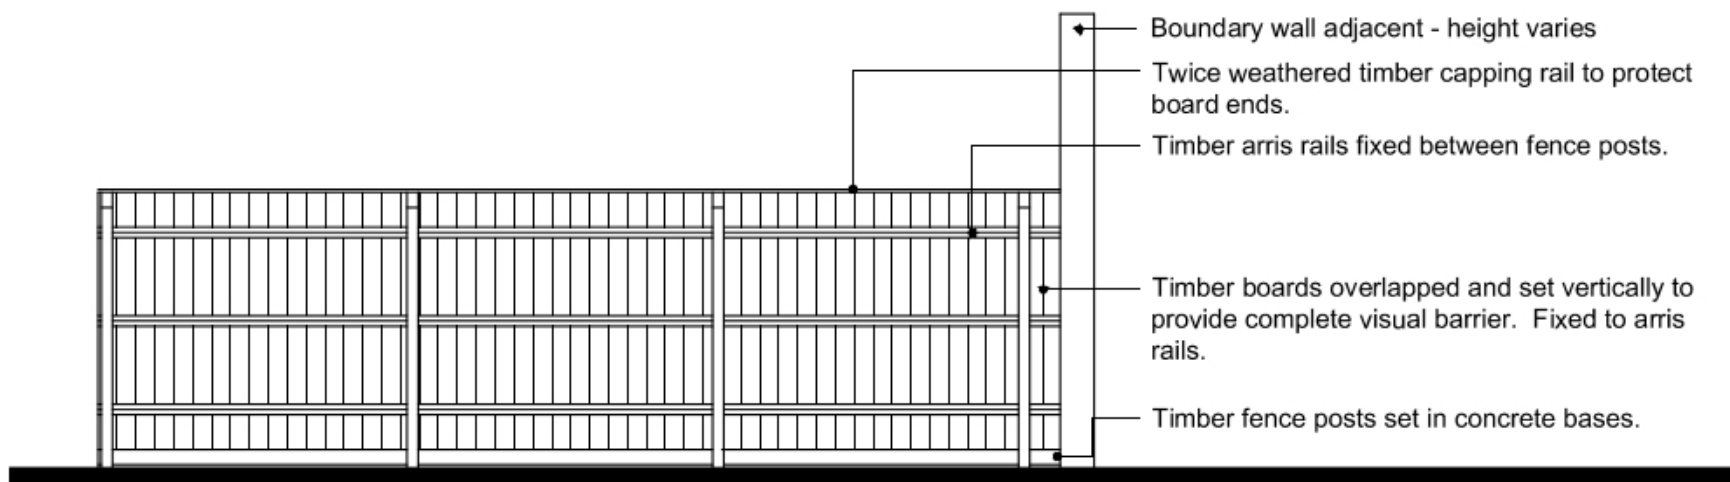
Rear Boundary Fence Details - Typical elevation from inside of site.  
Scale 1:50

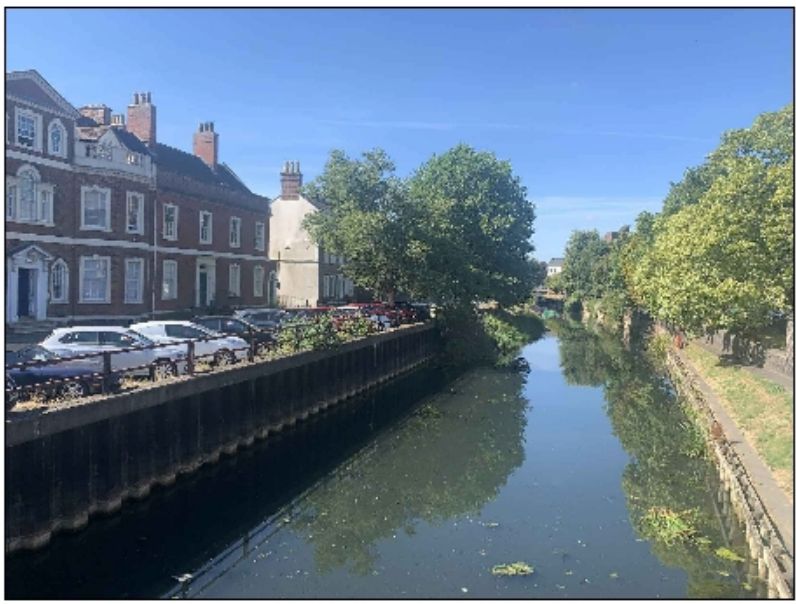
East (rear) elevation

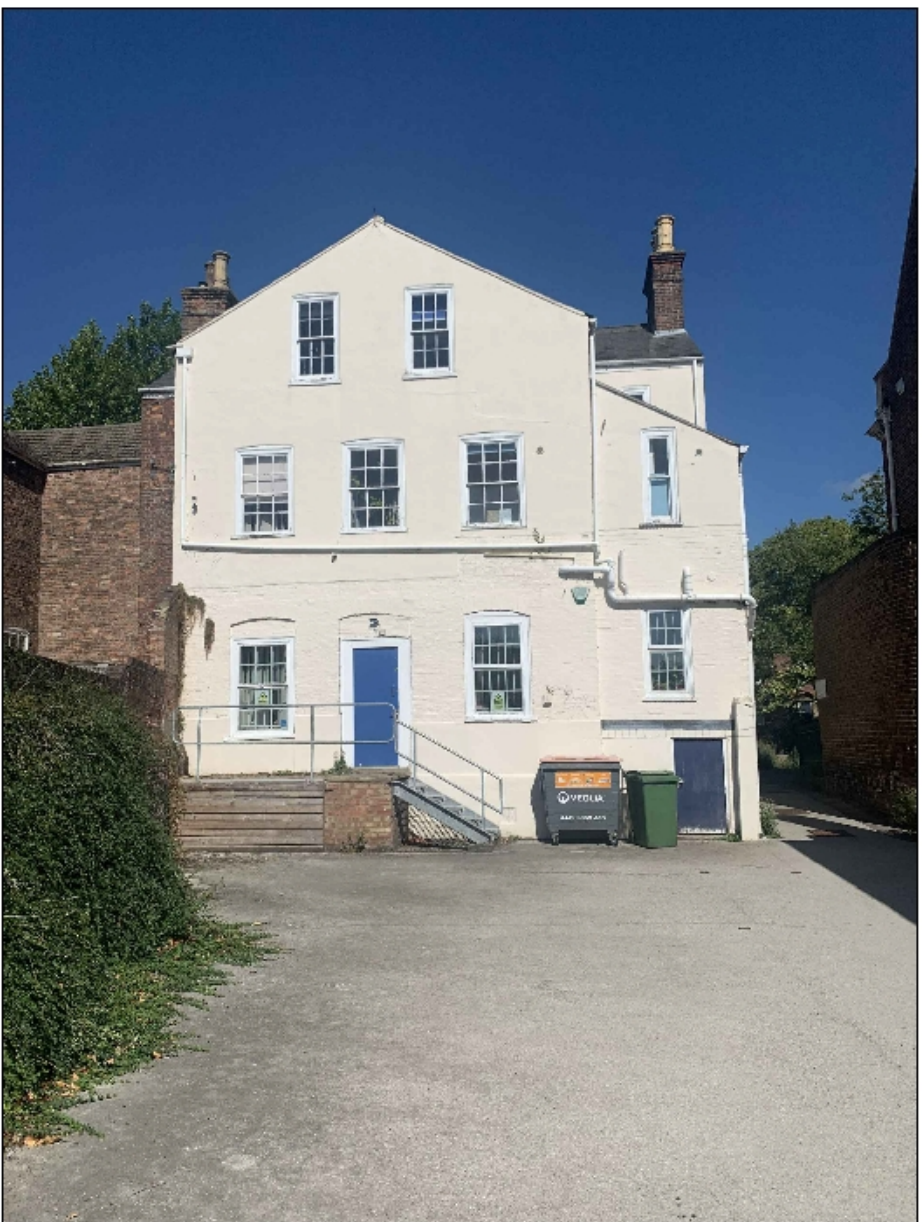
West (front) elevation viewed from the parking area
