**Project:** Planting masterplan for residential development.

**Location:** Land at Lucks Bridge, South Drove, Spalding Common, Lincs

**Drawing No:** LUC/22/01. **Date:** July '22

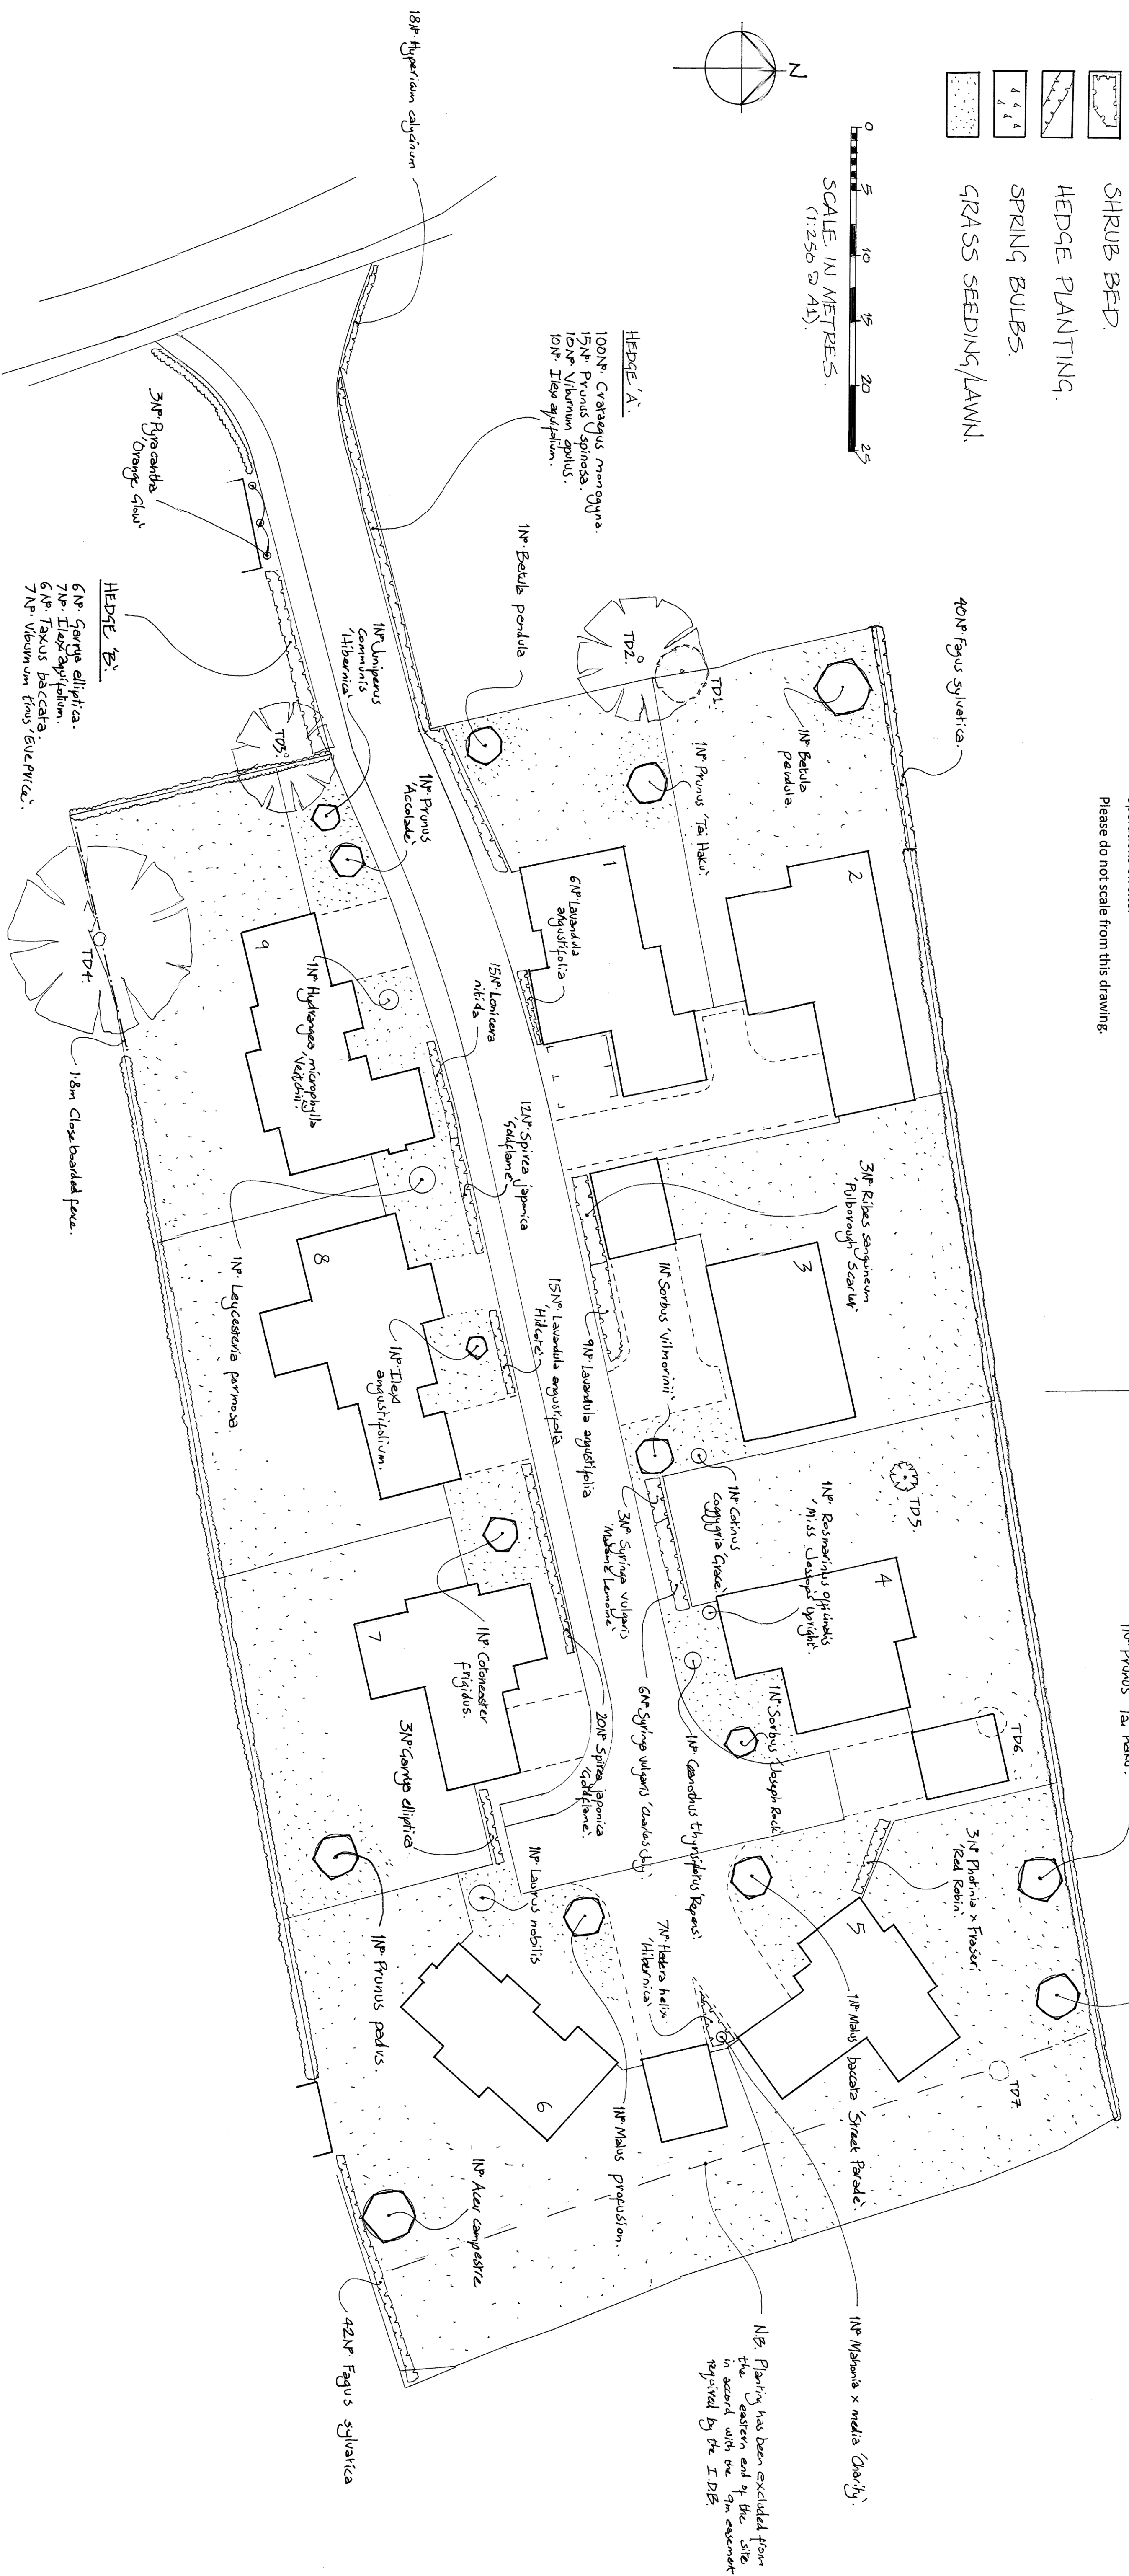
N.B. This planting plan has been prepared to satisfy conditions 3(iv), 5, 6 (part) & 10 of the planning consent for the development of the site for residential

## TREE SURVEY:

| Ref. | Botanical Name | Common Name | Ht. | Canopy Ø. | Trunk Ø | Condition/Remarks. |
| TD1 | <i>Sambucus nigra</i> | Elder. | 3.5m. | 4m | m/s. | Good. Self v seedled. Remove. |
| TD2 | <i>Quercus robur</i> . | Oak. | 9m t | 10m. | 0.6m. | Previously pollarded. Good amenity value. Retain. |
| TD3 | <i>Betula pendula</i> | Silver Birch. | 8.5m. | 8m. | 0.28m | Good rounded crown. Retain. |
| TD4 | <i>Aesculus hippocastanum</i> . | Horse Chestnut. | 12m t. | 15m | 14m. | Veteran. Lots of dead wood. Advanced in y growth. Clear evidence of leaf miner. Monitor. |
| TD5 | <i>Rumex cerasifera</i> Naga. | Purple leaved plum. | 5m. | 6m. | 0.15m. | Split stem o base. Retain. |
| TD6 | <i>Malus sylvestris</i> . | Crab Apple. | 4.5m. | 2.3m. | — | Biprivated stem 500mm above G.L. Good canopy, self-seeded. Remove. |
| TD7 | <i>Fraxinus excelsior</i> . | Ash. | 4m. | 2.5m. | m/s. | Poor form, self-seeded. Within ID18, excavate. Remove. |
