| REVISION | DATE | DRAWN | CHECKED | DESCRIPTION | SCALE | DATE |
|---|---|---|---|---|---|---|
| PROJECT | 14 Market Place, Spalding | DRAWN | CHECKED | | | |
| DRAWING TITLE | Shop Front Detail | JOB NUMBER | DRAWING NO. | REVISION | | |
| Elevation | | 231432 | 101 | B | | |

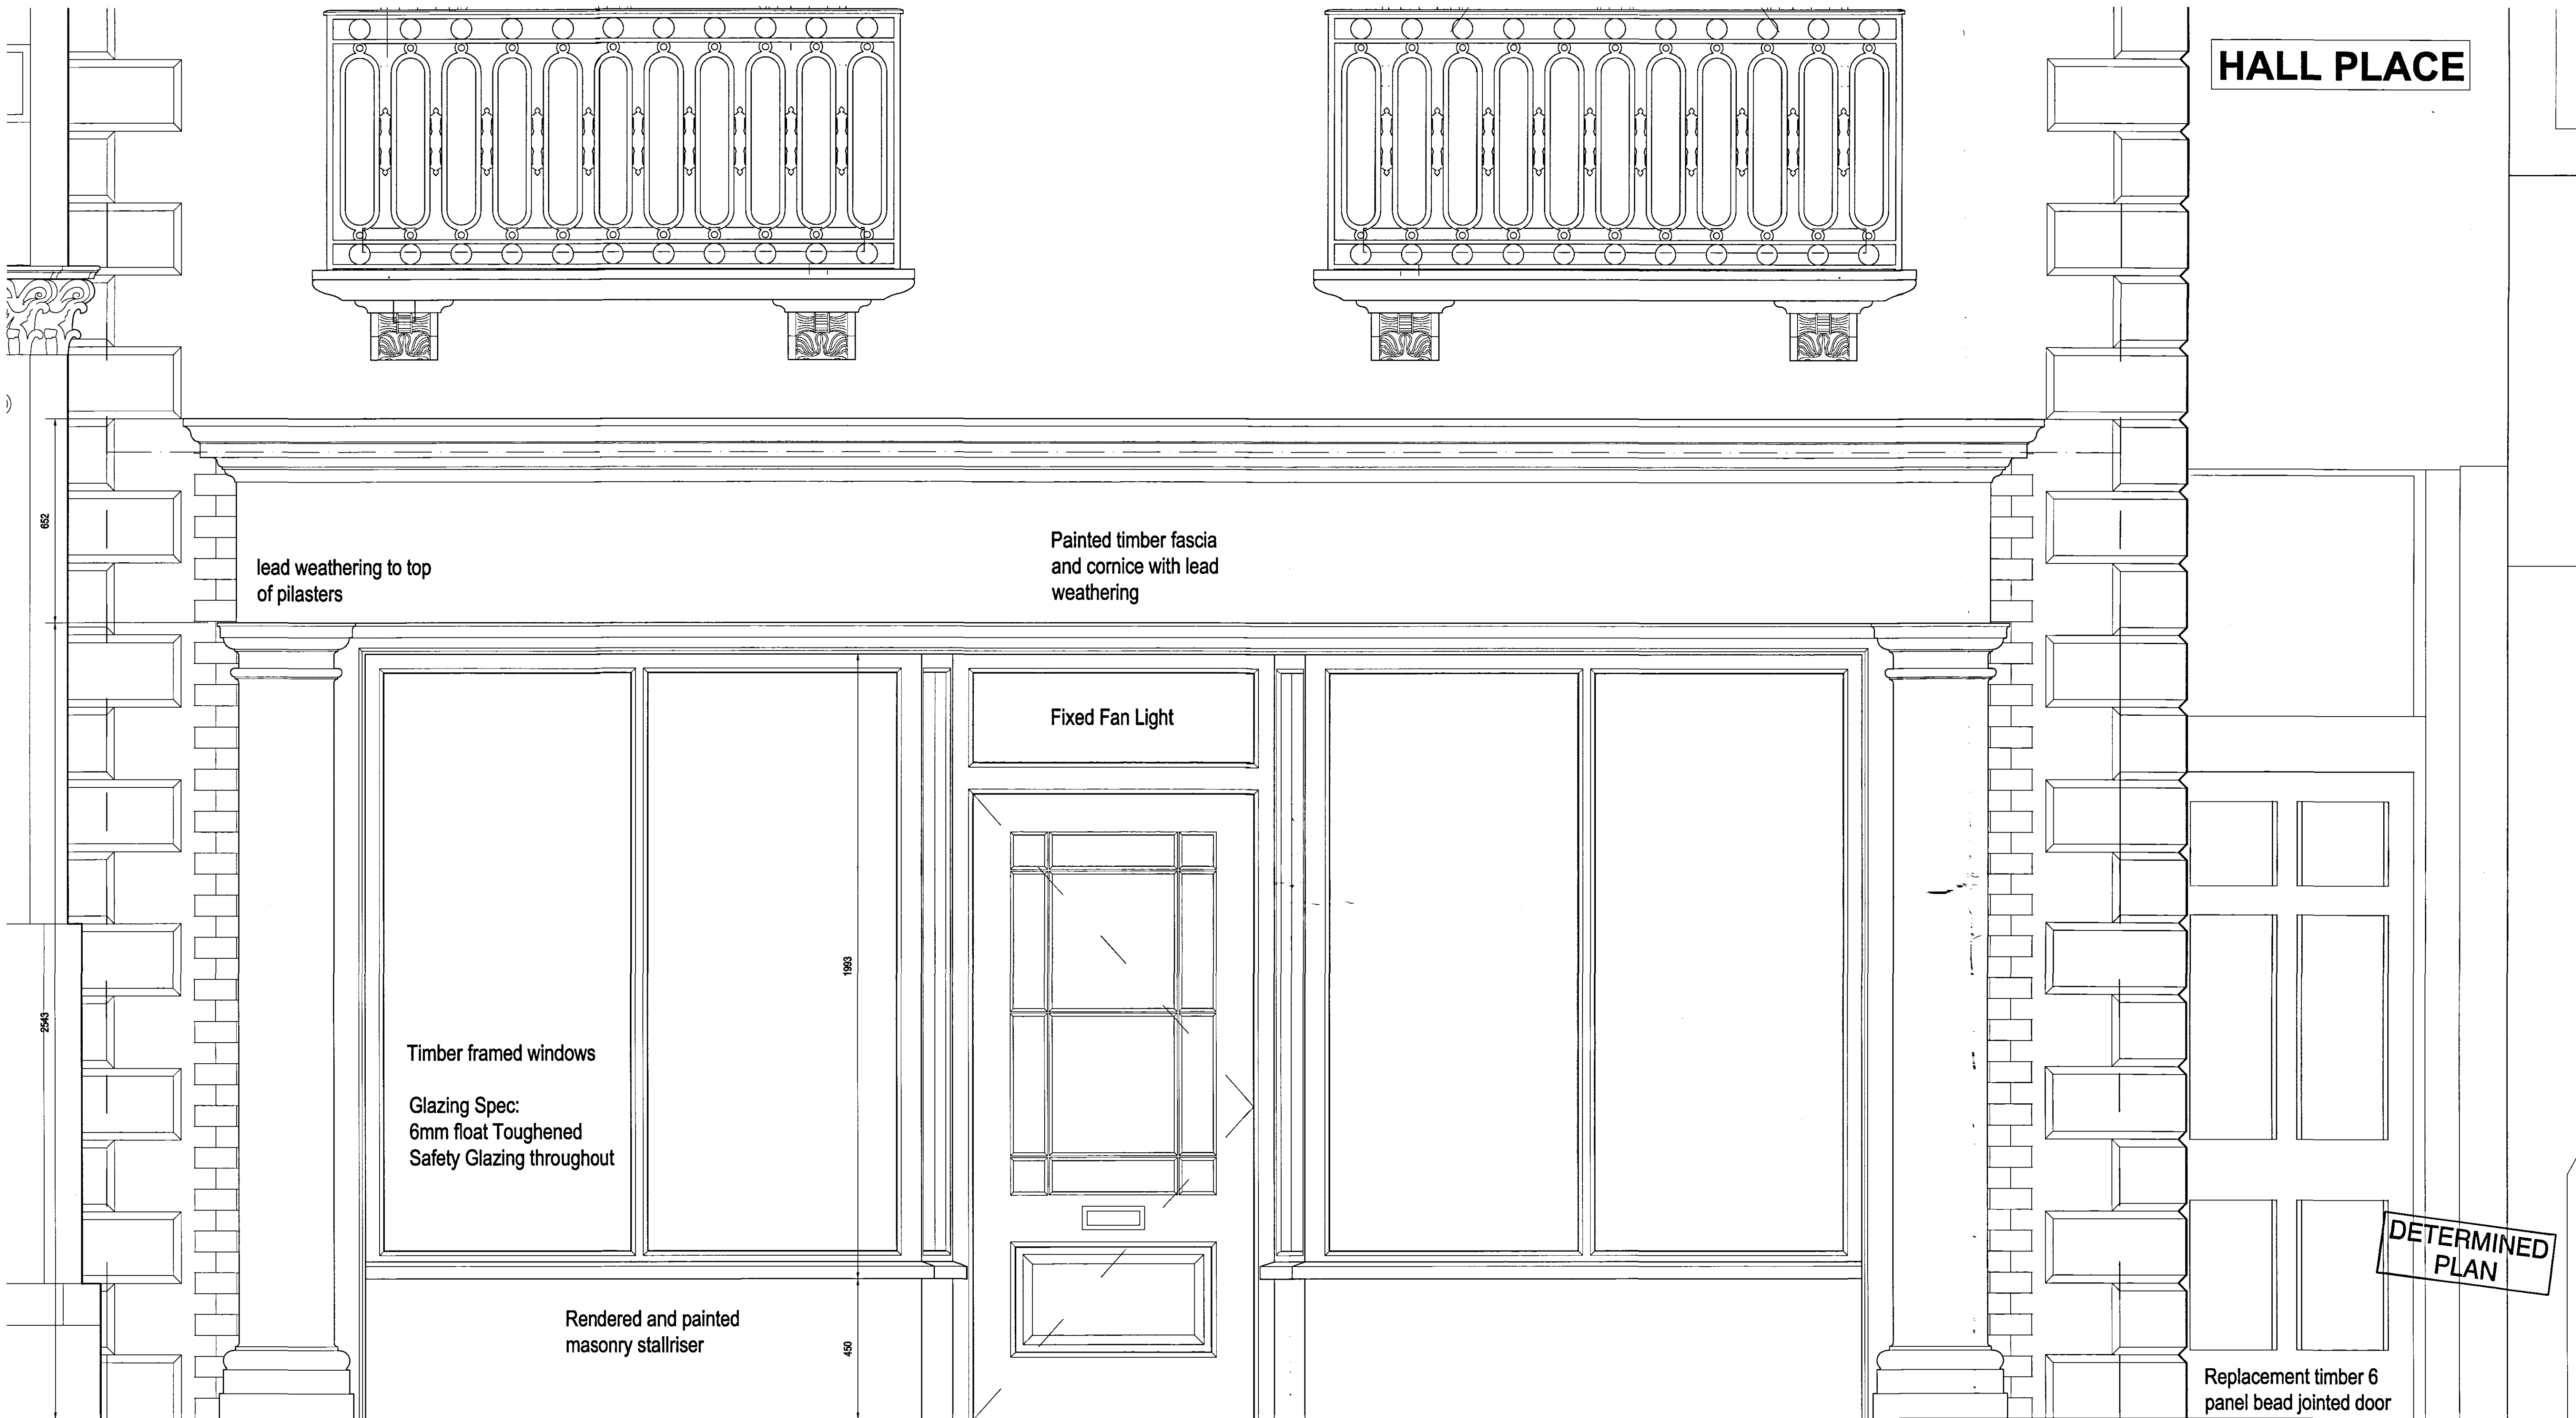
New brickwork to be neatly keyed into existing brick bond

Extent of damage to existing stone quoins to be surveyed post removal of facade. Care required to minimise any damage to the existing stonework during demolition

Timber glazed and panelled door
