#### **4. Potential Flooding Sources**

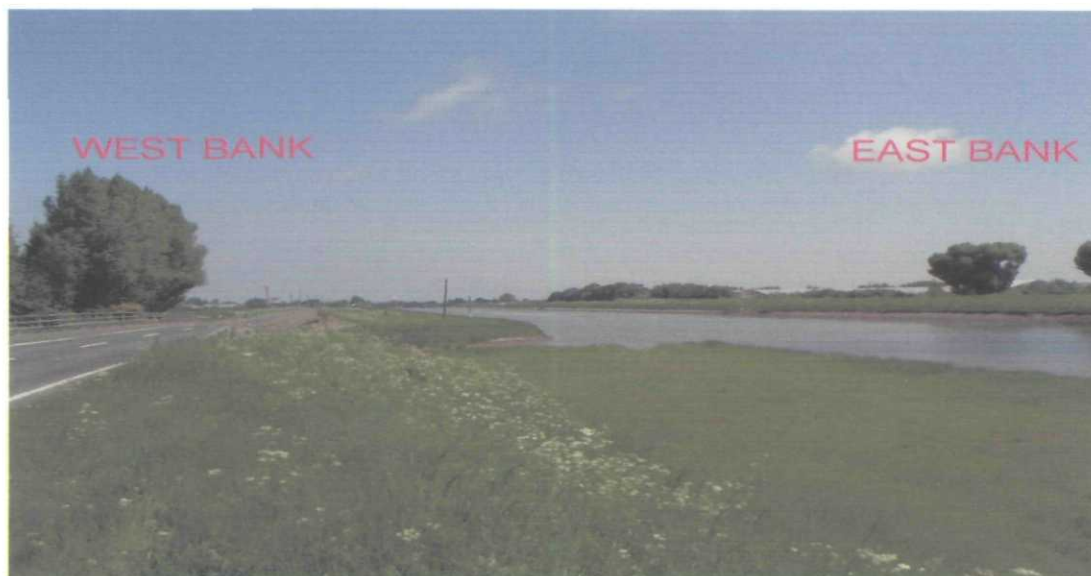
#### **TIDAL RIVER NENE**

- 4.1 A breach or over-topping of The River Nene embankments at this location is unlikely as the embankment levels 1 km to the North at Port Sutton Bridge would allow flood waters to escape downstream of this site into the former dock which is now Sutton Bridge Golf course, parts of which are at a level of 2.00 metres ODN.
