CHURCHGATE

#### SITE PLAN

15/10/97 - site survey

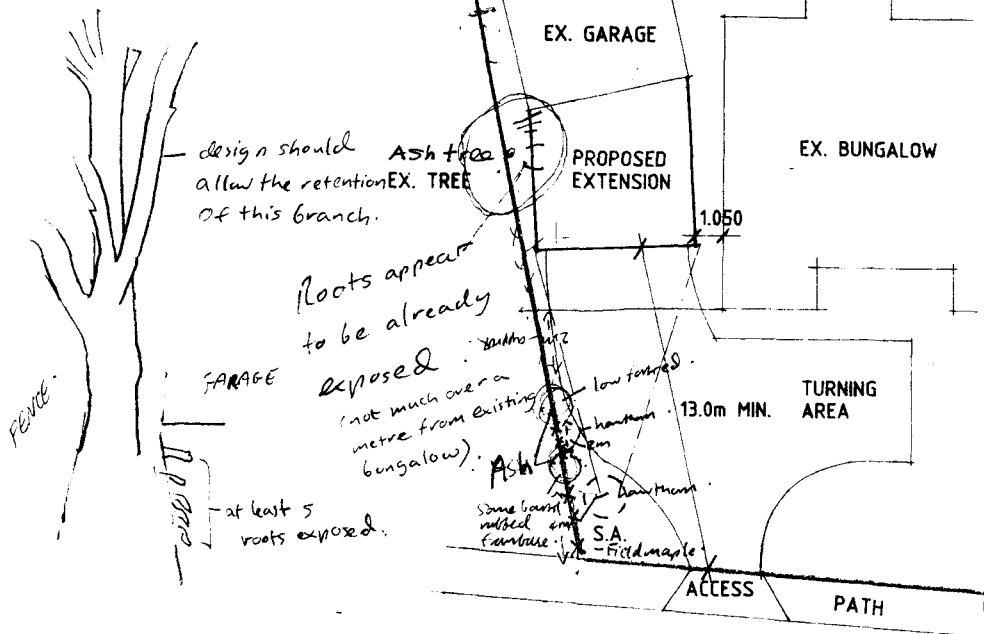
It is likely further roots will be damaged if the extension is allowed as angle reaches further back across root spread.

Be aware of root damage near frontage. Evidence of some root material exposed.

+ any change in soil level. If anything at present the soil level looks lowered - as roots exposed.
