# **Ground Gas Mitigation: Verification Inspection Report**

Pearsons Close  
(Prev. 128 Barrier Bank),  
Cowbit, Spalding, PE12 6AL

Issue 2

March 2026

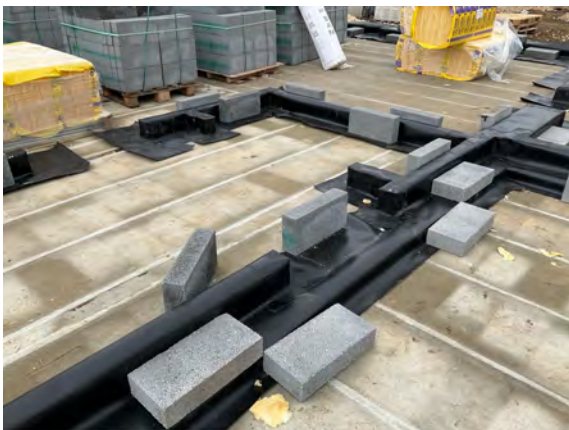
Overview of internal masonry wall installation using Juta GP DPC.

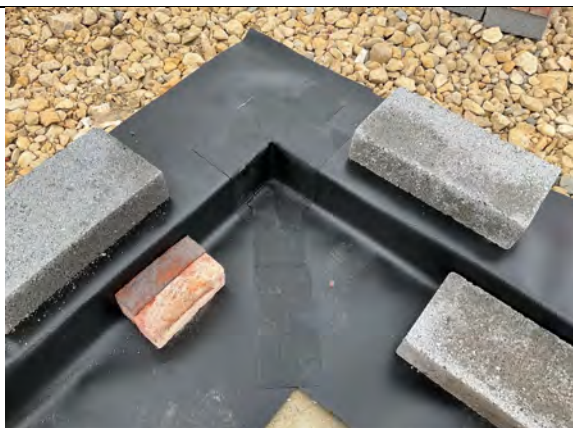
Corner detailing with Juta GP1 SAM.

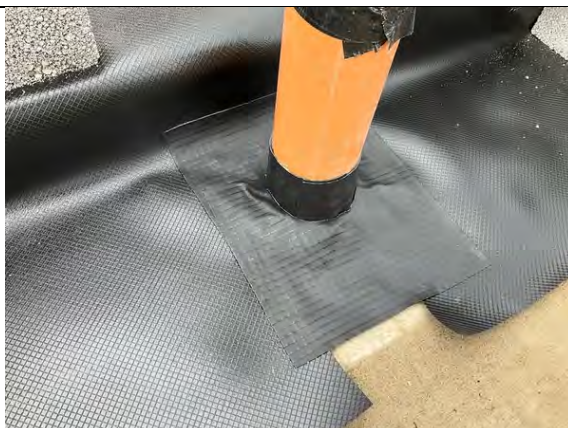
Pipe penetration detailing with Juta GP1 SAM.

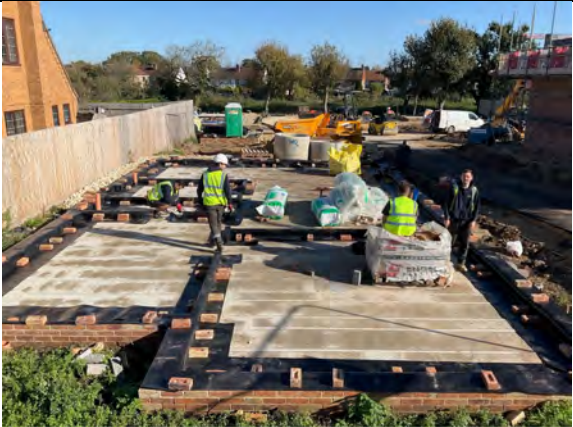
Overview of the perimeter installation to Plot 1.

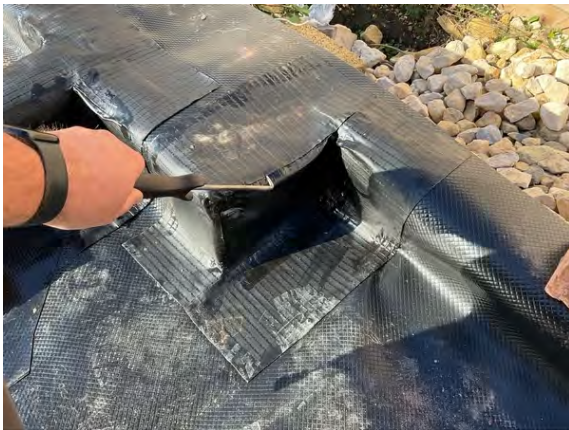
Plot 1. Probe testing to door threshold detailing.

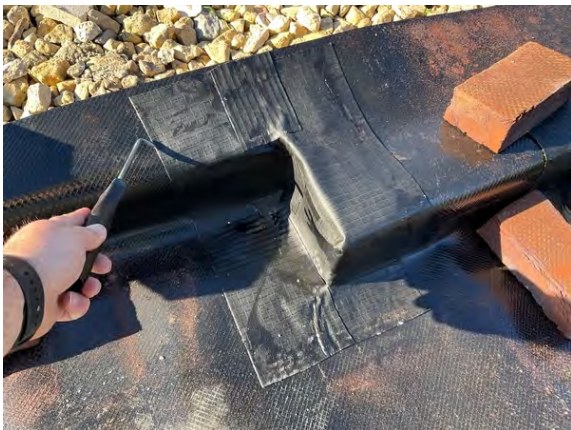
Plot 3. Probe testing to door threshold detailing.

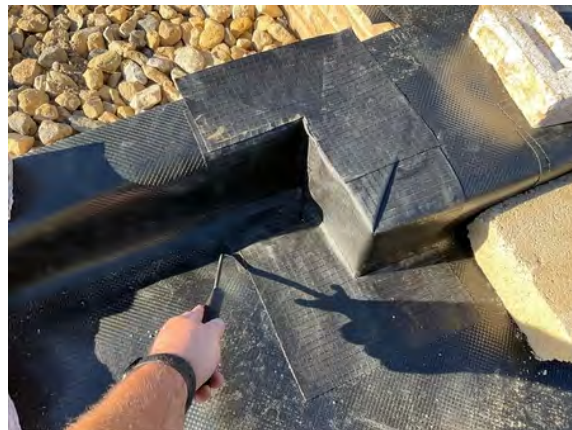
Plot 4. Probe testing to corner detailing.

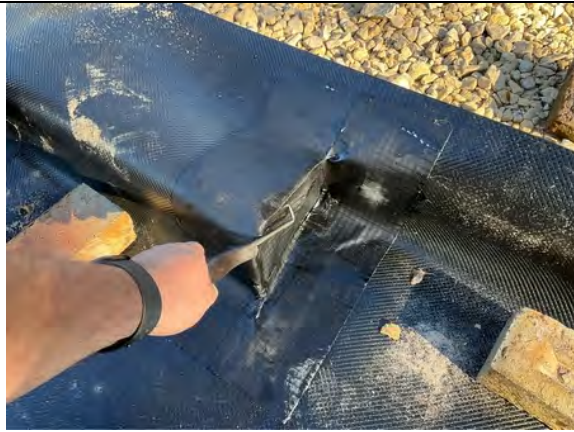
Plot 4. Probe testing along hand welded membrane lap joint.

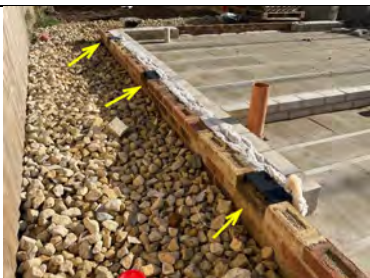
| (Section 1, Materials and Method of Seal) | |
|---|---|
| Plot 1: Advisory, air bricks were not in place at time of MEC inspection. | No defects recorded and therefore no action required. |

Plot 1. Telescopic vents in place.  
*Note: Air bricks were not installed at the time of inspection.*

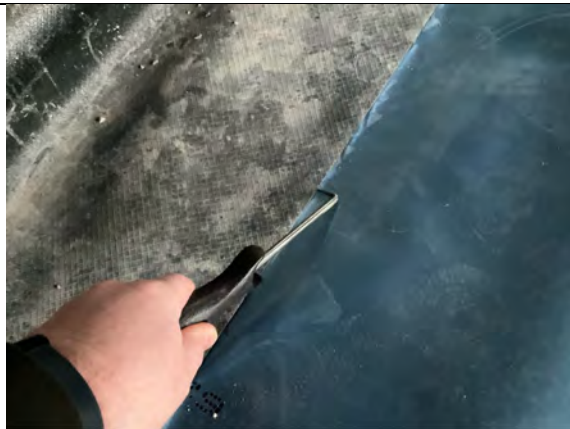
Probe testing along hand welded membrane lap joint.

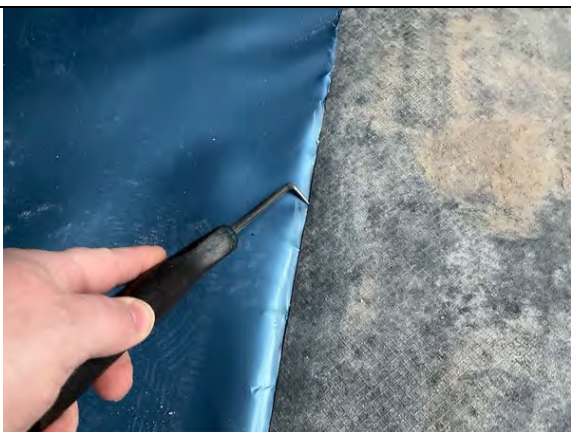
Probe testing along hand welded membrane lap joint.

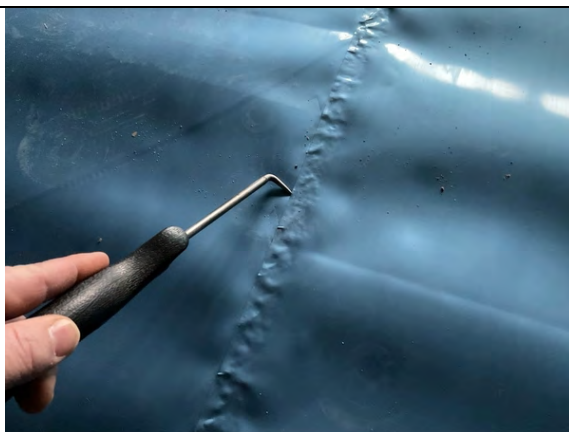
Probe testing along hand welded membrane lap joint.

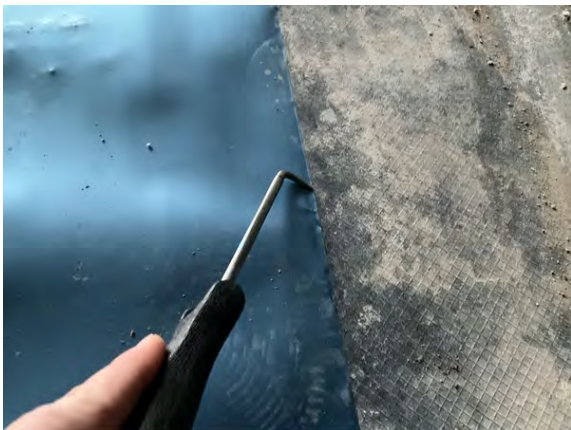
Probe testing along hand welded membrane lap joint.

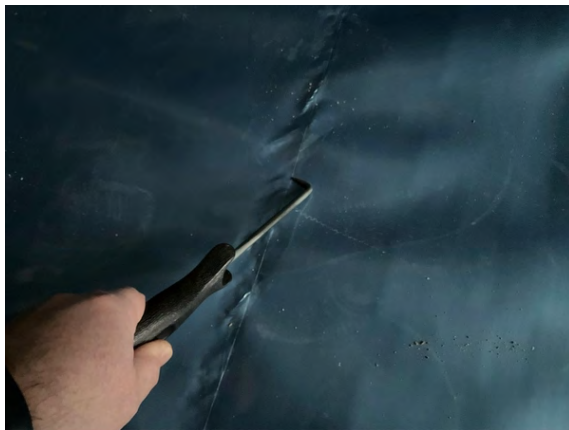
Probe testing along hand welded membrane lap joint.

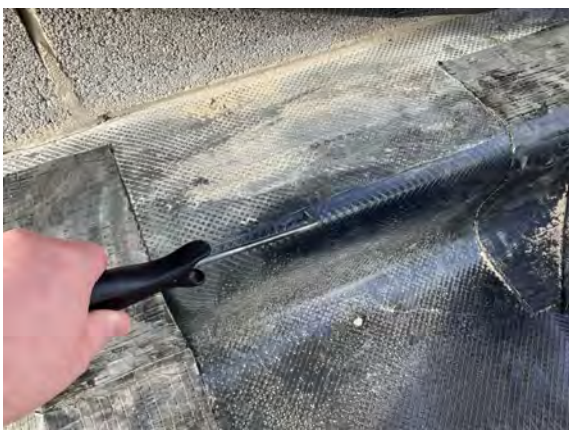
Probe testing along hand welded membrane lap joints to existing perimeter membrane.

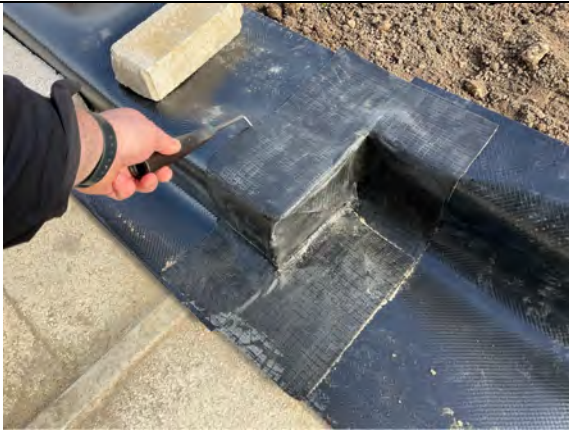
Probe testing to door threshold details.

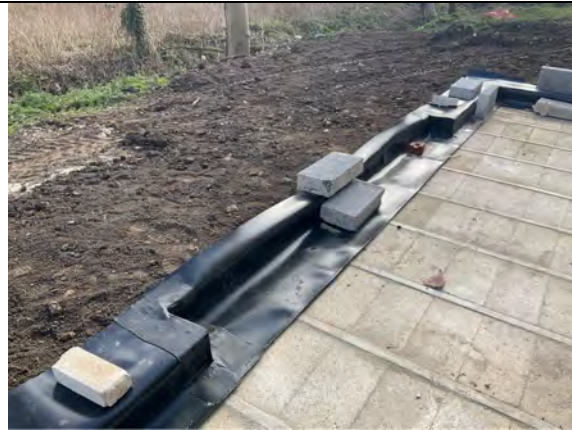
Juta GP TitanTech DPC lined along perimeter walls of extension.

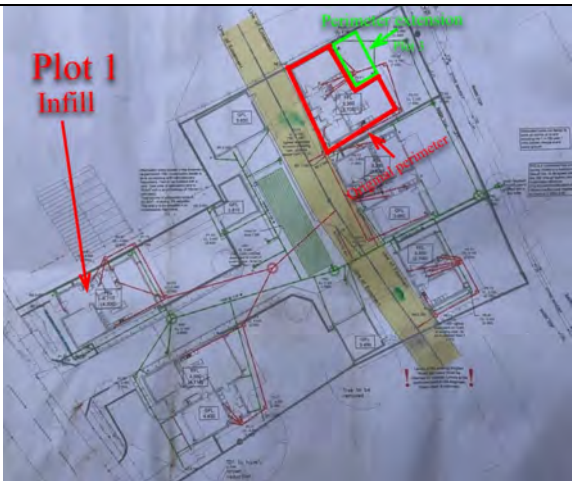
Site plan and where today's inspection took place.

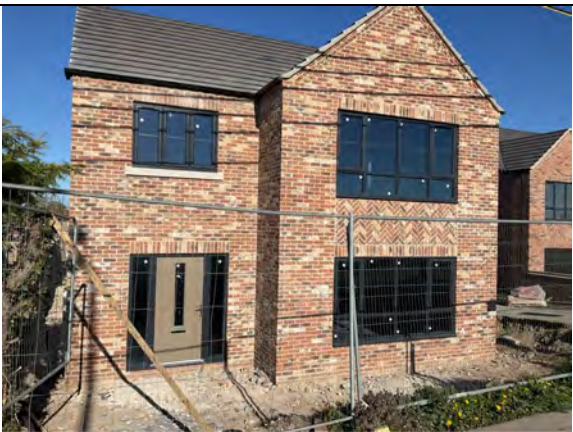
General overview of Plot 1.

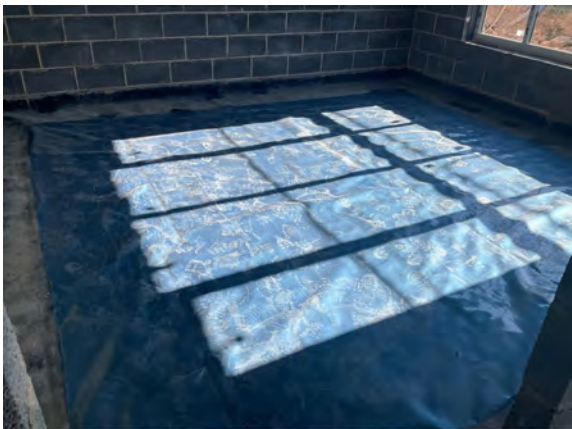
Overview of the infill installation using Juta GP5 Gas Barrier.

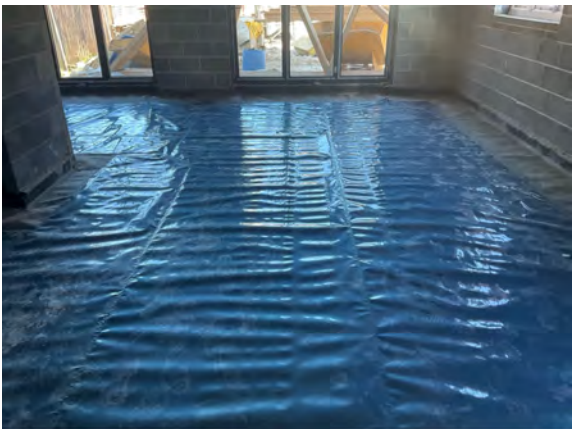
Overview of the infill installation using Juta GP5 Gas Barrier.

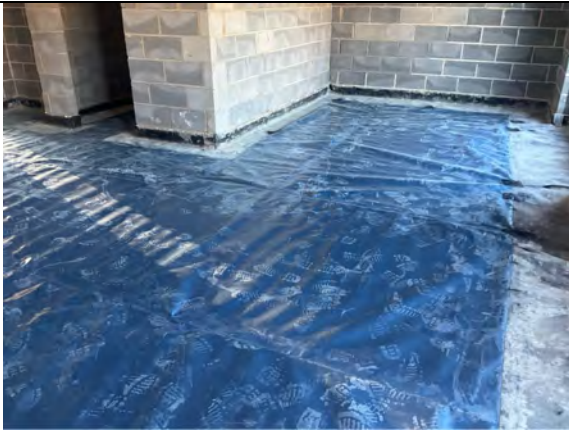
Overview of the infill installation using Juta GP5 Gas Barrier.

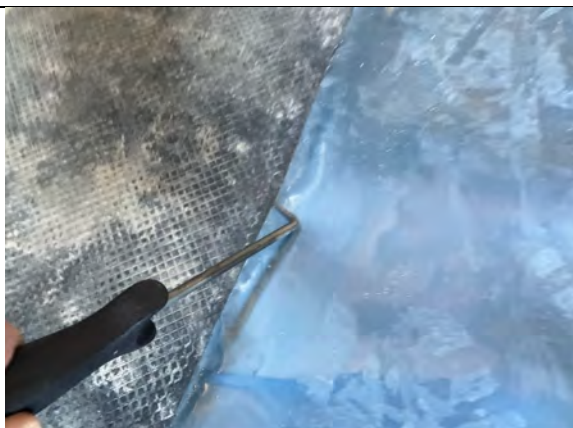
Plot 1. Probe testing along hand welded membrane lap joints.

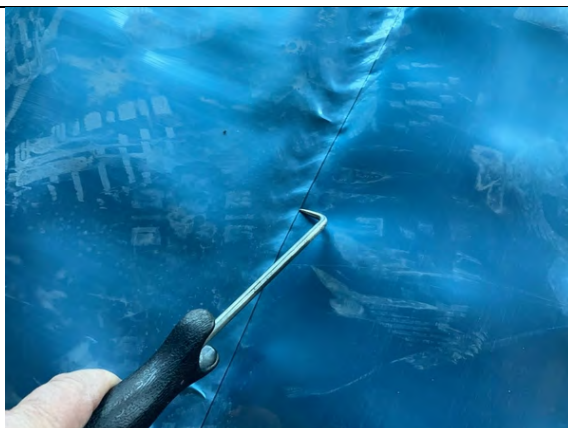
Plot 1. Probe testing along hand welded membrane lap joints.

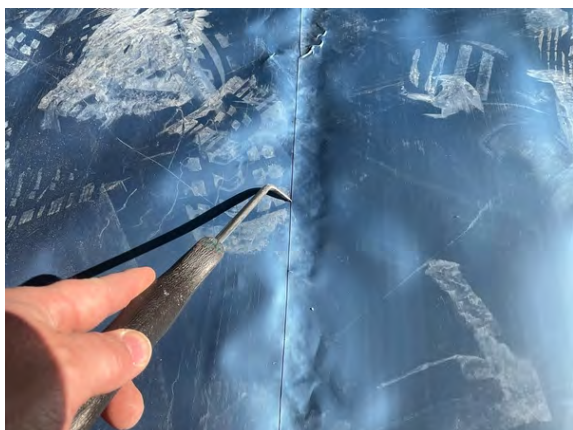
Plot 1. Probe testing along hand welded membrane lap joints.

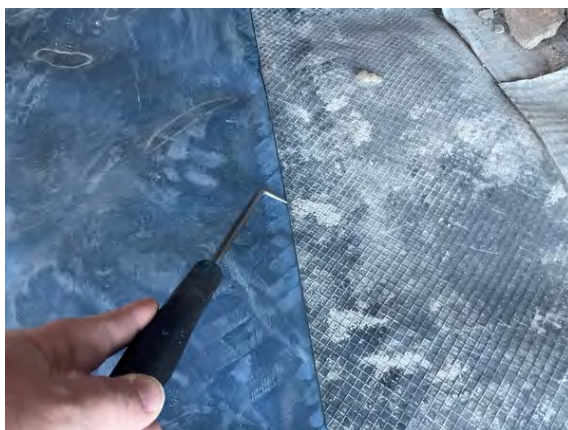
Plot 1. Probe testing along hand welded membrane lap joints.

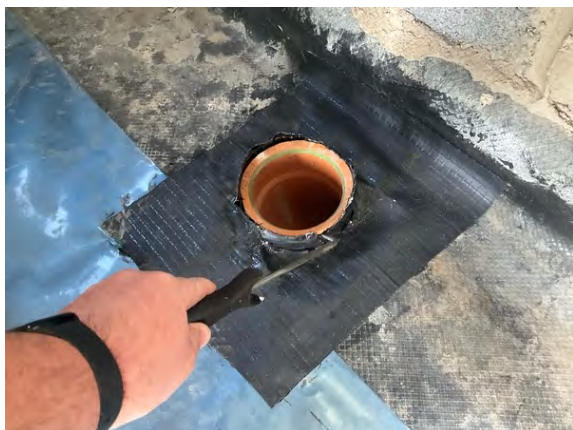
Plot 1. Probe testing to pipe penetration details.

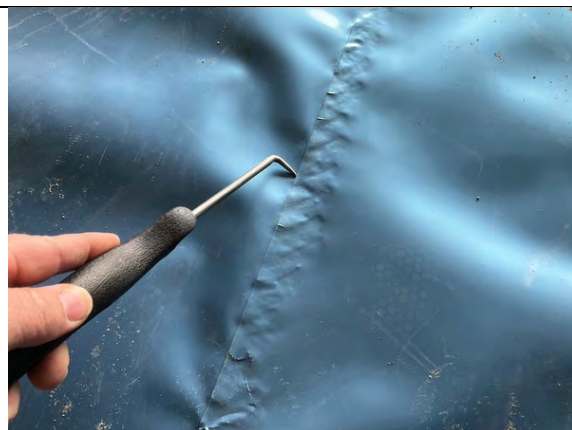
Plot 4. Probe testing along hand welded membrane lap joints.

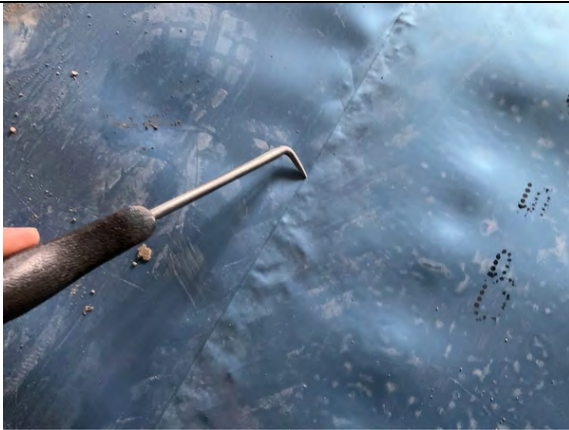
Plot 4. Probe testing along hand welded membrane lap joints.

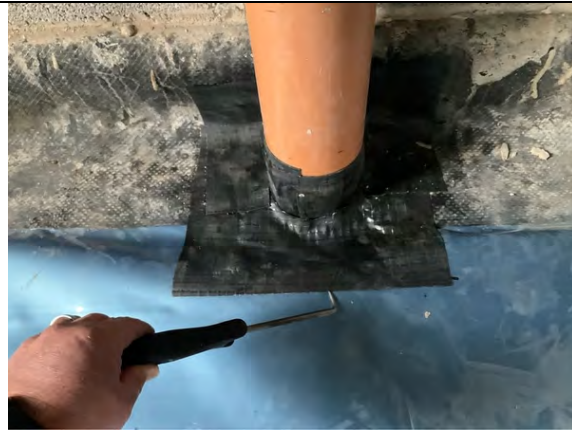
Plot 4. Probe testing to pipe penetration details.

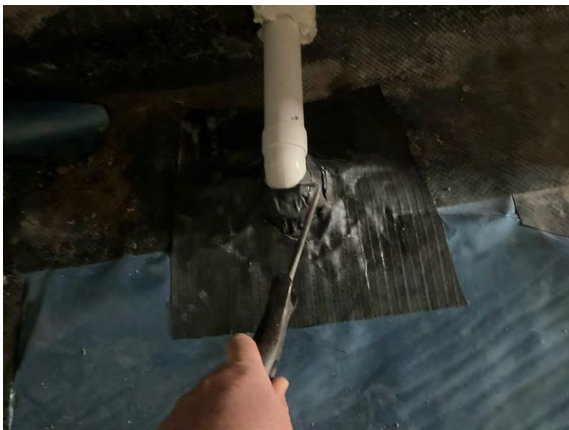
Plot 4. Probe testing to pipe penetration details.

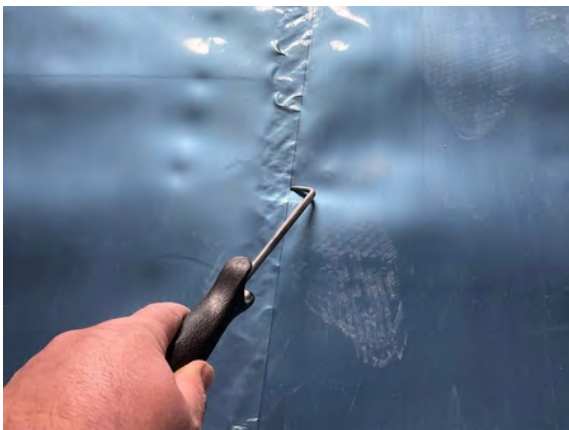
Plot 5. Probe testing along hand welded membrane lap joints.

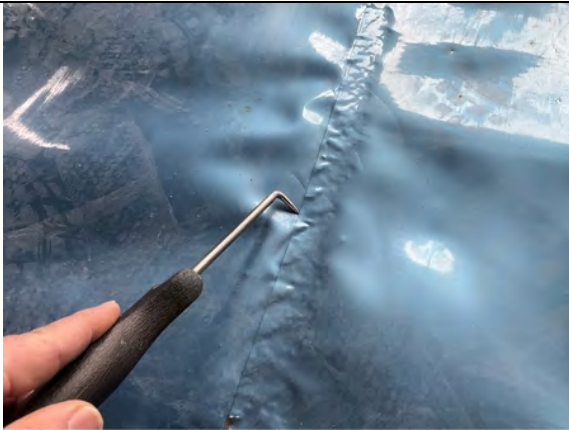
Plot 5. Probe testing along hand welded membrane lap joints.

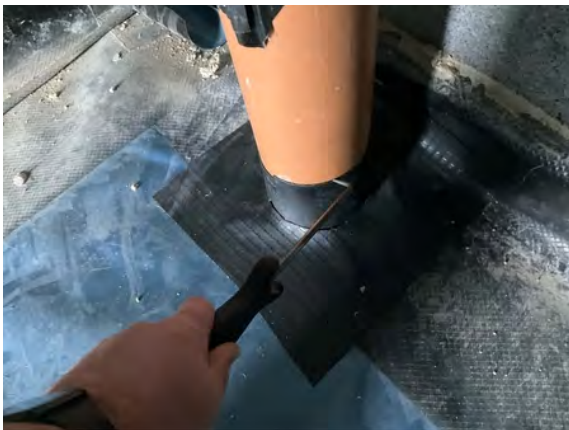
Plot 5. Probe testing to pipe penetration details.

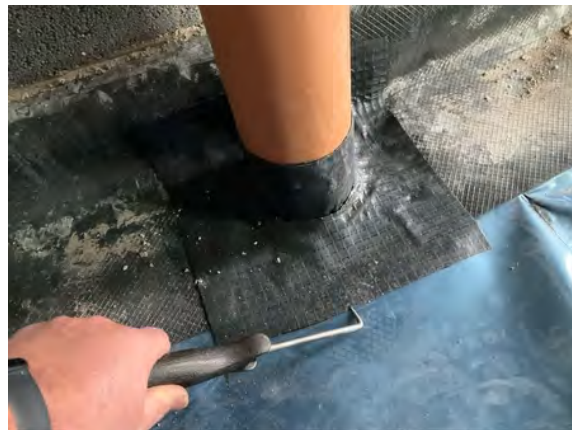
Plot 5. Probe testing to pipe penetration details.

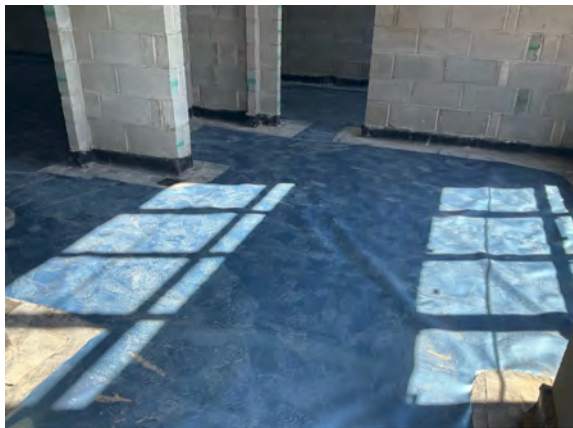
Overview of the infill installation.

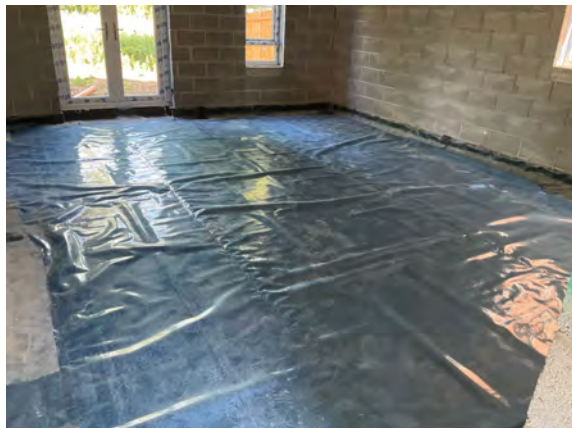
Overview of the infill installation using Juta GP5 Gas Barrier.

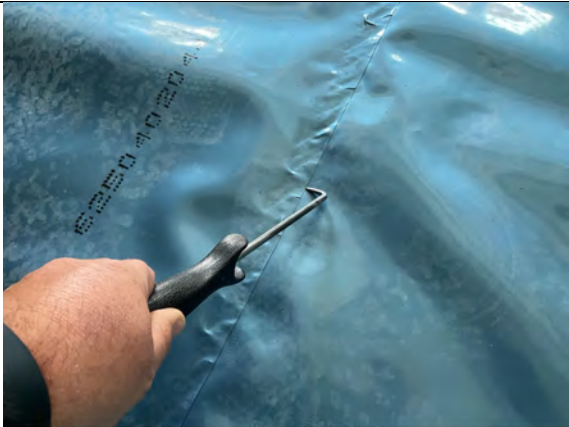
Probe testing along hand welded membrane lap joints.

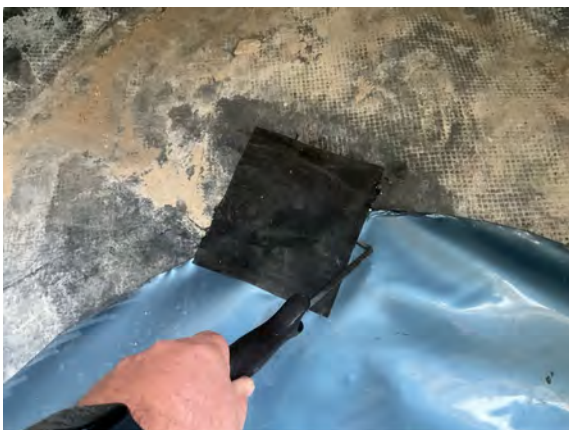
Probe testing to installers own CQA patch repairs.

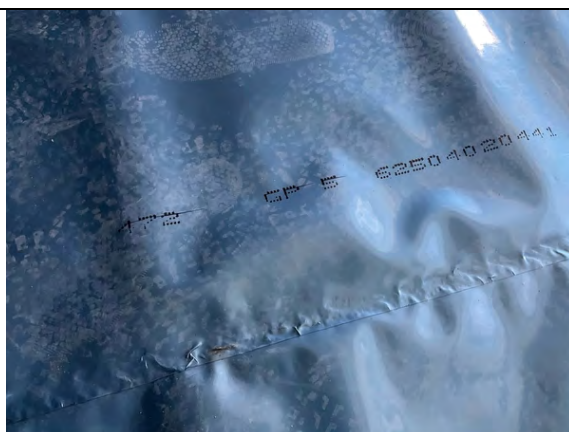
Evidence of the Juta GP5 Gas Barrier labelling.

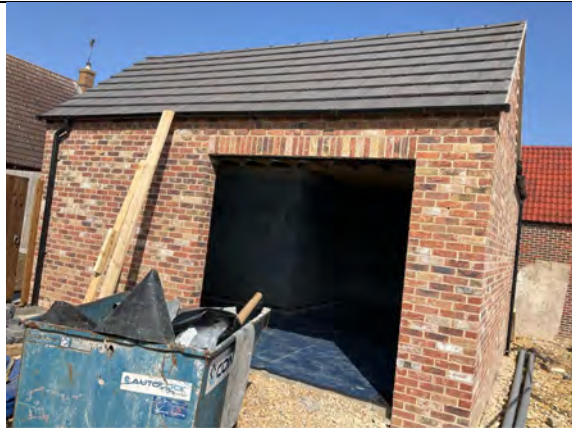
General overview of Plot 1 Garage.

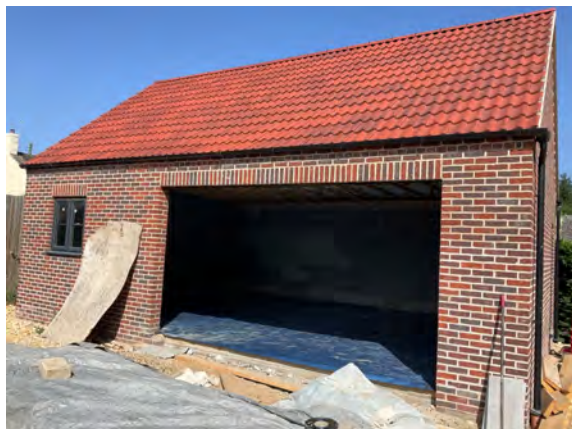
General overview of Plot 3 Garage.

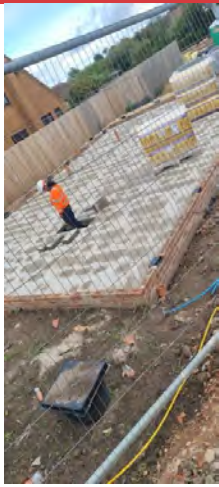
**PLOT 1 - CONFIRMATION OF VOID DEPTH**

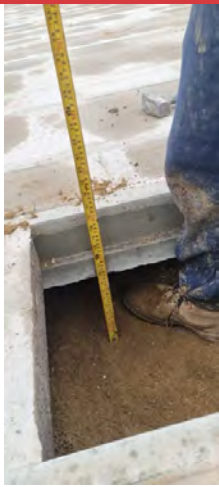
**PLOT 1 - VOID DEPTH 250MM**

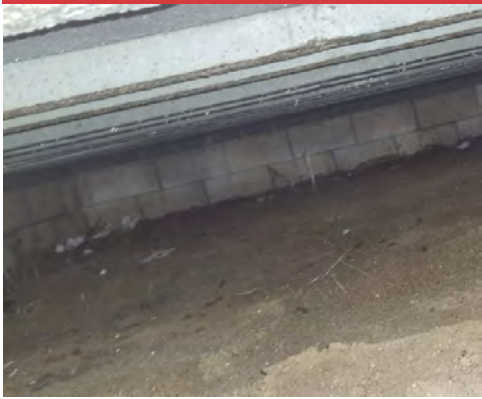
**PLOT 1 GARAGE - OPEN VOID**

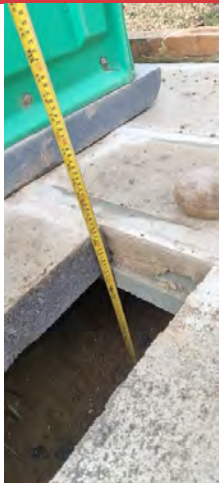
**PLOT 1 GARAGE - VOID DEPTH 480MM**

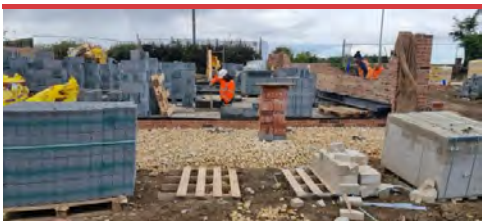
**PLOT 2 - CONFIRMATION OF VOID DEPTH**

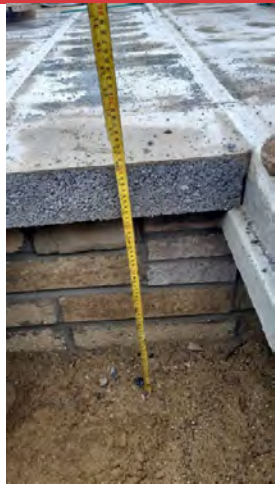
**PLOT 2 - VOID DEPTH 500MM**

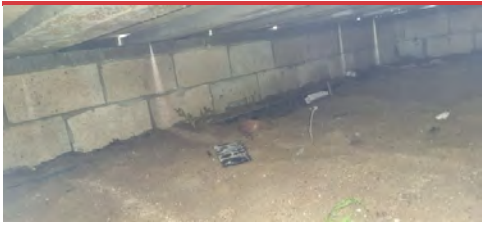
**PLOT 3 GARAGE - OPEN VOID**

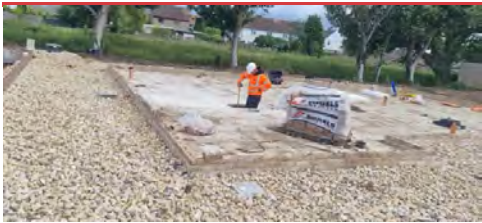
**PLOT 3 GARAGE - VOID DEPTH 550MM**

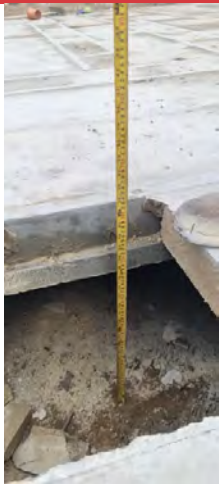
**PLOT 4 - MISSED BLOCKWORK TO SLEEPER WALLS**

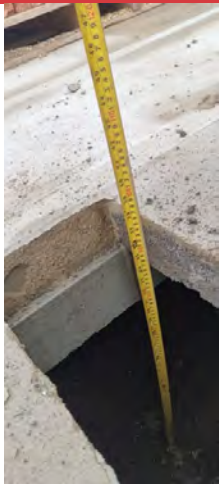
**PLOT 5 GARAGE - CONFIRMATION OF VOID DEPTH**

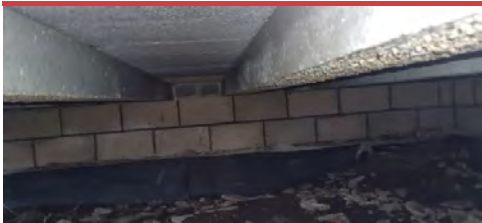
**PLOT 5 GARAGE - VOID DEPTH ~500MM**
