PRELIMINARY ASSESSMENT OF EXTERIOR AT MANOR HOUSE, CROWLAND,  
LINCOLNSHIRE

JOB NO. 438-44

MR AND MRS SMEDLEY

14 NOVEMBER 2024 AND 28 JANUARY 2025

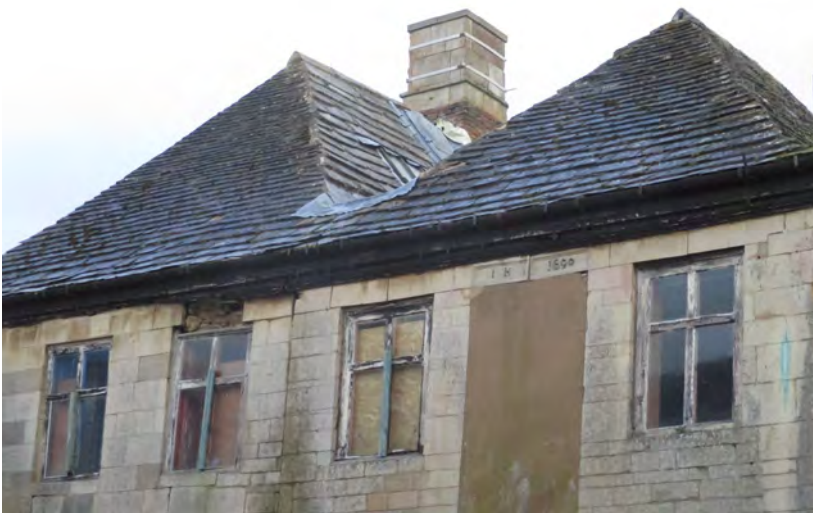
Fig 2:

Roof R1b.

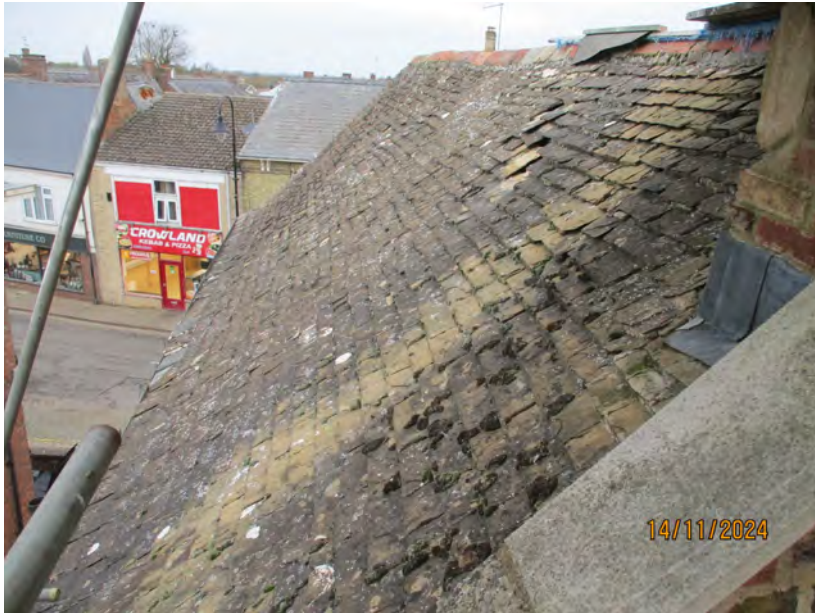
**Fig 3:**

Roof R1c.

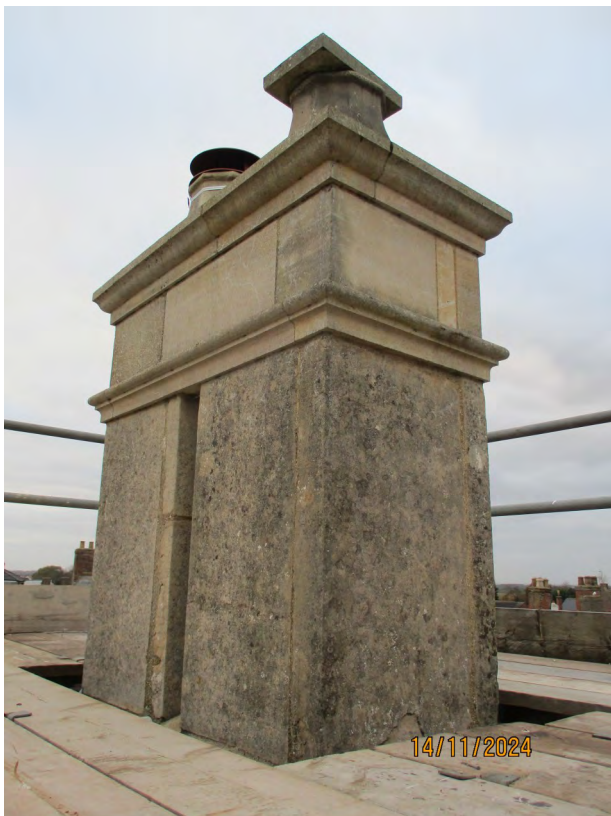
**Fig 4:**

Chimneystack Cs2 (Roof R1).

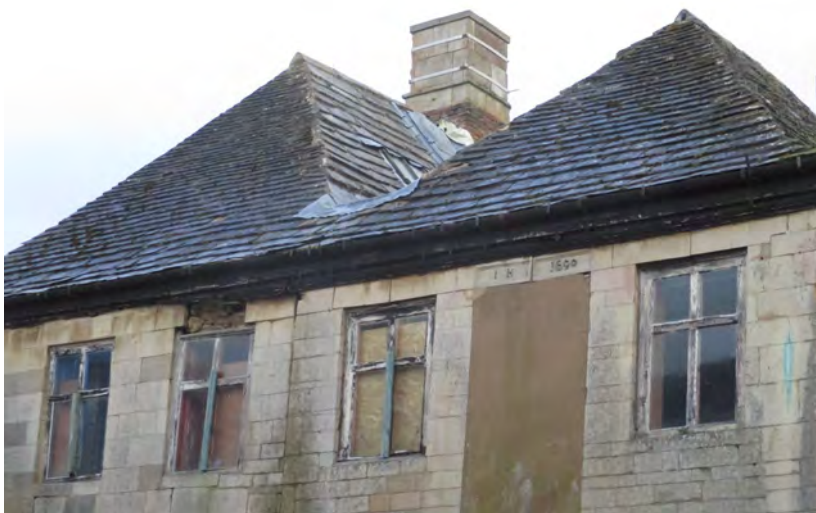
**Fig 6:**

Roof R2a..

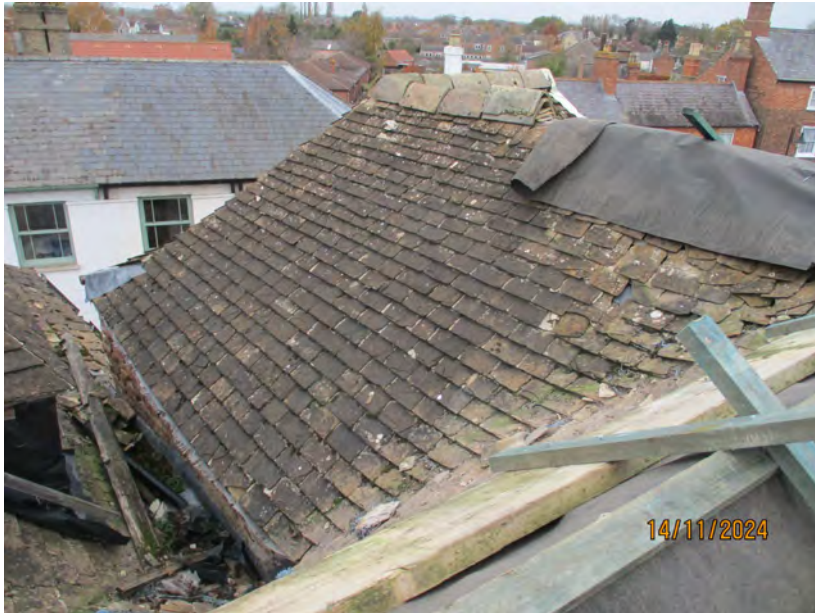
**Fig 13:**

Roofs R4e.

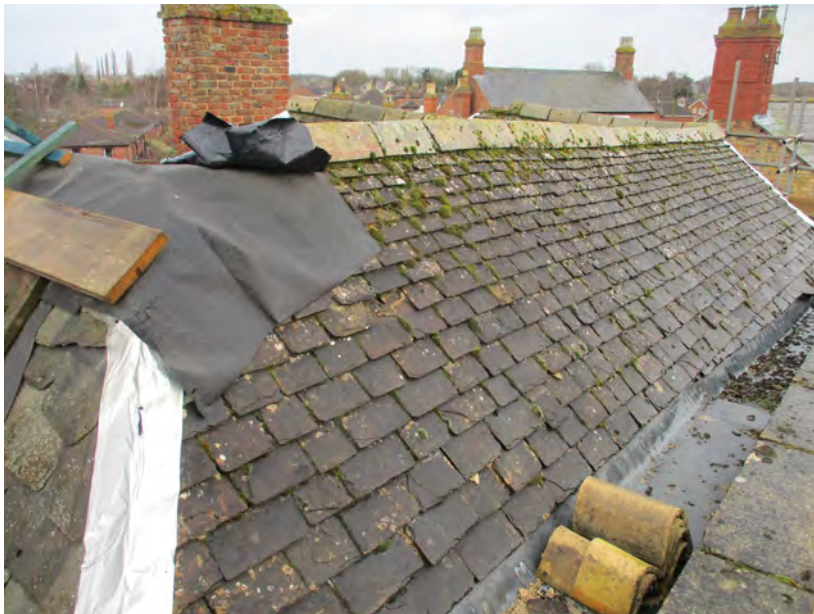
**Fig 22:**

Roof R7c.

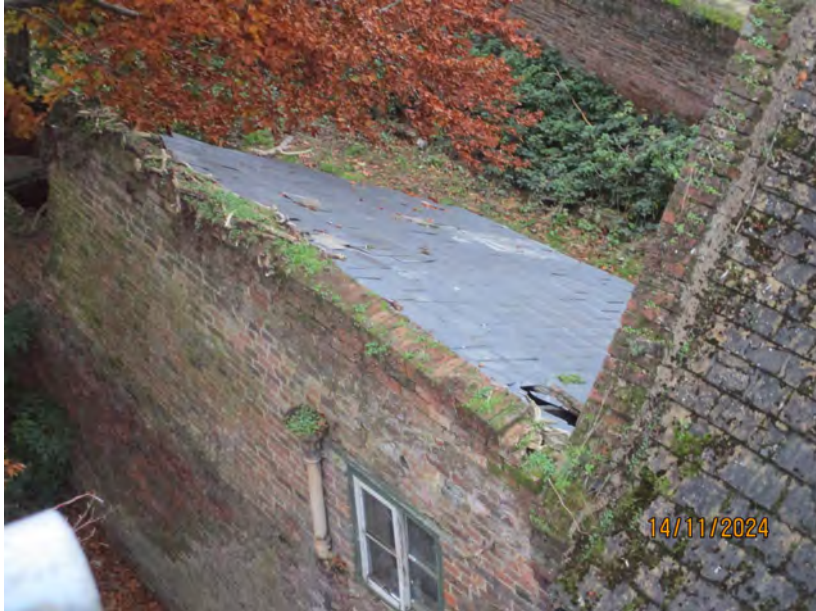
**Fig 23:**

Roof R8.

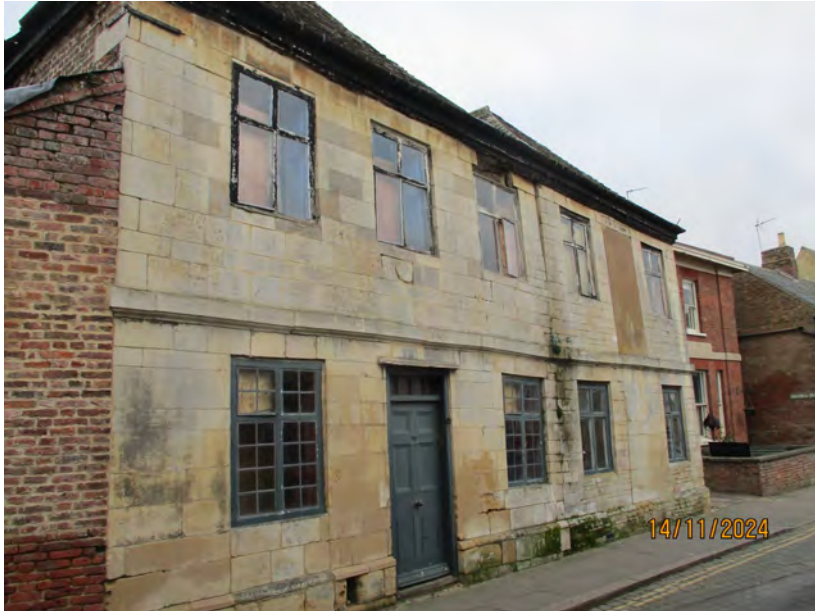
**Fig 29:**

Elevation 1 (north).

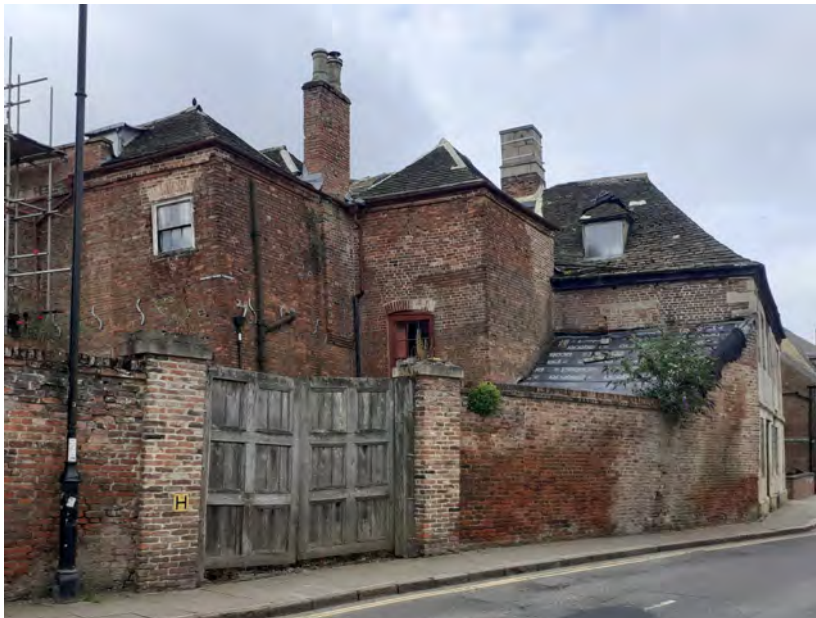
**Fig 40:**

North boundary wall.

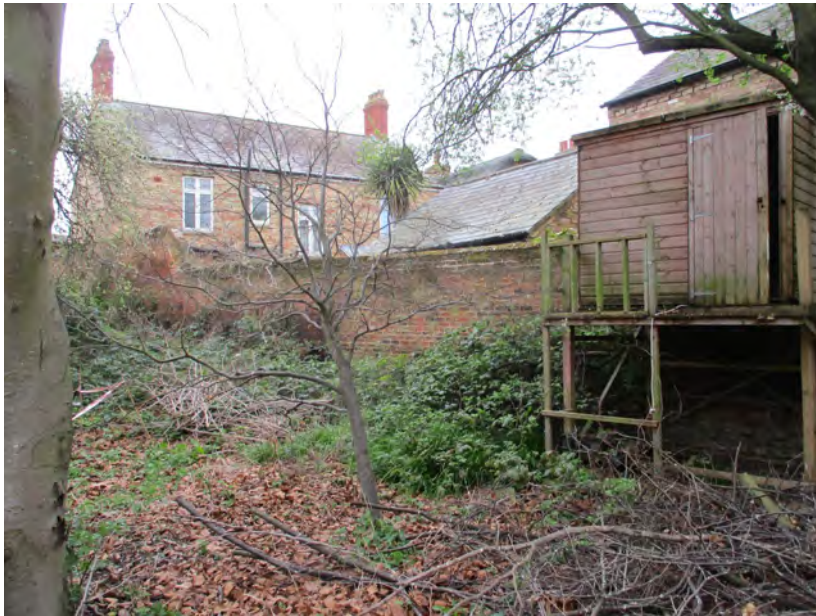
**Fig 41:**

East boundary wall.

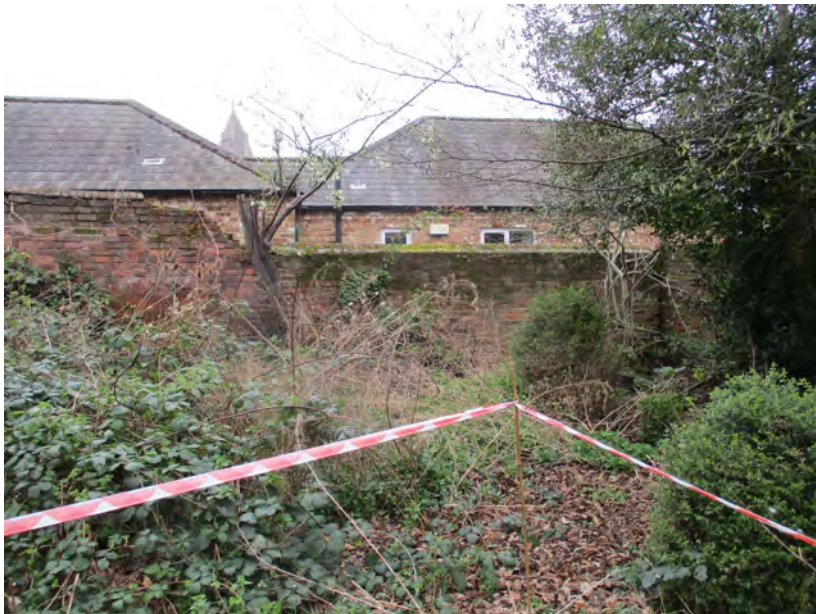
**Fig 42:**

South boundary wall.

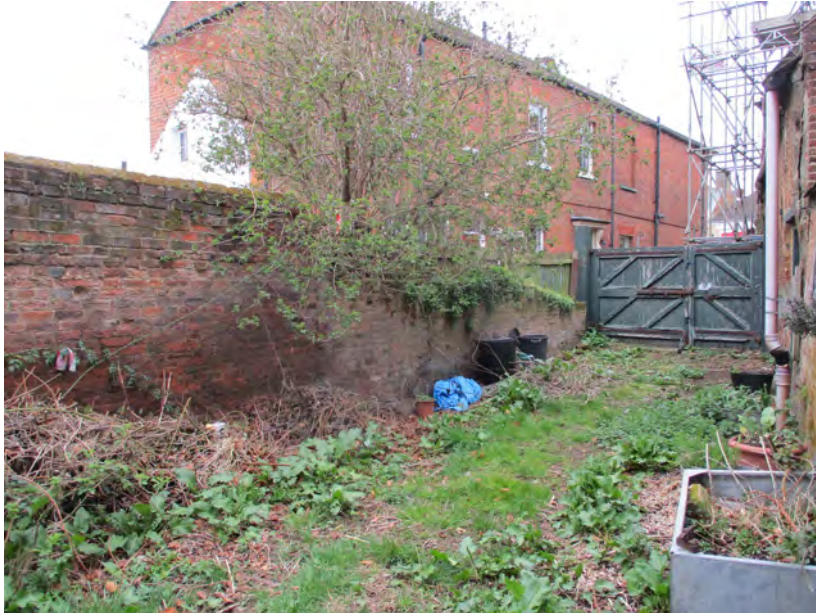
**Fig 43:**

West boundary wall.

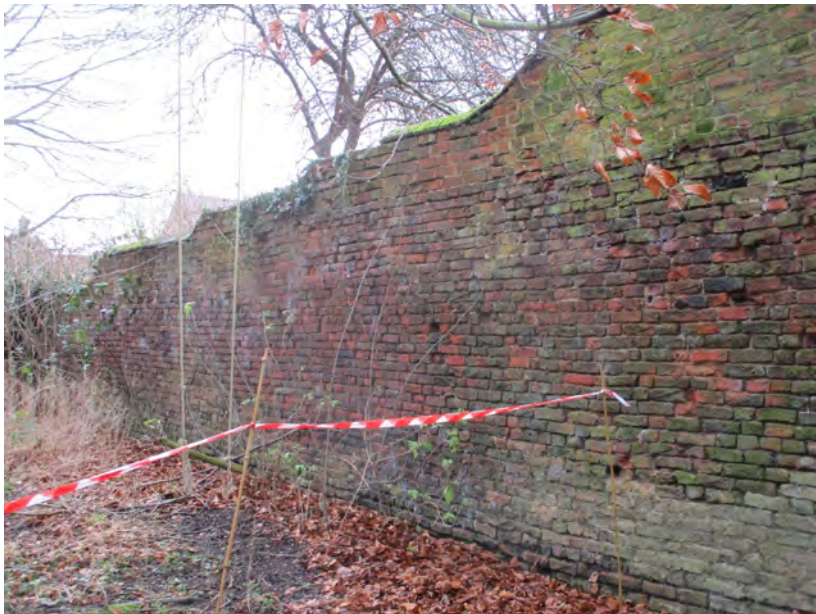
**Fig 44:**

North/south garden wall between shared driveway and garden (east side).

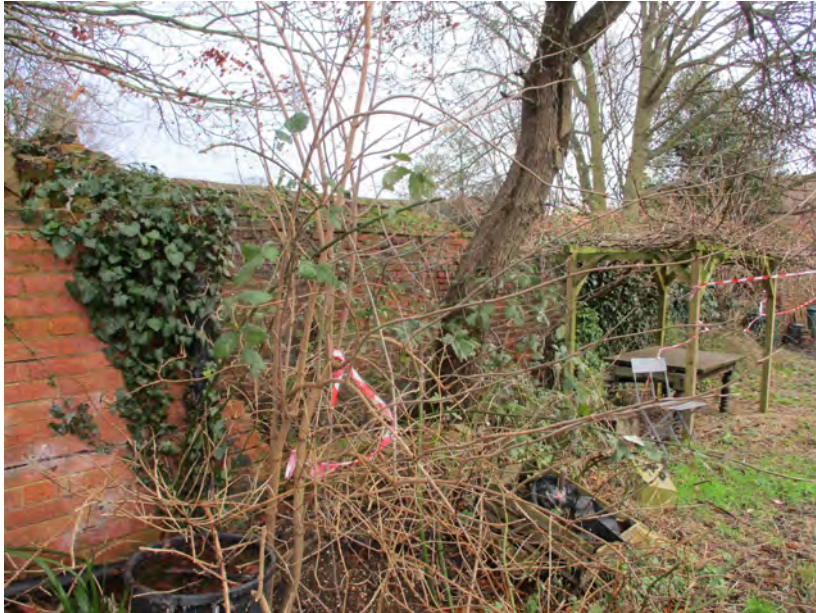
**Fig 45:**

North/south garden wall between shared driveway and garden (west side).

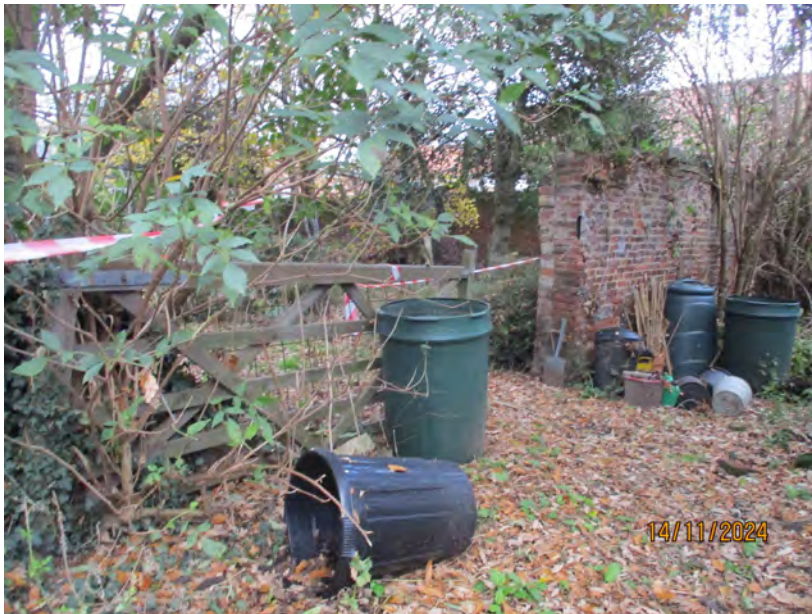
**Fig 46:**

North/south garden wall between shared driveway and garden with gateway (west side).

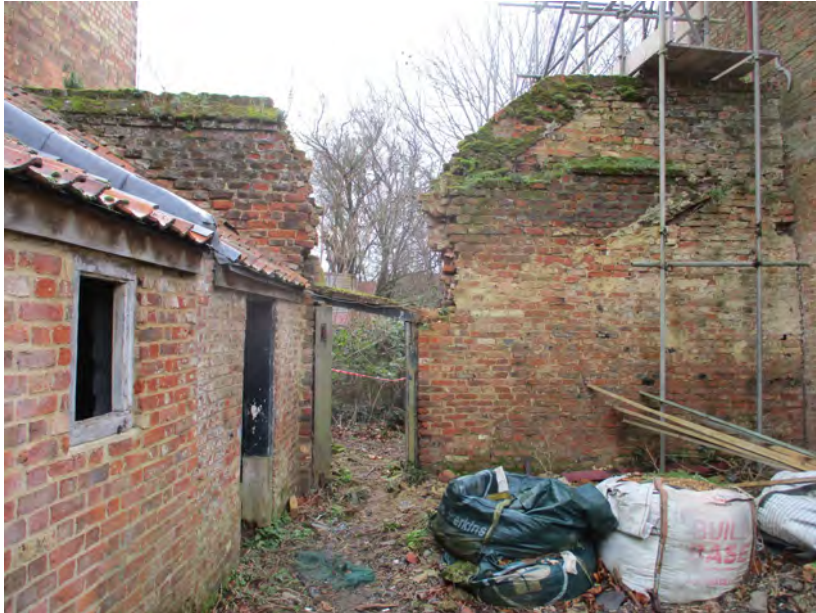
**Fig 47:**

East/west garden wall between courtyard and garden (orth side).

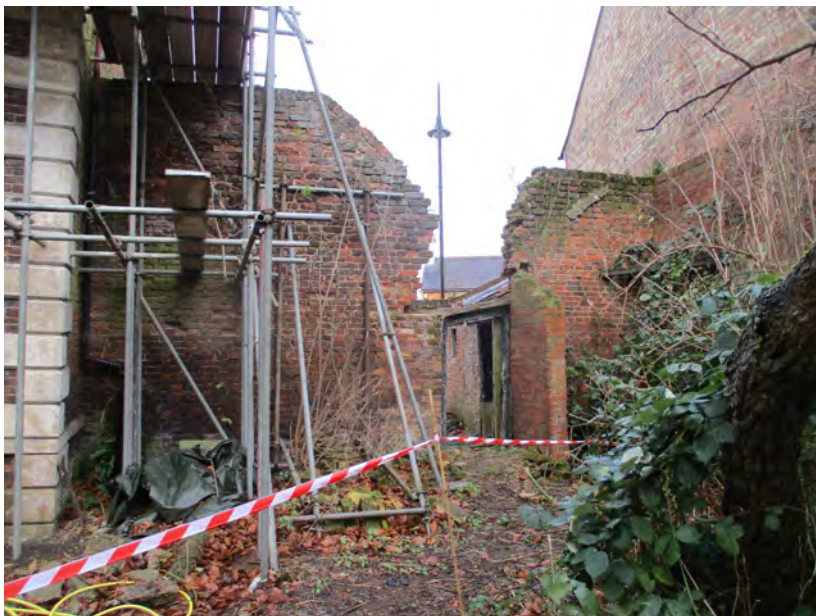
**Fig 48:**

.East/west garden wall between courtyard and garden (south side).

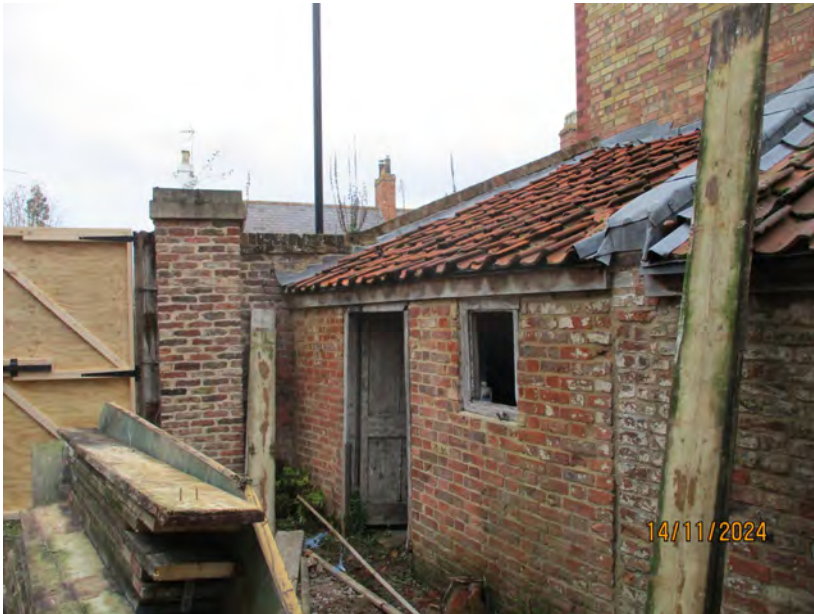
**Fig 49:**

Outbuilding facing courtyard,

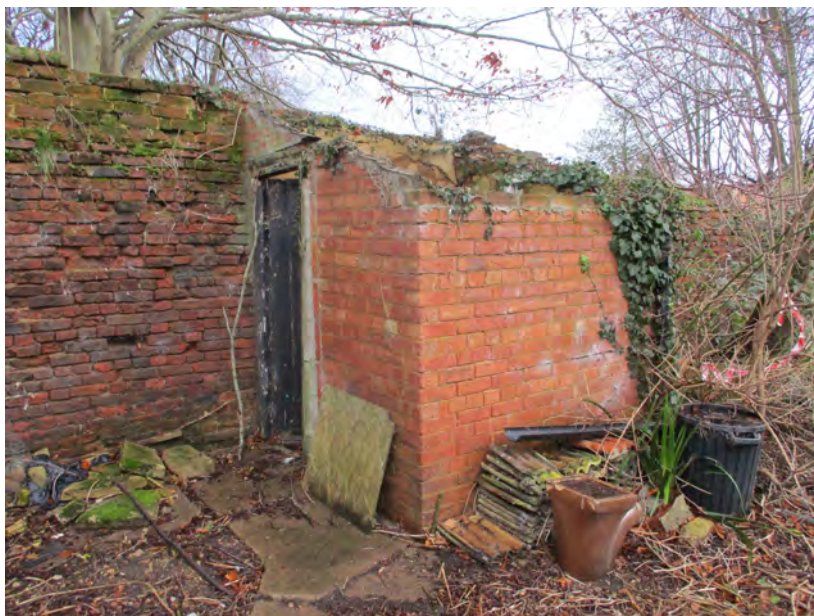
**Fig 50:**

Outbuilding to west side of garden wall

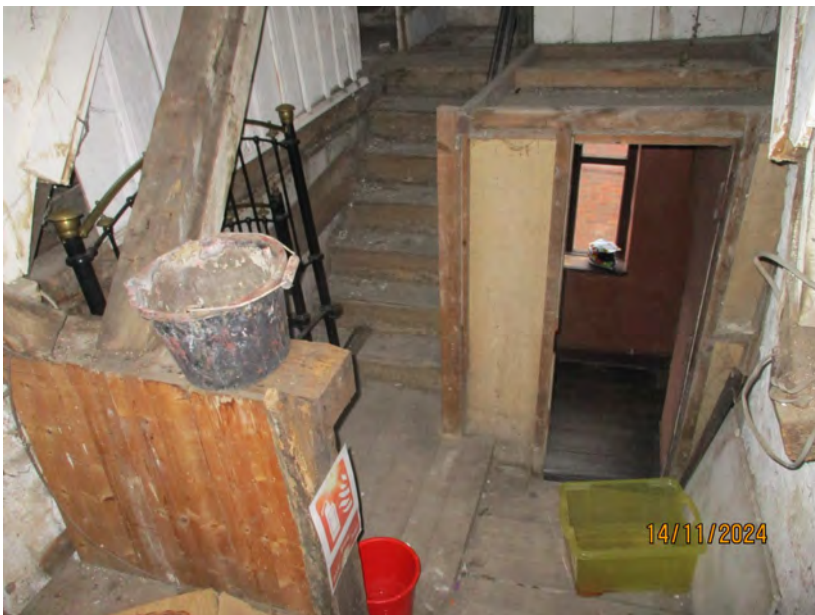
**Fig 1:**

Room S1.

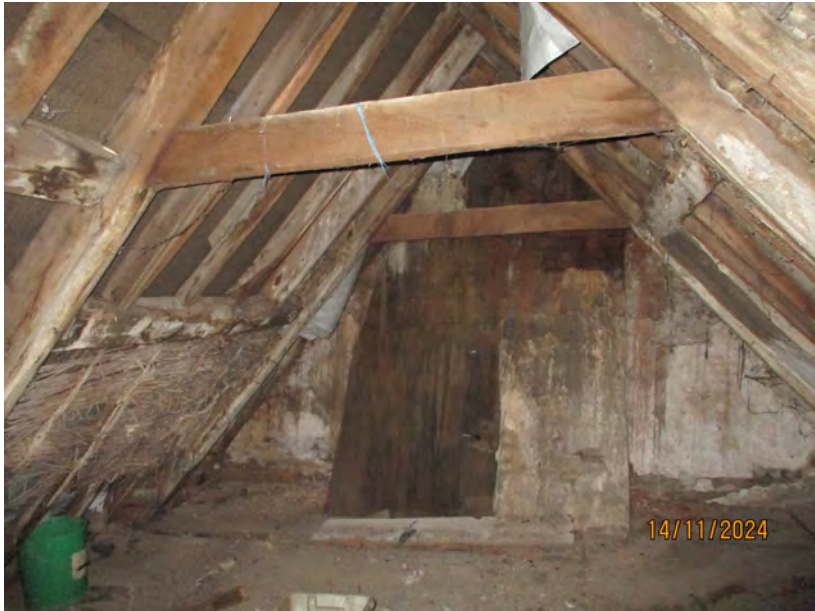
**Fig 2:**

Room S2.

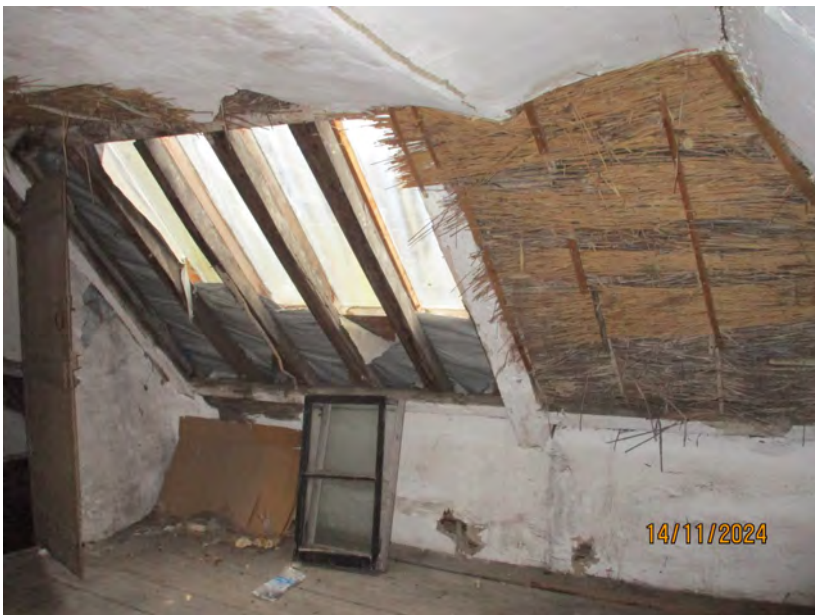
**Fig 3:**

Room S3.

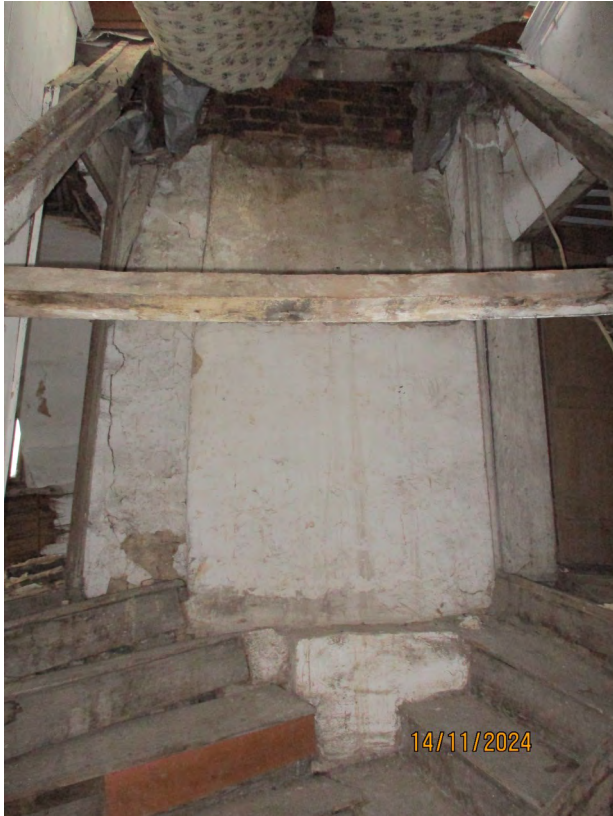
**Fig 4:**

Room S4.

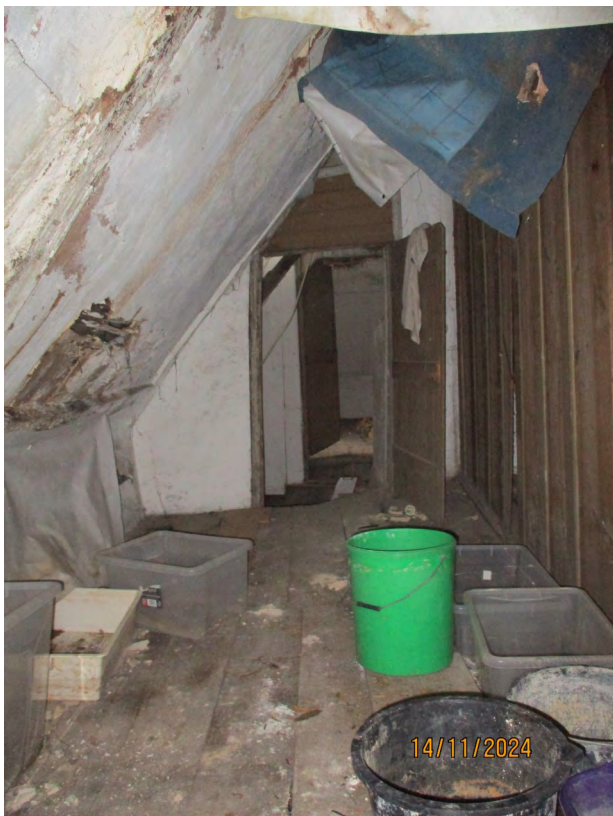
**Fig 5:**

Room S5.

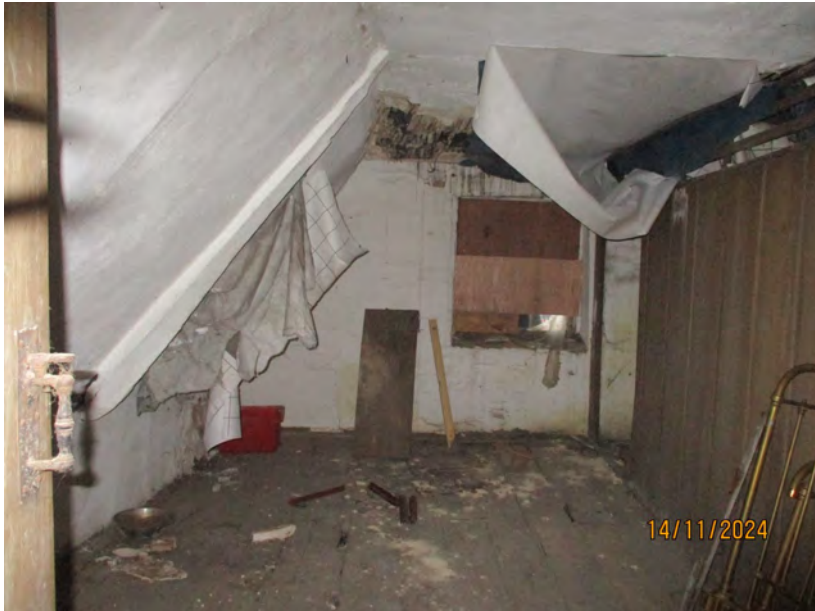
**Fig 6:**

Room S6.

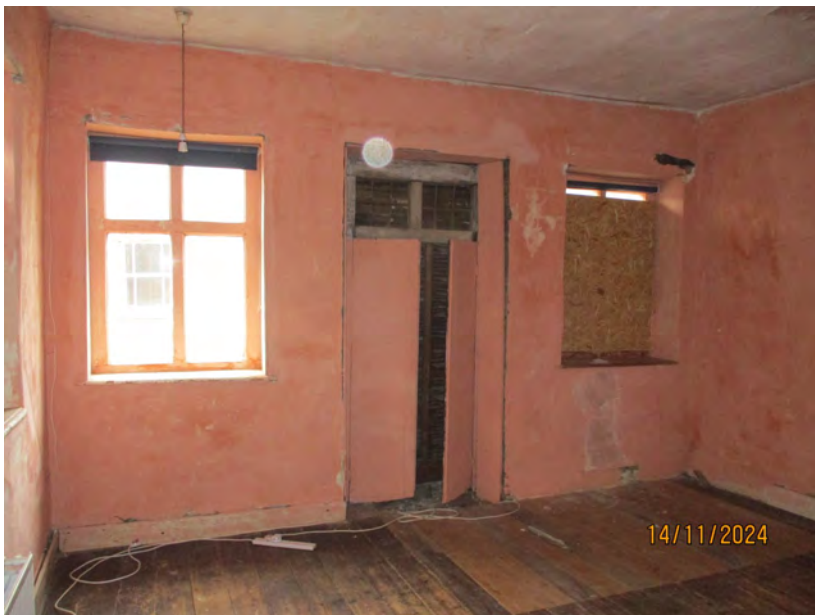
**Fig 7:**

Room S7.

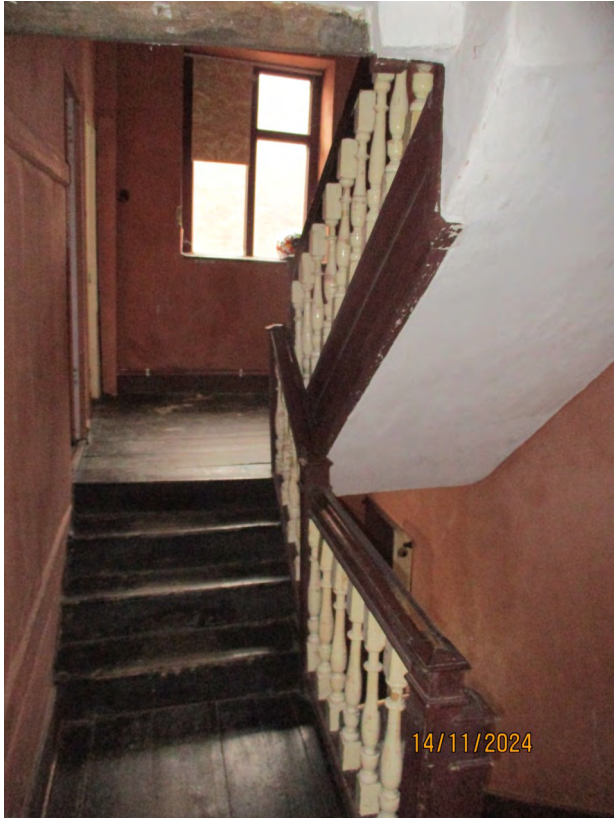
**Fig 8:**

Room F1.

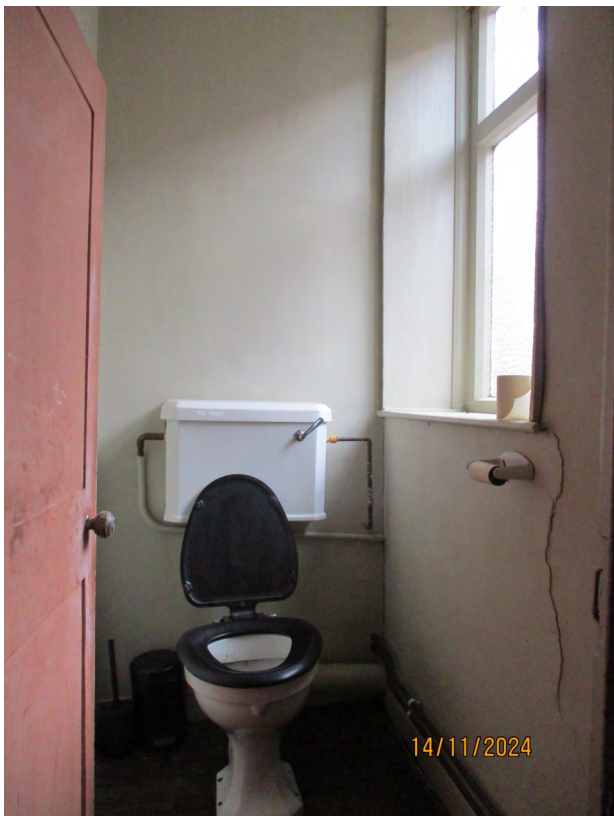
Fig 9:

Room F2.

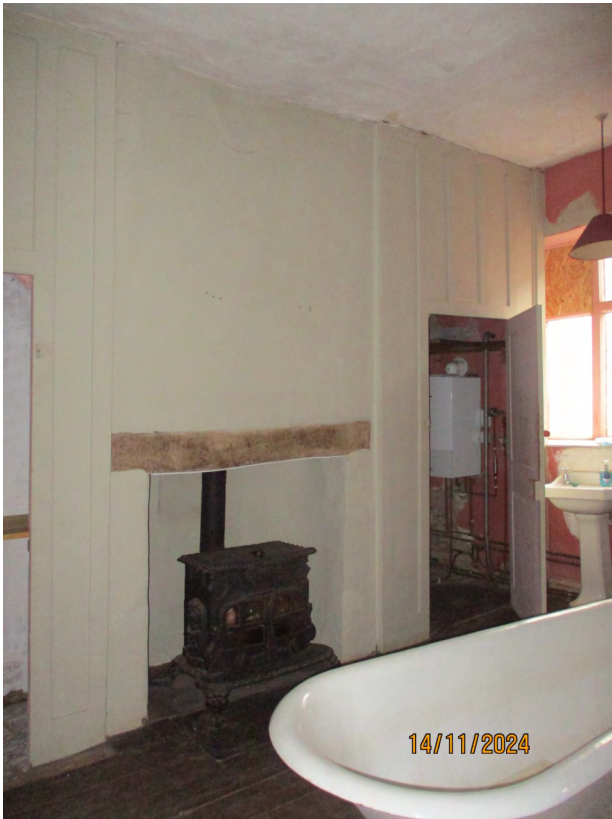
Fig 10:

Room F3.

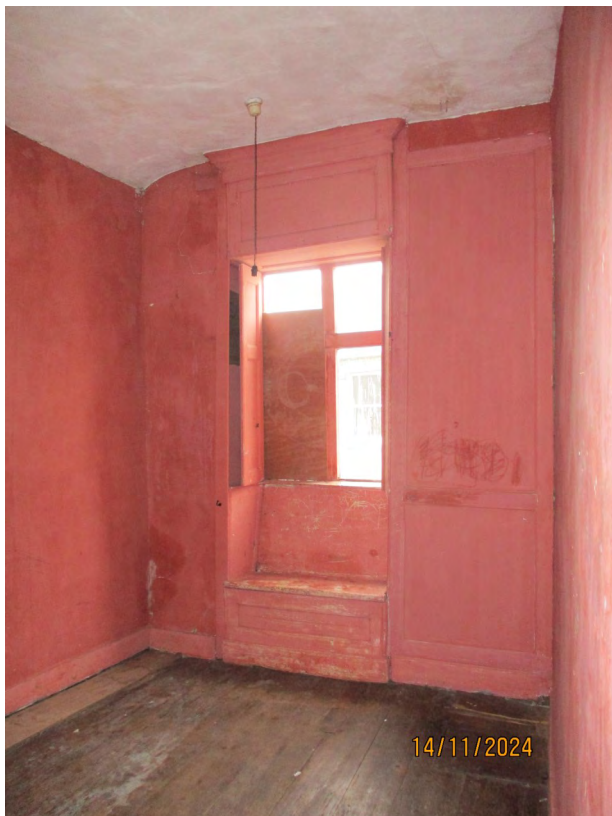
**Fig 11:**

Room F4.

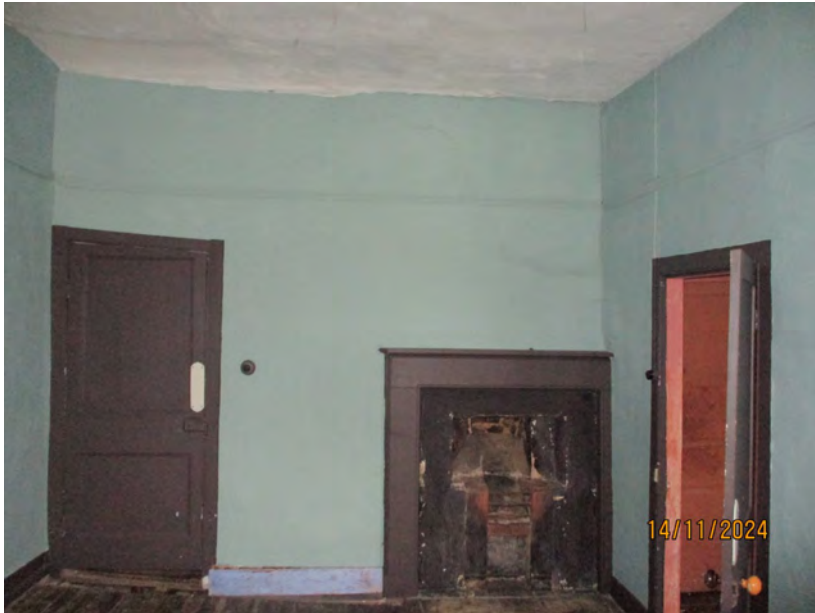
**Fig 12:**

Room F5.

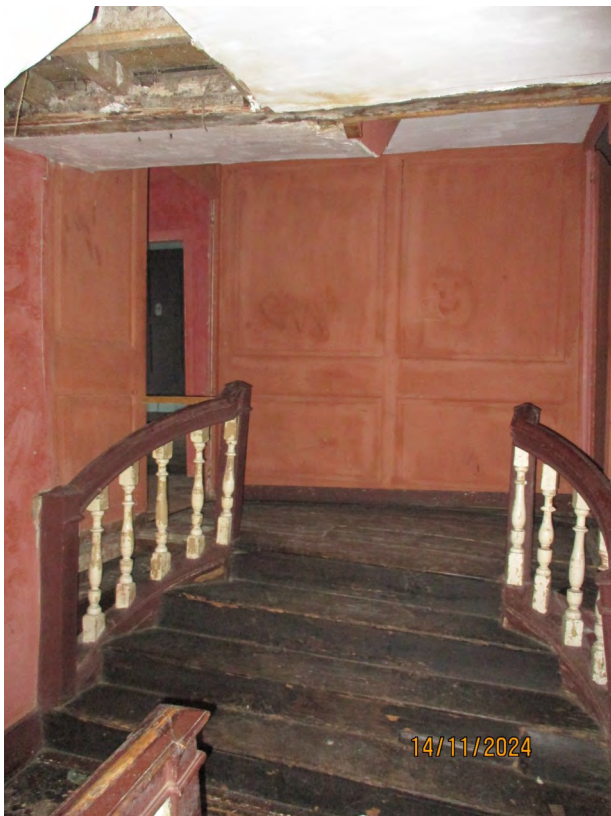
**Fig 13:**

Room F6.

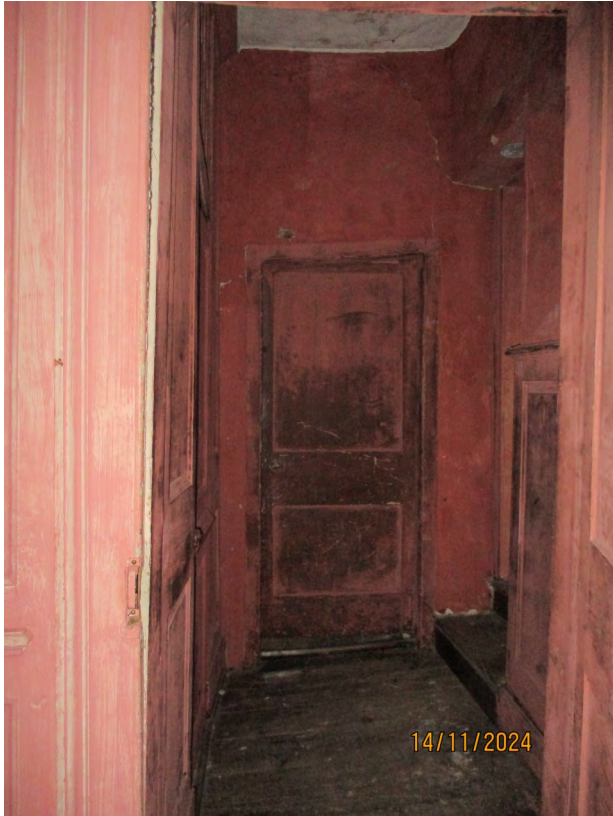
**Fig 14:**

Room F7.

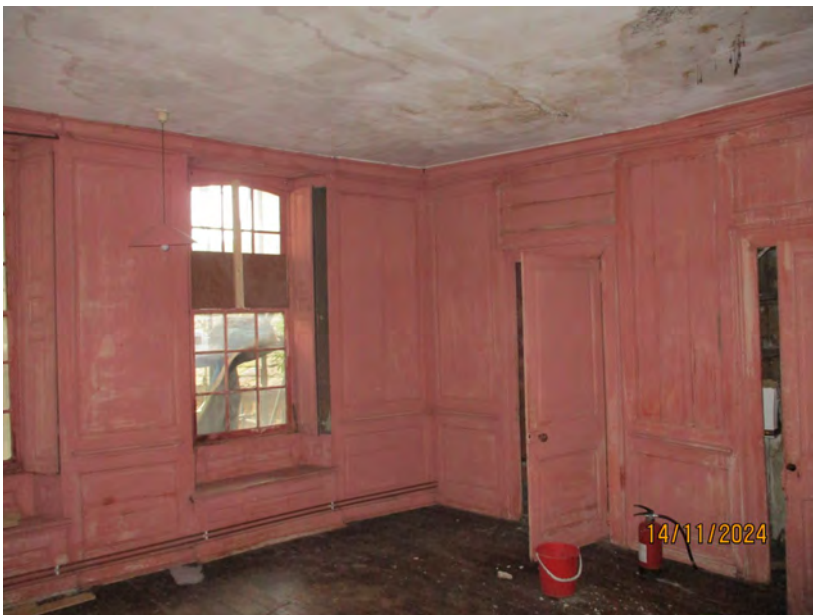
**Fig 15:**

Room F8.

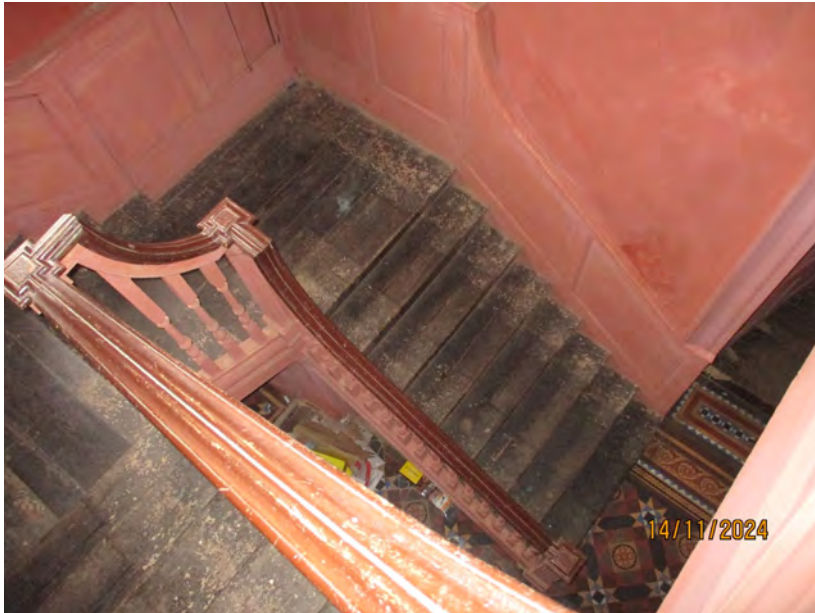
**Fig 16:**

Room F9.

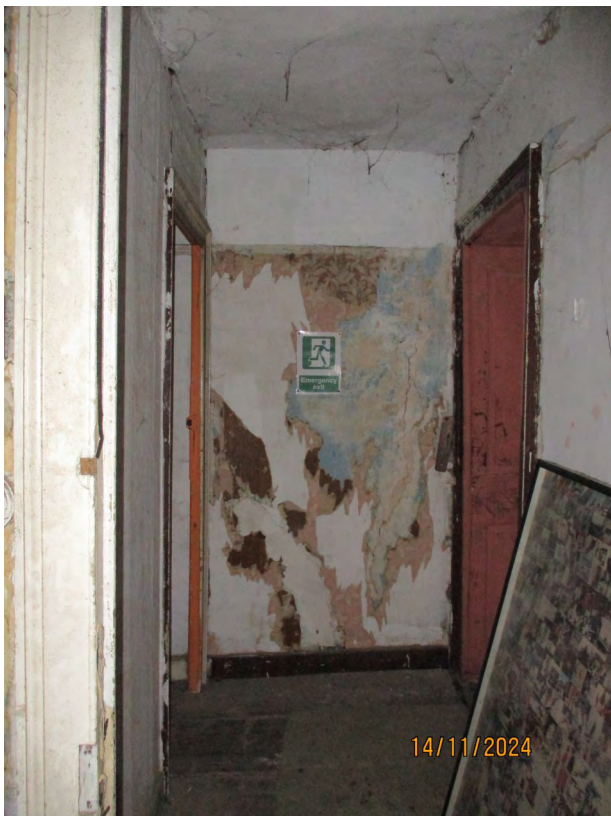
**Fig 17:**

Room F10.

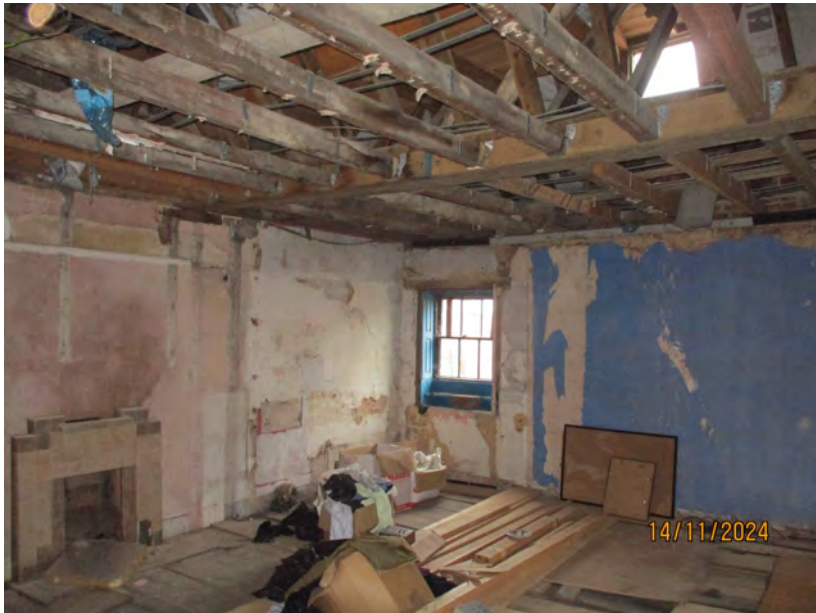
**Fig 18:**

Room F11.

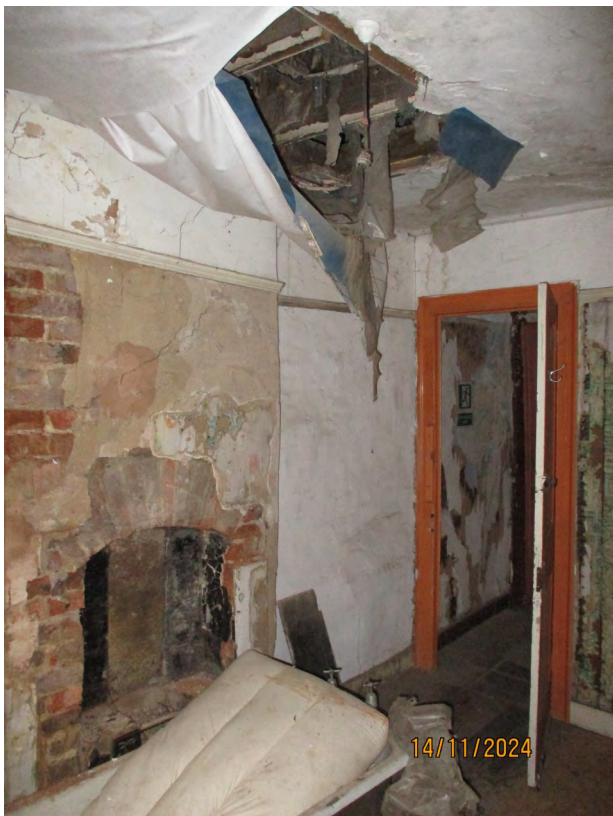
**Fig 19:**

Room F12.

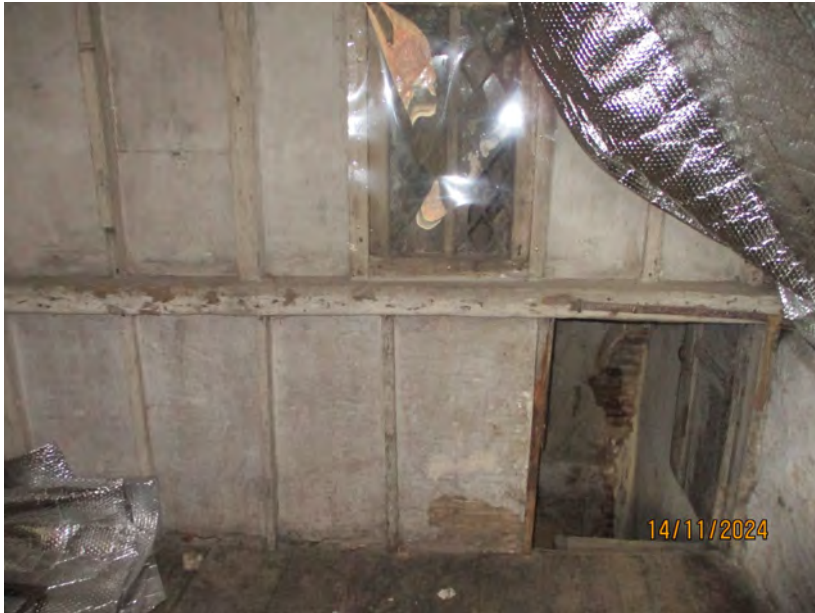
**Fig 20:**

Room F13.

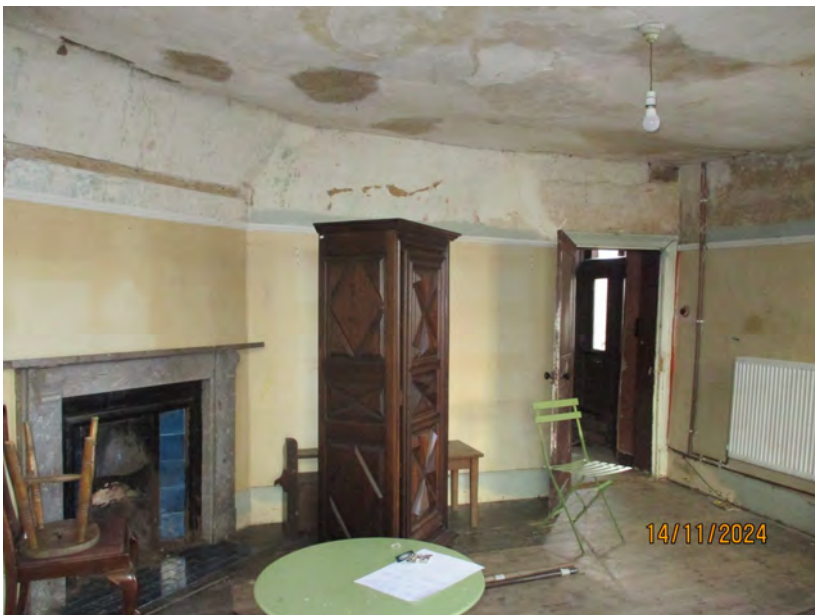
Fig 21:

Room F14.

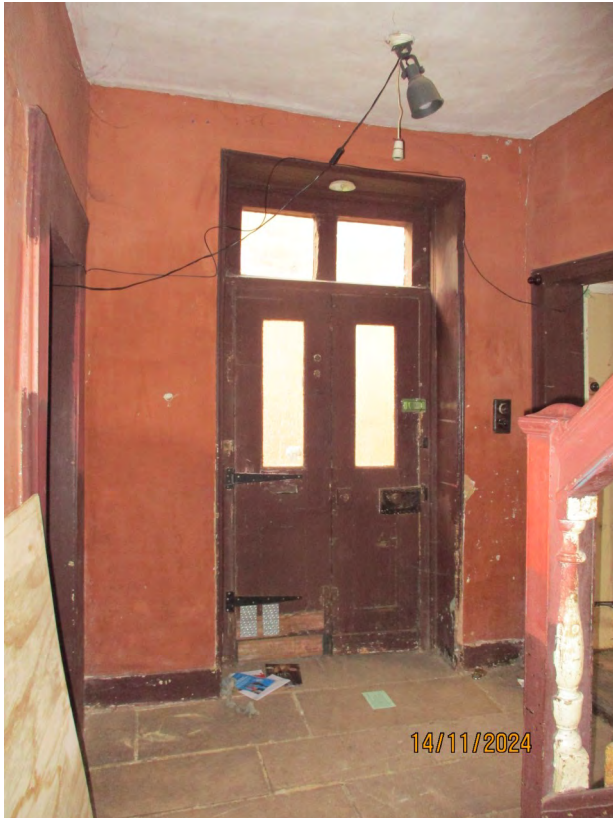
Fig 22:

Room G1.

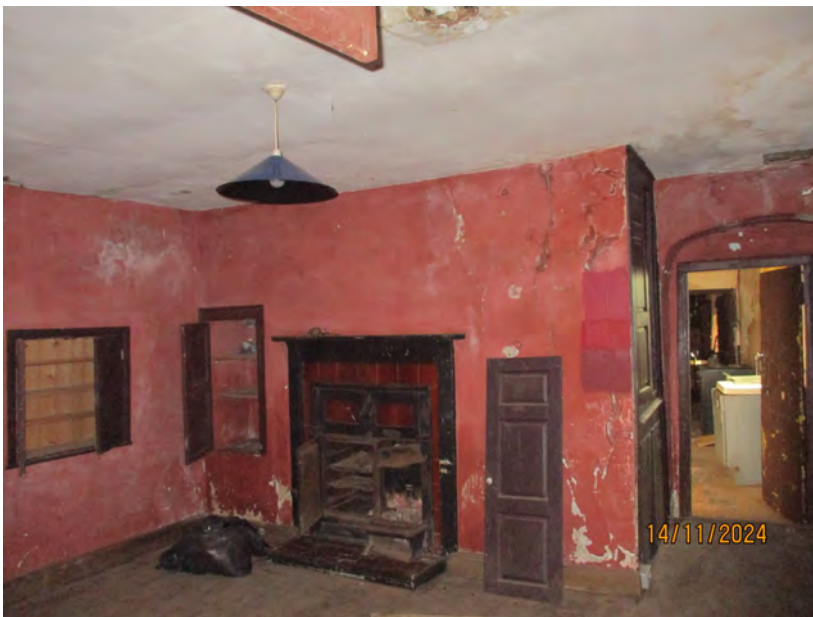
Fig 23:

Room G2.

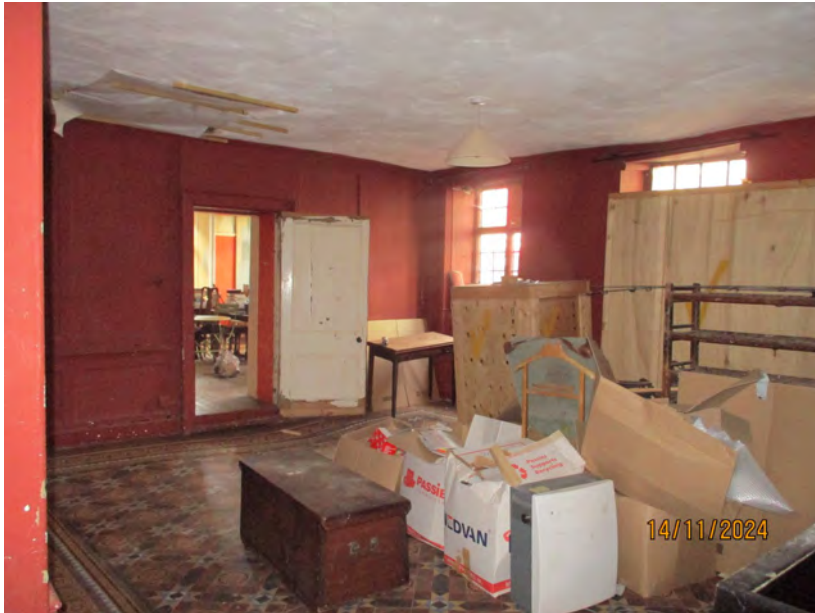
Fig 24:

Room G3.

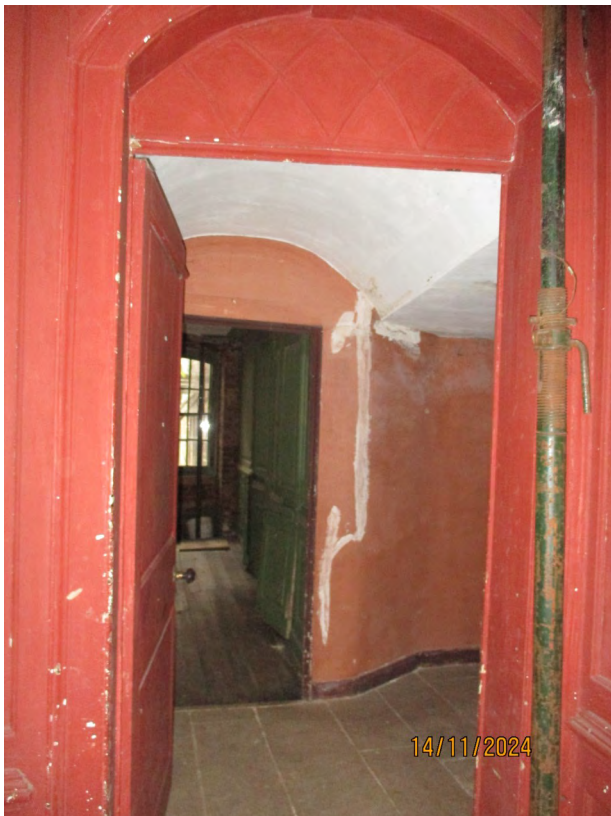
Fig 25:

Room G4.

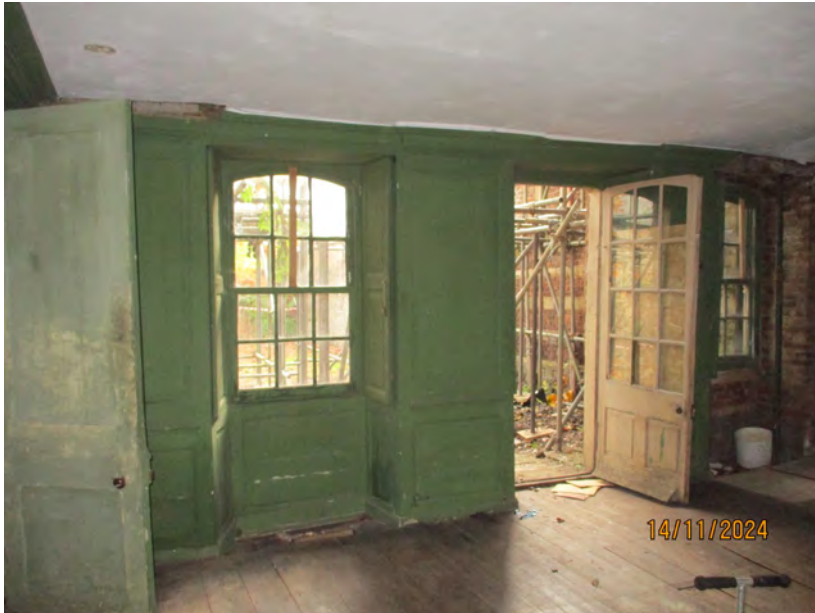
Fig 26:

Room G5.

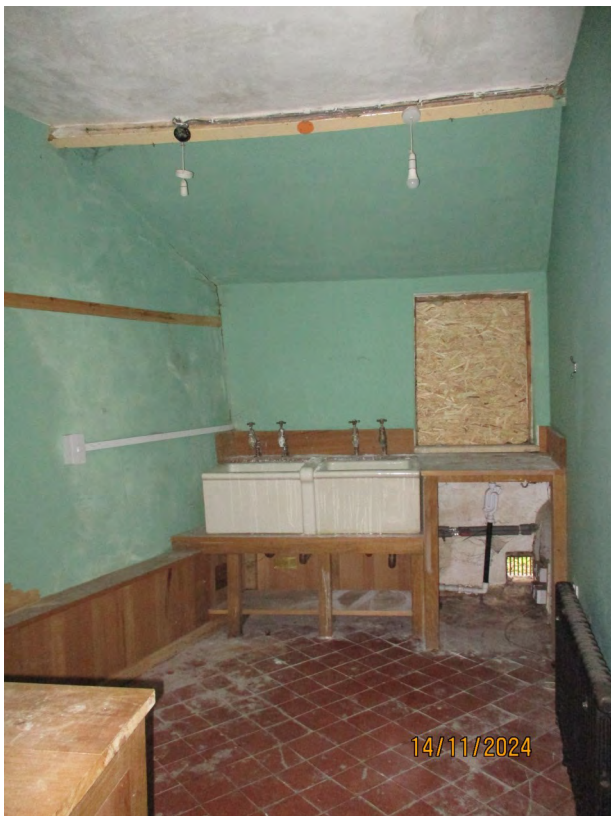
Fig 27:

Room G6.
