PRELIMINARY ASSESSMENT OF EXTERIOR AT MANOR HOUSE, CROWLAND,  
LINCOLNSHIRE

JOB NO. 438-44

MR AND MRS SMEDLEY

14 NOVEMBER 2024 AND 28 JANUARY 2025

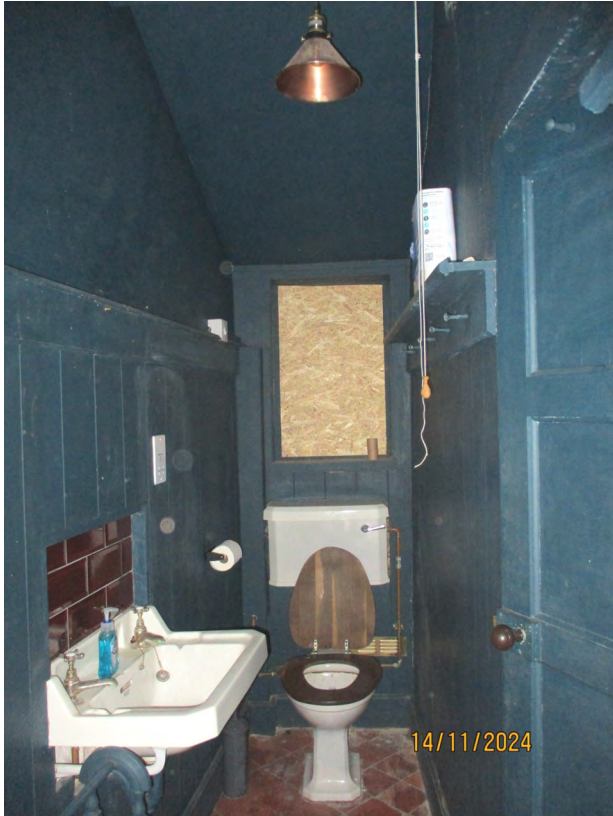
Fig 28:

Room G7.

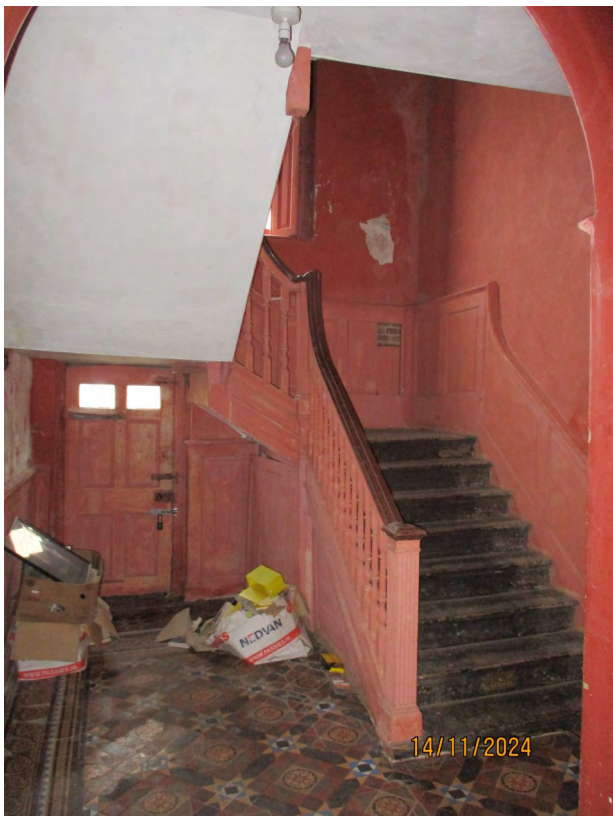
Fig 29:

Room G8.

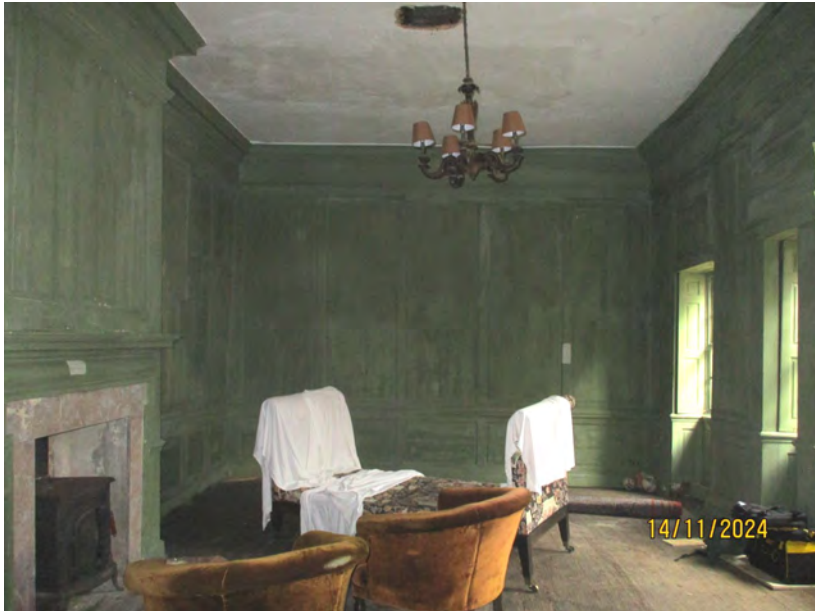
Fig 30:

Room G9.

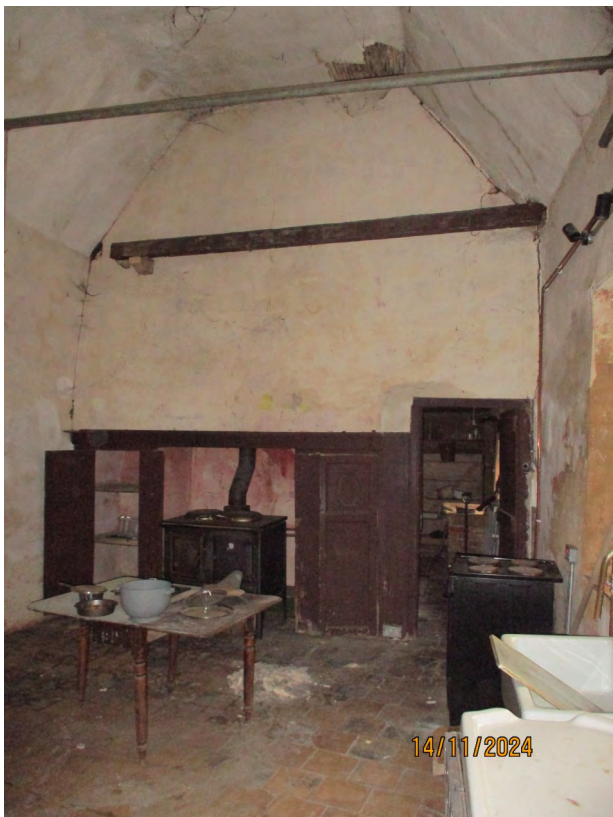
**Fig 31:**

Room G10.

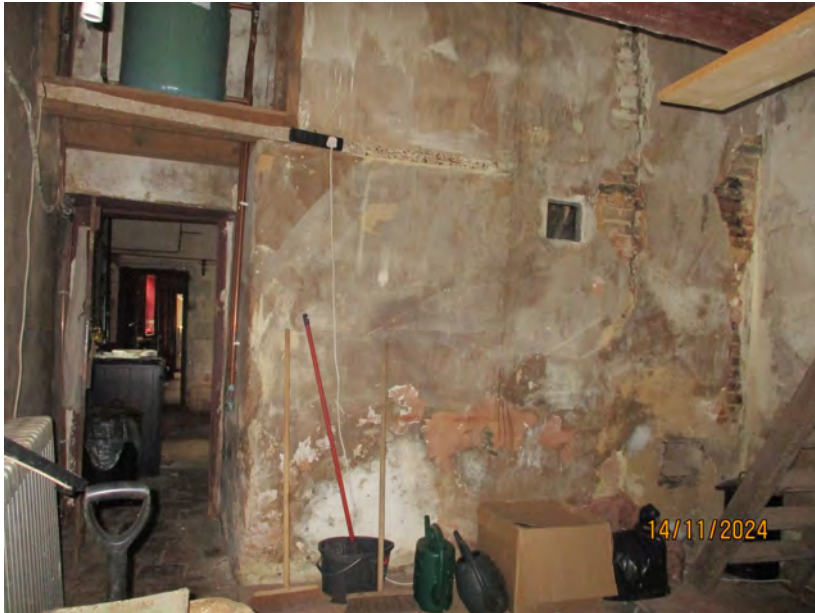
**Fig 32:**

Room G11.

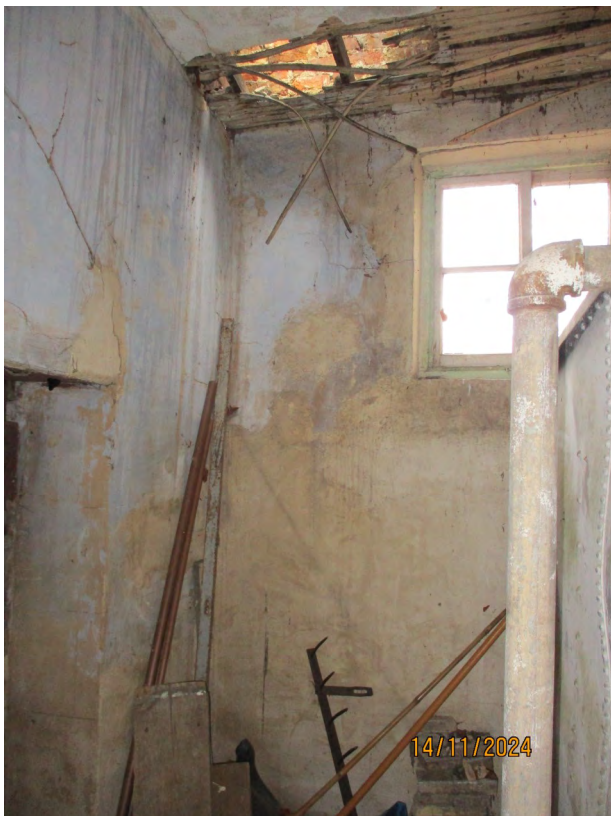
**Fig 33:**

Room G12.

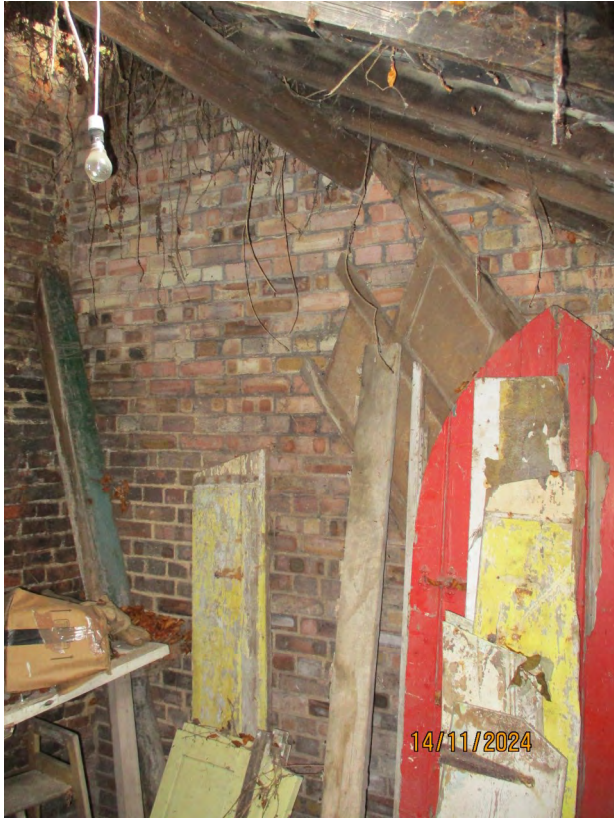
**Fig 34:**

Room G13.

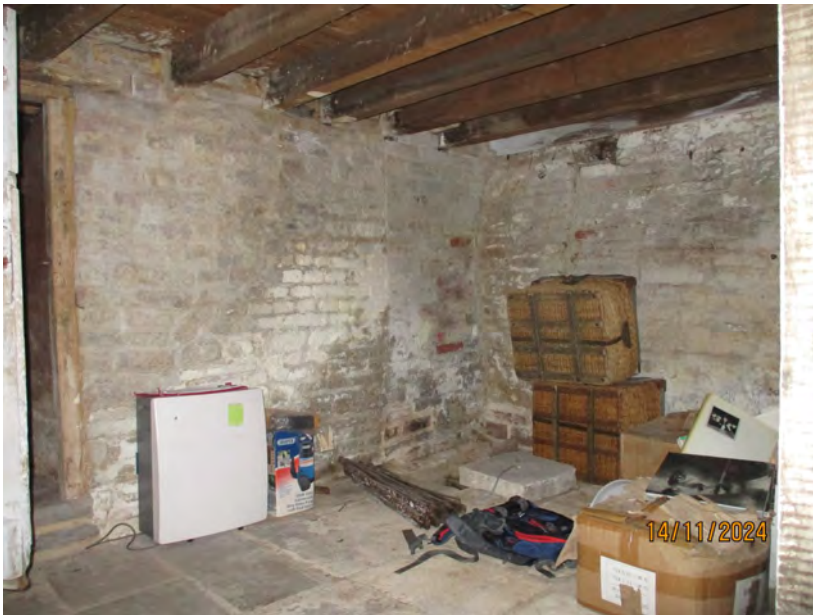
Fig 35:

Room G14.
