David Aldridge Architecture Limited  
 Leadenhall House, Holbeach St. Marks  
 'As existing' photographs  
 Sheet No. 1

Ref: 0219-10

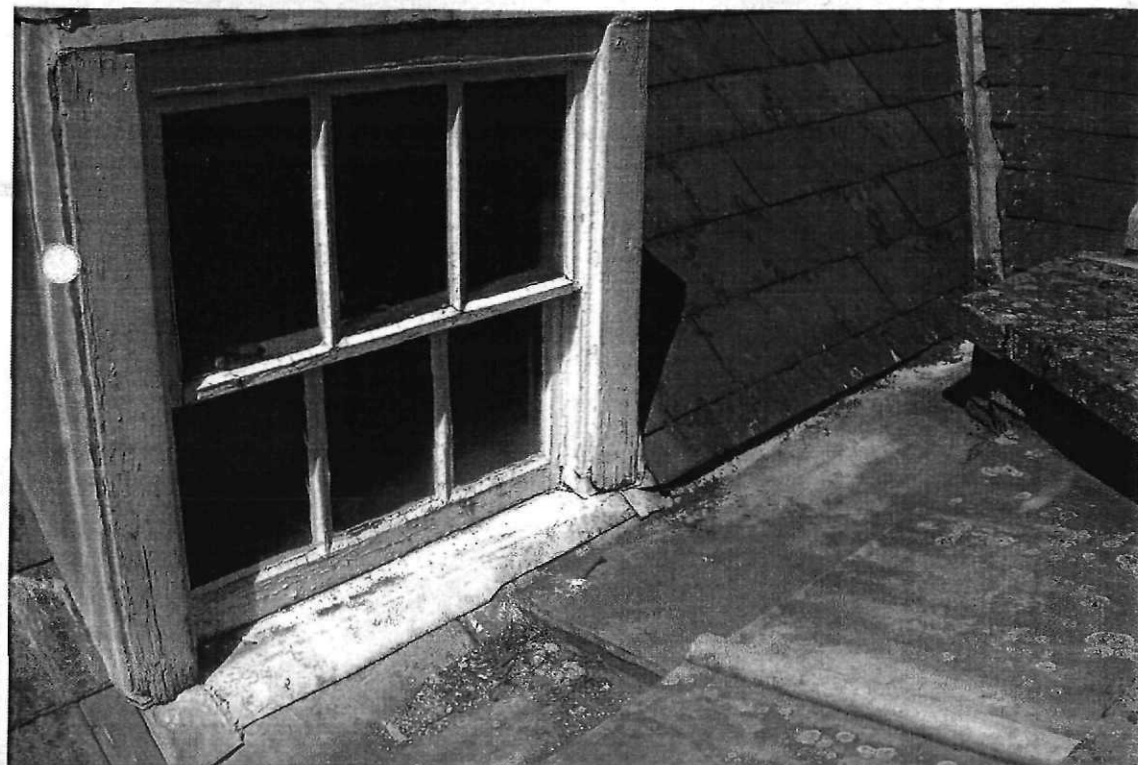
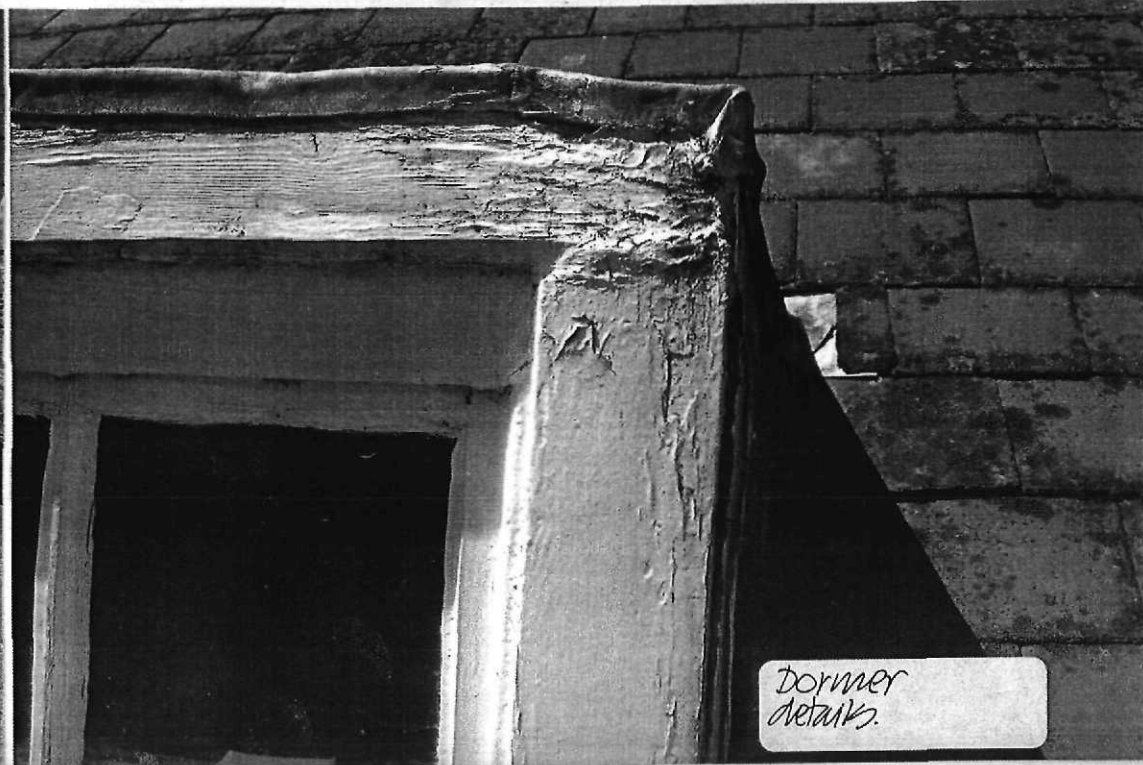
Dormer  
details.

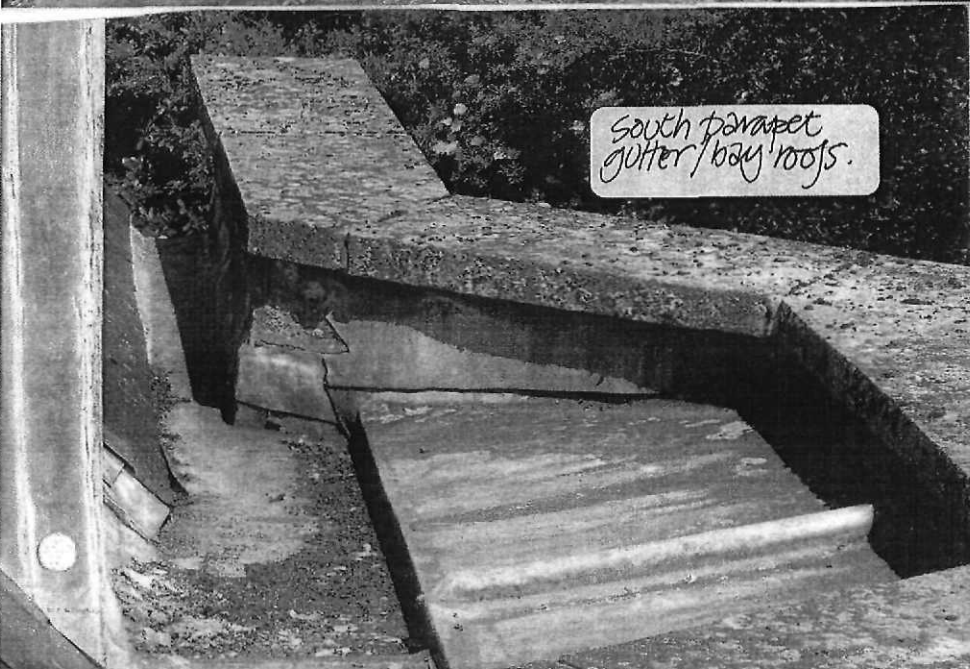
South parapet  
gutter/bay roofs.

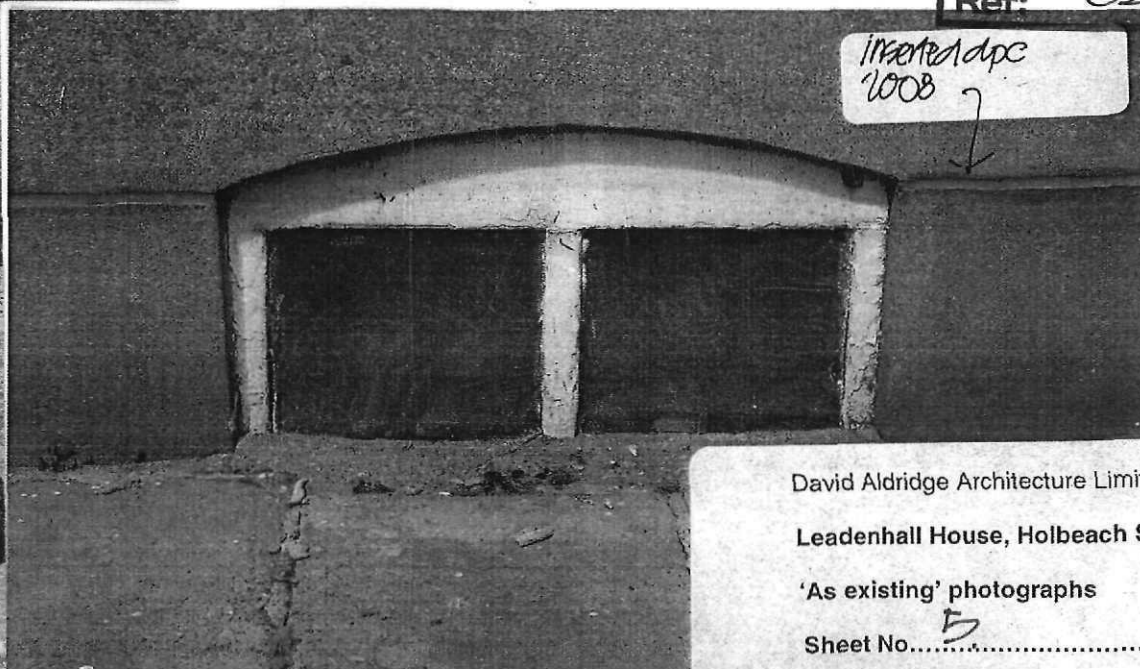
Inverted dpc  
2008

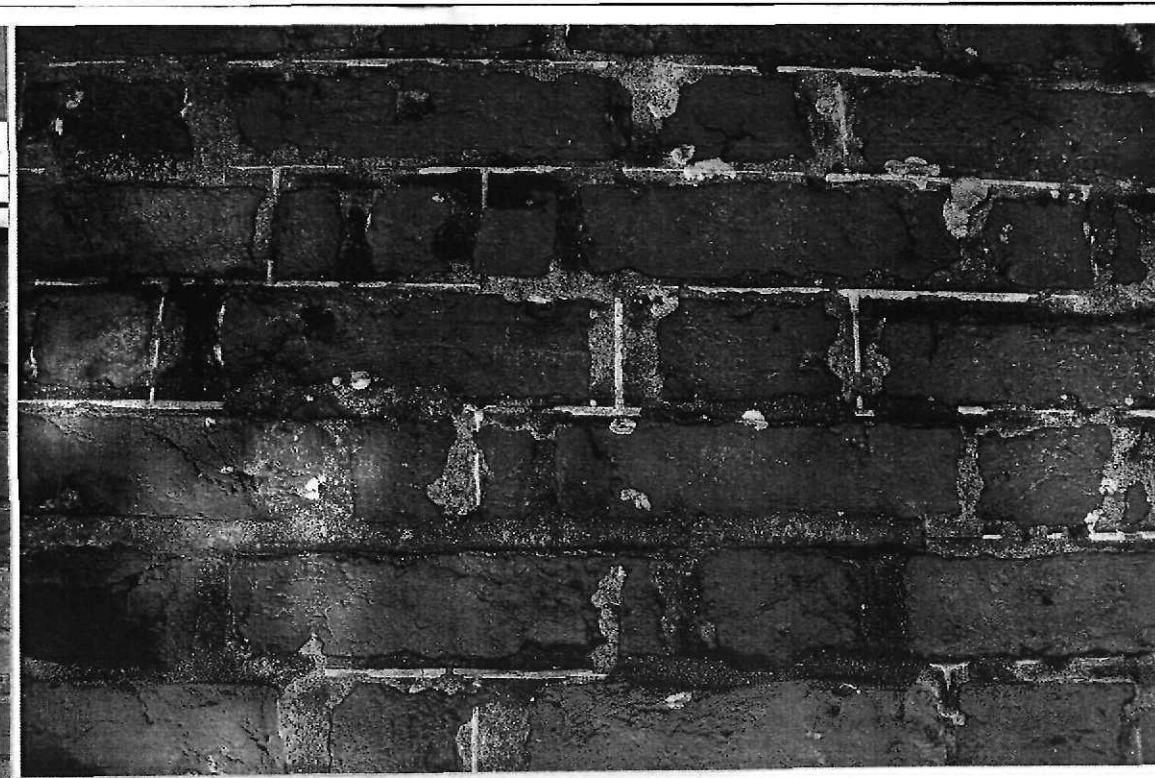
E. elevation "tuck pointing"

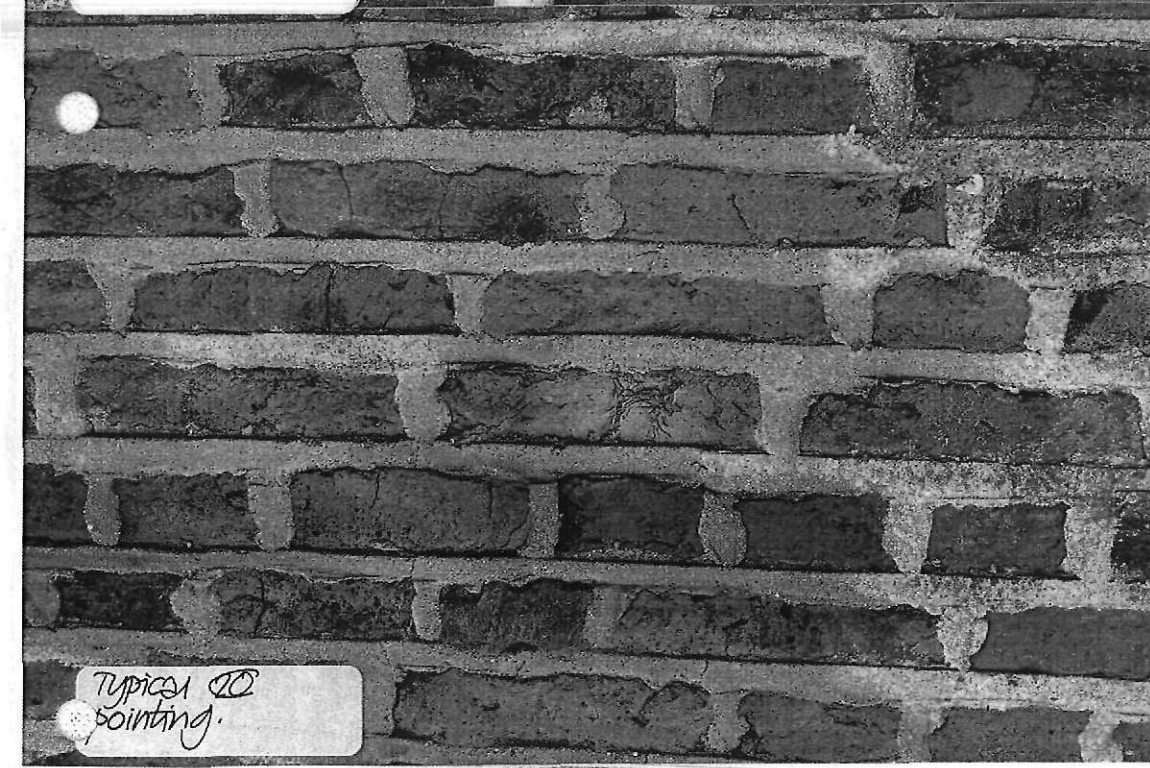
Typical tuck pointing.

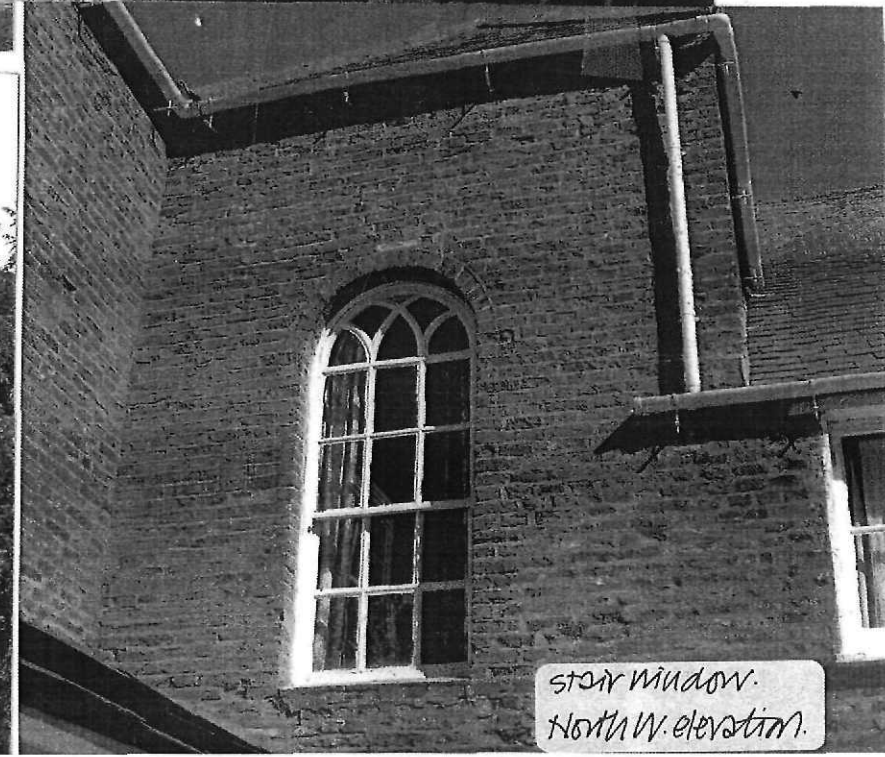
Stair window. North W. elevation.

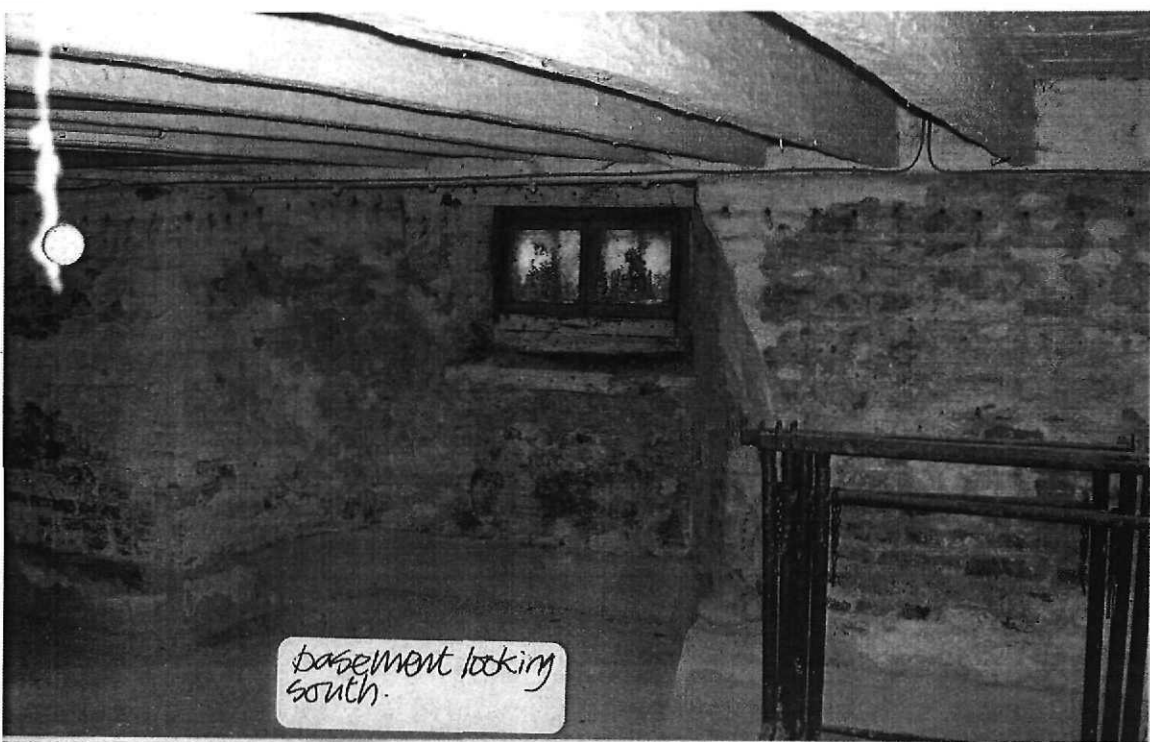
basement looking south.

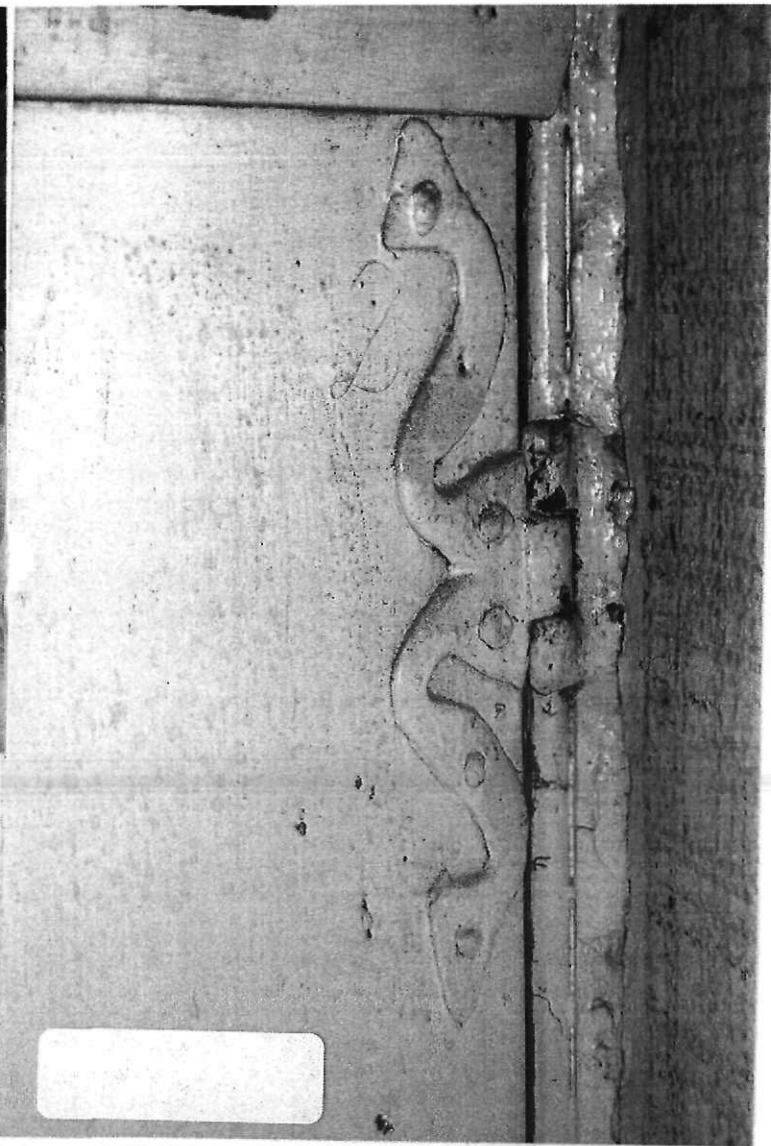
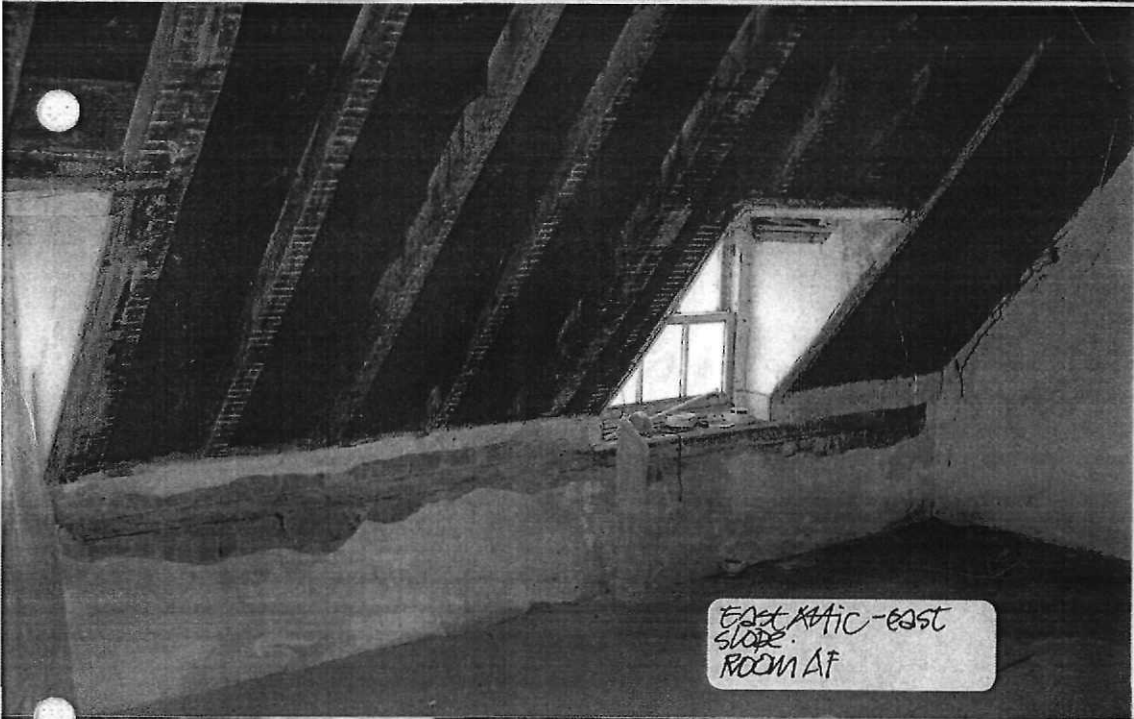
East Attic-East Slope Room A1

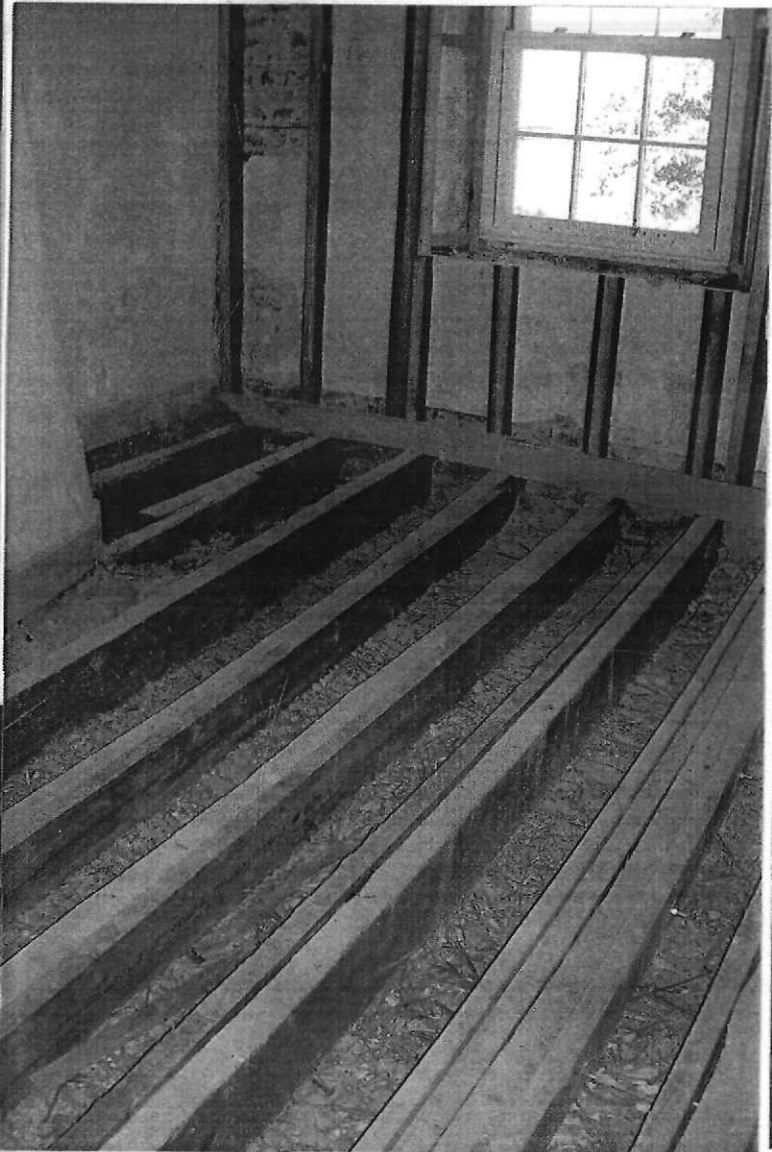
first floor-East Room A1

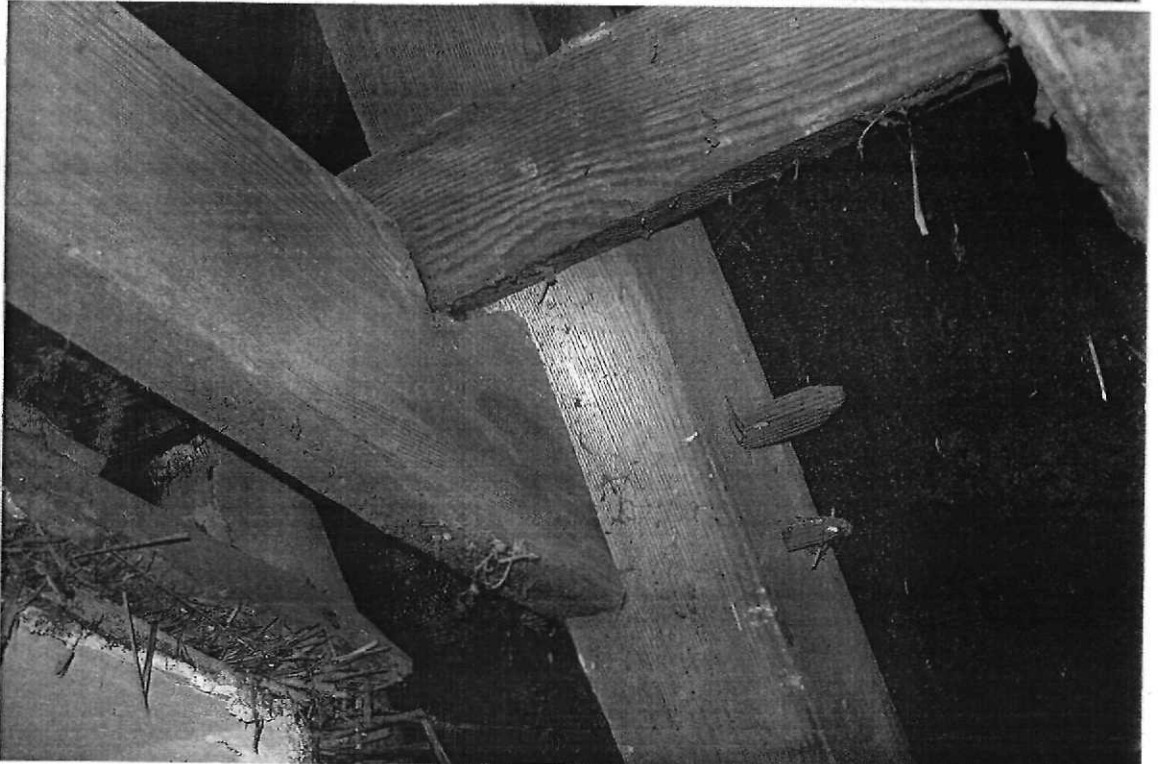
Attic Room Frame Details

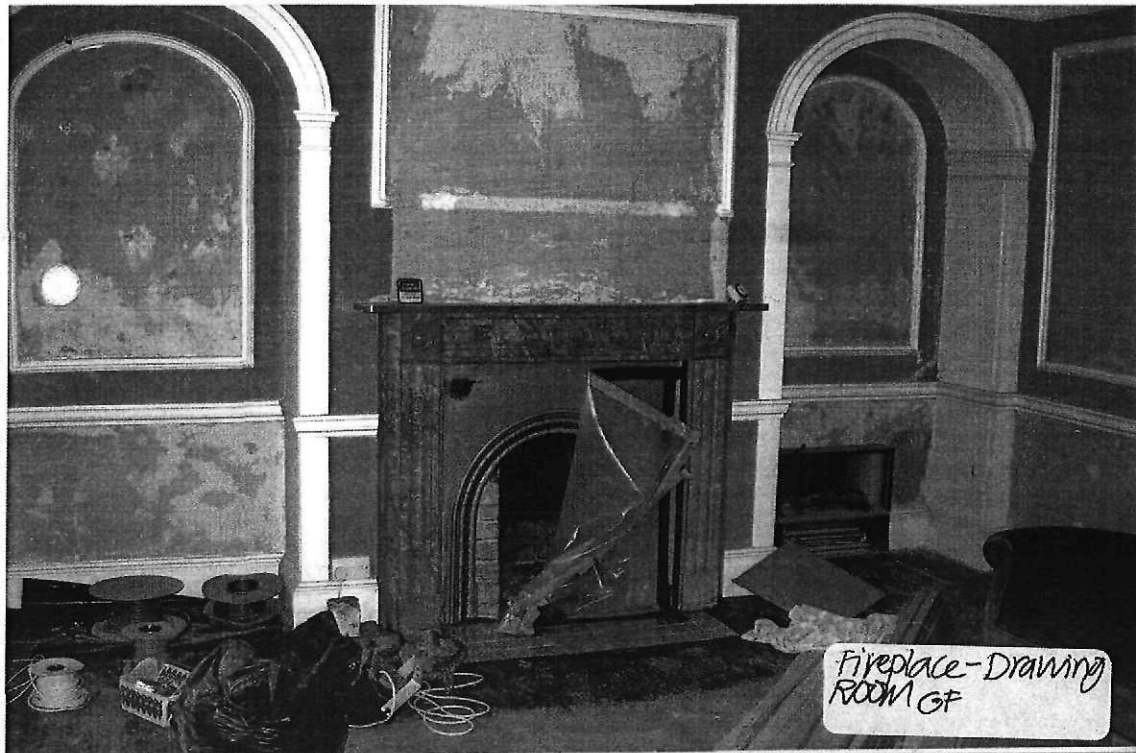
Fireplace-Drawing  
Room GF

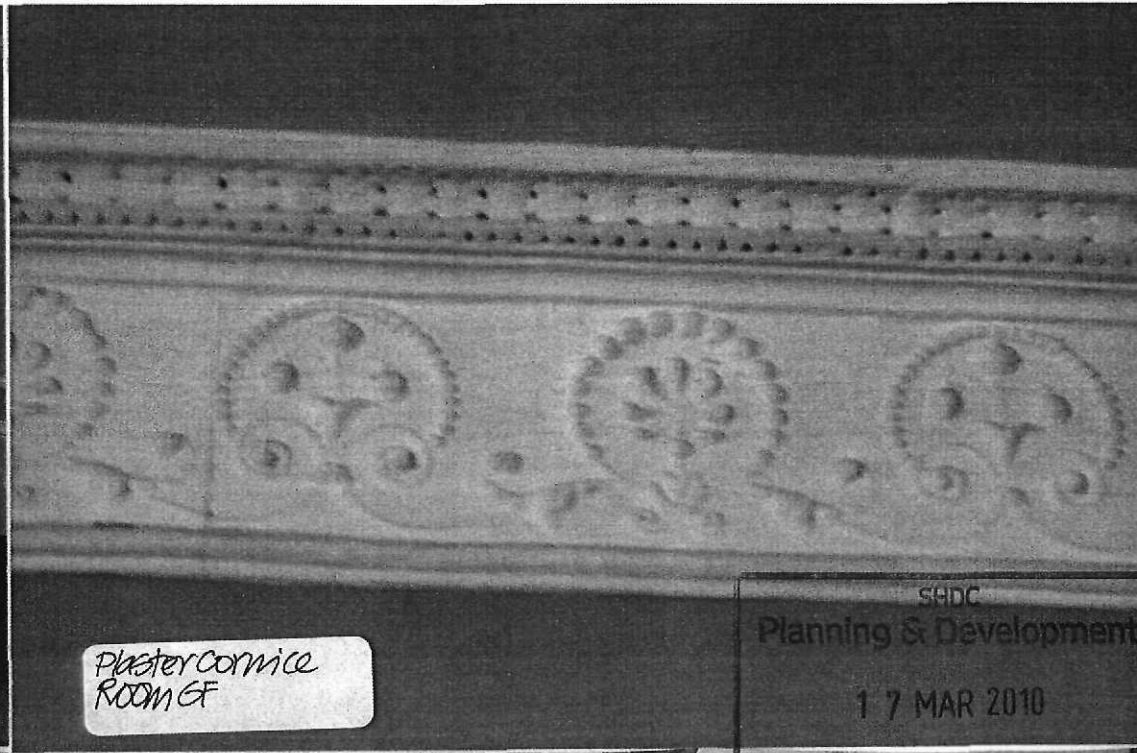
Plaster cornice  
Room GF

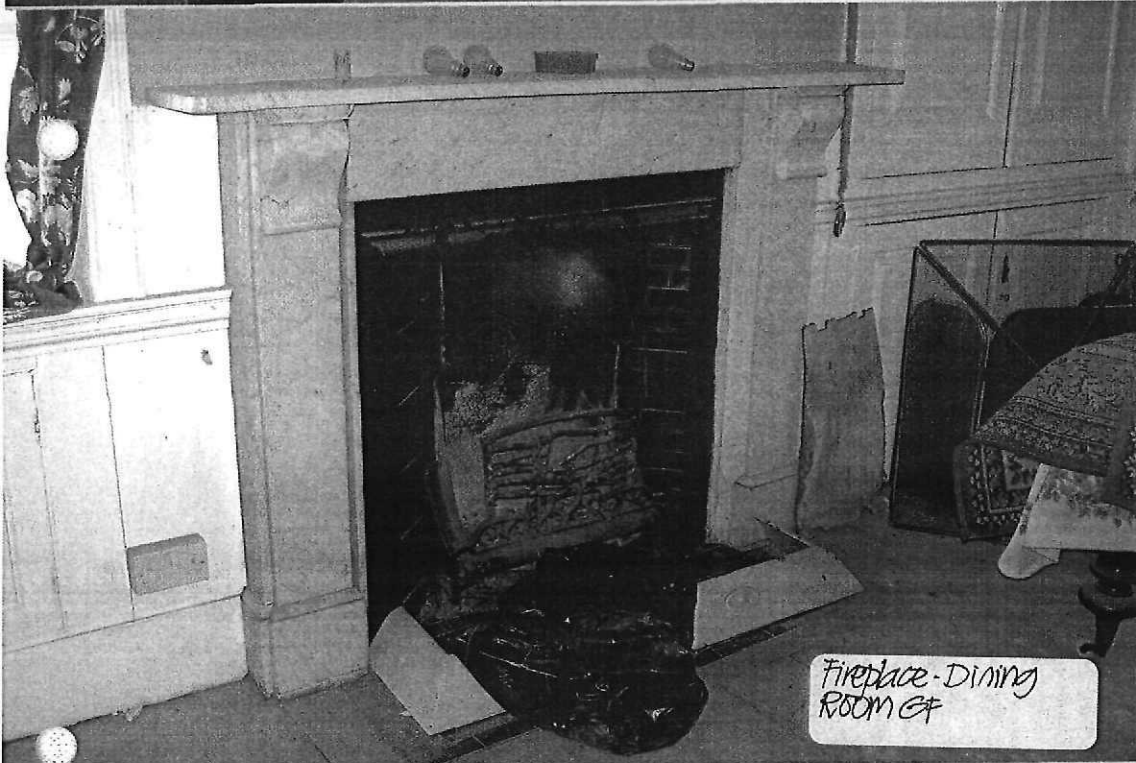
Fireplace-Dining  
Room GF

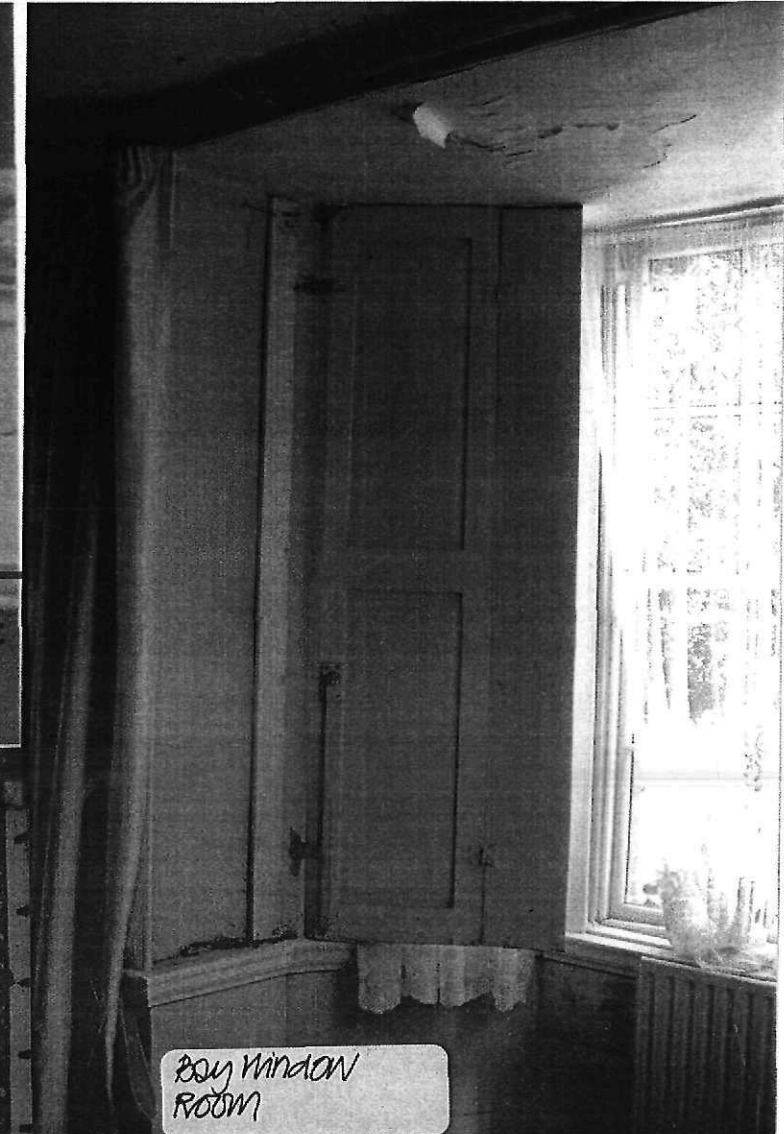
Boy Window  
Room

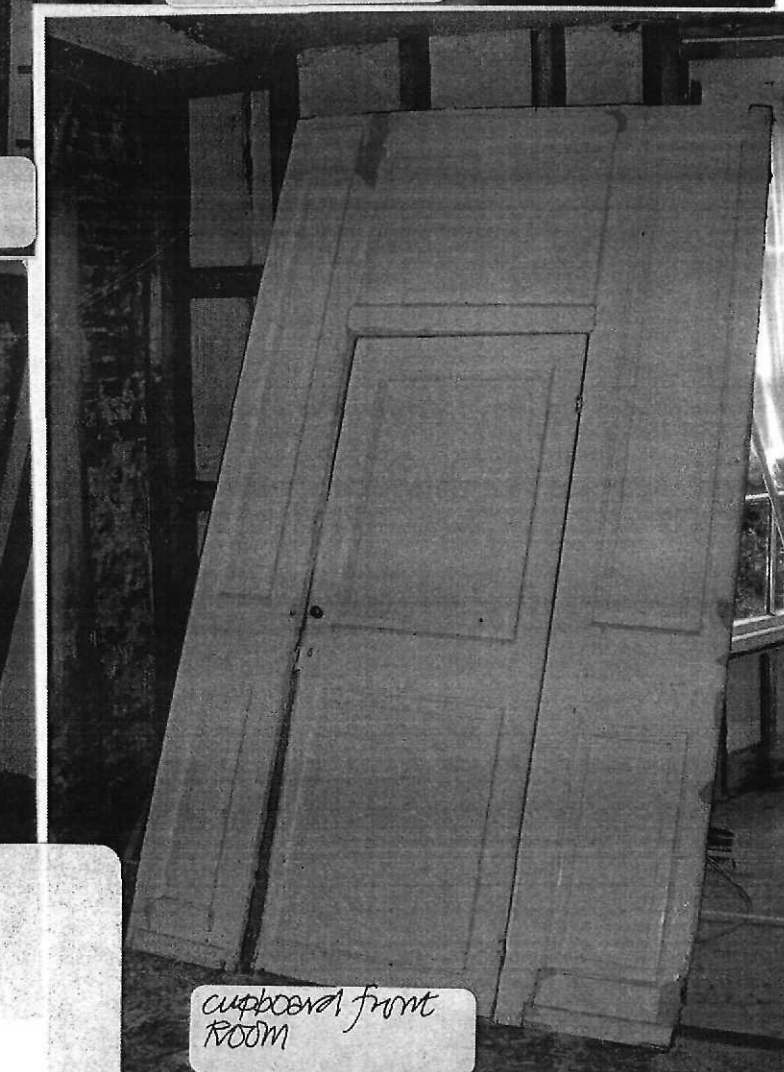
cupboard front  
Room

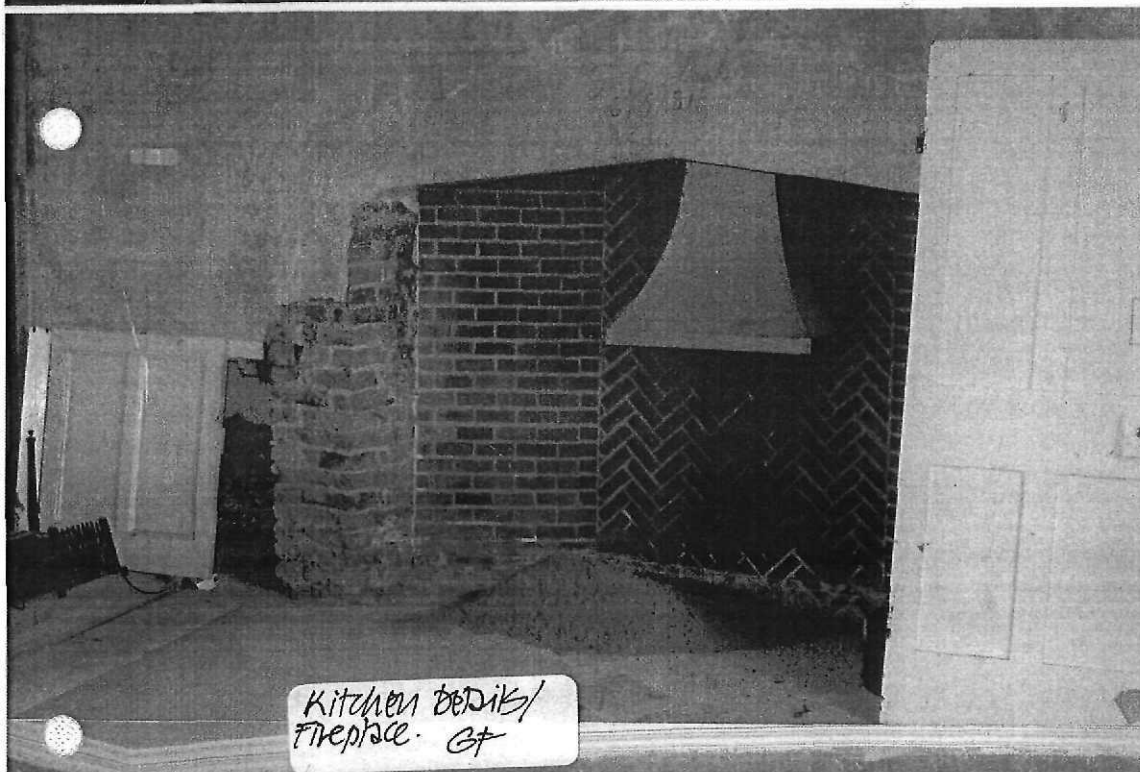
Kitchen Details/  
Fireplace. GF

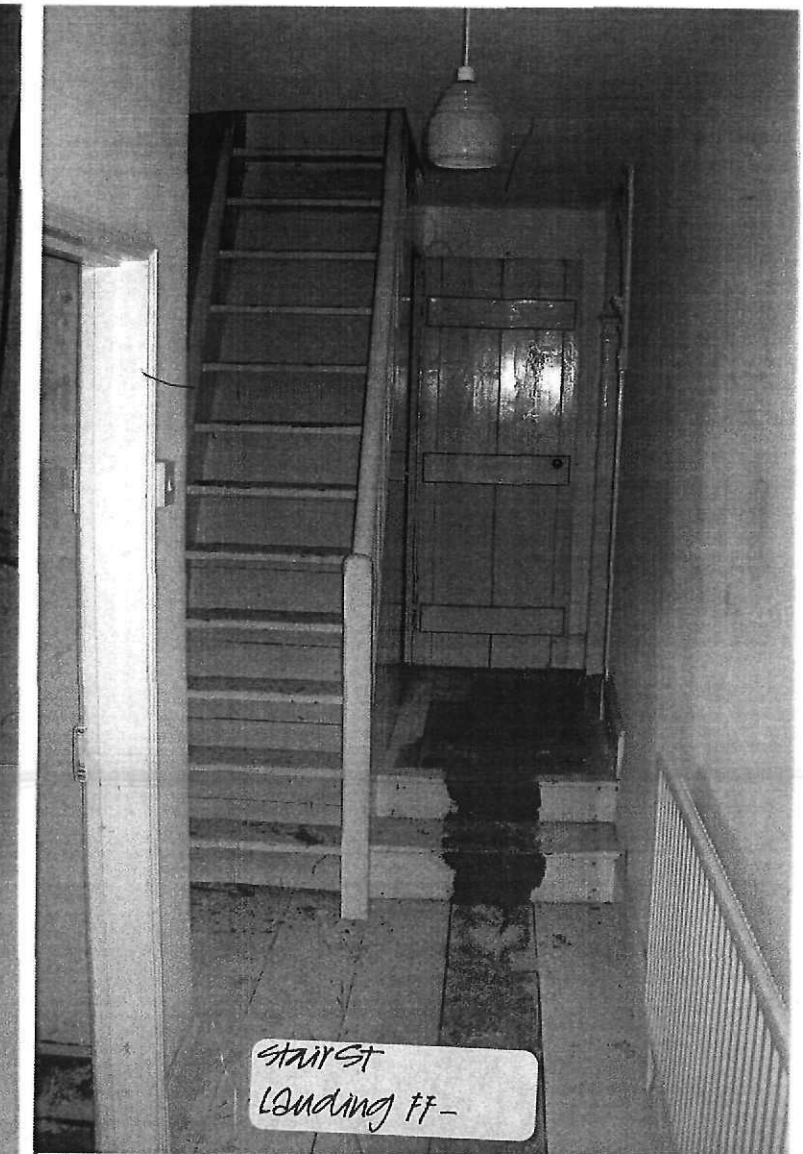
STAIRS  
Landing FF-

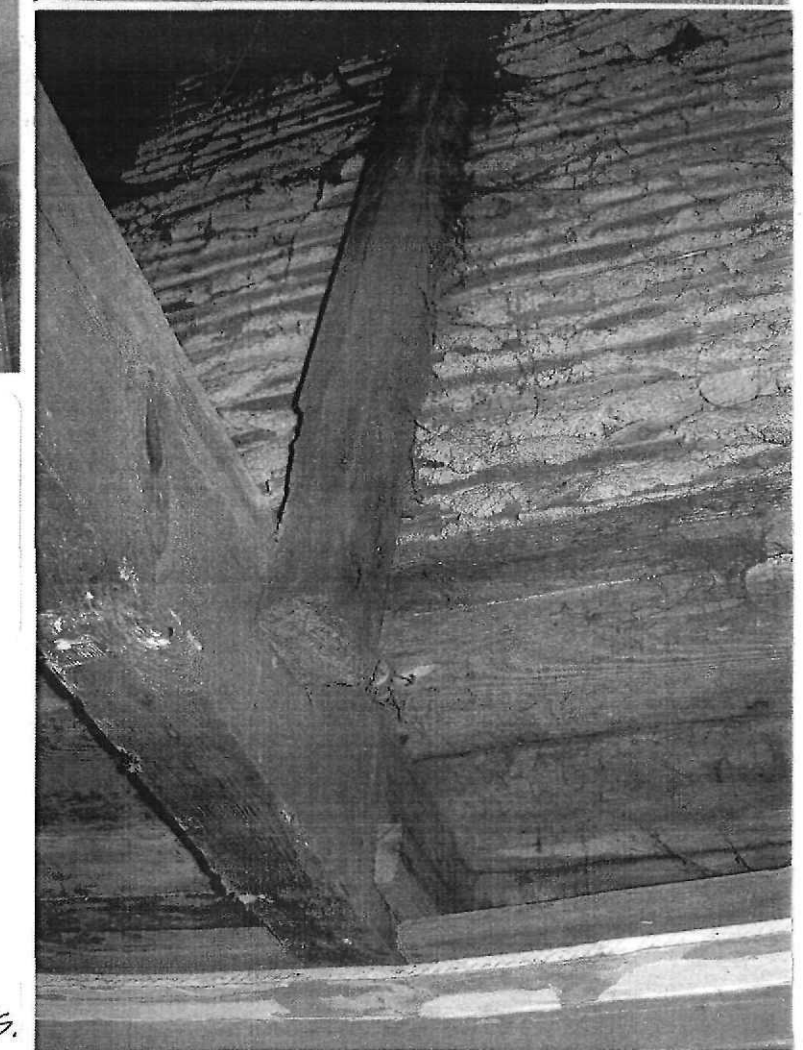
Bathroom  
Roof/Ceiling details.

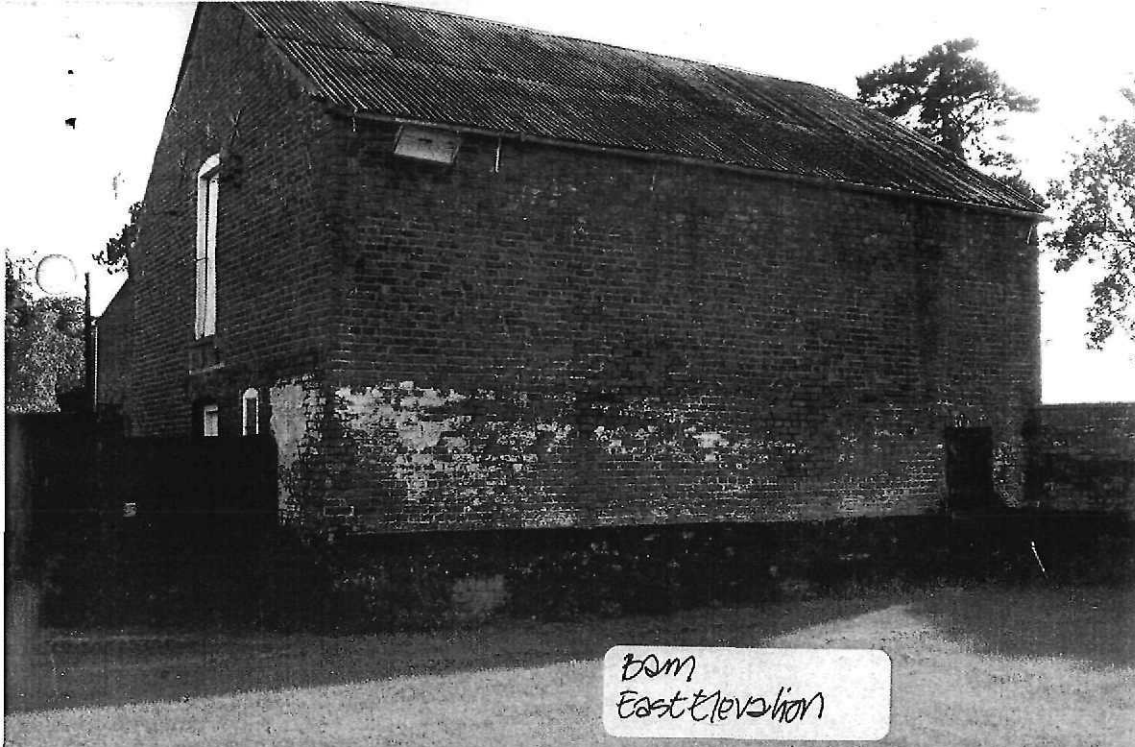
Barn  
East elevation

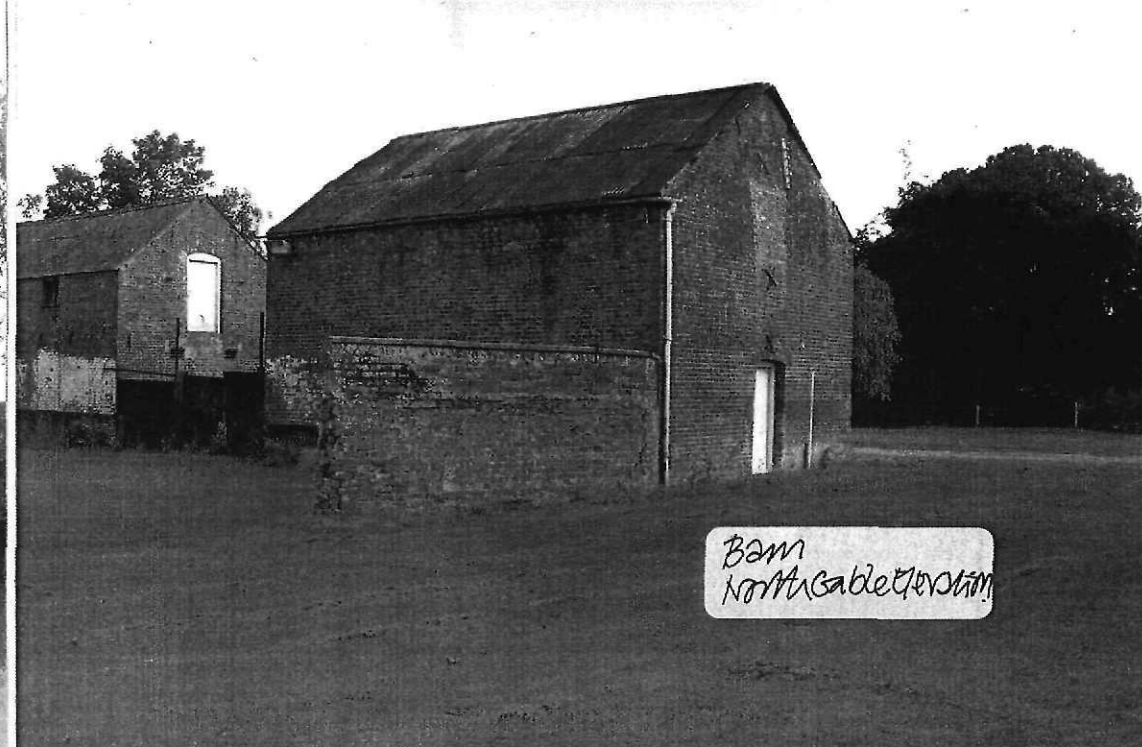
Barn  
North side elevation

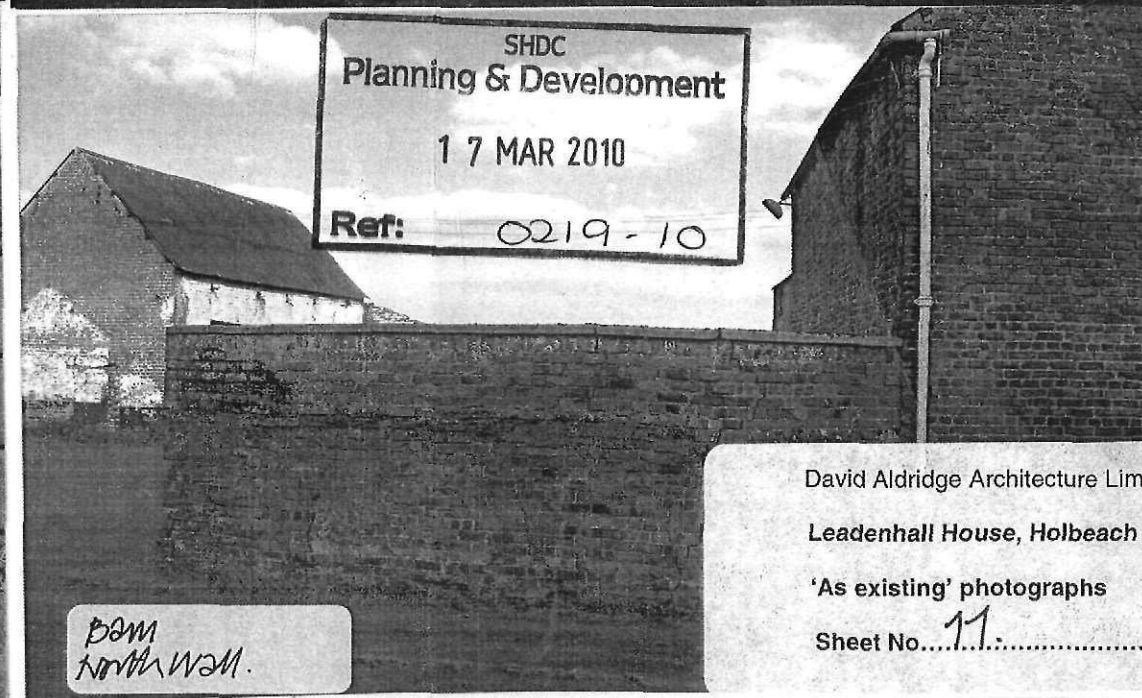
Barn  
North wall.

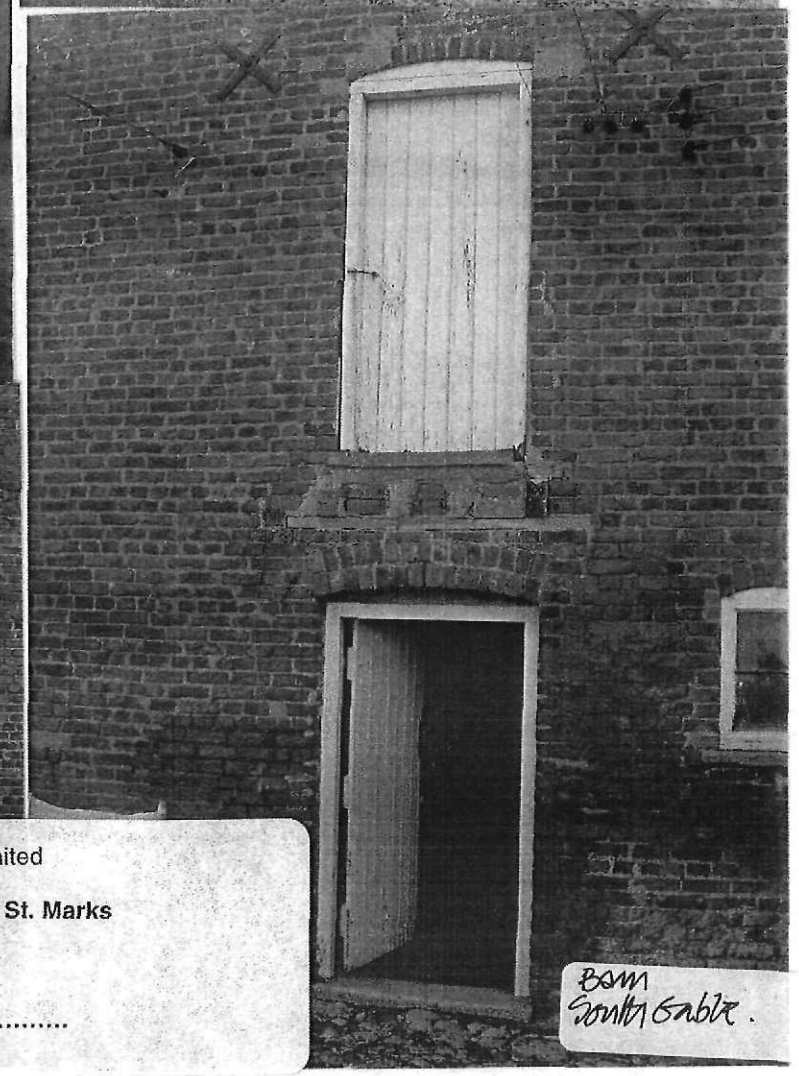
Barn  
South side.
