**STRUCTURAL REPORT ON  
LIMMINGS BUILDING,  
PARK ROAD, HOLBEACH,  
PE12 7EE**

**PROJECT NO.  
MGC/EH/HW/50247-RP001**

**STRUCTURAL REPORT ON LIMMINGS BUILDING, PARK ROAD, HOLBEACH,  
PE12 7EE**

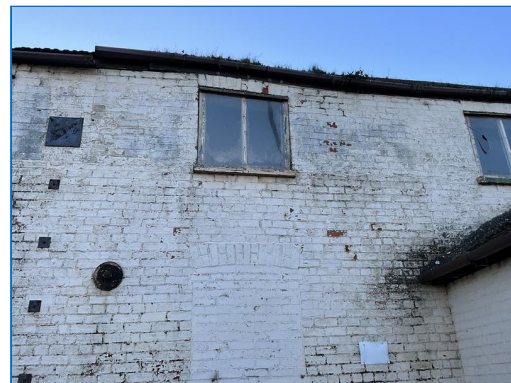
Photo - 3

There is fine stepped cracking, extending down in a south easterly direction from the far right hand window. There is also further cracking and pushing out of the brickwork around the central to first floor windows around eaves level.

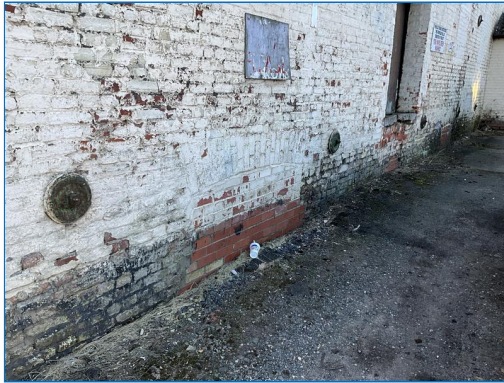
*Photo - 4*

There are a number of plates that suggest that tie bars have been installed to the front elevation of the property. The lower level bars fall within the ground floor joist position which was not accessible during our inspection. There are also a couple of higher level bars however, these do not appear to span between the front and rear walls of the building.

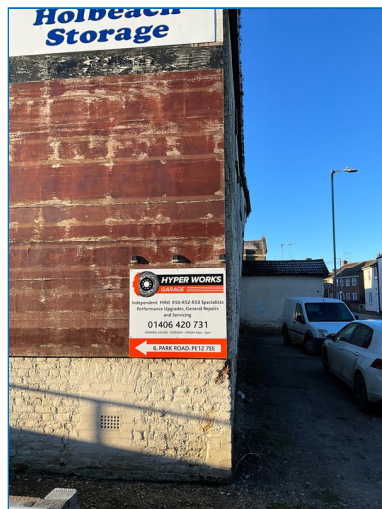
*Photo - 5*

There is some general leaning of the wall at low level as well as significant pushing out and bowing of the brickwork along the eaves level to the centre of the elevation.

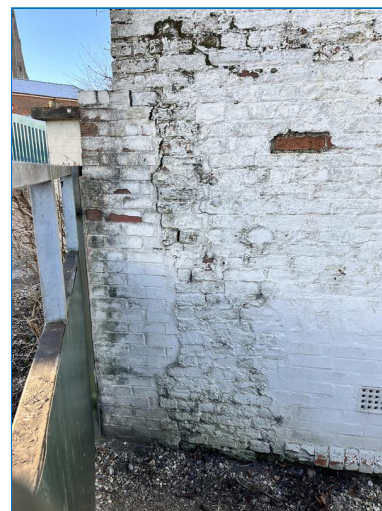
Photo - 9

There is some minor weathering and damage to the brickwork and further evidence of bricked up openings. An area of the wall is covered with signage. There is some cracking, generally vertical in direction, to the bottom left hand corner of the elevation along what appears to be a junction between original and newer/rebuilt brickwork sections which steps out to form a small pier to which the gate post abuts/is fixed.

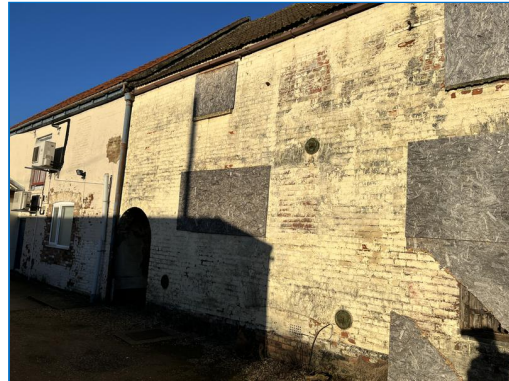
*Photo - 13*

As with the other elevations, the brickwork is largely in a commensurate condition for the building's age. A number of previous openings have been bricked up and there are again end plates to tie beams which do not appear to be present internally. A small section of the elevation is covered in climbing plants. The remaining openings have been boarded up, however, one has been damaged from recent trespass into the building.

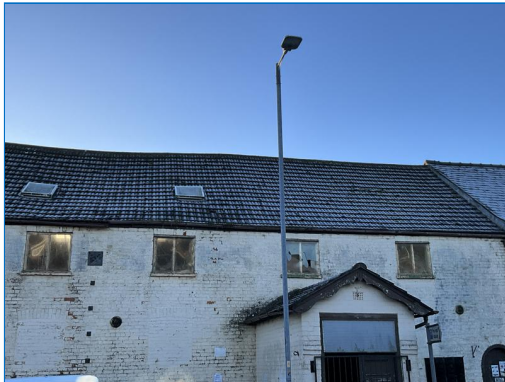
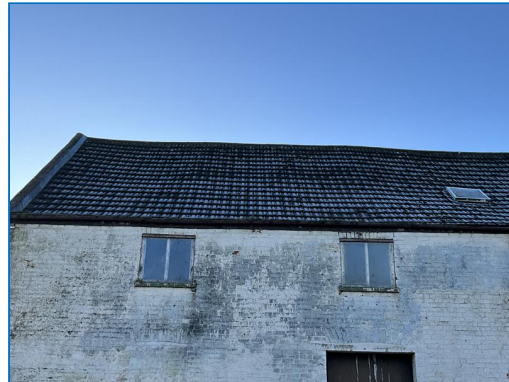
There are extensive undulations in the roof and ridge lines to the centre of the front roof pitch, which coincides with the pushing out of the brickwork at eaves level. There is also extensive vegetation within the guttering to which there are gaps and signs of poor maintenance.

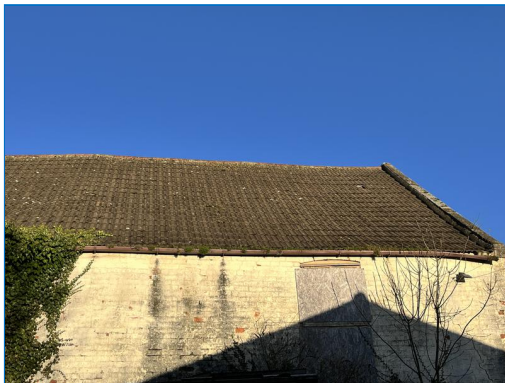
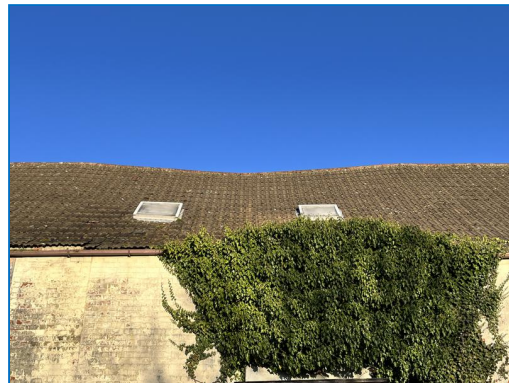
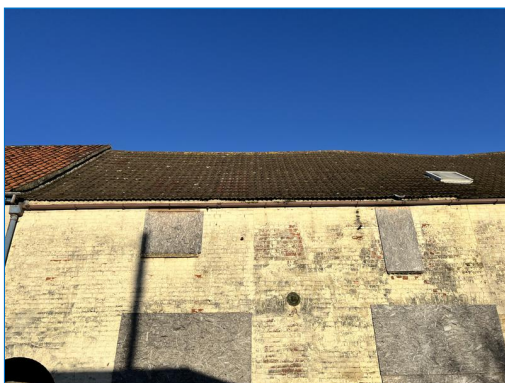
As with the front pitch, there are extensive undulations in the roof and ridge lines to the centre of the front roof pitch. There is also vegetation within the guttering which has been poorly maintained.

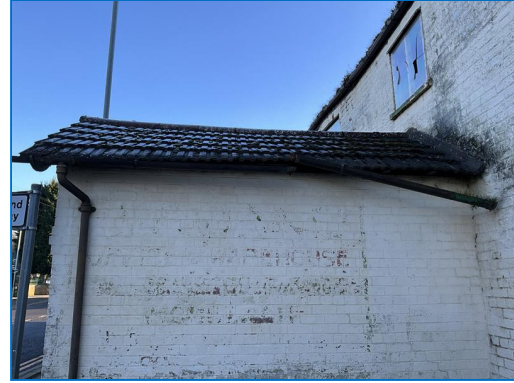
Photo - 25

The roof covering itself is in fair condition however, the rainwater goods are full of vegetation and/or are damaged or missing.

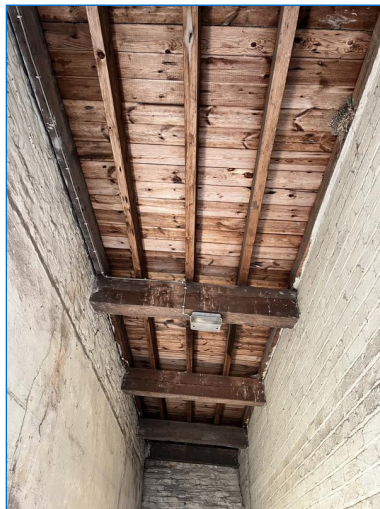
Photo - 26

The internal mezzanine floor joists are exposed to the soffit of the alleyway. The joists slope in an eastward direction when compared with the brickwork coursing.

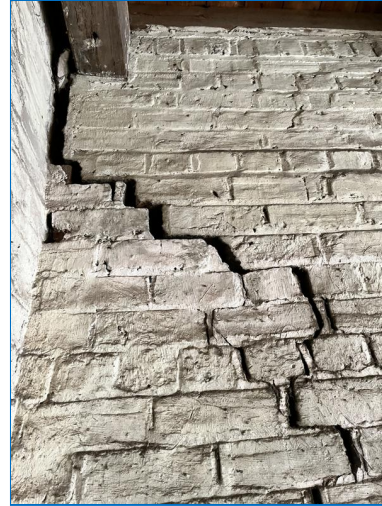
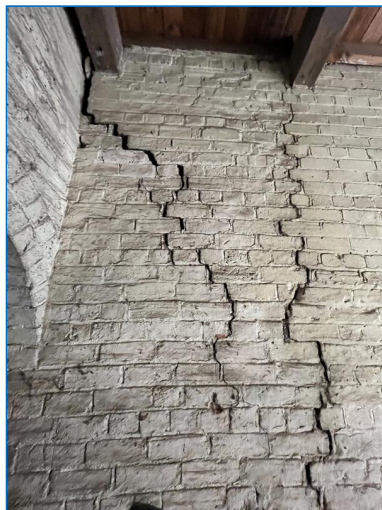
There is significant cracking to the internal corners both sides of the arched door opening to the front elevation, as well as vertical cracking, extending down from the second floor joist above. The cracks to the internal corners are notably wider on the vertical, perpend joints as compared to the horizontal, bed joints.

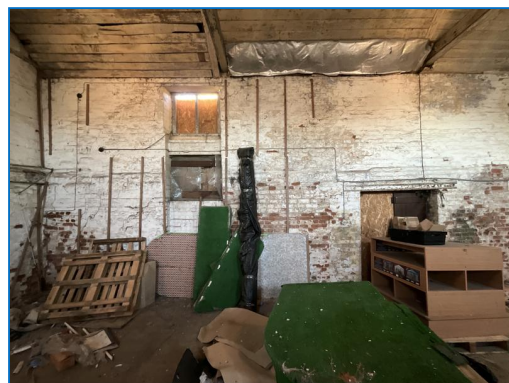
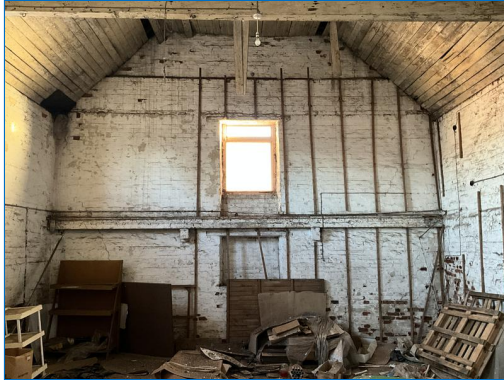
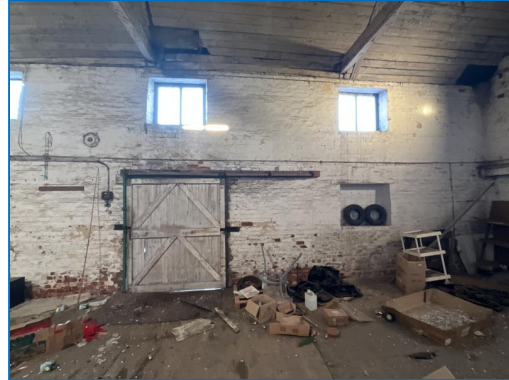
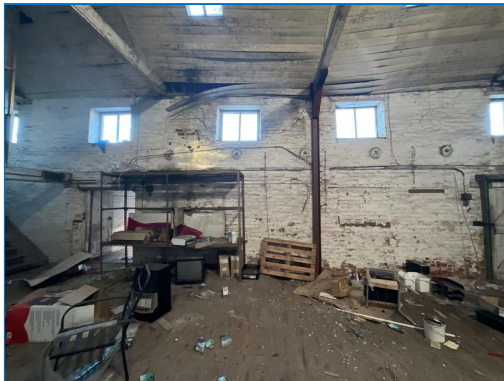
Around the room there are various alterations to openings, with a number of old windows bricked up. There is widespread deterioration of the brickwork as well as spalling and salts to the surface evident.

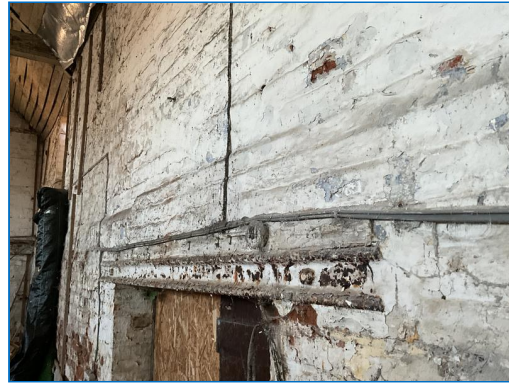
*Photo - 43*

Alterations to and bricking up of old openings to the south wall are evident. Timber and steel lintels have been retained above and there is a step out in the brickwork noted above the door openings. There is also stepped cracking extending down from the top left hand corner of the left hand door opening down in a south westerly direction.

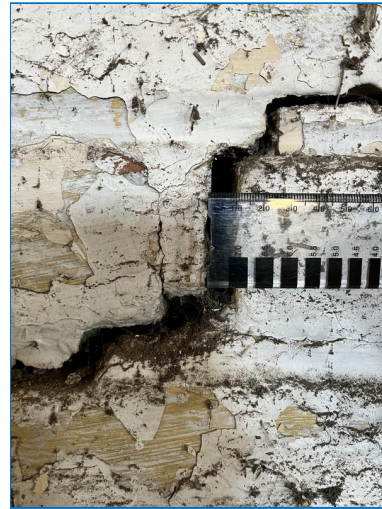
*Photo - 48*

There are a number of stepped cracks extending upwards in a north easterly direction to the left hand section of the south wall. The cracking appears to widen with height and is wider to the perpend joints (up to 10mm) that to the bed joints (up to 4mm).

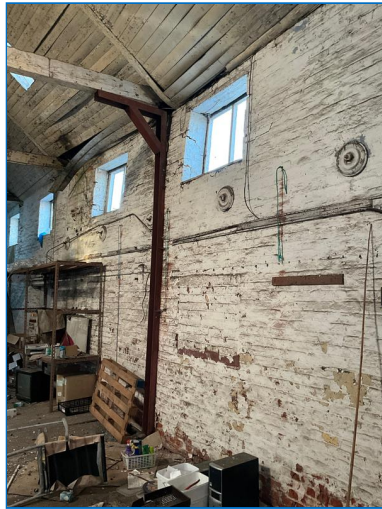
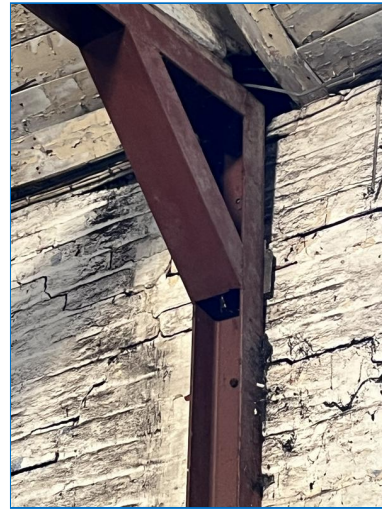
A steel column and beam over the gallows bracket has been installed to the north wall where the top of the wall has pushed out leaving the roof collar above unsupported. This has been bolted through the external wall up to the underside of the gallows bracket, with the top section of brickwork remaining unbraced.

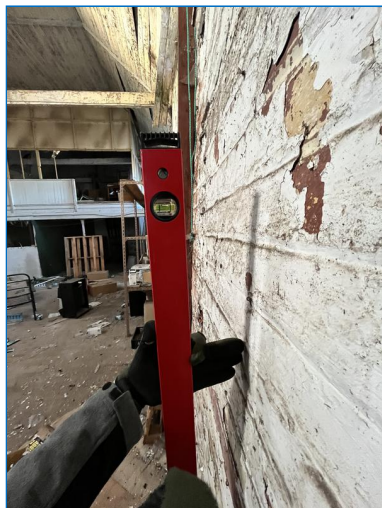
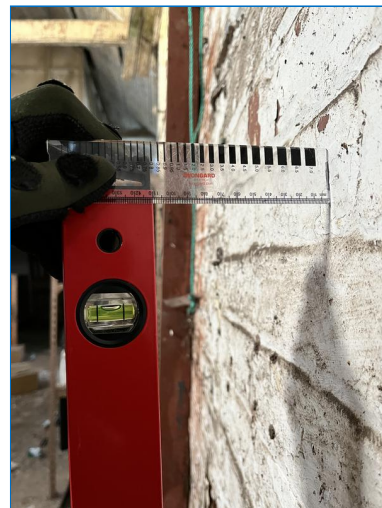
The lower section of the north wall leans outwards significantly, by up to approximately 110mm over 1.8m at its' most severe point.

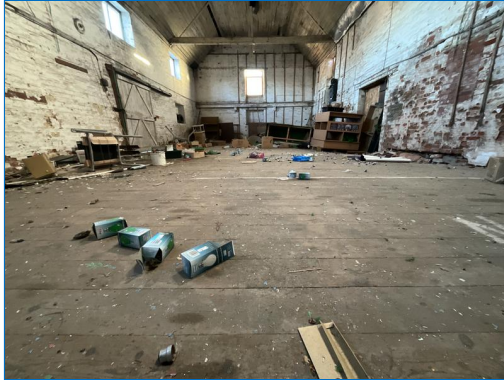
Photo - 64

The floor slopes to the front and rear walls of the building.

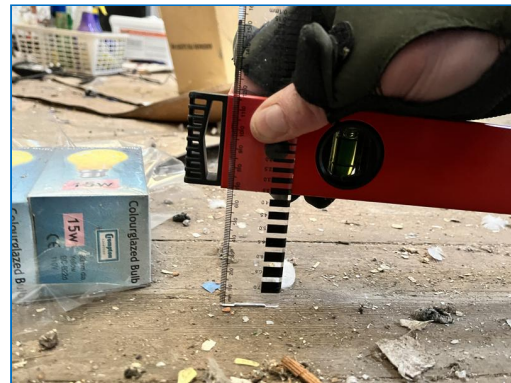
The south and north sides of the floor were measured for levelness. The south side slopes towards the south wall by approximately 99mm over 1.8m and the north side slopes towards the north wall by approximately 68mm over 1.8m.

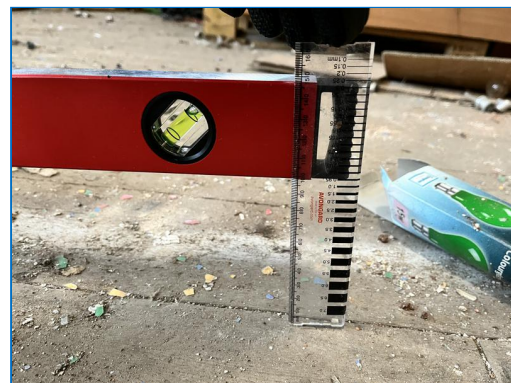
Photo - 68

There are a number of areas where the floorboards have dropped and rotted away, largely adjacent to the external walls of the building.

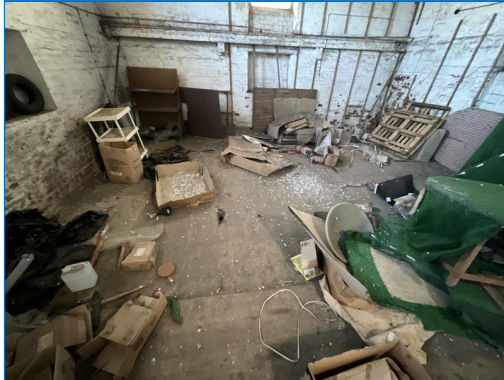
*Photo - 74*

The floorboards to the east side of the main room are laid perpendicular to the rest of the room, which suggests the floorboards below span in a perpendicular direction to the rest of the room.

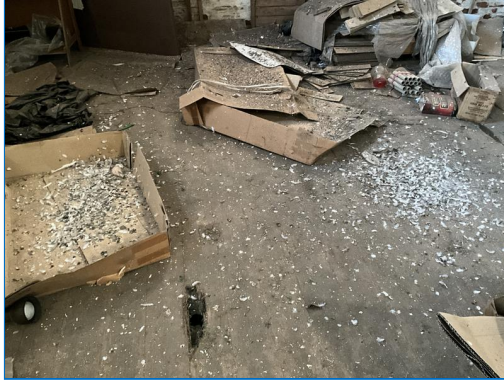
*Photo - 81*

Pigeons are also able to get inside the building via these gaps and gaps in the roof structure and there were feathers and guano on the floor of the building.

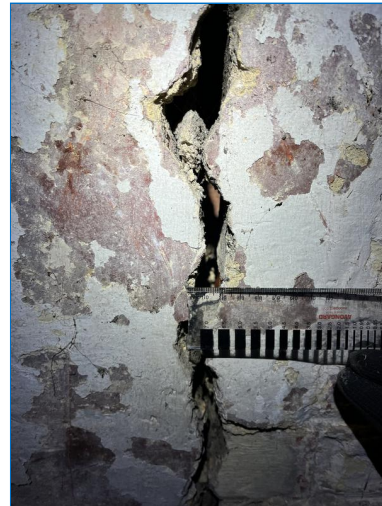
Photo - 85

There is a vertical crack (up to approximately 20mm in width) to the west wall to adjacent to the north west corner of the building which has a stepped crack, extending up generally in a north east direction. The cracking to the corner of the room is wider to the perpend as compared with the bed joints and widens with height up to approximately 42mm in width.

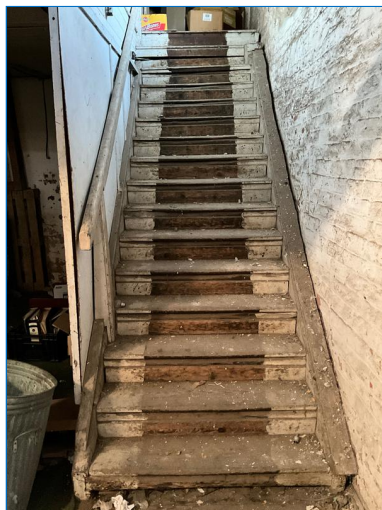
*Photo - 89*

The stairs slope in a southward direction and becomes more severe with height.

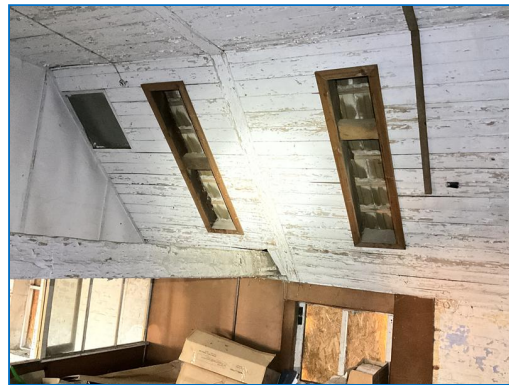
*Photo - 94*

The underside of the roof structure has been lined with timber panelling restricting the view of the structure above. There appears to be some staining to the underside of the sarking board but a close up inspection could not be made.

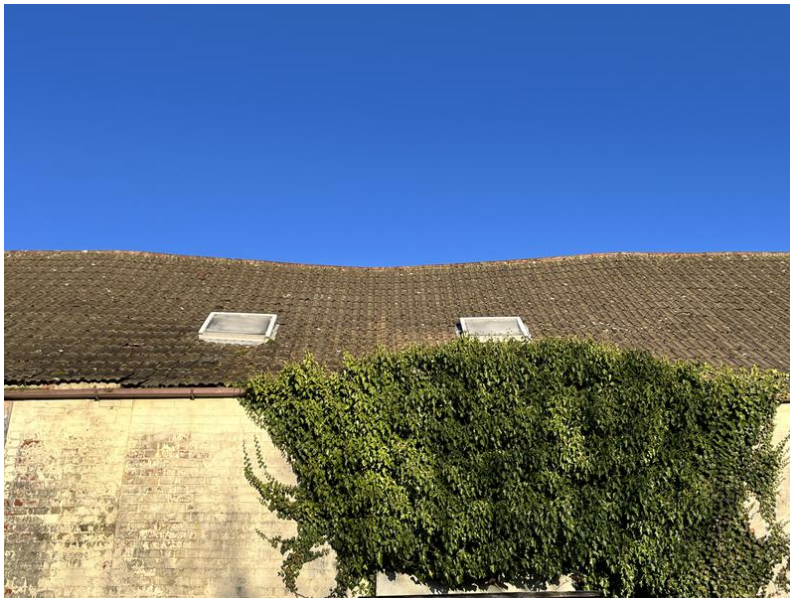
**Photograph No. 21**

Photo - 21

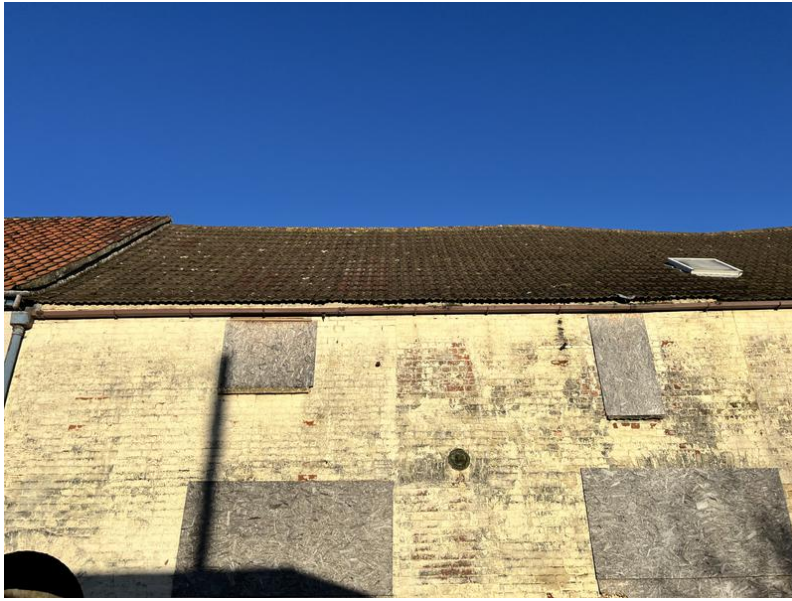
**Photograph No. 22**

Photo - 22

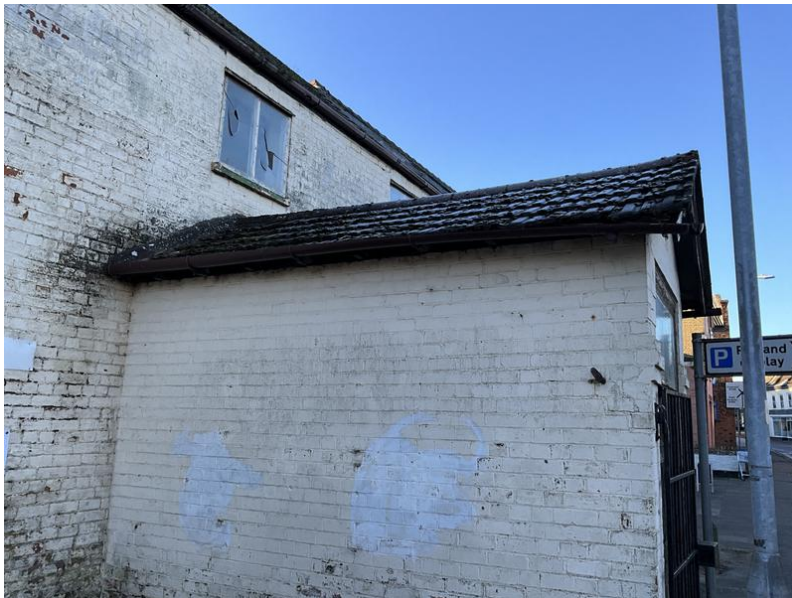
**Photograph No. 23**

Photo - 23

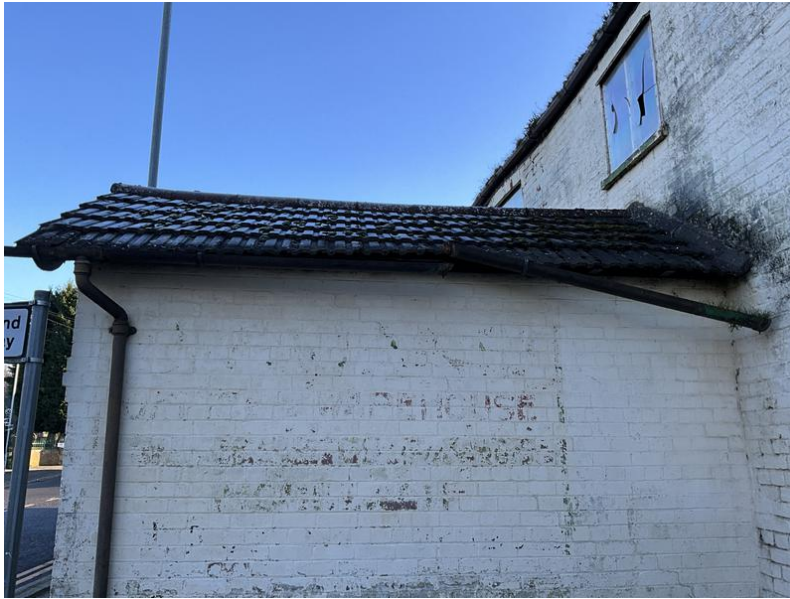
**Photograph No. 24**

Photo - 24

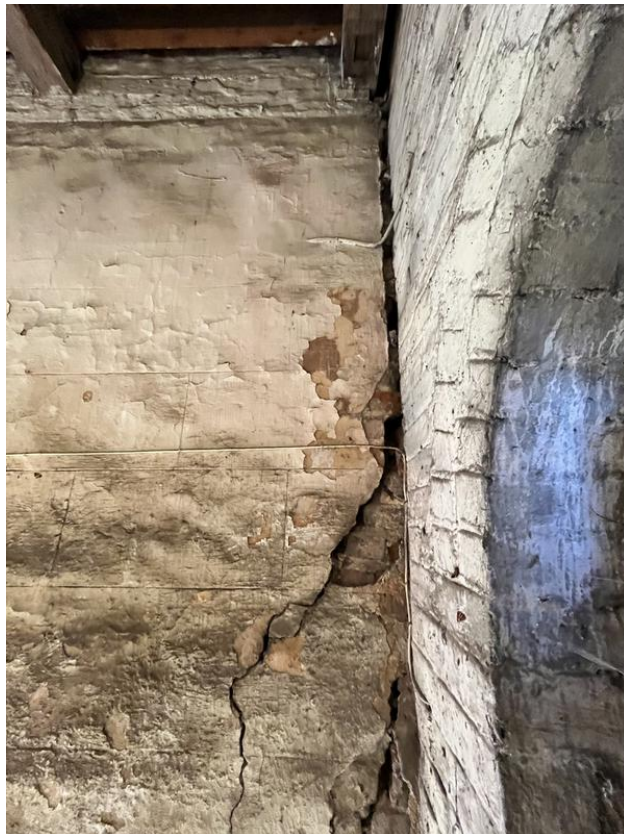
**Photograph No. 27**

Photo - 27

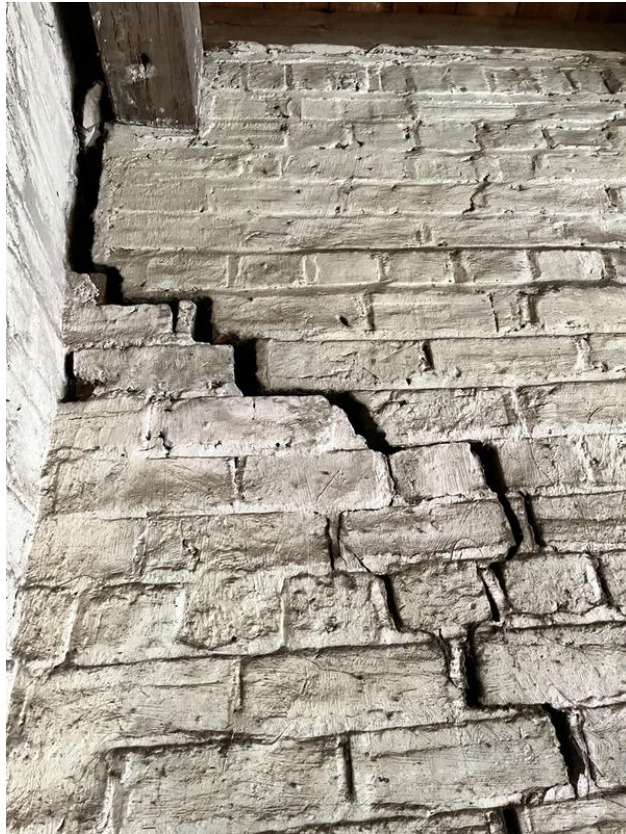
**Photograph No. 28**

*Photo - 28*

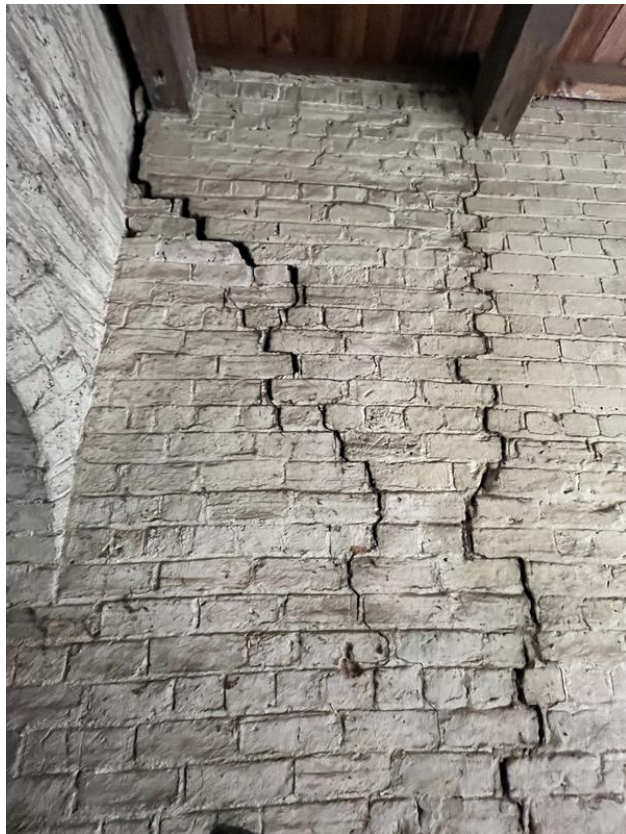
**Photograph No. 29**

*Photo - 29*

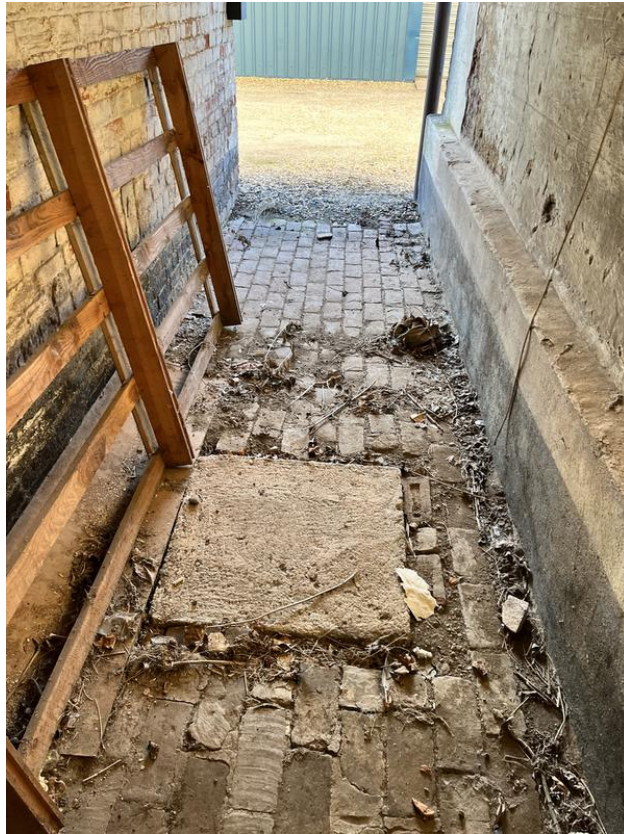
**Photograph No. 30**

*Photo - 30*

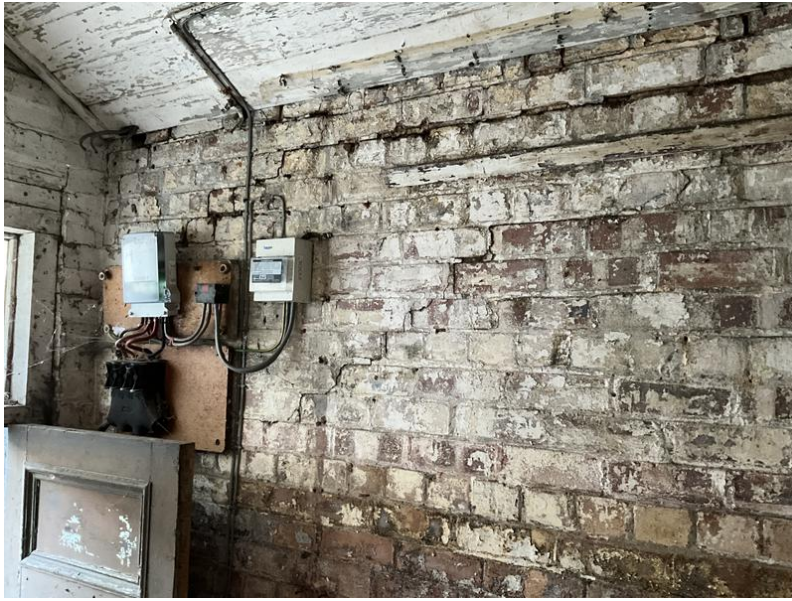
**Photograph No. 32**

*Photo - 32*

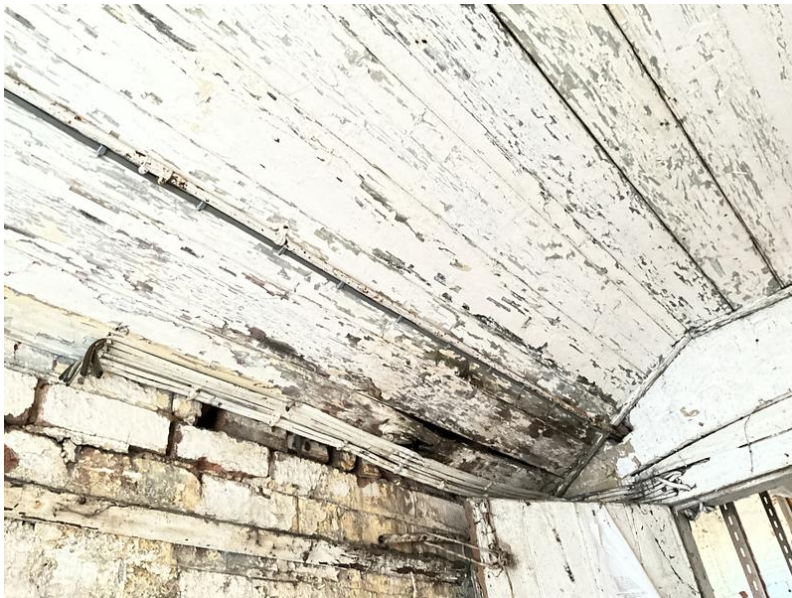
**Photograph No. 33**

*Photo - 33*

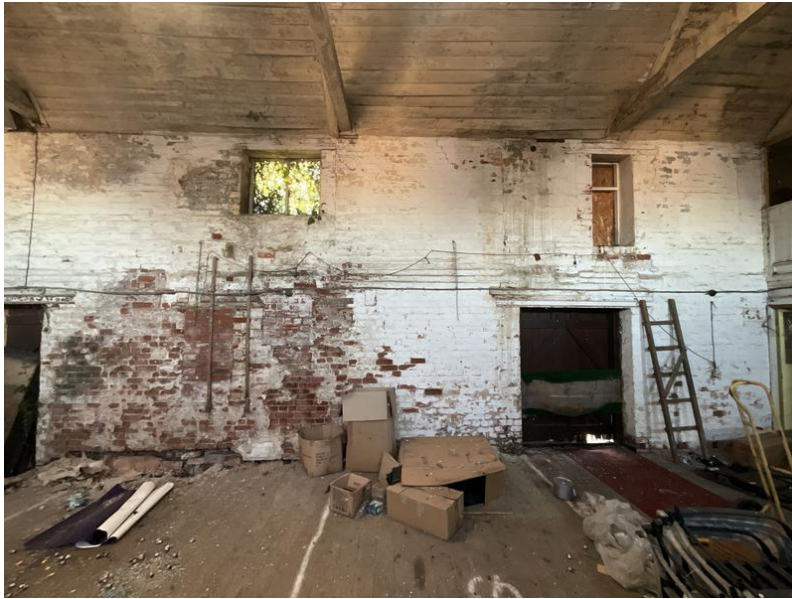
**Photograph No. 34**

*Photo - 34*

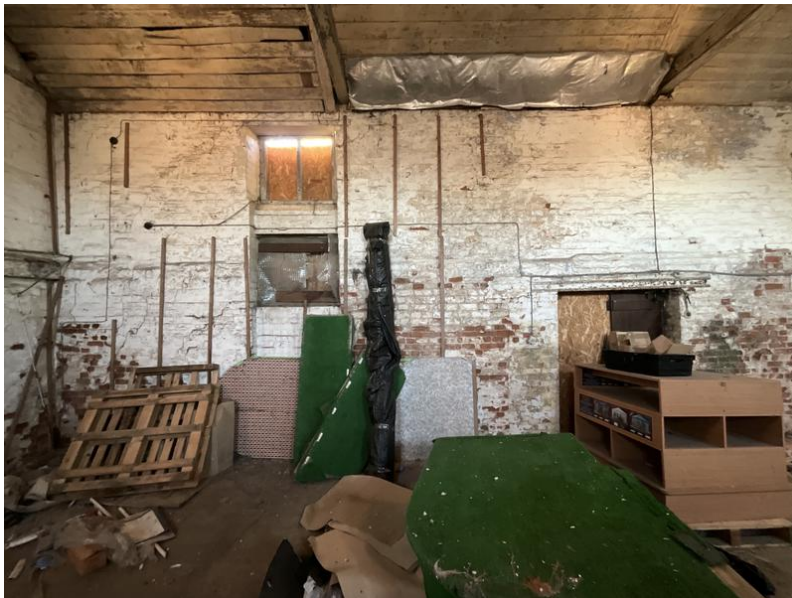
**Photograph No. 35**

*Photo - 35*

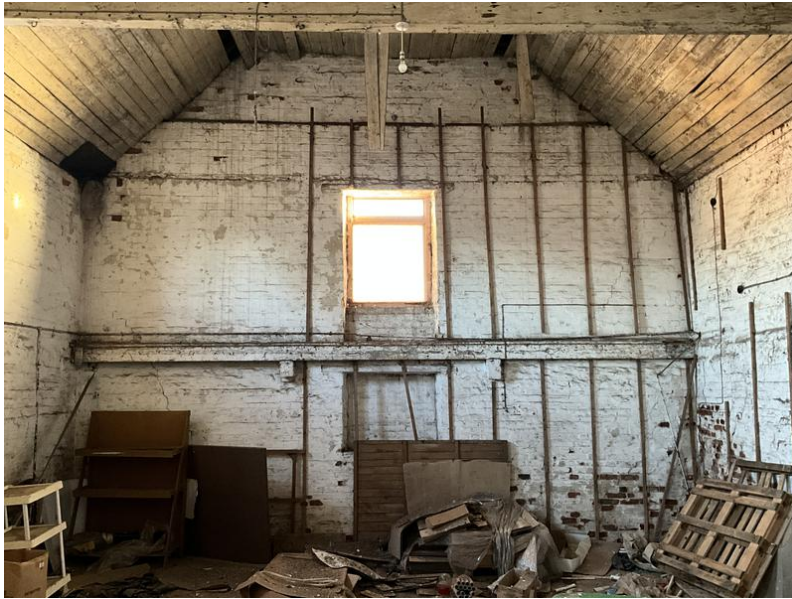
**Photograph No. 36**

*Photo - 36*

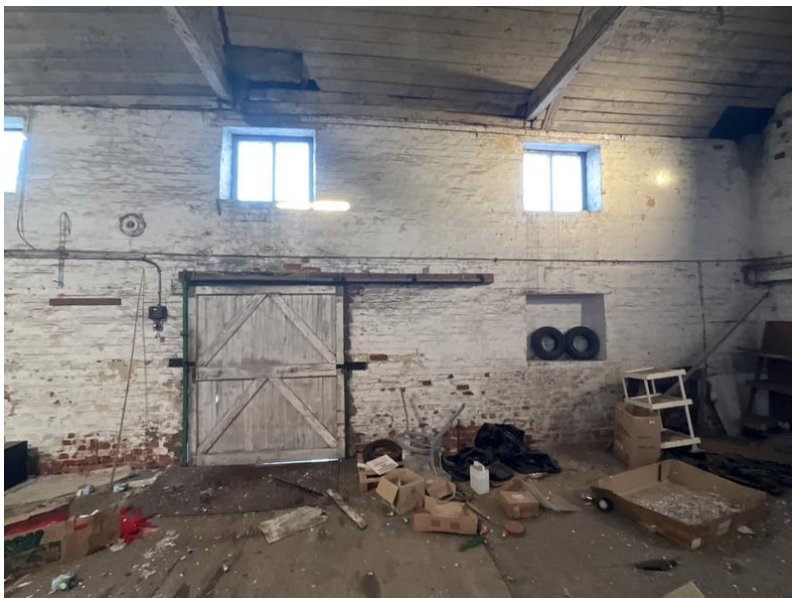
**Photograph No. 37**

Photo - 37

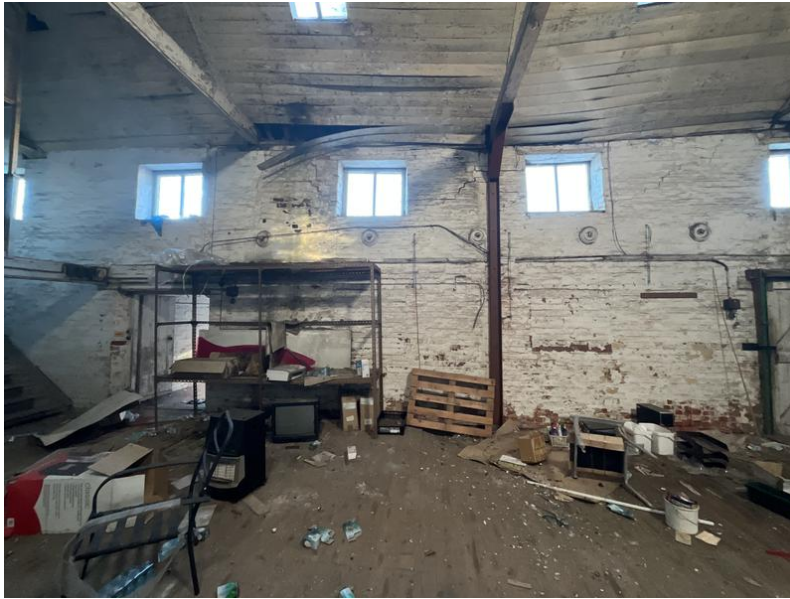
**Photograph No. 38**

Photo - 38

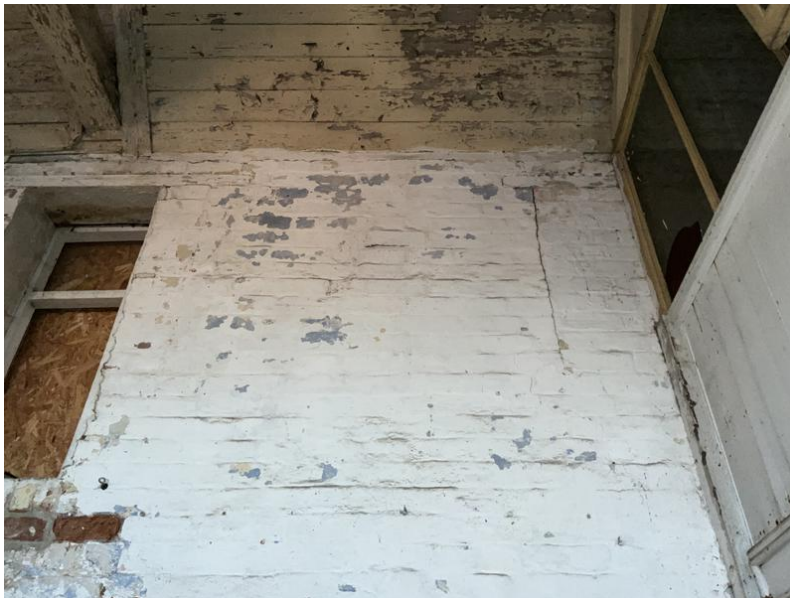
**Photograph No. 39**

Photo - 39

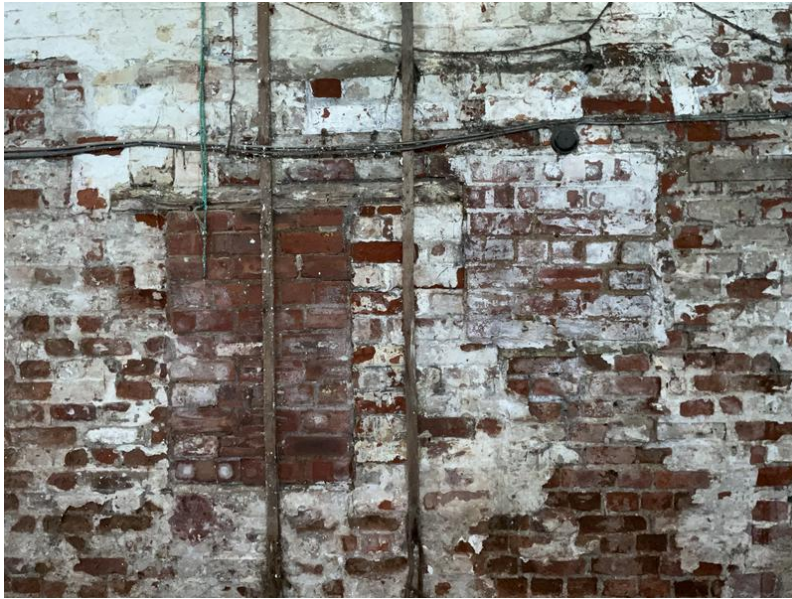
**Photograph No. 40**

Photo - 40

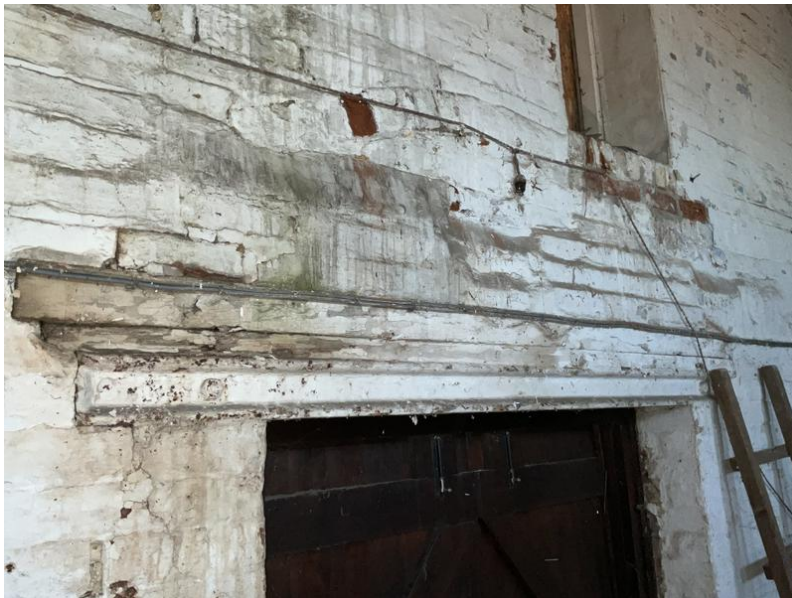
**Photograph No. 41**

Photo - 41

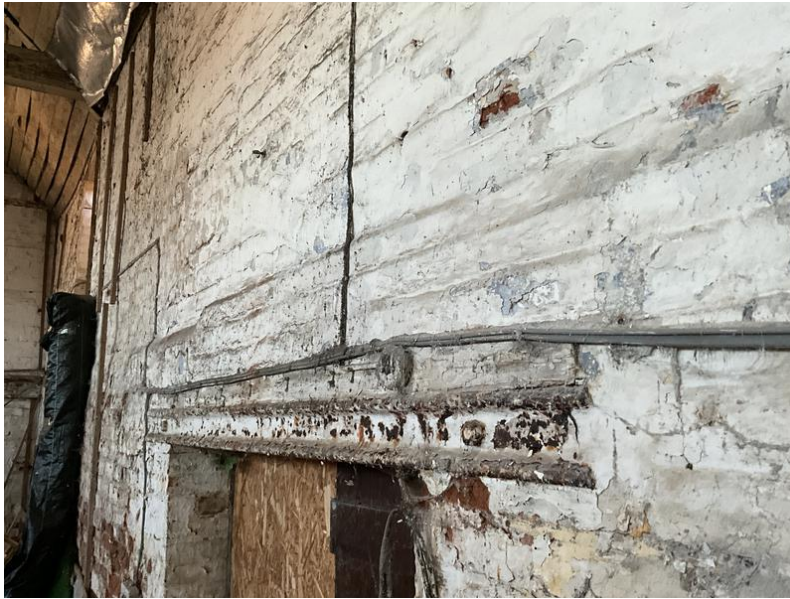
**Photograph No. 42**

*Photo - 42*

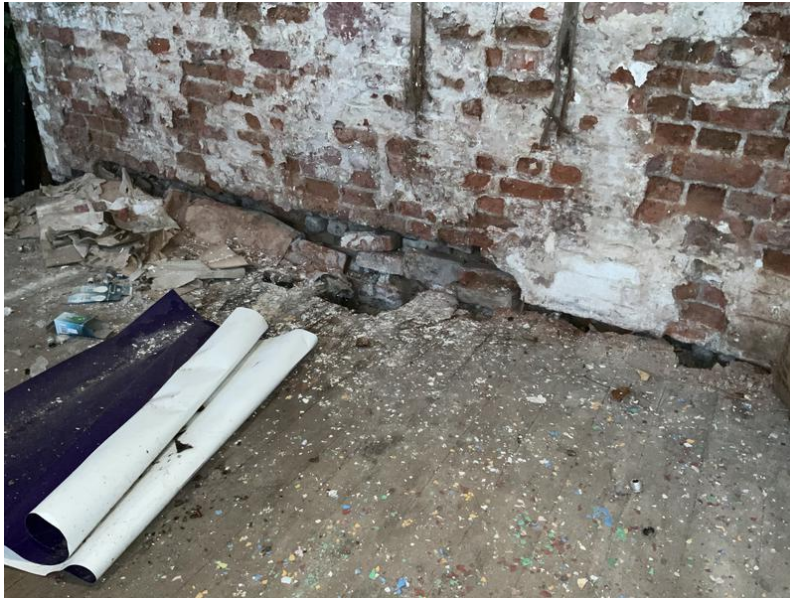
**Photograph No. 44**

*Photo - 44*

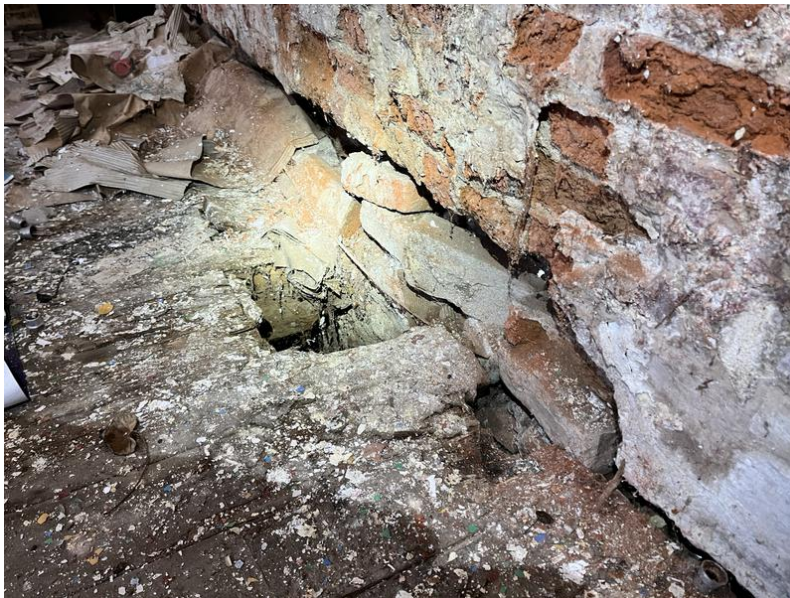
**Photograph No. 45**

*Photo - 45*

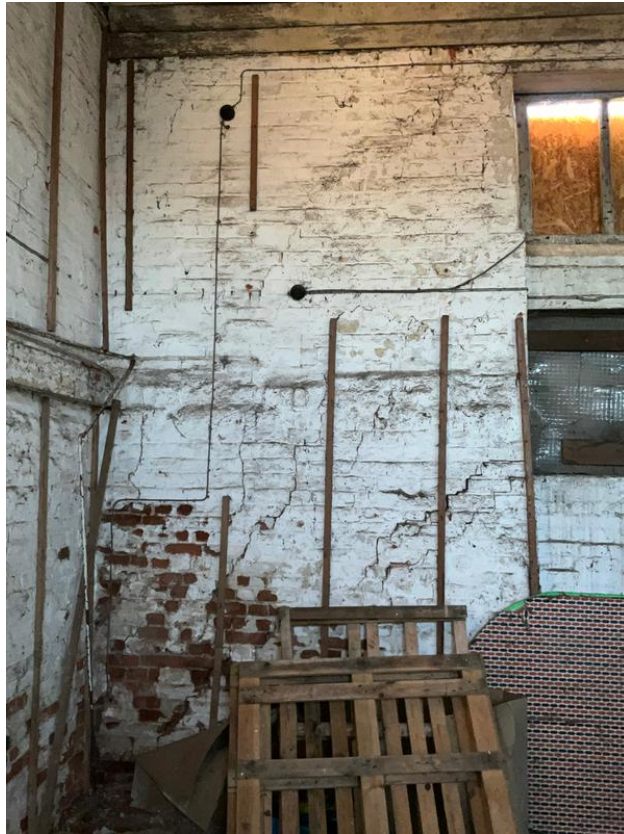
**Photograph No. 46**

*Photo - 46*

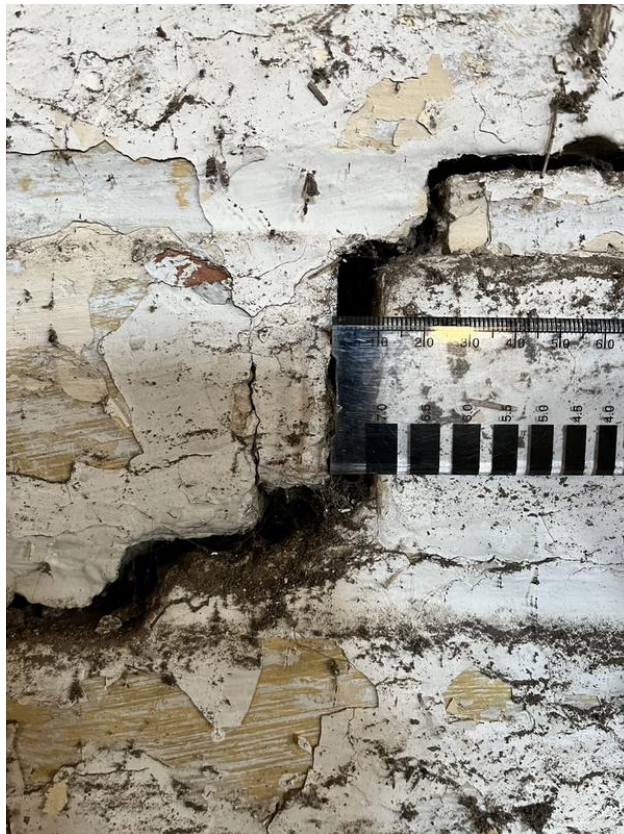
**Photograph No. 47**

*Photo - 47*

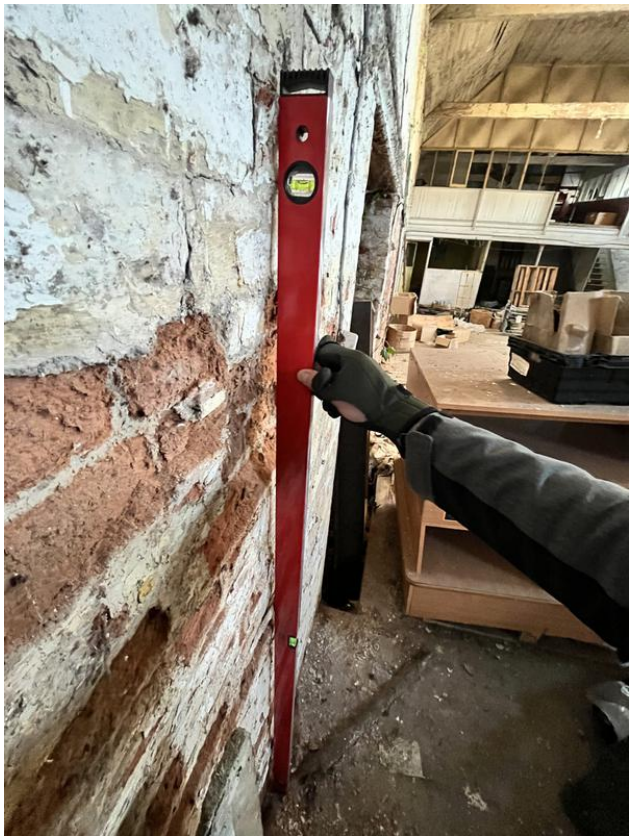
Photograph No. 49

*Photo - 49*

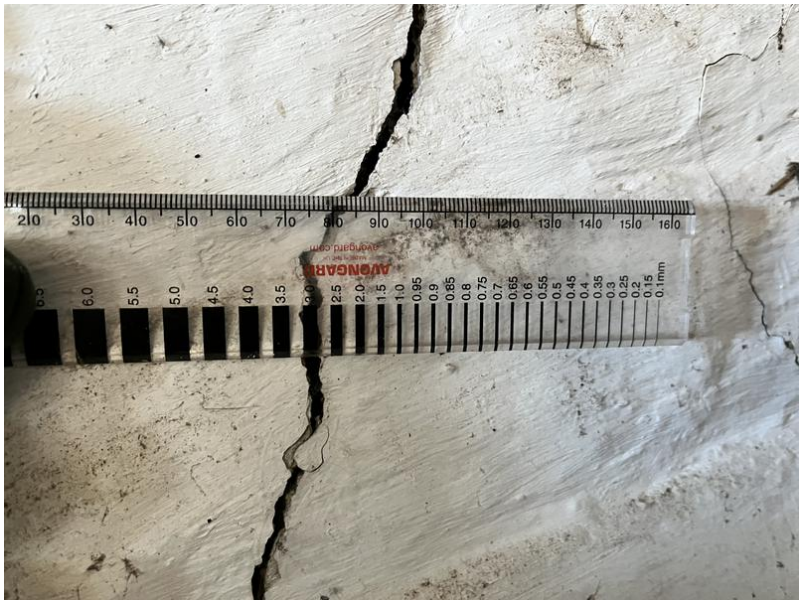
Photograph No. 50

Photo - 50

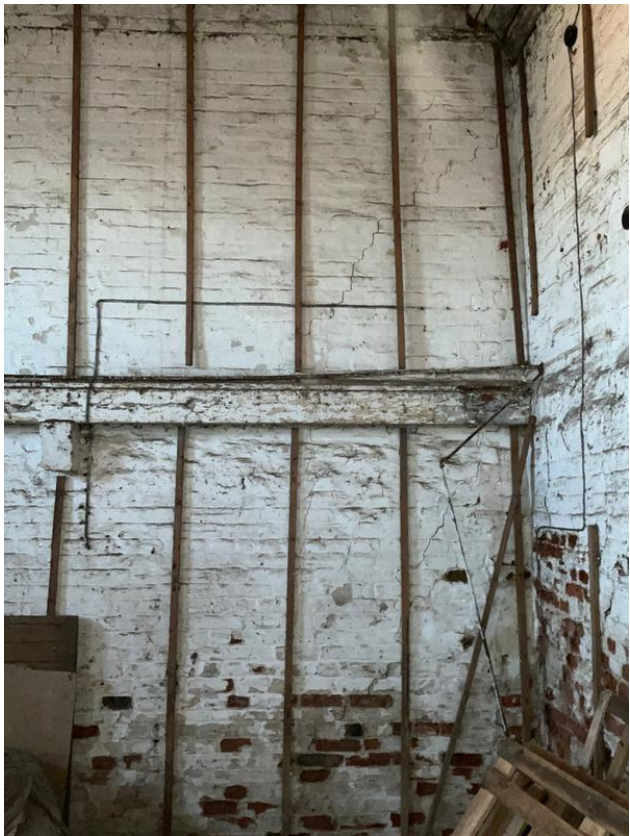
Photograph No. 51

Photo - 51

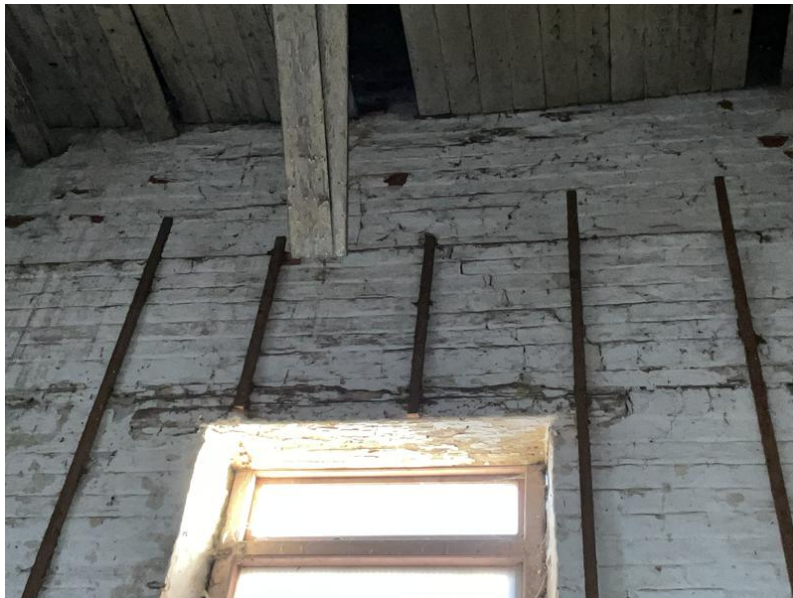
**Photograph No. 53**

*Photo - 53*

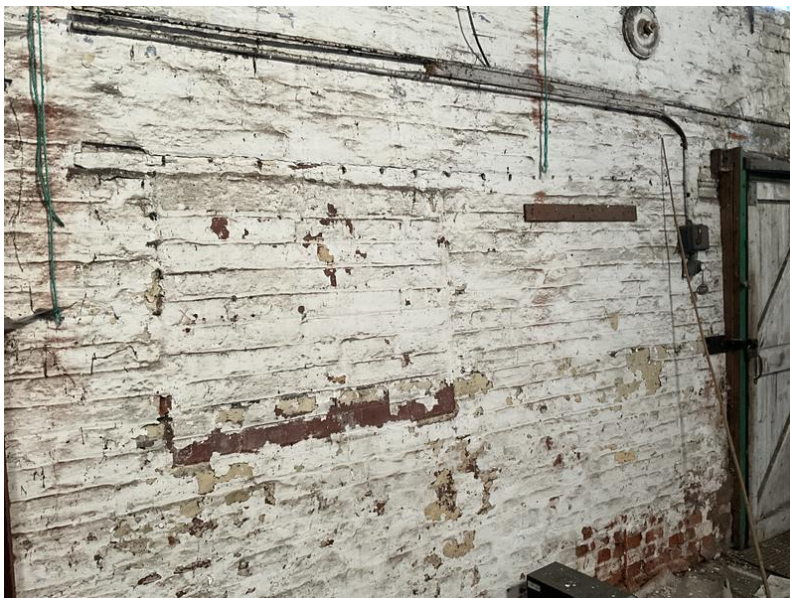
**Photograph No. 55**

*Photo - 55*

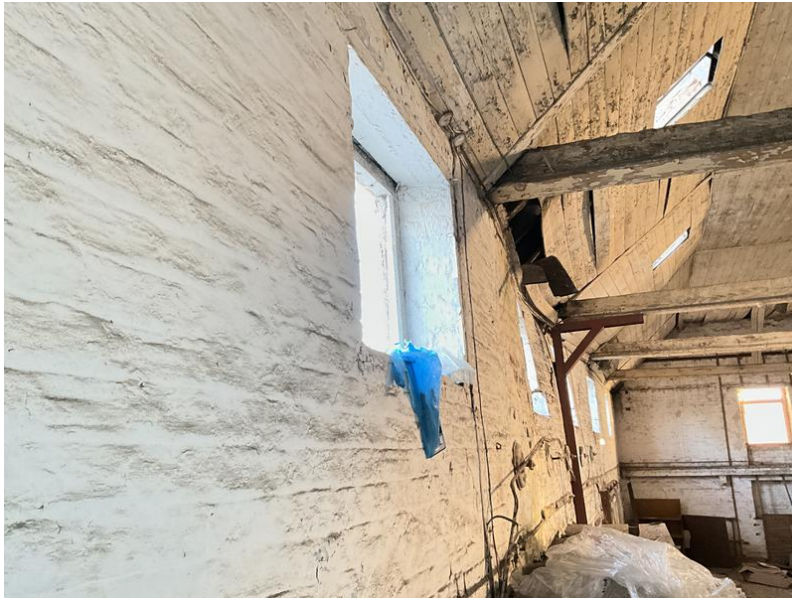
**Photograph No. 56**

*Photo - 56*

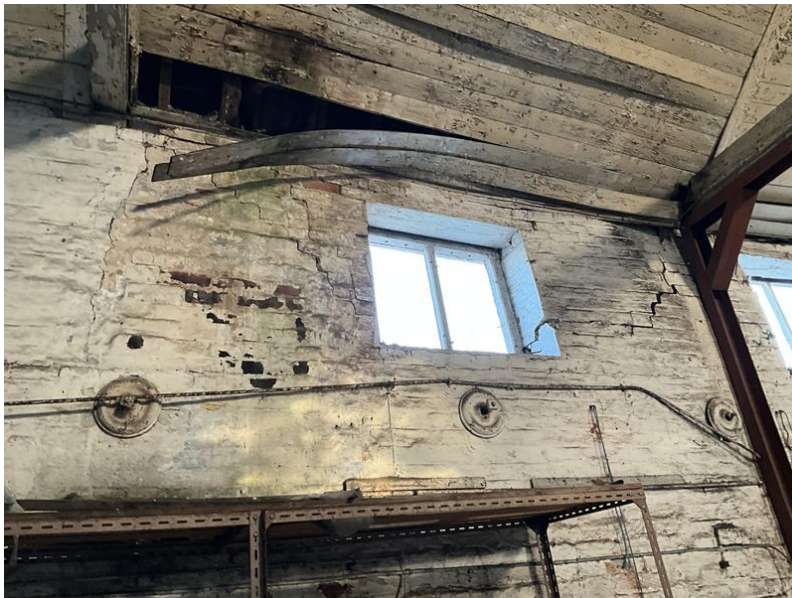
**Photograph No. 57**

*Photo - 57*

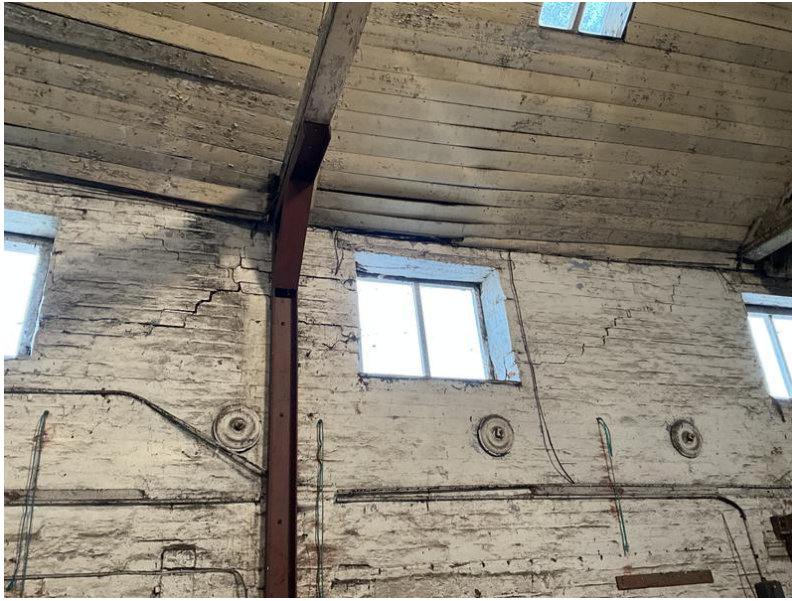
**Photograph No. 58**

*Photo - 58*
