**STRUCTURAL REPORT ON  
LIMMINGS BUILDING,  
PARK ROAD, HOLBEACH,  
PE12 7EE**

**PROJECT NO.  
MGC/EH/HW/50247-RP001**

**STRUCTURAL REPORT ON LIMMINGS BUILDING, PARK ROAD, HOLBEACH,  
PE12 7EE**

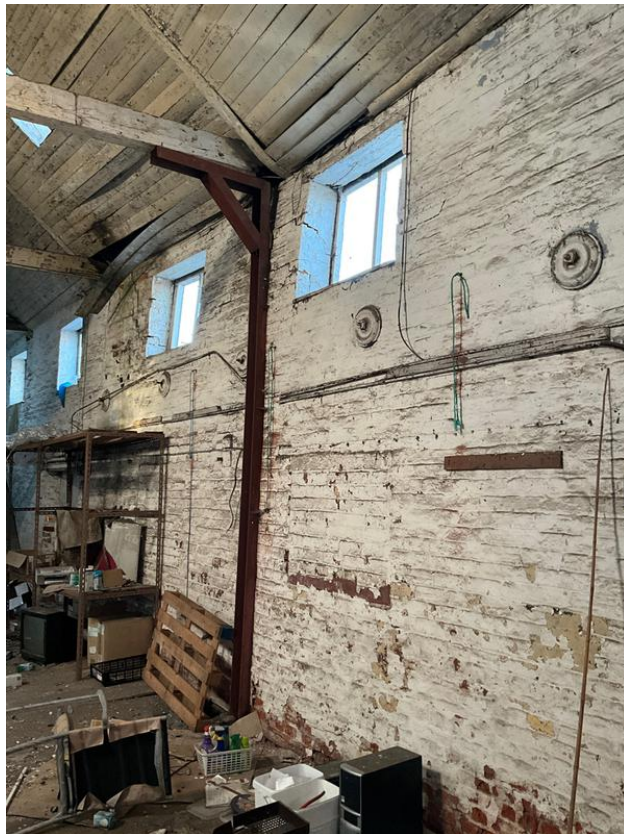
**Photograph No. 59**

*Photo - 59*

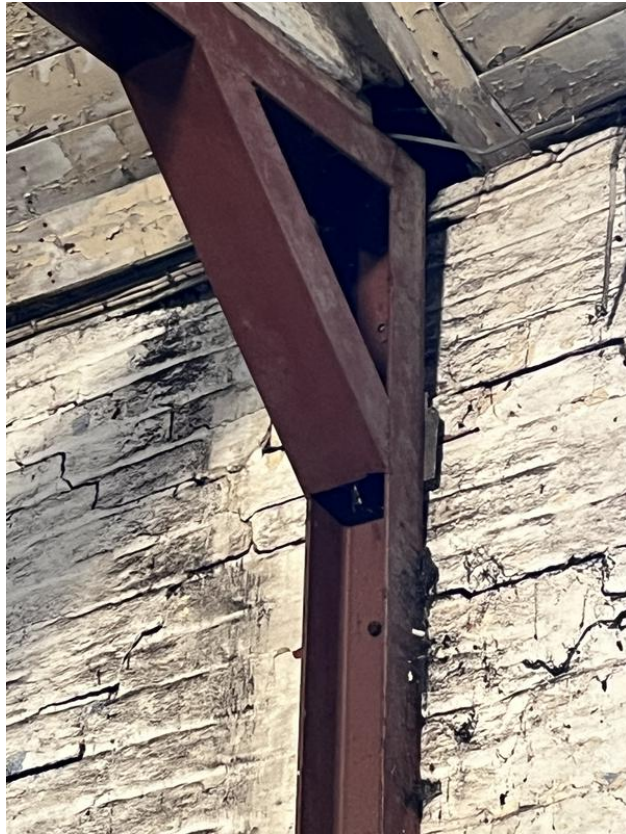
**Photograph No. 60**

Photo - 60
