# Ground Gas Verification Report

## Public Open Space, Wygate Park, Spalding

**BRD241183-OR14-A**

**November 2020**

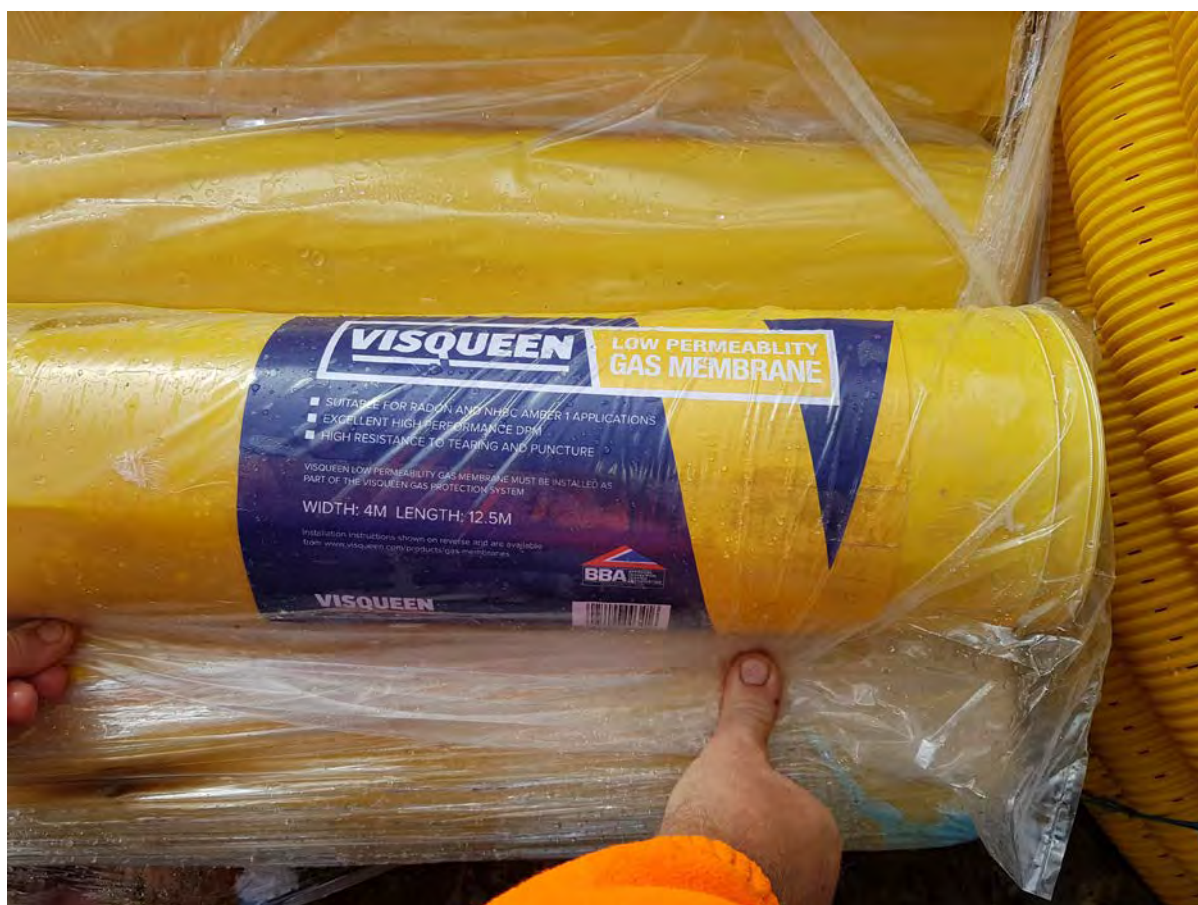
**Photo 1** – Membrane employed.

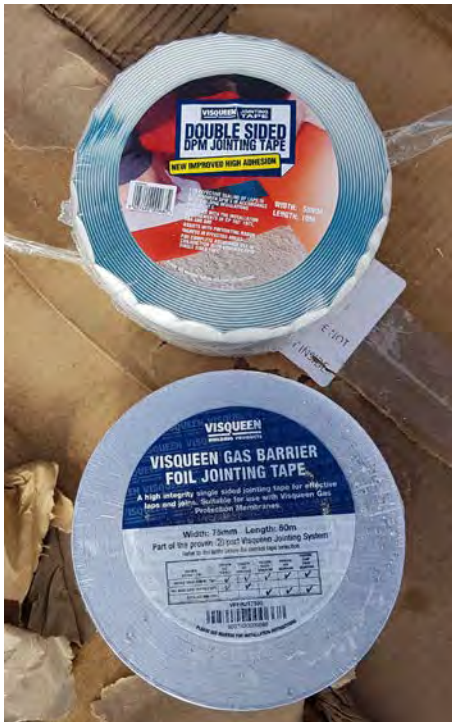
**Photo 2** – Tape materials used.

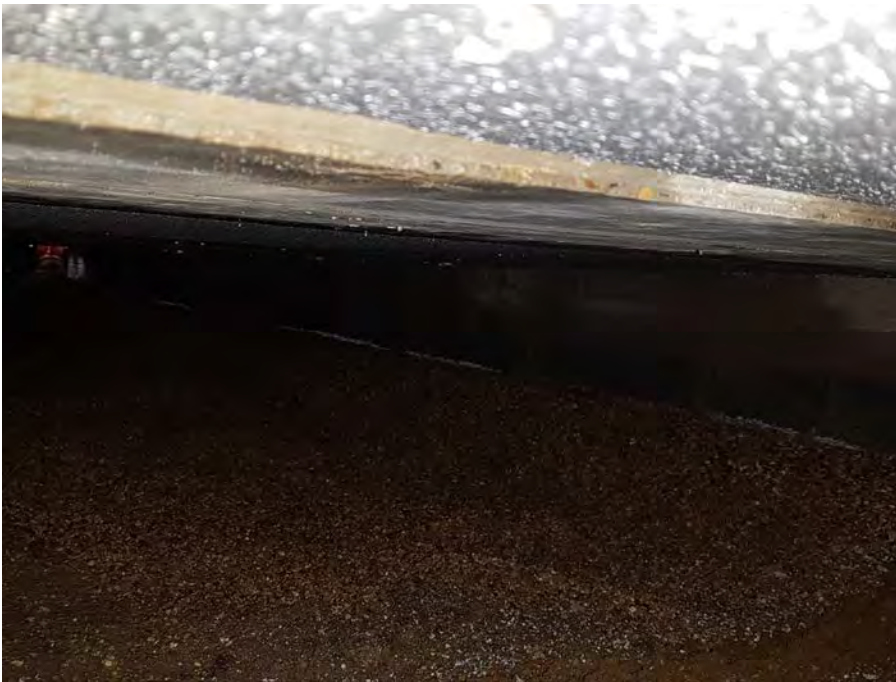
**Photo 4** – Sub-floor void in Plots 905 to 907.

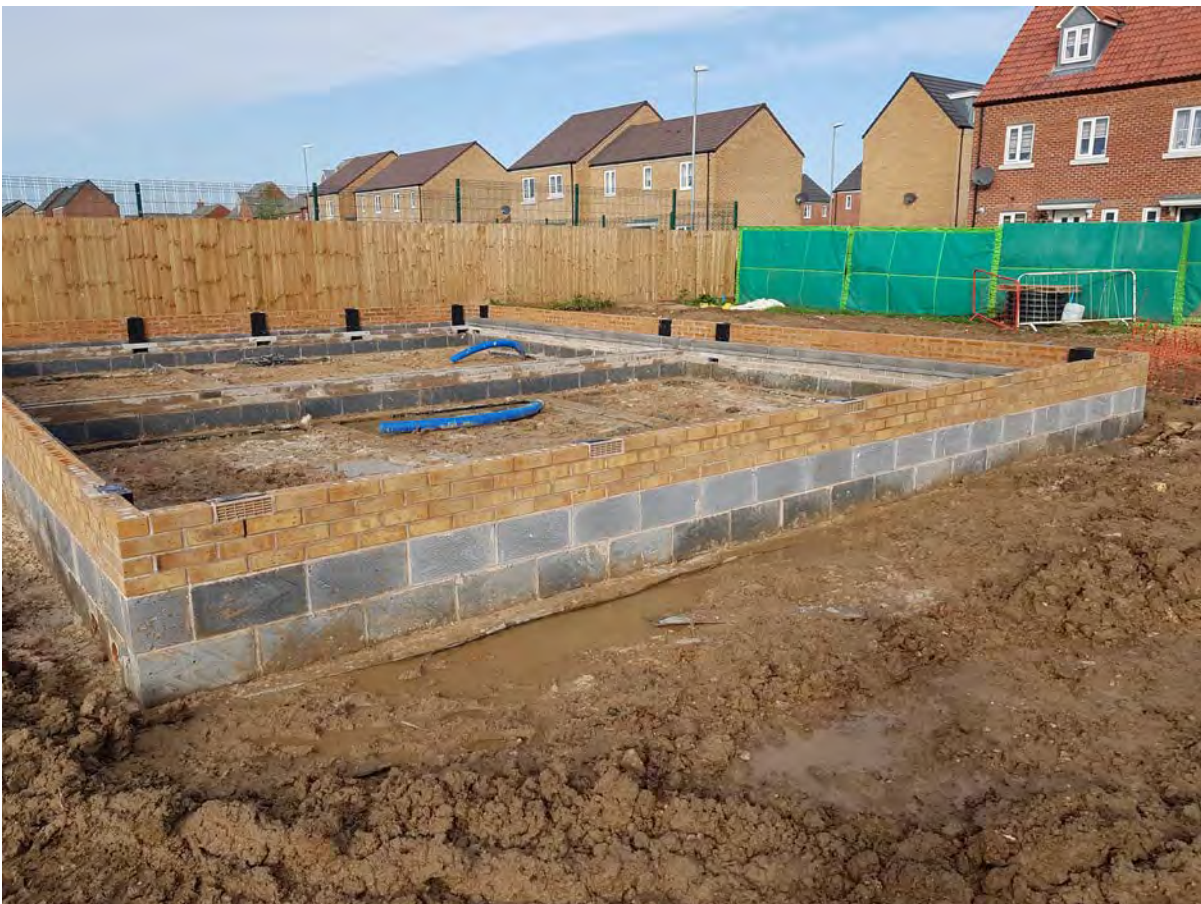
**Photo 5** – Plot 910/911 before placement of beams showing ready void and periscopic vents.

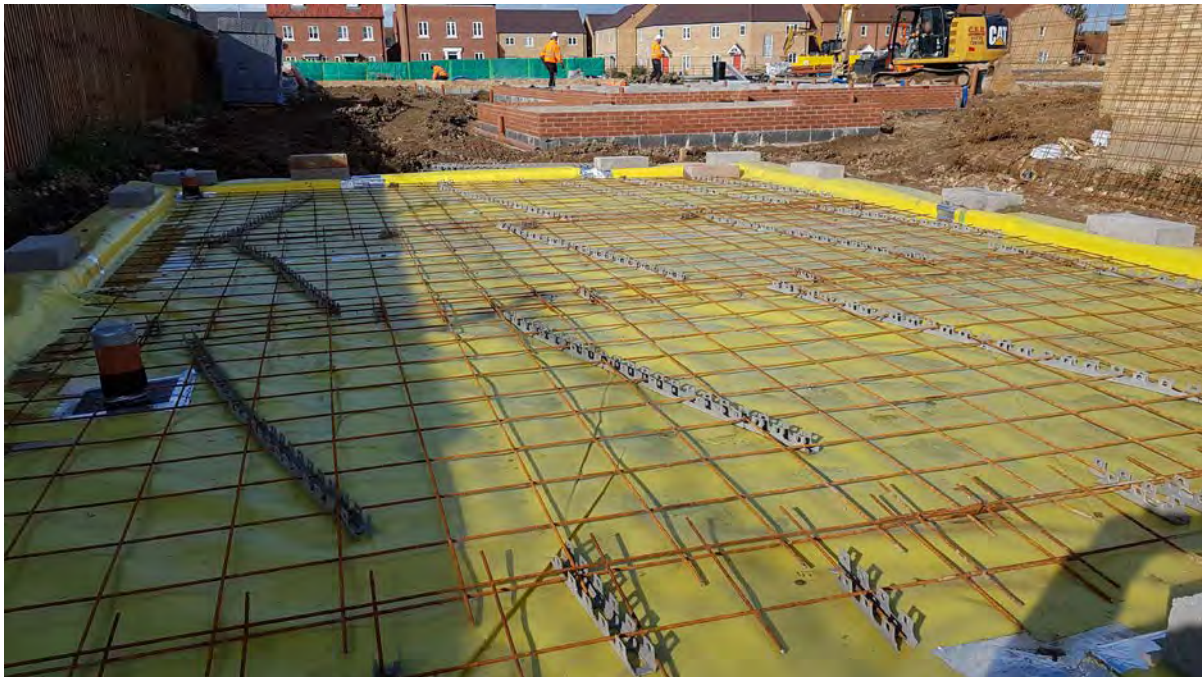
**Photo 7** – Installation of the mesh reinforcement for the screed on the first house (Plot 904). Note use of dedicated supports.

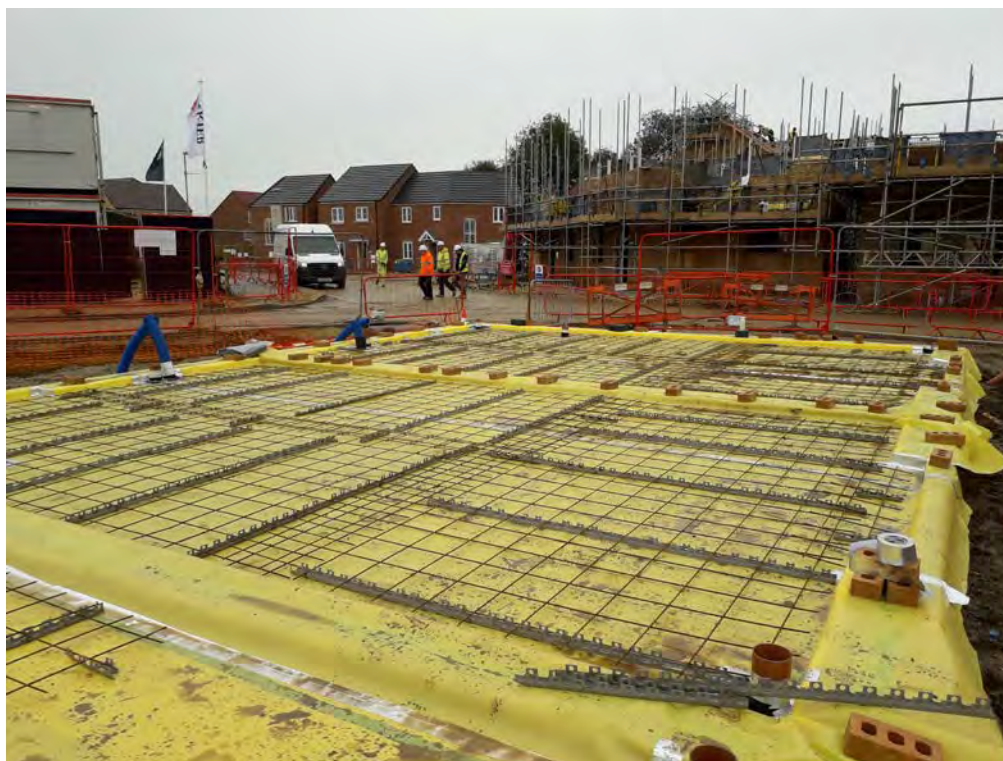
**Photo 1** – General view across Plots 901 to 903, looking south east. Note reinforced steel mesh on dedicated supports within the plots.

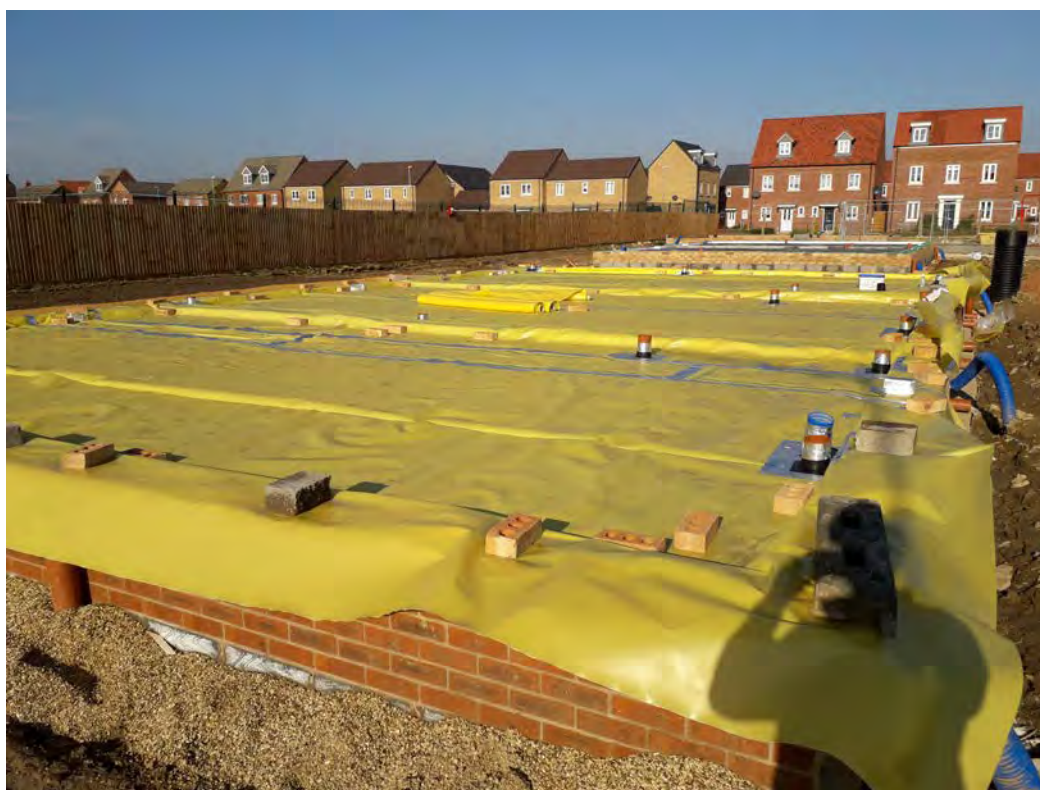
**Photo 1** – General view across Plots 905 to 907.

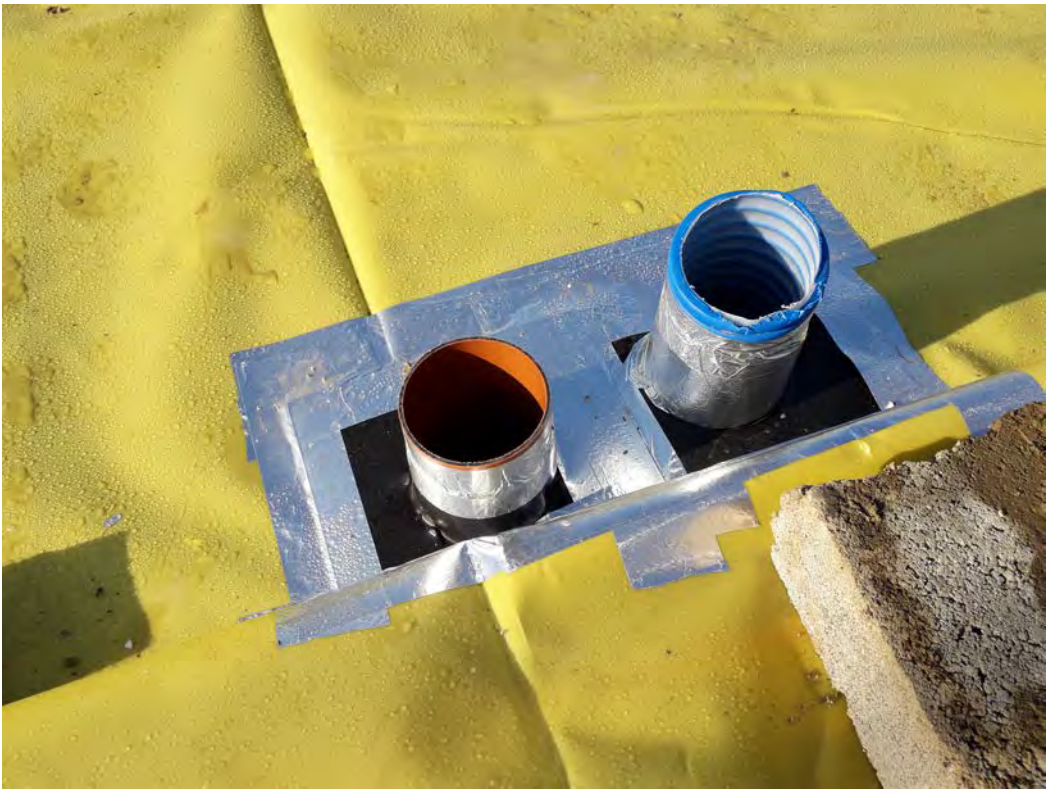
**Photo 2** – Detail of seals around service entry points.

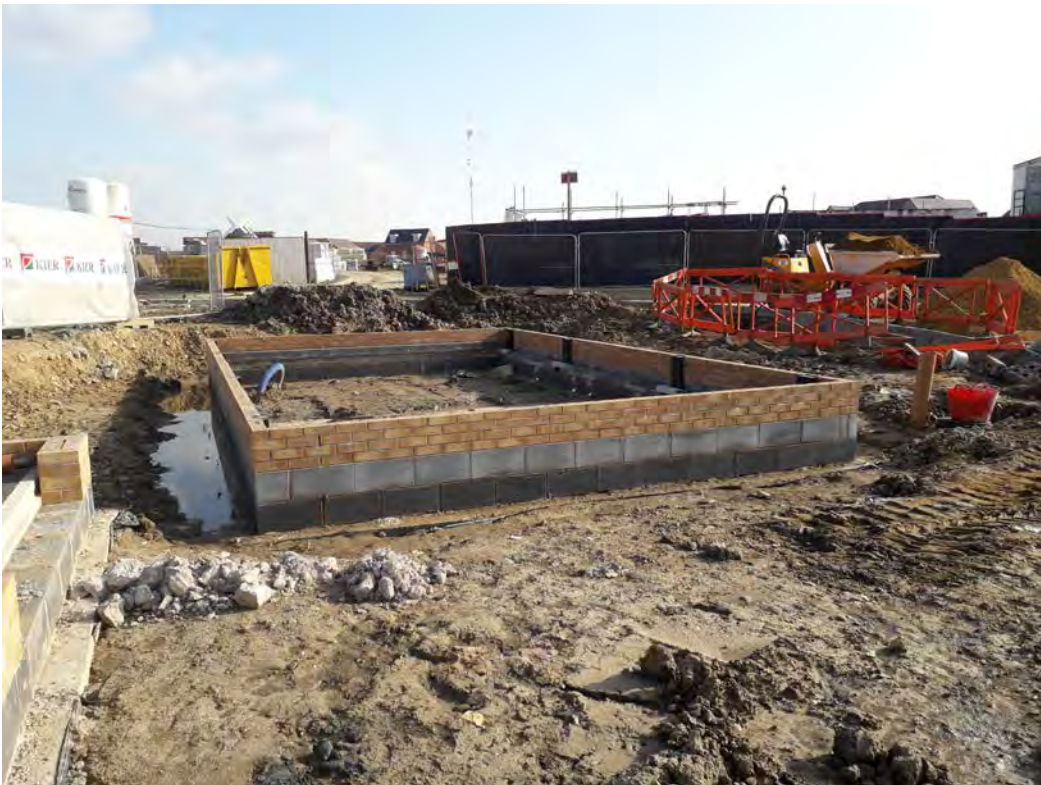
**Photo 5** – Plot 920 showing void, air bricks and periscopic ducts.

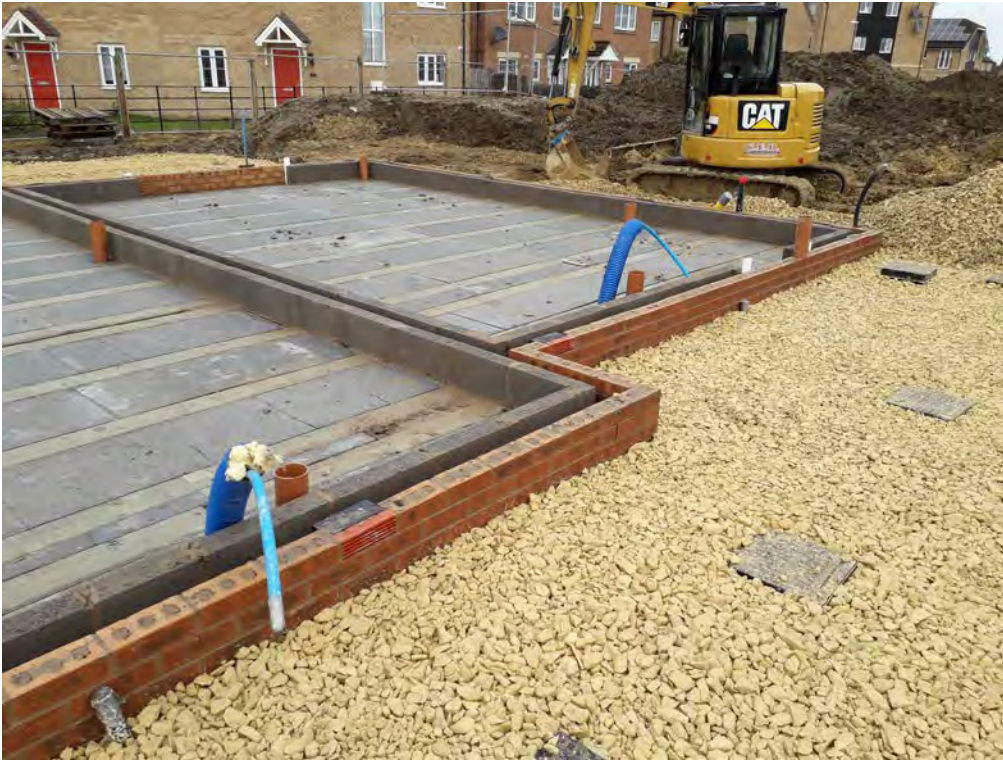
**Photo 4** – Showing air brick to Plot 912/913/914.

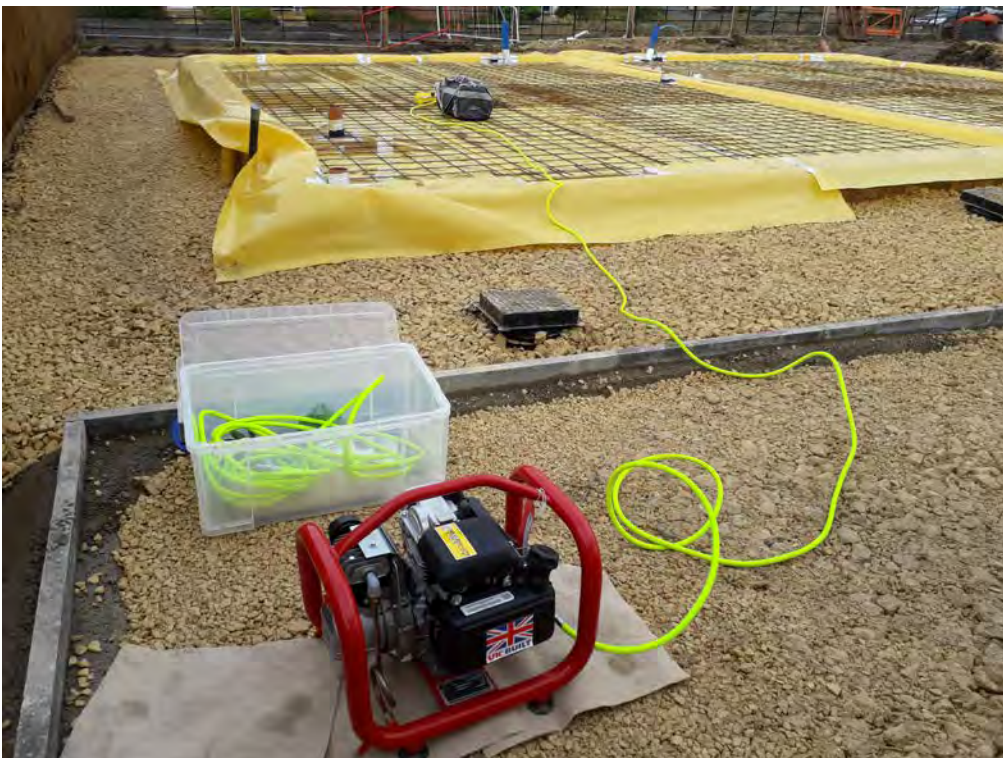
**Photo 5** – Use of air lance testing to check the integrity of the membrane.

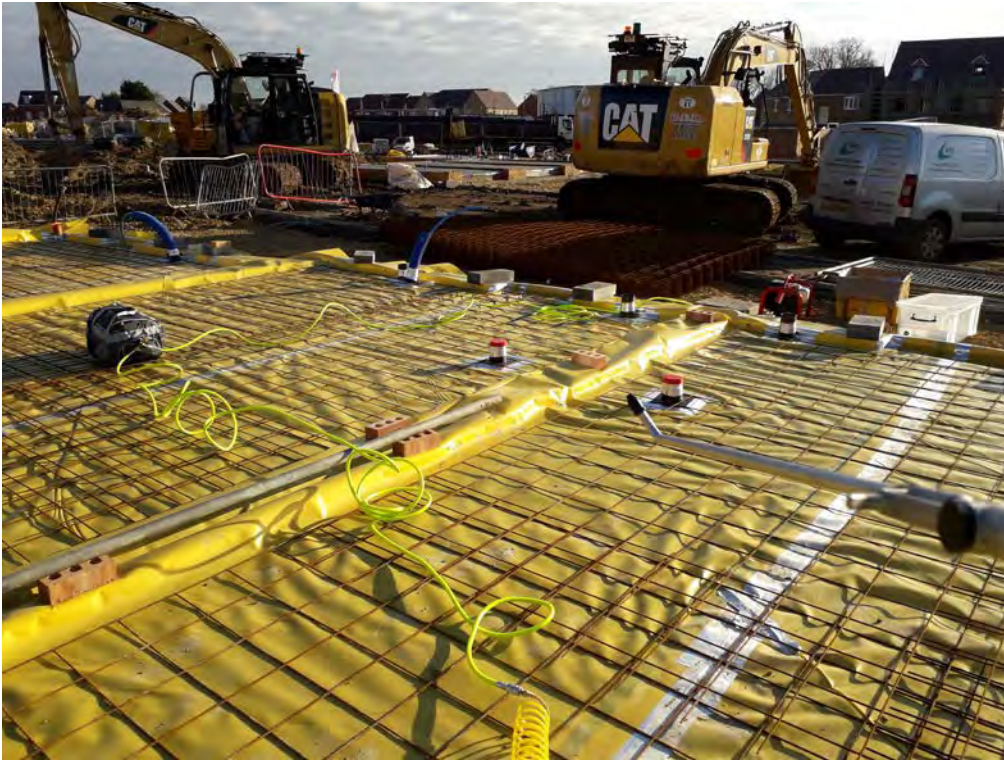
**Photo 2** – Air lance testing of membrane to Plot 912/913/914.

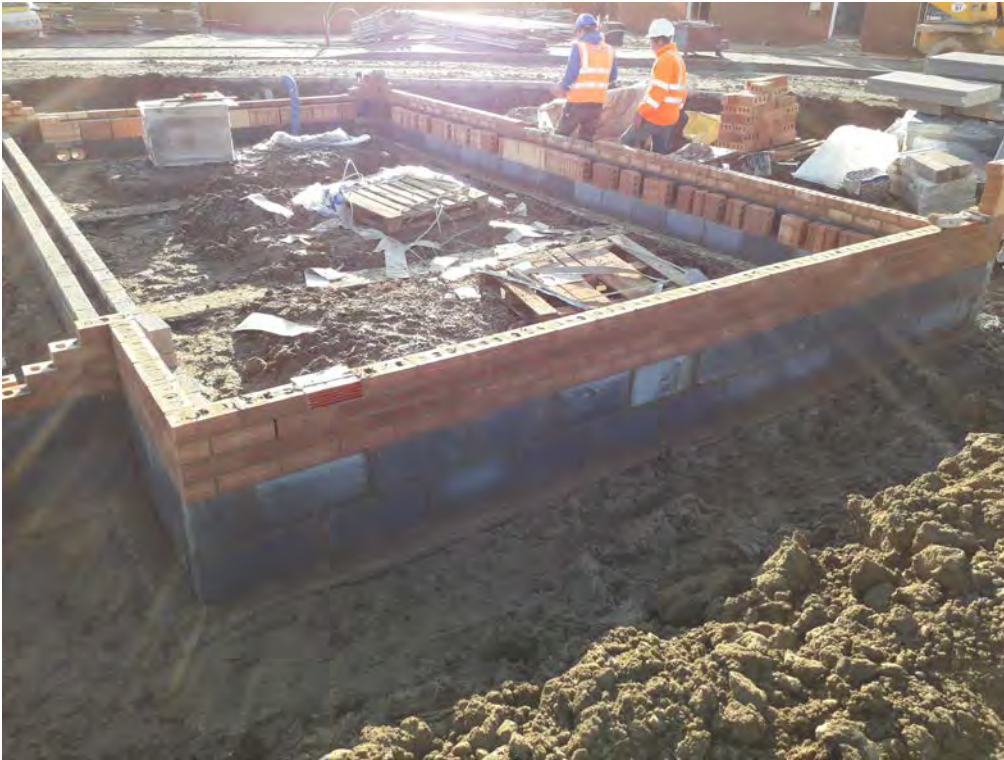
**Photo 6** – Void to Plot 917/918/919.

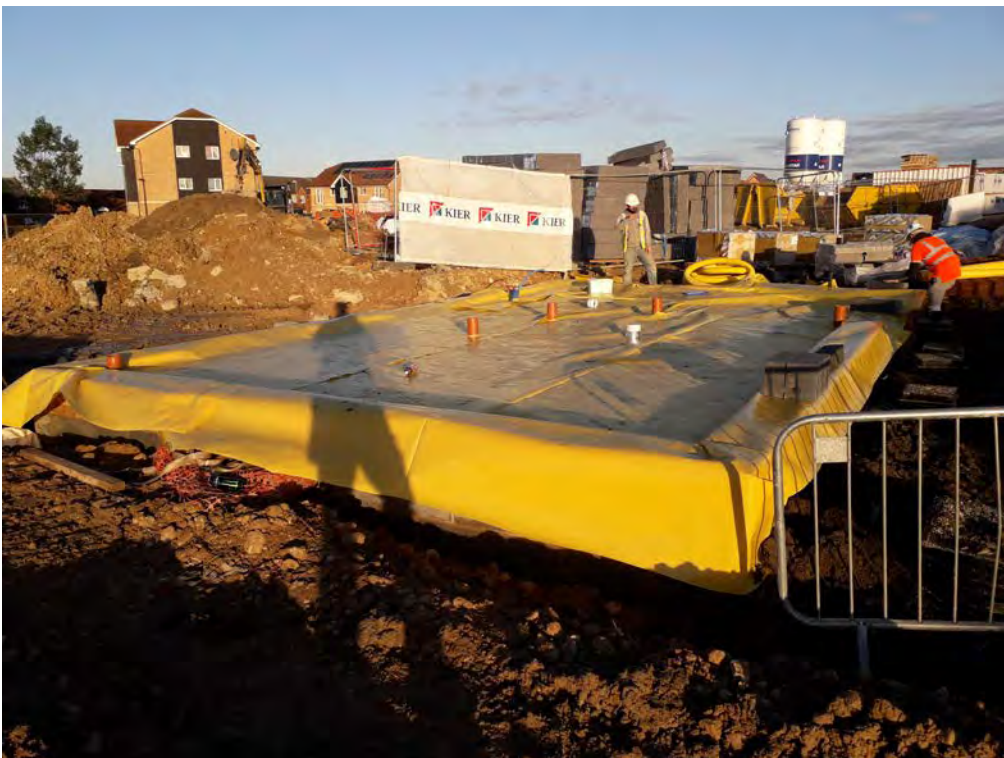
**Photo 7** – Plot 920 showing ongoing installation of membrane.

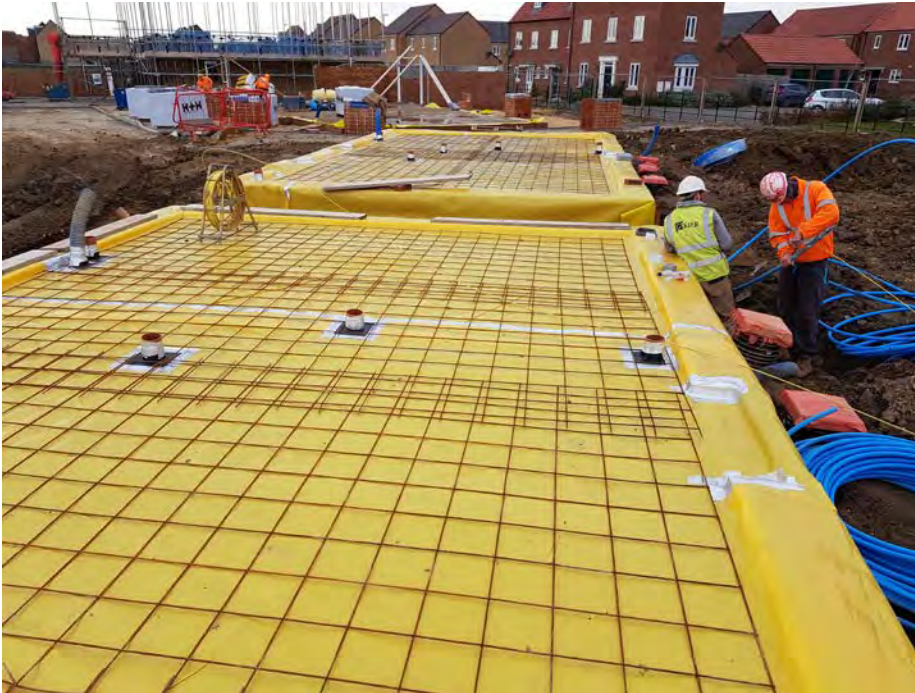
**Photo 1** – General view across Plots 915 (background) & 916 (foreground).

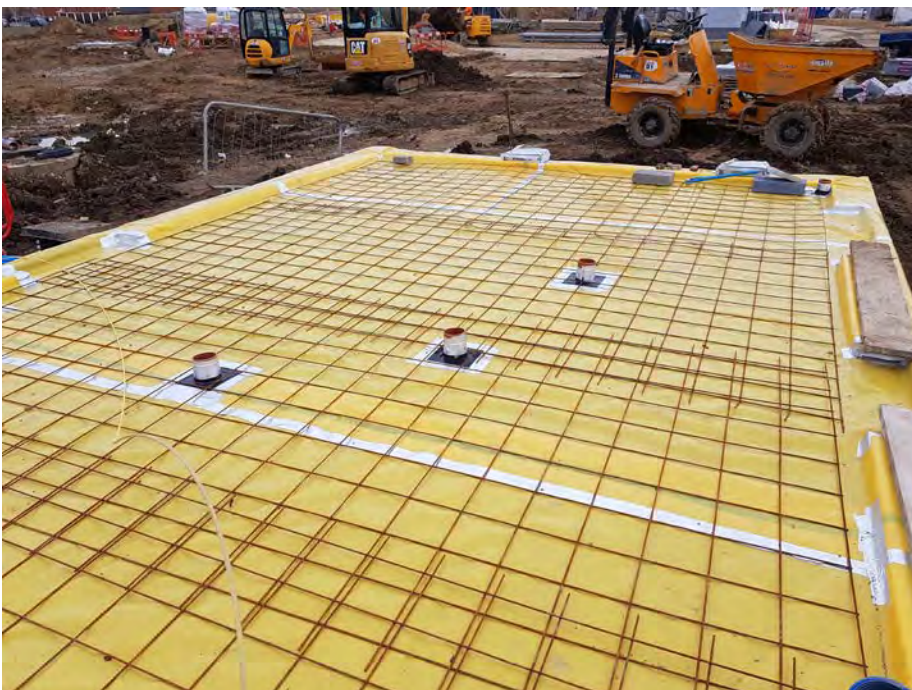
**Photo 2** – Membrane of Plot 916.

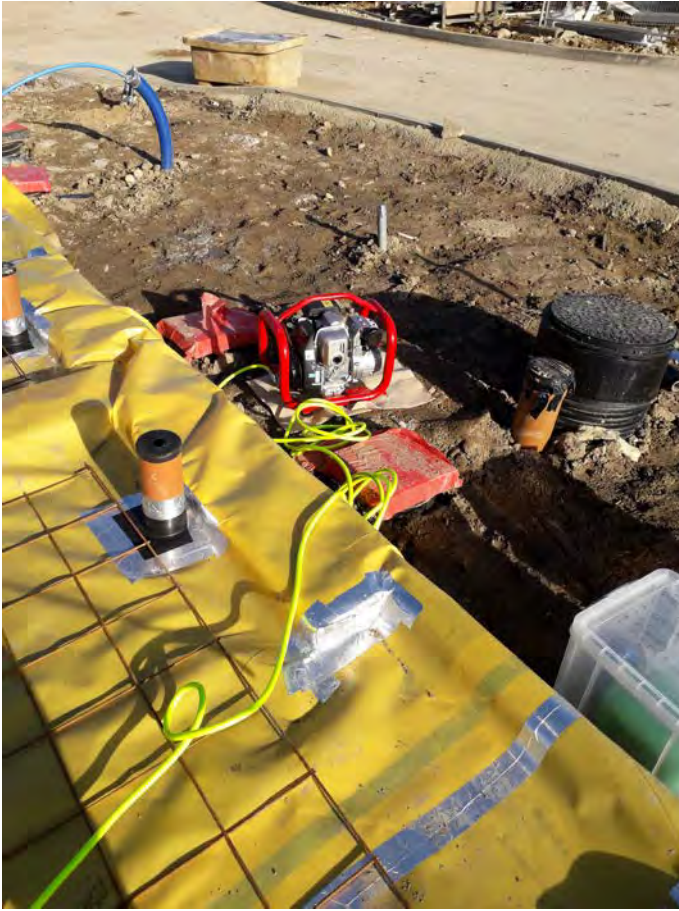
**Photo 2** – Air lance testing of membrane to Plot 921/922.

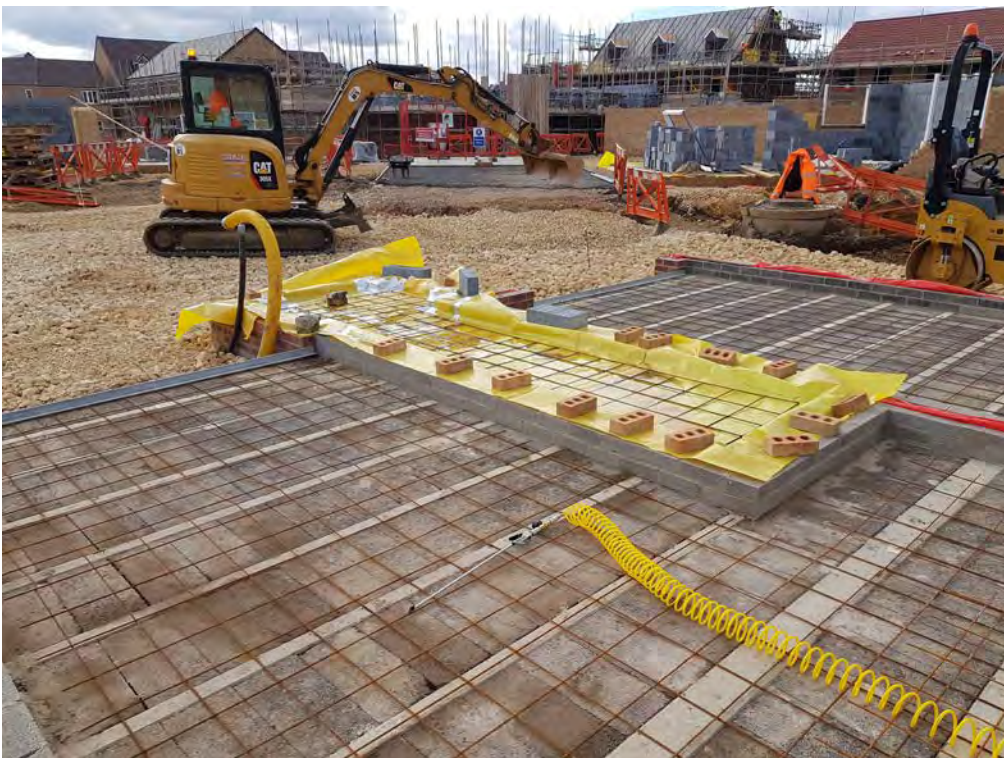
**Photo 3** – View of membrane to stairwell of Plot 923. Note air lance used during verification.

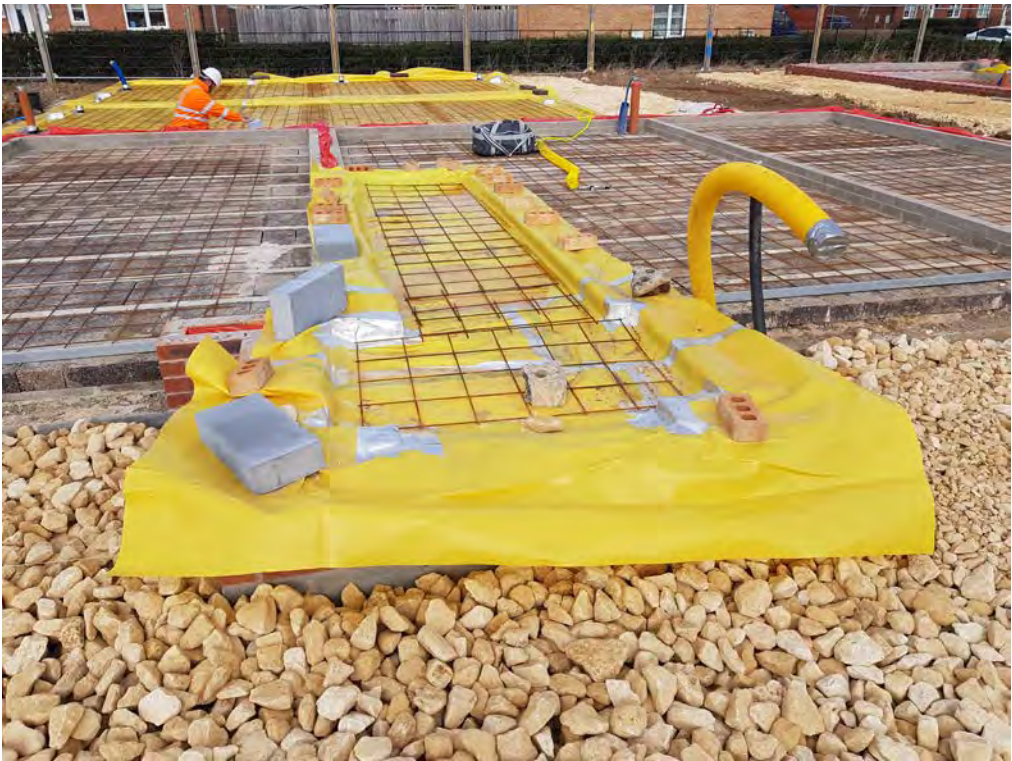
**Photo 4** – View of corner detail for Plot 923.

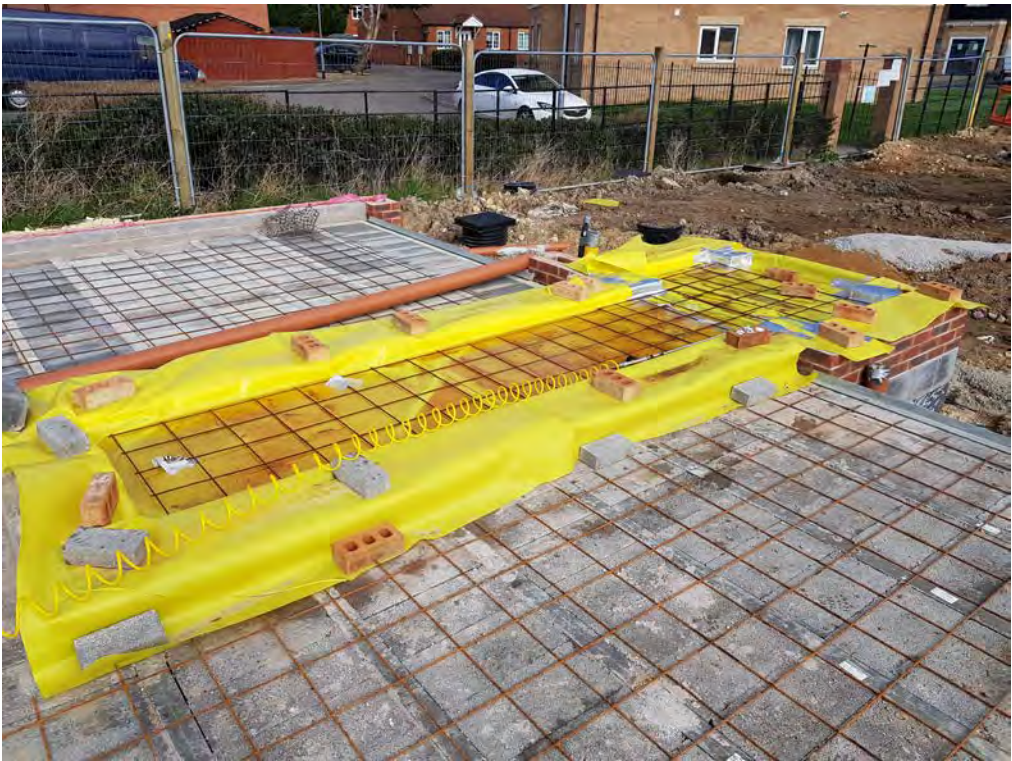
**Photo 6** – General view of Plot 926.

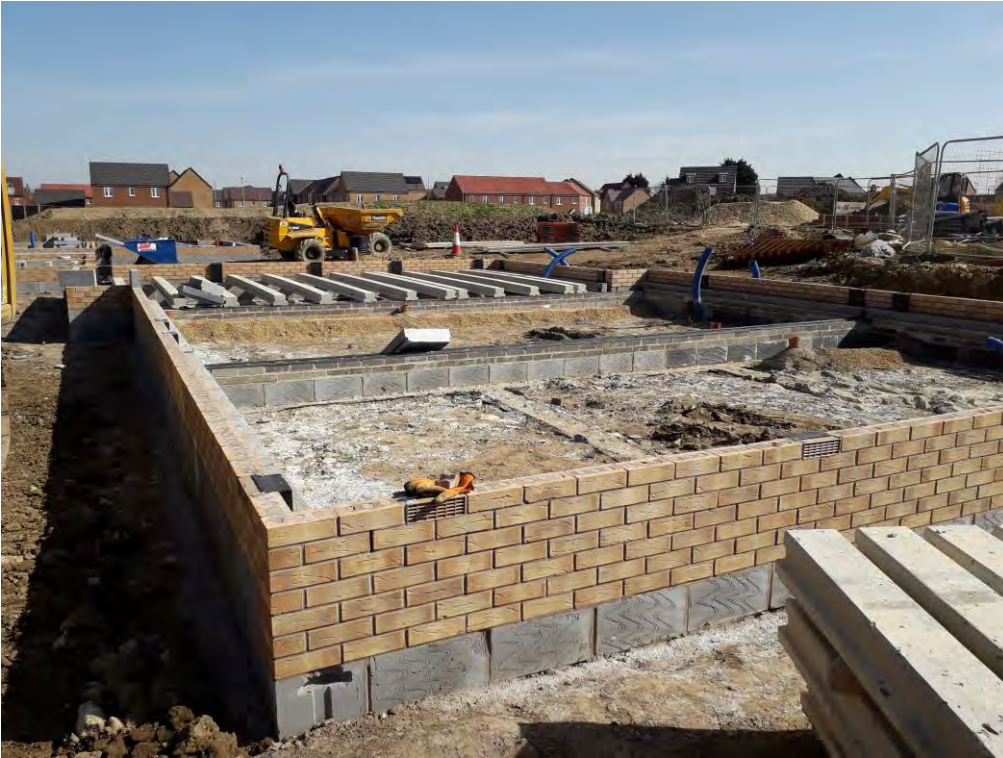
**Photo 2** - General view of Plot 930/931/932 showing sub-floor void and air brick.
